Incident ID	NAPP2104348535
District RP	
Facility ID	
Application ID

Site Name PLU 13 DTD 121H	Site Type Well Pad
Date Release Discovered 2/05/2021	API# (if applicable)

**RE: Closure Request
PLU 13 DTD 121H
Incident Number NAPP2104348535
Eddy County, New Mexico**

WSP USA Inc. (WSP), on behalf of XTO Energy, Inc. (XTO), presents the following Closure Request detailing site assessment, soil sampling, and excavation activities at the Poker Lake Unit (PLU) 13 DTD 121H (Site) in Unit D, Section 24, Township 24 South, Range 30 East, in Eddy County, New Mexico (Figure 1). The purpose of the site assessment, soil sampling, and excavation activities was to address impacts to soil following a release of frac fluid at the Site. Based on the excavation activities and laboratory analytical results from the soil sampling events, XTO is submitting this Closure Request, describing remediation that has occurred and requesting no further action (NFA) for Incident Number NAPP2104348535.

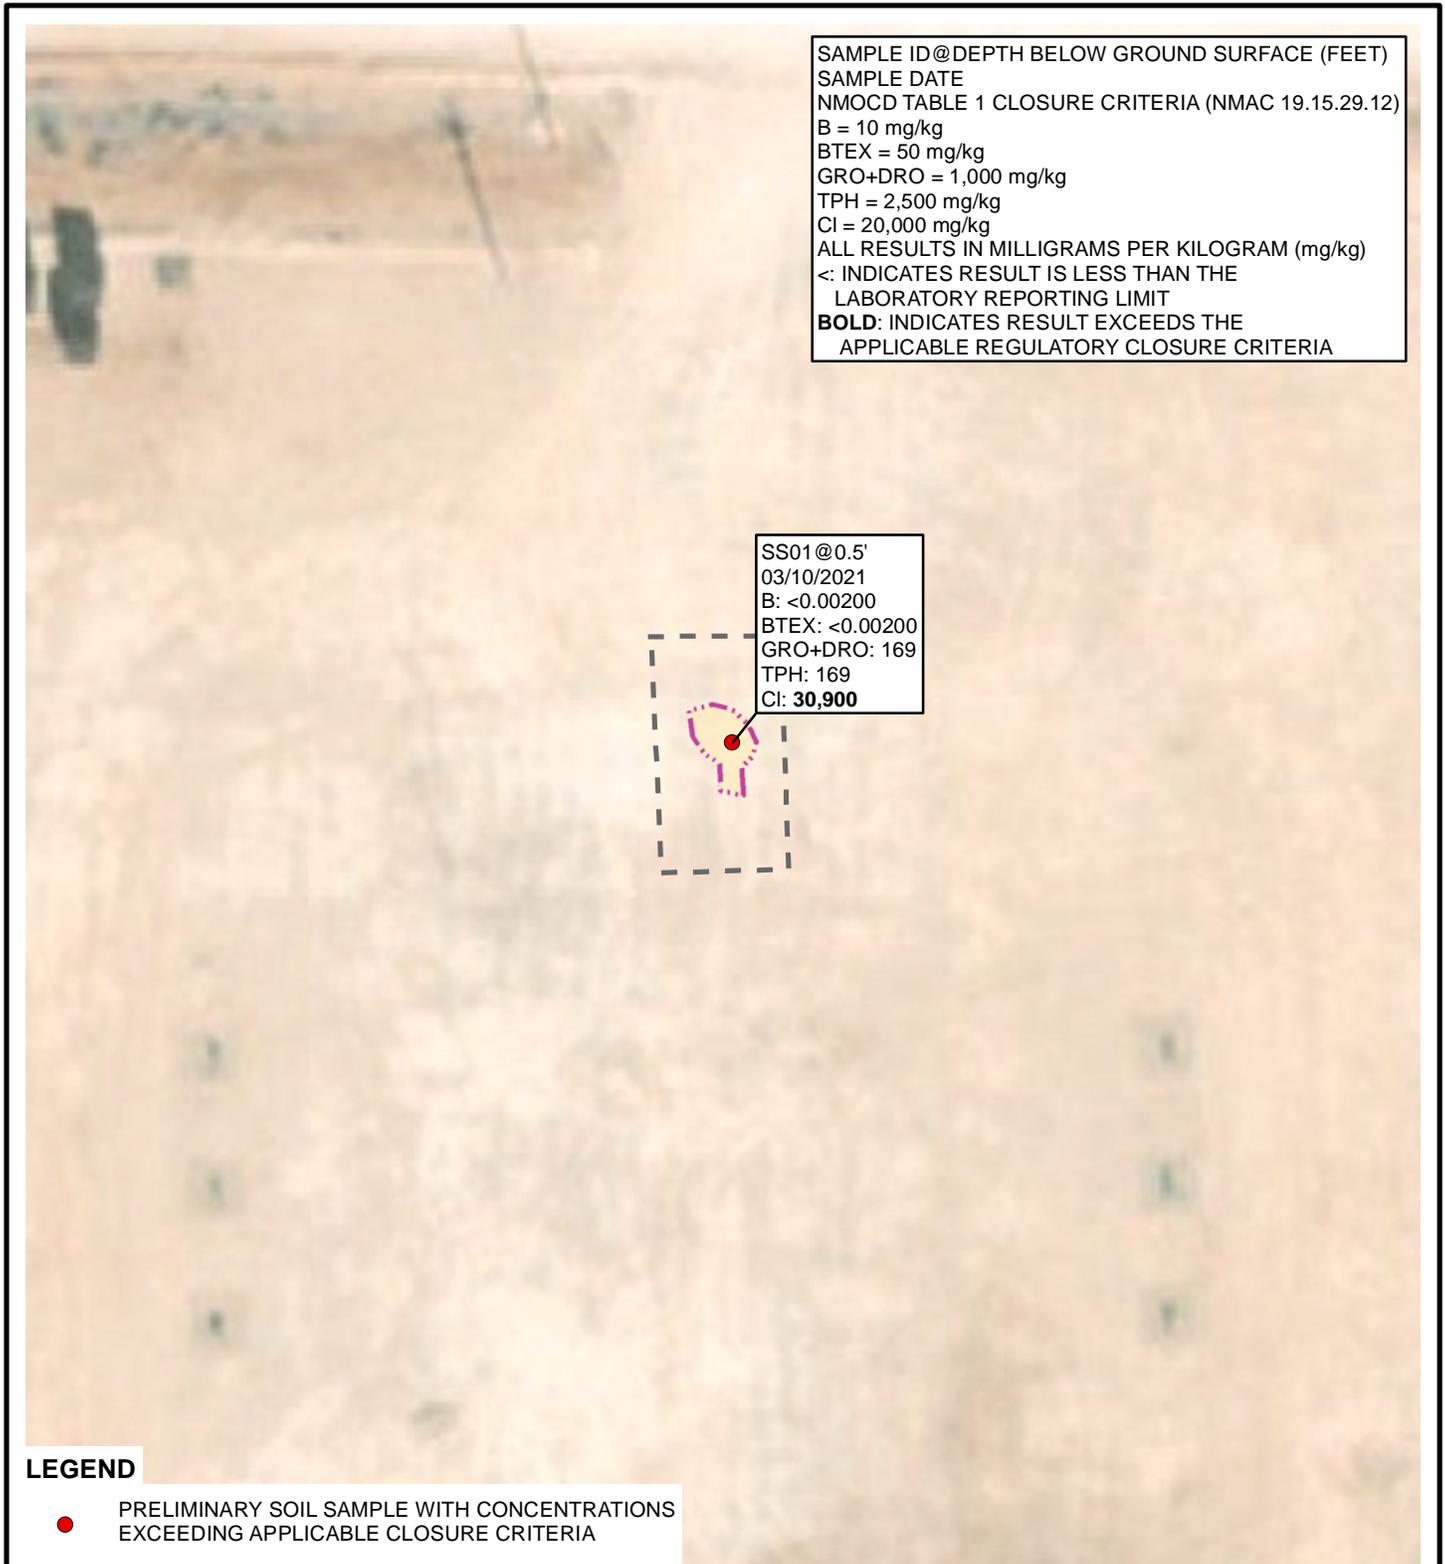
FIGURE 2
 PRELIMINARY SOIL SAMPLE LOCATIONS
 PLU 13 DTD 121H
 UNIT D SEC 24 T24S R30E
 EDDY COUNTY, NEW MEXICO
 XTO ENERGY, INC.

On March 10, 2021, WSP personnel visited the Site to evaluate the release based on information provided on the Form C-141 and visual observations. The temporary containment had been removed at the time of the Site visit and visible surface staining was observed in the release area. WSP personnel collected one preliminary assessment soil sample (SS01) at the documented location of the tear in the liner from a depth of approximately 0.5 feet bgs to assess the extent of the impacted soil. The preliminary soil sample was field screened for volatile aromatic hydrocarbons and chloride utilizing a calibrated photoionization detector (PID) and Hach® chloride QuanTab® test strips, respectively. The release extent and preliminary soil sample location were mapped utilizing a handheld Global Positioning System (GPS) unit and are depicted on Figure 2.

Laboratory analytical results for preliminary soil sample SS01 indicated that chloride concentrations exceeded the Closure Criteria. Benzene, BTEX, TPH-GRO/TPH-DRO, and TPH concentrations were compliant with the Closure Criteria. Based on visible staining in the release area, elevated field screening results, and laboratory analytical results for the preliminary soil sample, delineation and excavation activities were warranted.

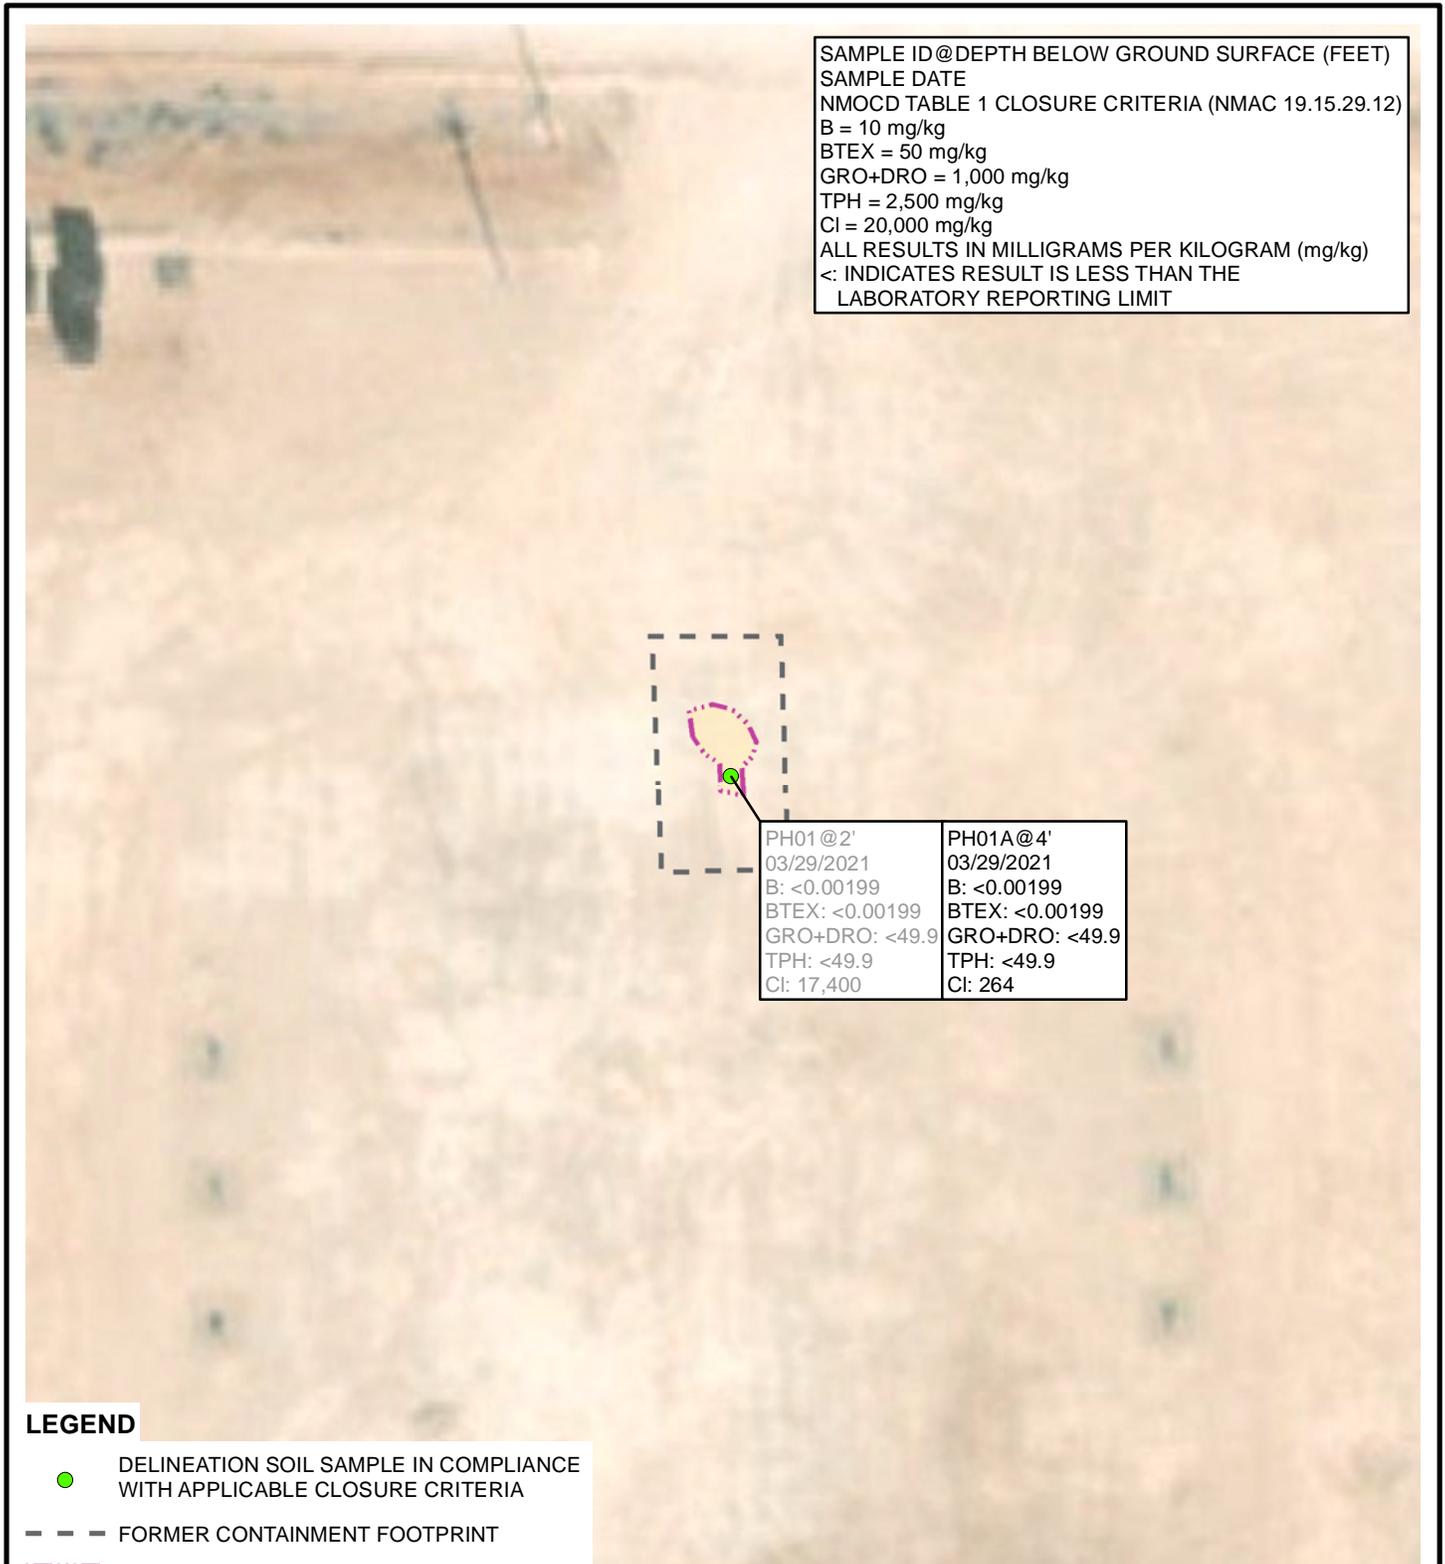
FIGURE 3
 DELINEATION SOIL SAMPLE LOCATIONS
 PLU 13 DTD 121H
 UNIT D SEC 24 T24S R30E
 EDDY COUNTY, NEW MEXICO
 XTO ENERGY, INC.

On March 29, 2021, WSP personnel were at the Site to oversee site assessment and excavation activities. One pothole (PH01) was advanced via backhoe within the release extent to assess the vertical extent of impacted soil. PH01 was advanced to a depth of 4 feet bgs. Soil from the pothole was field screened for volatile aromatic hydrocarbons and chloride utilizing PID and Hach® chloride QuanTab® test strips, respectively. Delineation soil samples were collected at depths of 2 feet and 4 feet bgs. Field screening results and observations for the pothole were logged on a lithologic/soil sampling log, which is included in Attachment 2. The pothole soil sample location is depicted on Figure 3.

Laboratory analytical results for pothole delineation soil samples PH01 and PH01A indicated that benzene, BTEX, TPH-GRO/TPH-DRO, TPH, and chloride concentrations were compliant with the Closure Criteria. Additionally, delineation soil sample PH01A, collected at 4 feet bgs, provided vertical delineation to the strictest Table 1 Closure Criteria.

PH01@2'	PH01A@4'
03/29/2021	03/29/2021
B: <0.00199	B: <0.00199
BTEX: <0.00199	BTEX: <0.00199
GRO+DRO: <49.9	GRO+DRO: <49.9
TPH: <49.9	TPH: <49.9
Cl: 17,400	Cl: 264

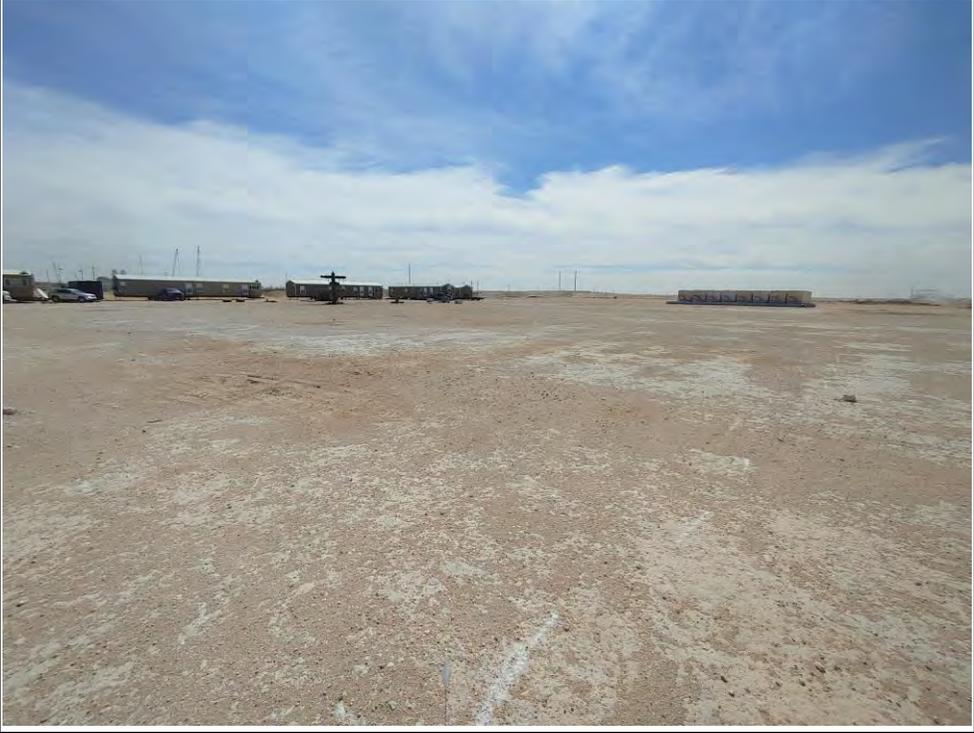
Photo No.	Date	
1	March 10, 2021

View of release area to the southeast.

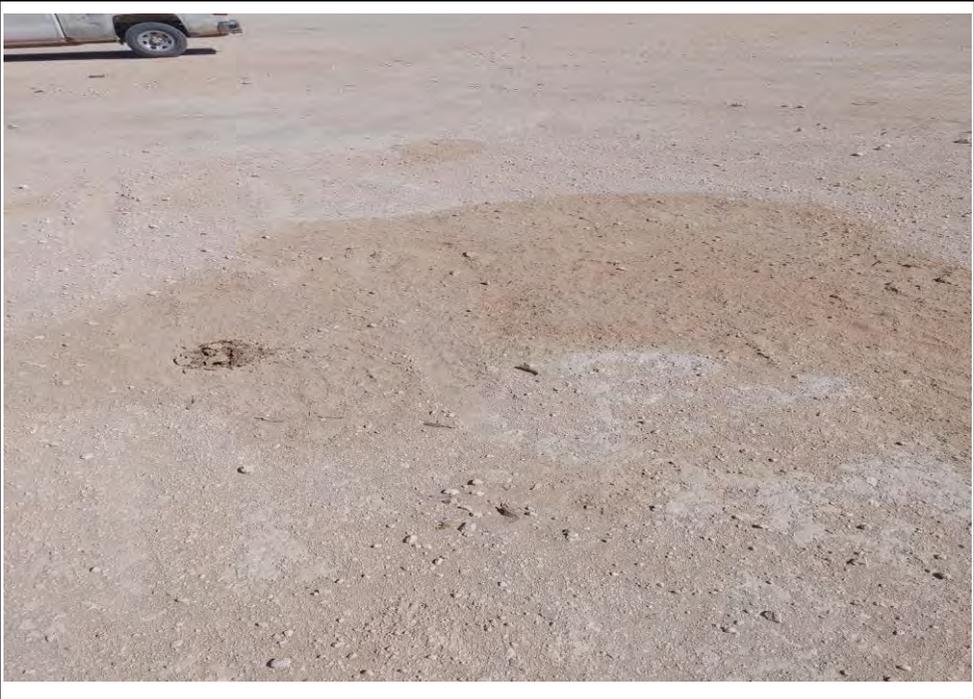
Photo No.	Date	
2	March 10, 2021

View of SS01 location to the east.

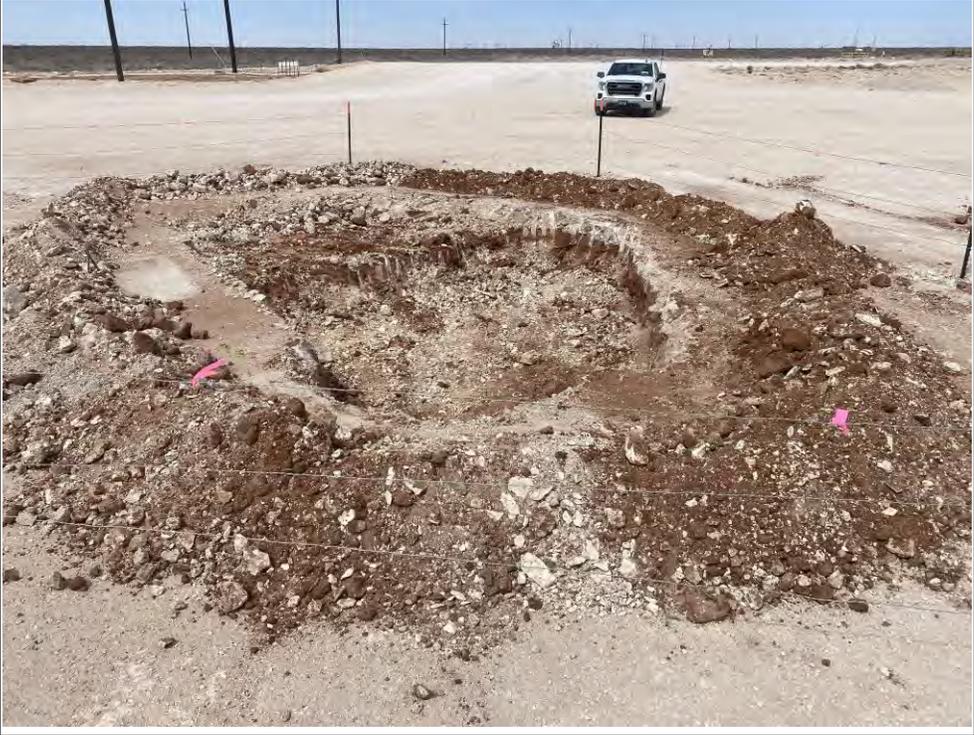
Photo No.	Date	
3	March 29, 2021

Excavation view to the north

Following delineation activities, impacted soil was excavated from the release area as indicated by visible staining, field screening results from pothole PH01, and laboratory analytical results for the preliminary soil sample. Excavation activities were performed using a track-mounted backhoe. To direct excavation activities, WSP screened soil for volatile aromatic hydrocarbons and chloride utilizing a PID and Hach® chloride QuanTab® test strips, respectively. The excavation was completed to depths ranging from 1-foot to 2.5 feet bgs.

The excavation area measured approximately 344 square feet. A total of approximately 30 cubic yards of impacted soil was removed during the excavation activities. The impacted soil was transported and properly disposed of at the R360 Facility in Hobbs, New Mexico. After completion of confirmation sampling, the excavation area was secured with fencing.

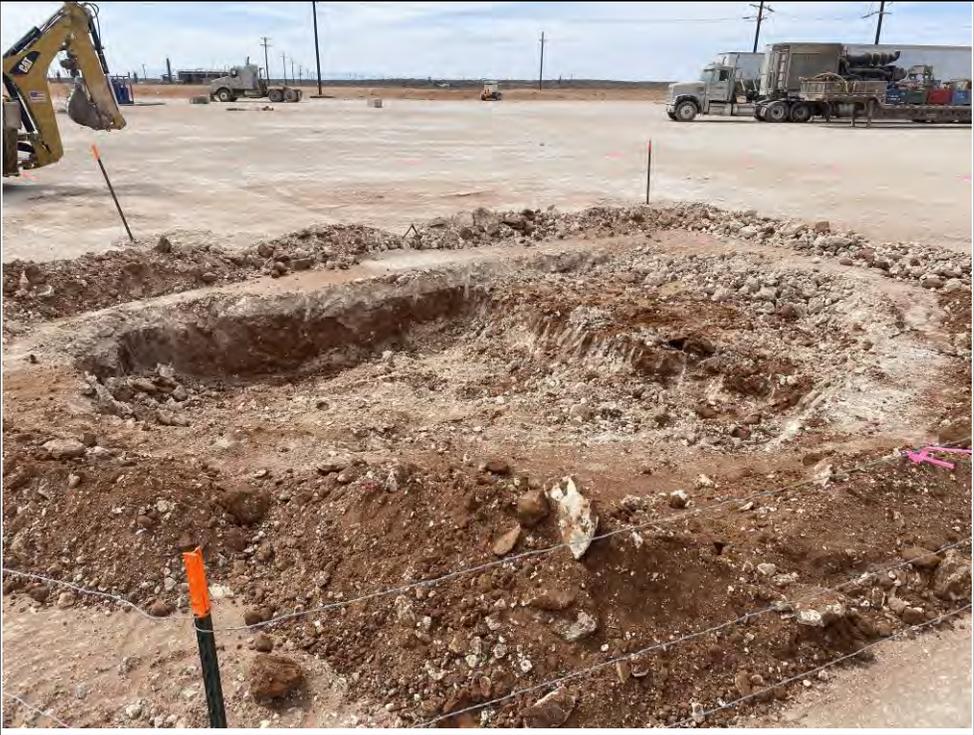
Photo No.	Date	
4	March 29, 2021

Excavation view to the west
