**CLOSURE REPORT**

**Lateral 3B-3 (9/1/21)  
Unit Letter D, S35 T30N R11W  
San Juan County, New Mexico**

**NM EMNRD OCD Incident ID No. NAPP2125035140**

November 30, 2021  
Ensolum Project No. 05A1226155

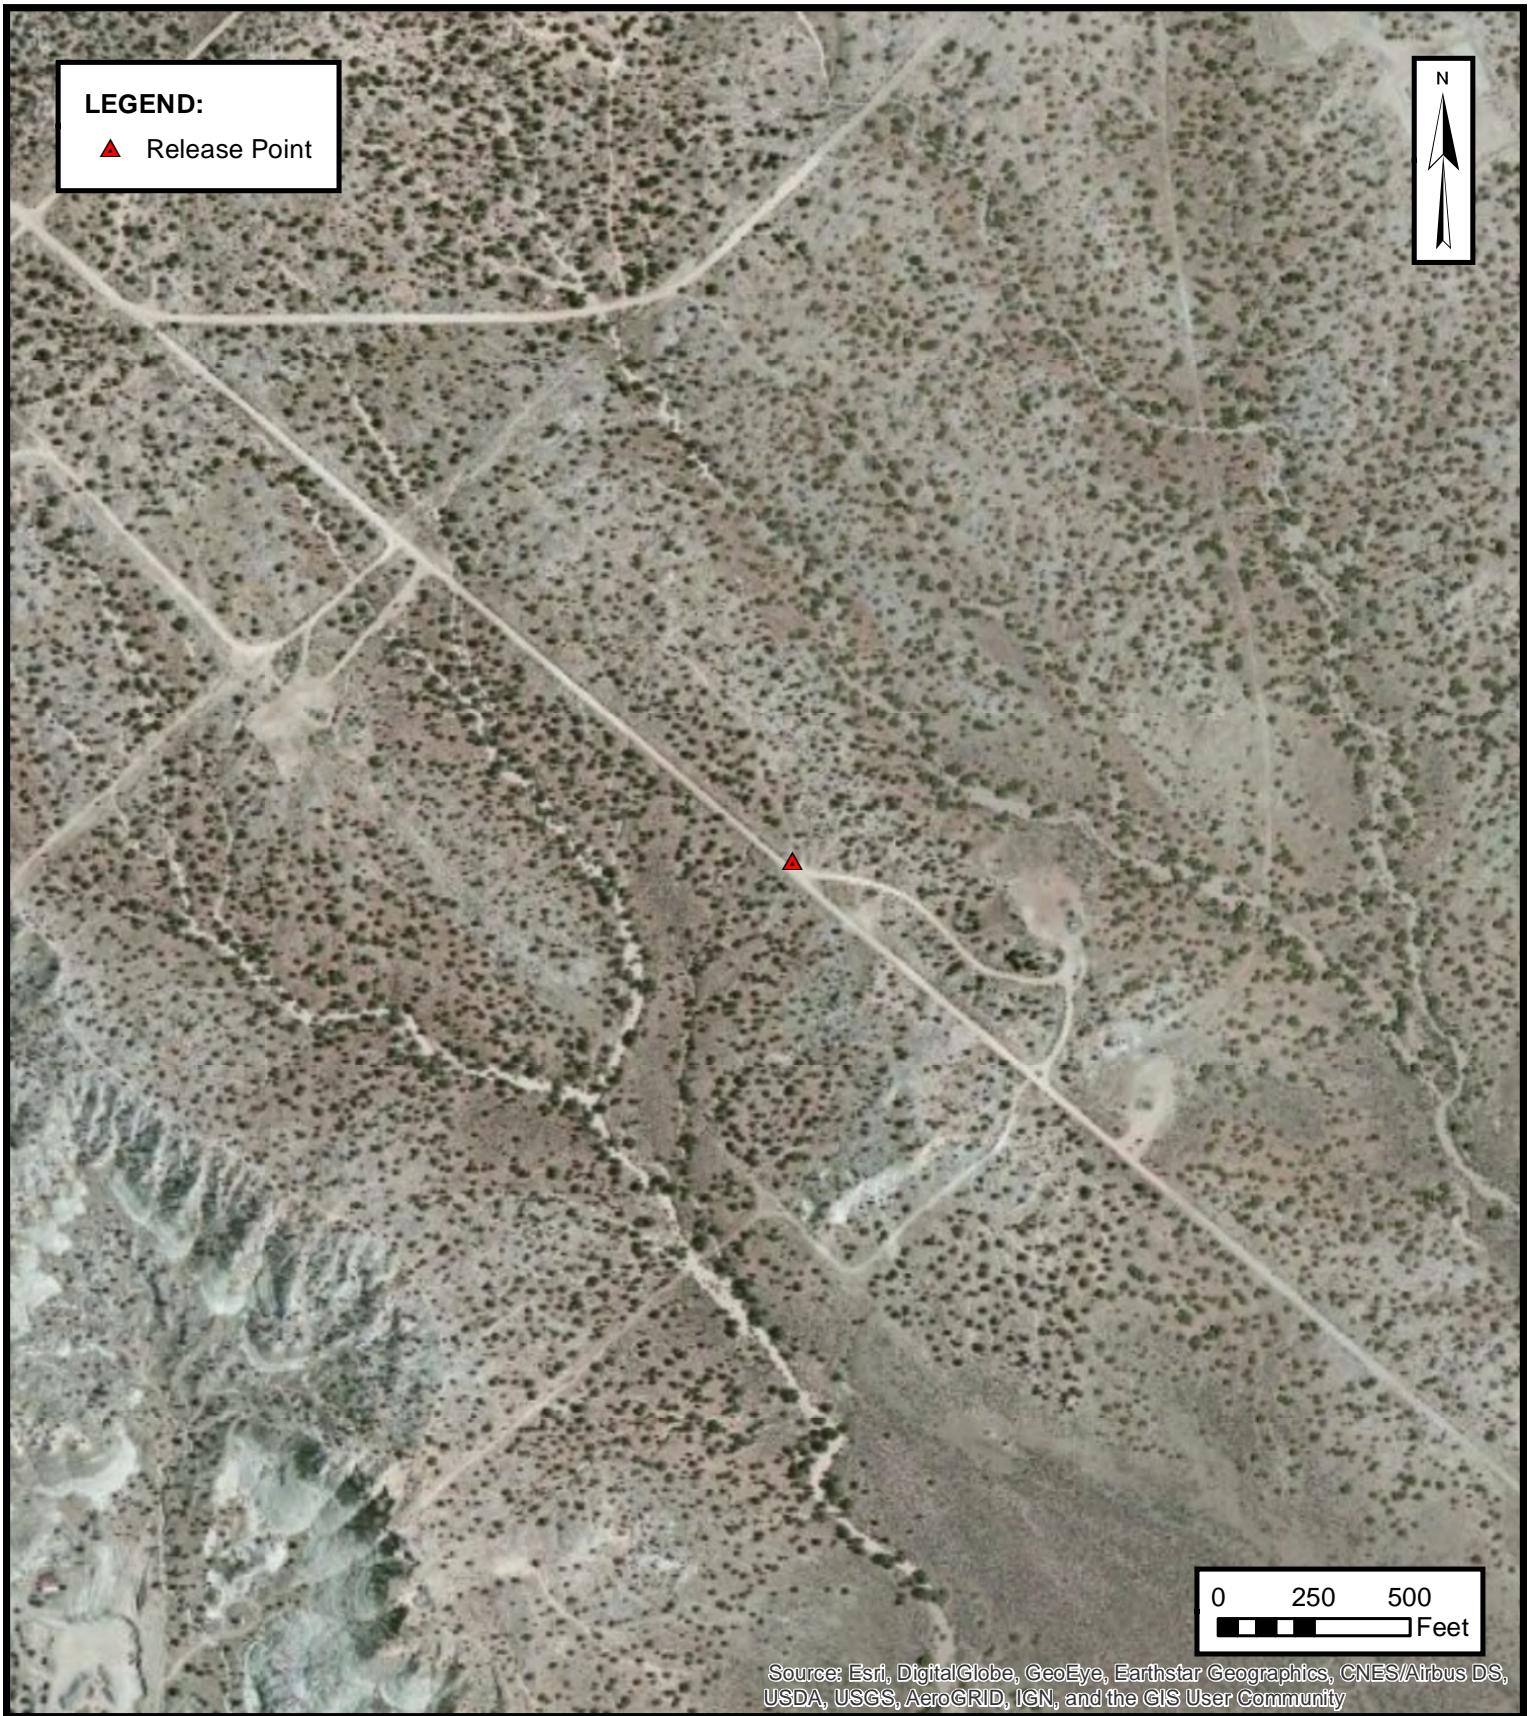
**FIGURE**  
**1**

**TOPOGRAPHIC MAP**  
 ENTERPRISE FIELD SERVICES, LLC  
 LATERAL 3B-3 (9/1/21)  
 Unit Letter D, S35 T30N R11W, San Juan County, New Mexico  
 36.772771° N, 107.968720° W  
 PROJECT NUMBER: 05A1226155

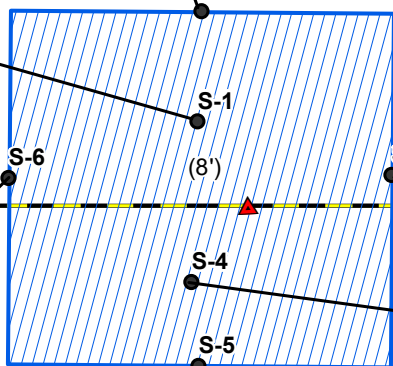
**S-5**  
 9/15/2021  
 W (0-8')  
 Benzene...<0.018  
 Toluene...<0.036  
 Ethylbenzene...<0.036  
 Xylenes...<0.072  
 Total BTEX...ND  
 TPH GRO...<3.6  
 TPH DRO...<10  
 TPH MRO...<50  
 Total Combined TPH  
 GRO/DRO/MRO...ND  
 Chloride...<60

**S-4**  
 9/15/2021  
 F (8')  
 Benzene...0.097  
 Toluene...0.18  
 Ethylbenzene...0.056  
 Xylenes...0.31  
 Total BTEX...0.64  
 TPH GRO...<3.6  
 TPH DRO...<9.2  
 TPH MRO...<46  
 Total Combined TPH  
 GRO/DRO/MRO...ND  
 Chloride...<60

**Figure 3** is a map that identifies approximate soil sample locations and depicts the approximate dimensions of the excavation with respect to the pipeline (**Appendix A**). Photographic documentation of the field activities is included in **Appendix D**.

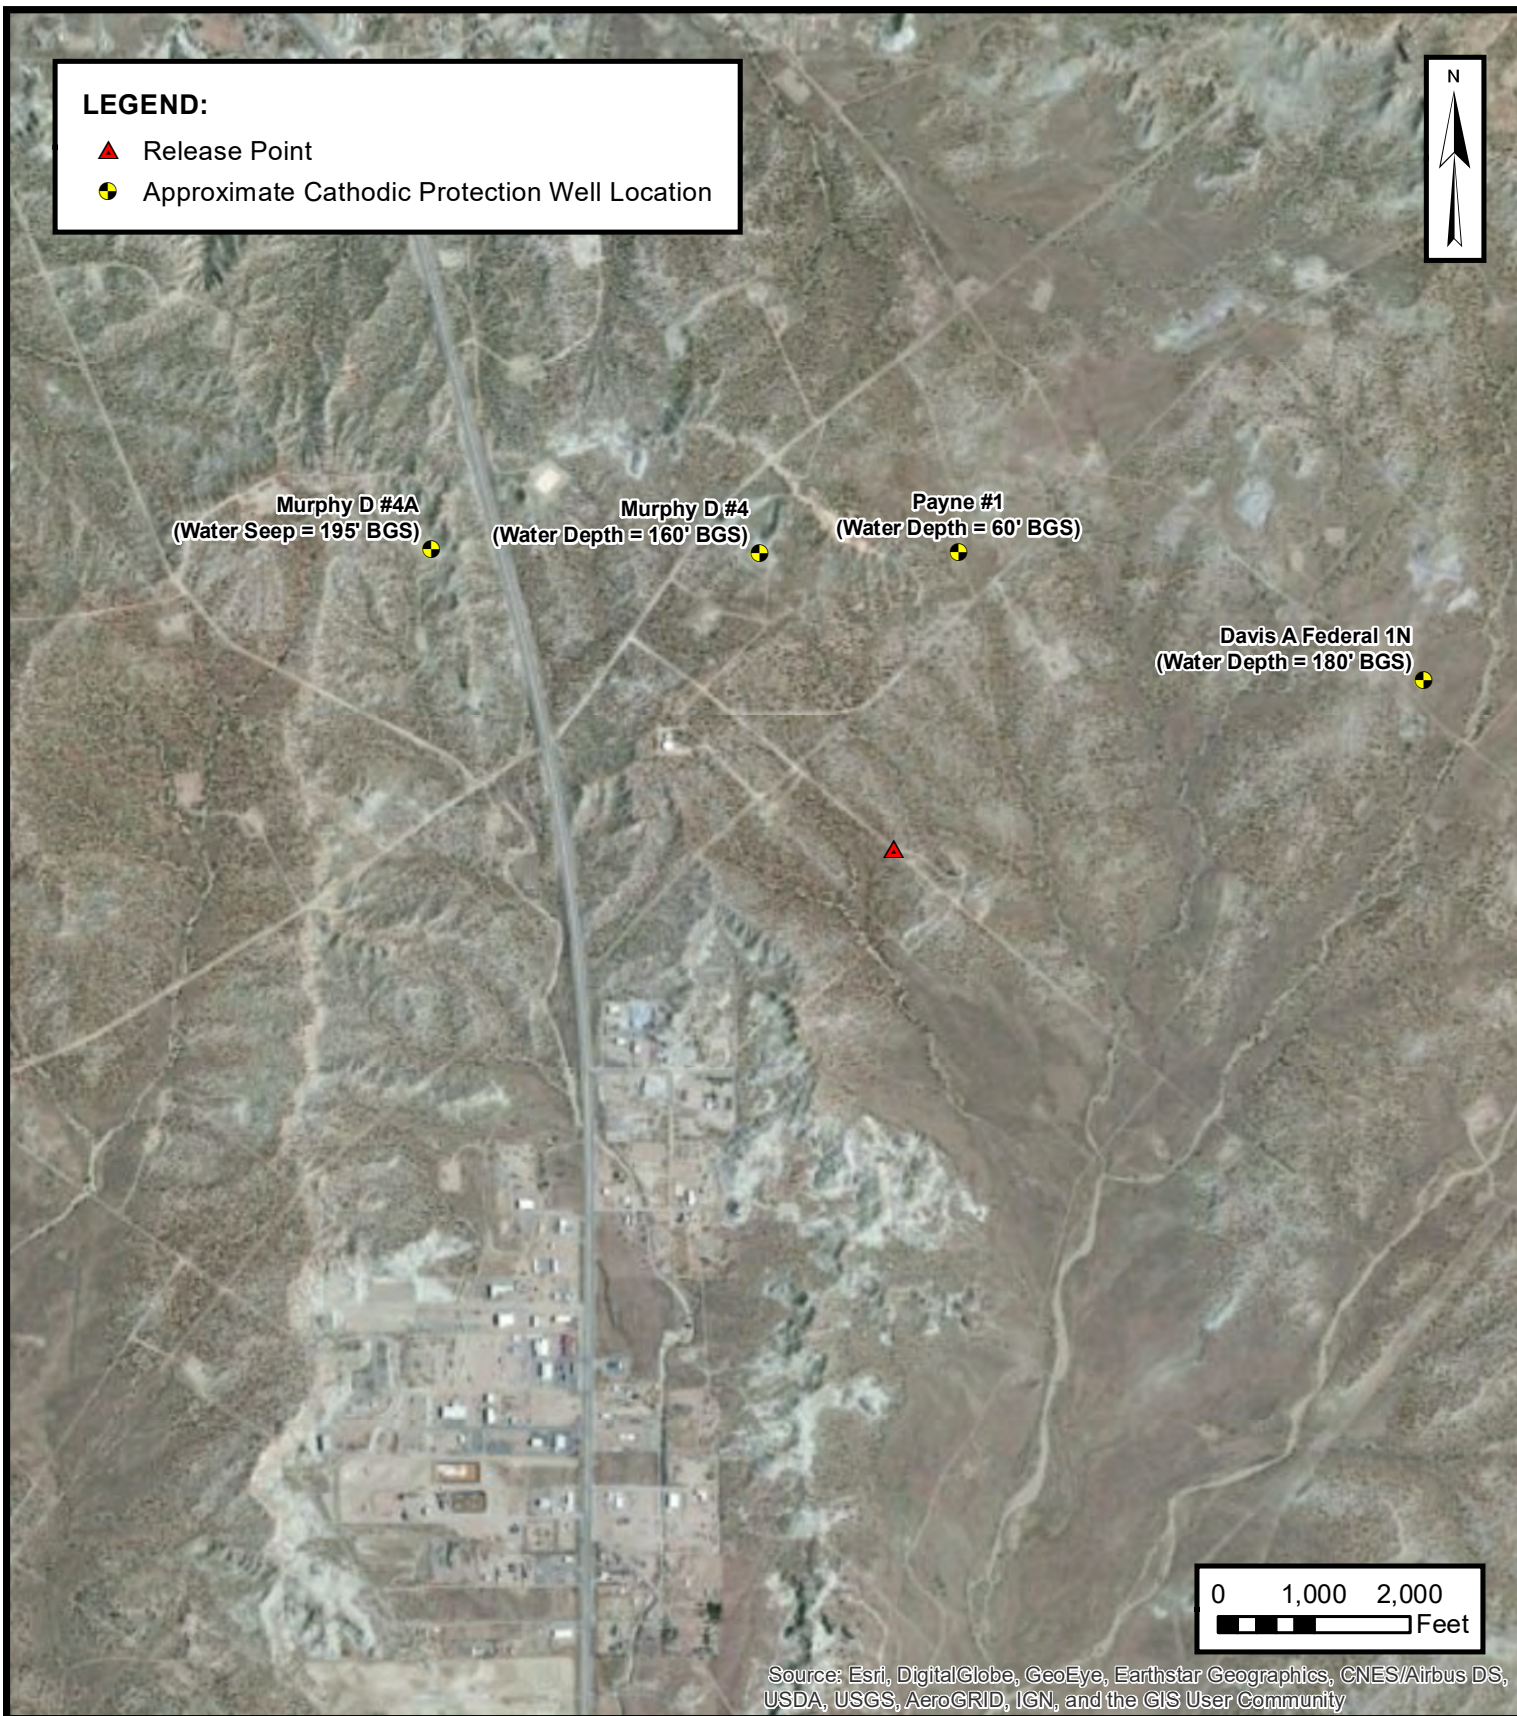
**A**

**1.0 MILE RADIUS WATER WELL/ POD LOCATION MAP**

ENTERPRISE FIELD SERVICES, LLC  
 LATERAL 3B-3 (9/1/21)  
 Unit Letter D, S35 T30N R11W, San Juan County, New Mexico  
 36.772771° N, 107.968720° W

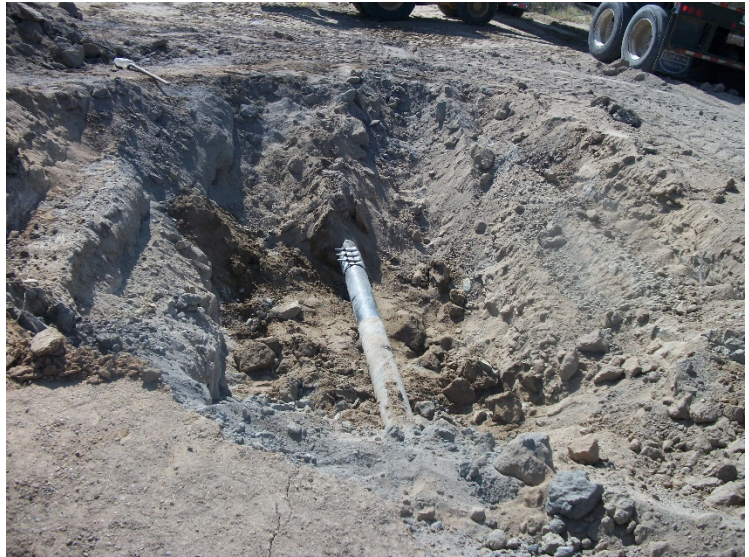
#### Photograph 1

Photograph Description: View of the initial excavation activities.

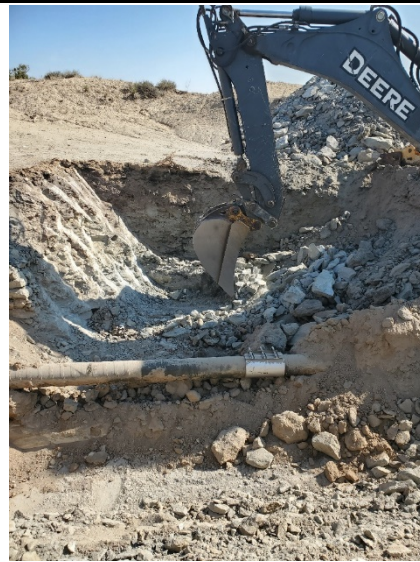
#### Photograph 2

Photograph Description: View of in-process excavation activities.

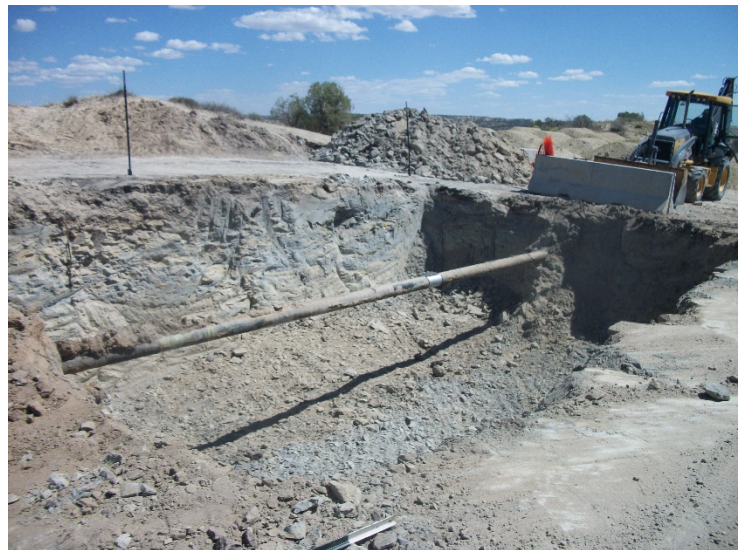
#### Photograph 3

The final excavation measured approximately 20 feet long and 18.5 feet wide at the maximum extents. The maximum depth of the excavation measured approximately eight feet bgs. The lithology encountered during the completion of remediation activities consisted primarily of unconsolidated silty sand underlain by weathered sandstone.

Photograph Description: View of the final excavation.

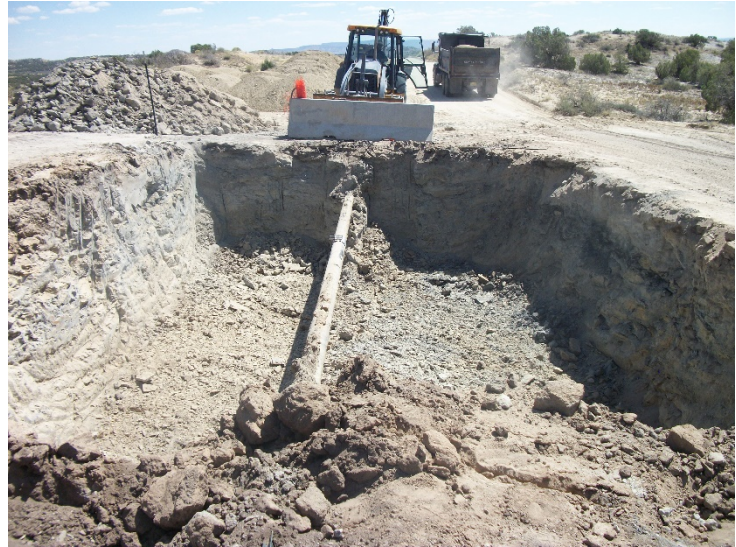
#### Photograph 4

Photograph Description: View of the final excavation.

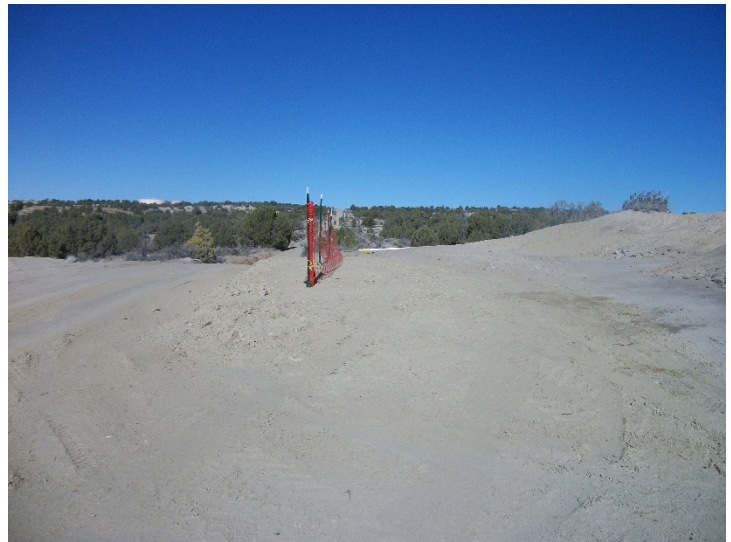
#### Photograph 5

Photograph Description: View of the site after initial restoration.

The excavation was backfilled with imported fill, and the area was then contoured to surrounding grade. The pipeline was daylighted again with the hydro-excavator to facilitate planned pipe replacement. Enterprise will re-seed the Site with a BLM-approved seed mixture after the pipeline is permanently repaired.
