Re: Remediation Plan
HT 18 Federal #001
API No. 30-025-39974
GPS: Latitude 32.8295326 Longitude -103.8126678
UL "M" Sec. 18, T17S, R32E
Lea County, NM
NMOCD Ref. No. NAPP2103541864

Pima Environmental Services, LLC (Pima) has been contracted by Spur Energy Partners, LLC. (Spur) to perform a spill assessment and submit a work plan for approved remediation activities for a crude oil/produced water mixed release that occurred at the HT 18 Federal #001 (HT). The initial C-141 was submitted on February 4th, 2020 (Appendix C). This incident was assigned Incident ID NAPP2103541864, by the New Mexico Oil Conservation Division (NMOCD).

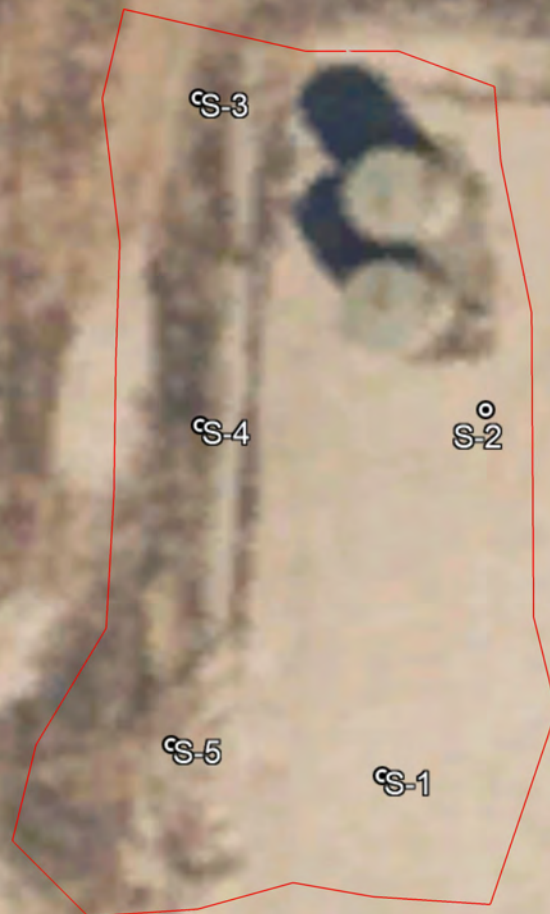
Spur Energy
API #30-025-39974
Site Map

On October 11th, 2021, Pima returned to the site to finish delineation of S-5. Laboratory results of this sampling event can be found in the following table. A Site Map can be found in Figure 4.

Spill Area

- This project will require a 2-man crew to till and treat the area around S-5 to a depth of 1' BGS. The area measures approximately 200 square feet and totals approximately 7.5 cubic yards of soil. To do this we will use our Soil RX chemical solution.

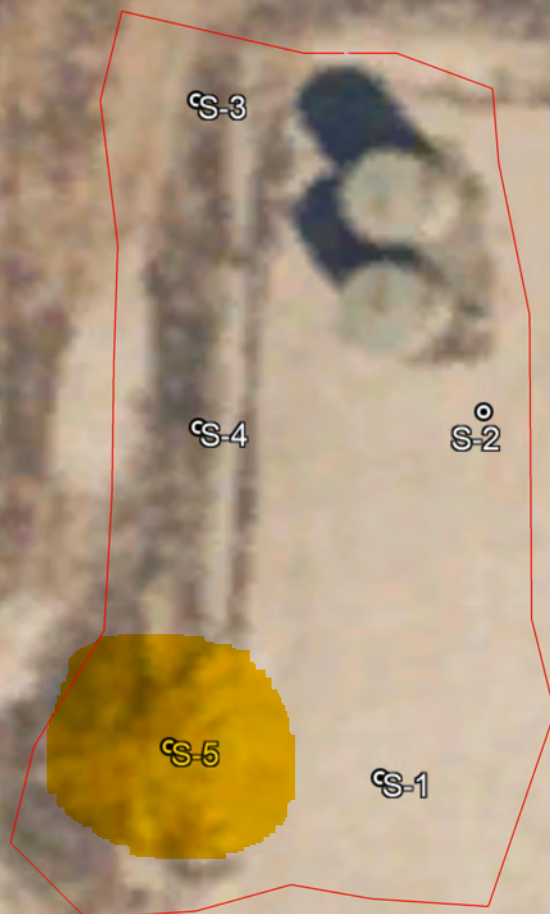
Spur Energy
API #30-025-39974
Proposed Sampling Plan Map

Pima, on behalf of Spur, requests approval to collect a 5-point composite sample from the bottom and sidewall areas at sample point CS-5 from a depth of 6" bgs as confirmation that the contamination has been neutralized. This Proposed Sampling Plan Map can be found in Figure 5.
