Closure Report

Taco AUK State #3 Battery
Lea County, New Mexico
API# 30-025-38288
Incident #nAPP2120237986

Subject: **Closure Report**
Taco AUK State #3 Battery
Lea County, New Mexico
API# 30-025-38288
Incident #nAPP2120237986

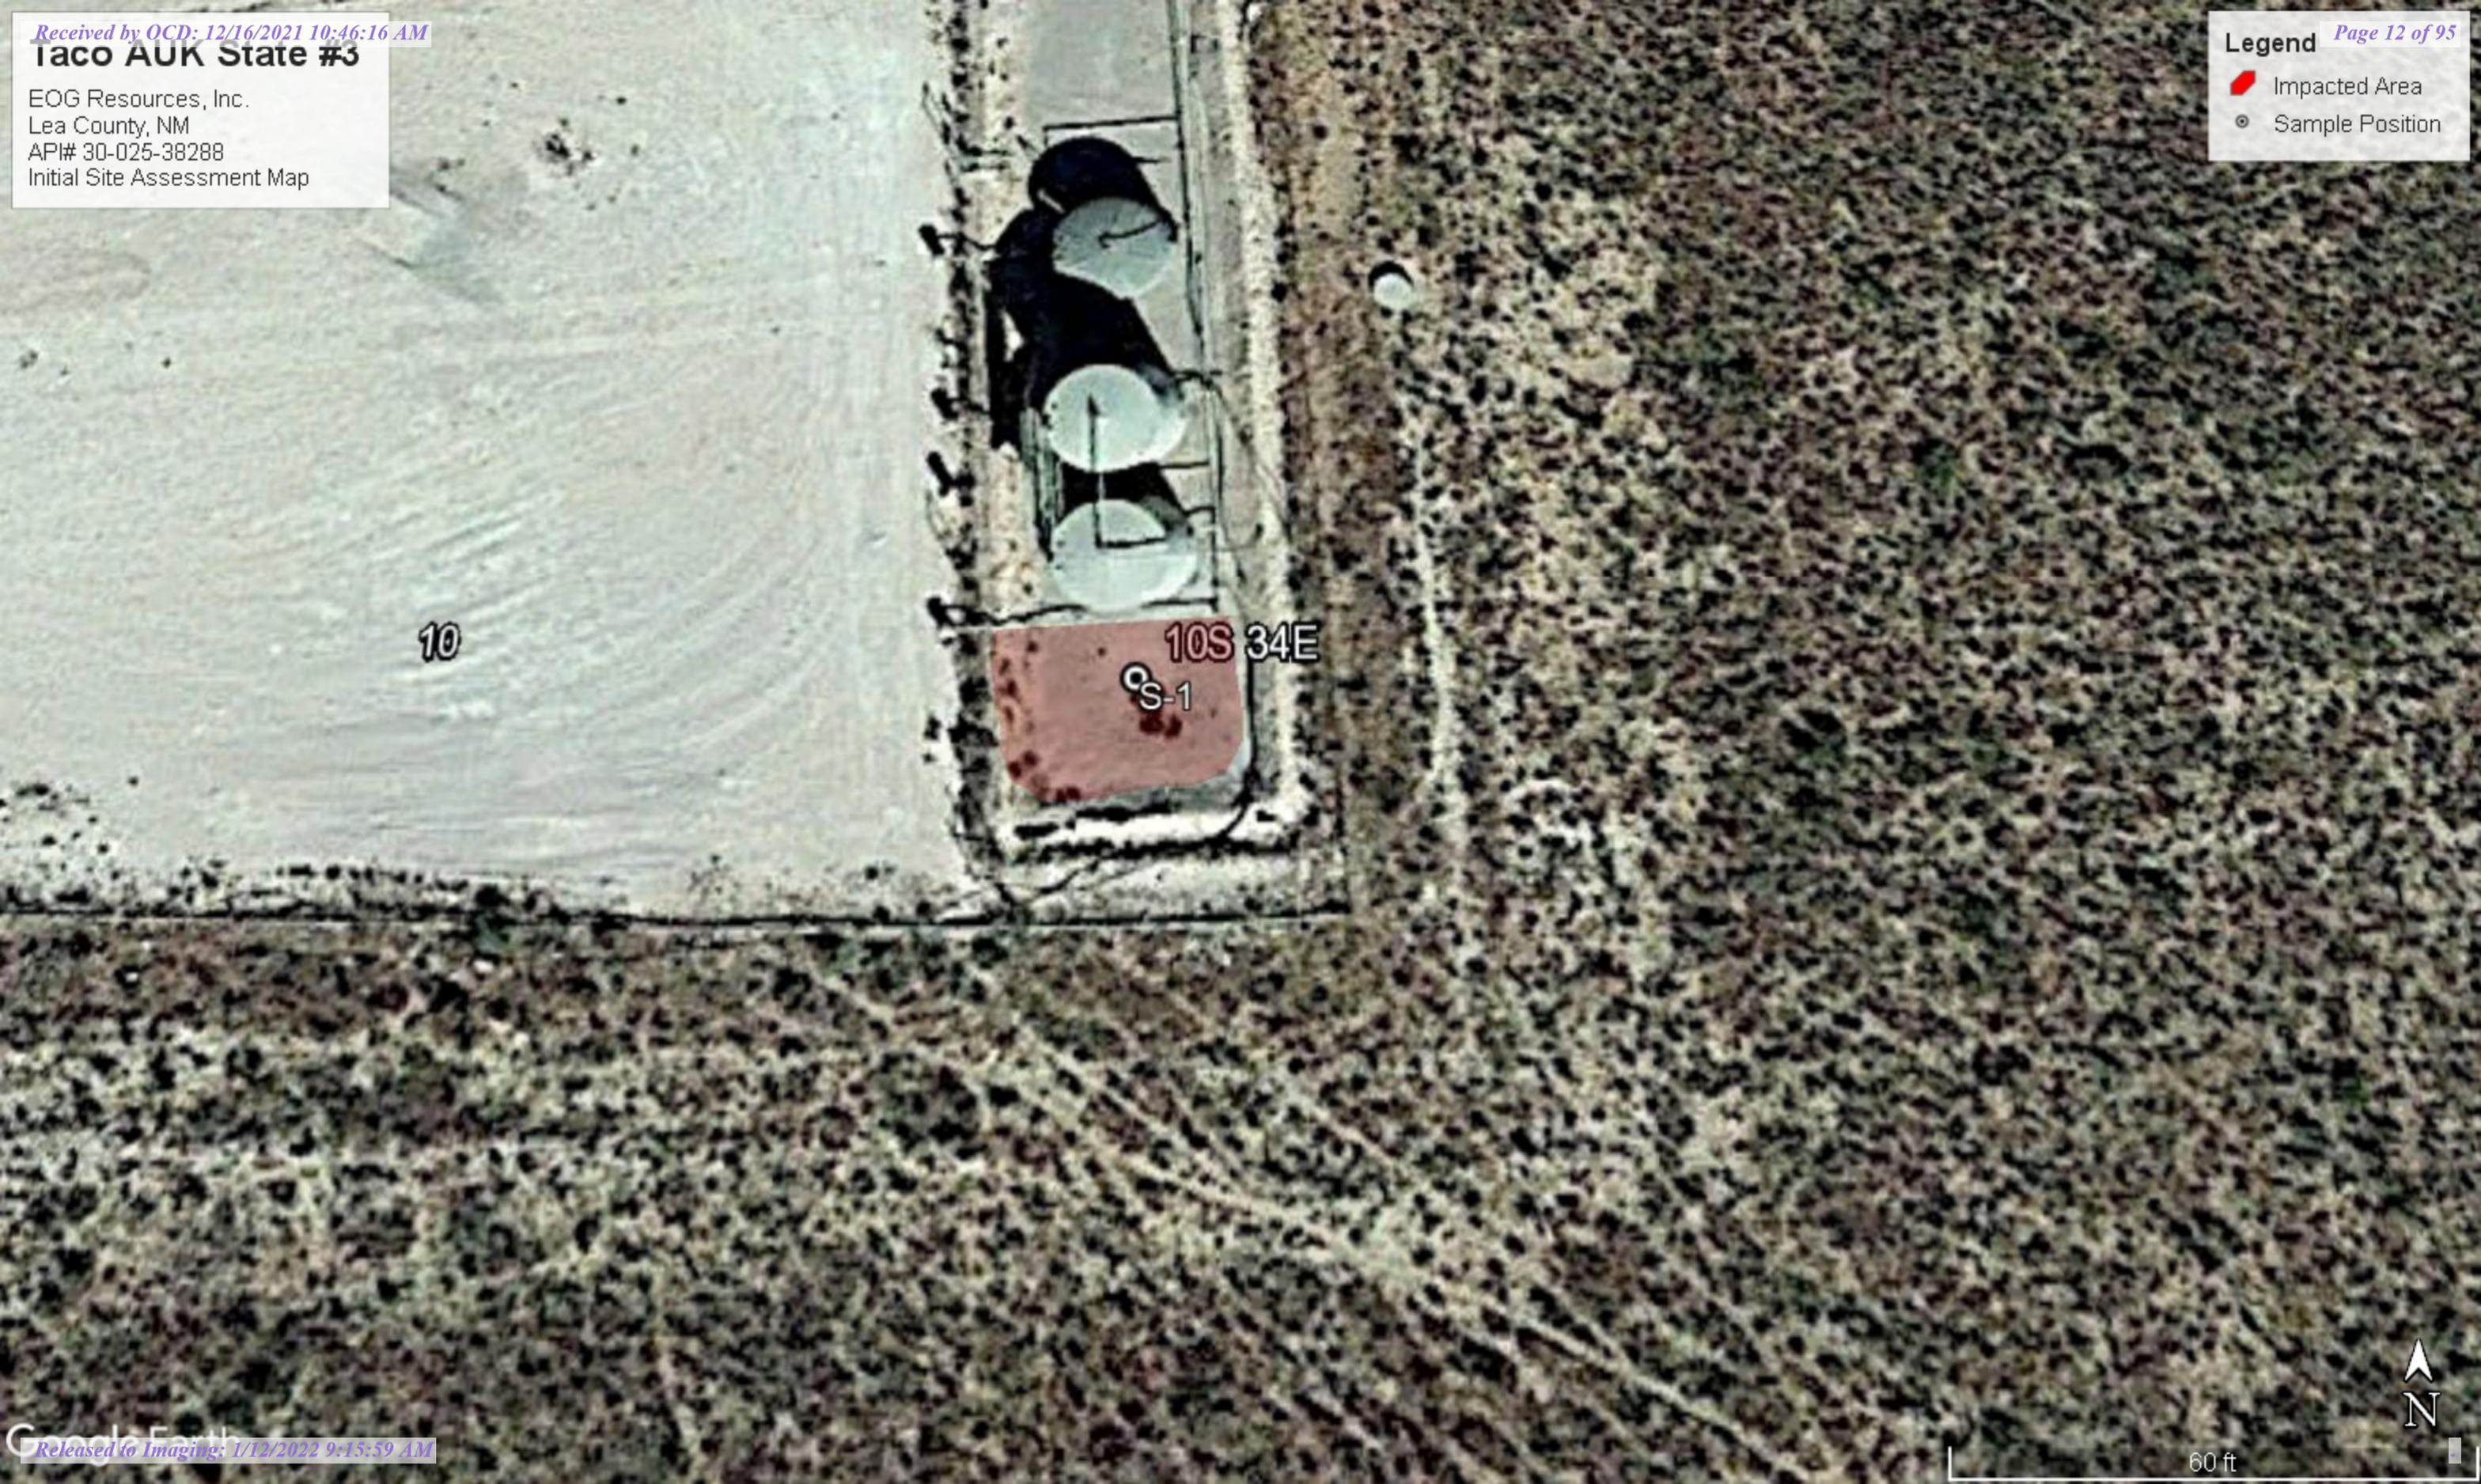
EOG Resources, Inc.
Lea County, NM
API# 30-025-38288
Initial Site Assessment Map

On July 30, 2021, Talon personnel mobilized to begin site assessment and sampling activities for the drafting of a work plan. A single grab soil sample was collected at the source with a hand auger until the depth of 2' bgs at which point refusal was encountered. On October 8, 2021, following client approval, Talon personnel returned to the site and utilizing a Geoprobe (direct push technology), the impacted area was sampled to a depth of 5' bgs where refusal was again encountered. All soil samples were properly packaged, preserved, and transported via chain of custody to Hall Laboratory, Inc., for analysis of Total Chlorides (EPA Method 300.0), TPH (EPA Method 8015M) and BTEX (EPA Method 8021B). Results from our initial sampling events are presented on the following data table and the complete laboratory reports can be found in Appendix V. Sample locations are shown on the attached site map (Appendix I).

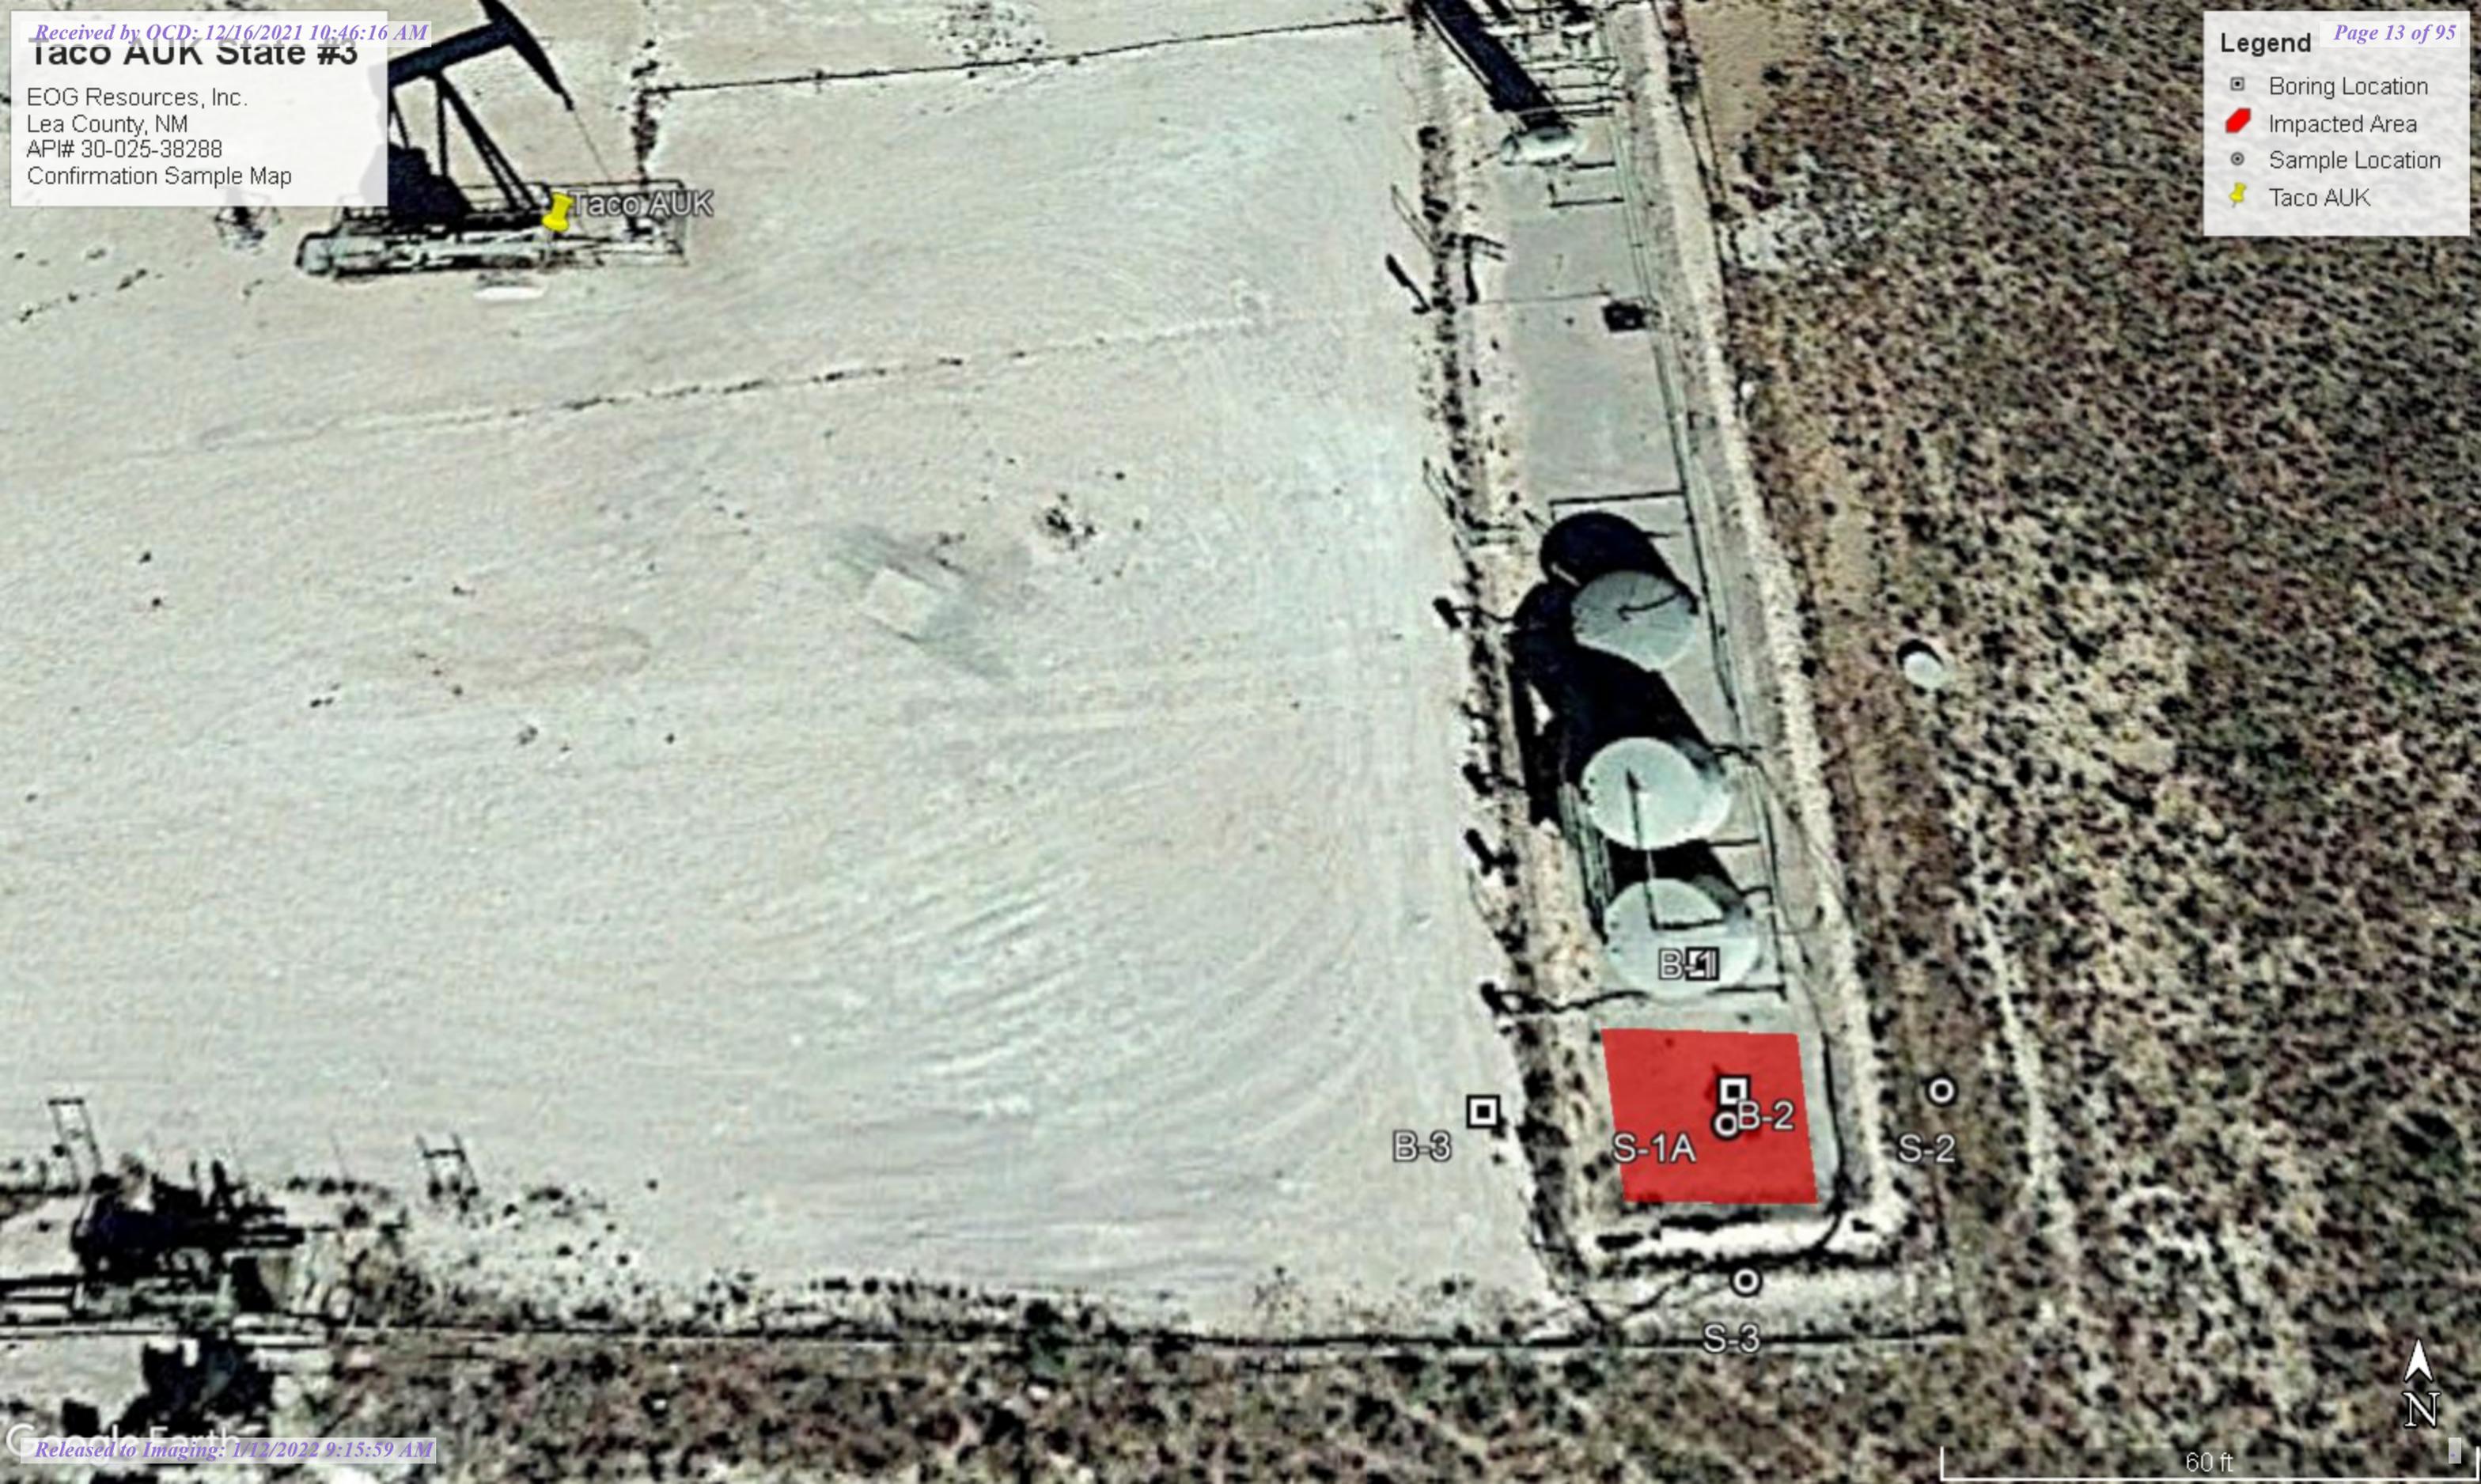
EOG Resources, Inc.
Lea County, NM
API# 30-025-38288
Confirmation Sample Map

A Boring Location Map is attached in [Appendix I](#). The complete laboratory report is presented in [Appendix V](#).

On October 31, 2021, Talon personnel and equipment mobilized to the site in order to excavate the impacted area at B-2 which was the same vicinity as the leaking tank. Hard rock refusal was encountered at 13' bgs utilizing an excavator. A hydrovac was subsequently utilized to clean the rock shelf. A confirmation sample was then collected, contained, preserved and transport to Cardinal Laboratories for analysis. The results are tabled below. The complete laboratory report is attached in [Appendix V](#). A confirmation sample map is presented in [Appendix I](#).

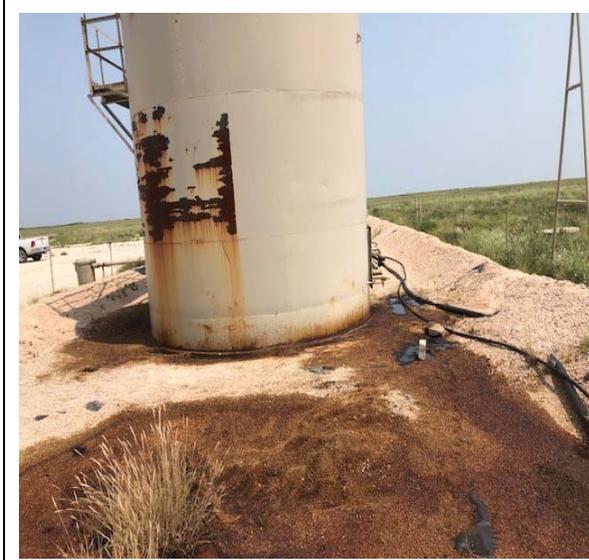
Photograph No.1 Description:

Source area following tank removal

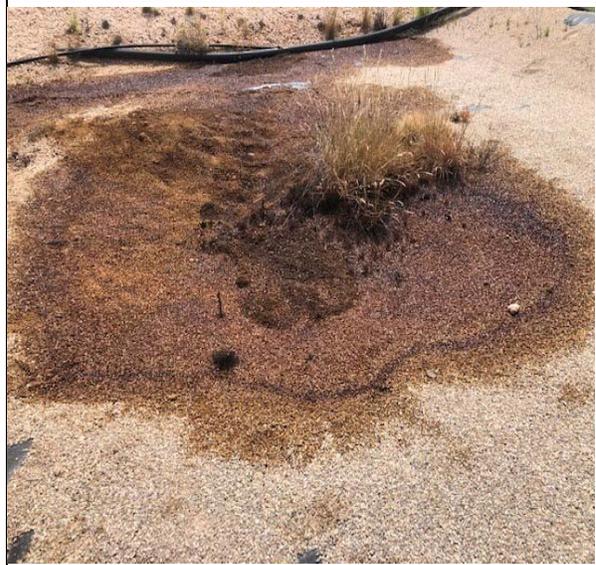
Photograph No.2 Description:

Impacted area under tank

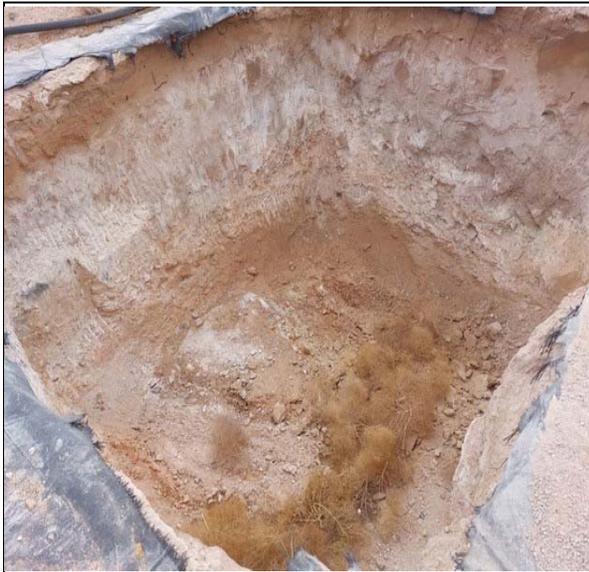
Photograph No.3 Description:

Hydrovac cleaned rock shelf 13' bgs

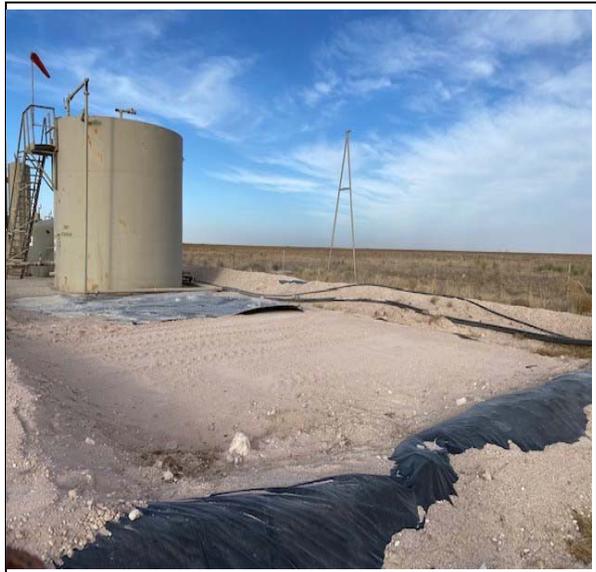
Photograph No.4 Description:

Remediated area backfilled to grade

- The impacted area was drilled to a depth of 26' bgs to vertically delineate the source under the leaking tank (removed by EOG) to NMOCD remediation guidelines of less than 100 mg/kg for TPH.
- The impacted area at sample locations S-1/B-2 was excavated to 13' bgs where hard rock refusal was encountered.
- A hydrovac was utilized to clean the rock shelf and a composite soil sample from bottom of excavation was collected to confirm NMOCD clean up criteria had been accomplished (soil sample S-1A).
- Photo documentation is presented in this report ([Appendix IV](#)).
- All impacted soil was transported to Lea Landfill, an NMOCD approved solid waste disposal facility.
- The excavated area was backfilled with clean, like material, machine compacted and returned to grade.
