Release Notification

Site Name Howell G Com 300	Site Type Well
Date Release Discovered 4/21/2021 @ 7:00am (MT)	API# 30-045-26913

**Subject: Site Characterization Report and Closure Request
Howell G Com 300
San Juan County, New Mexico
NMOCD Incident Number: nAPP2112525706**

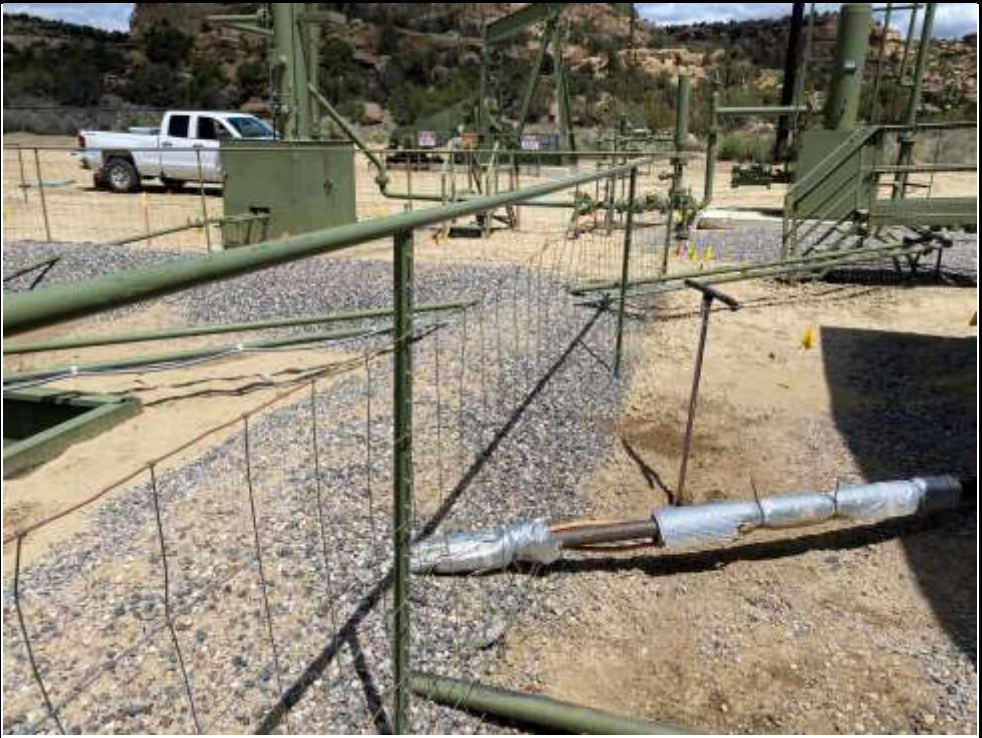
Photo No.	Date

4	6/30/2021	
Boring BH04, looking north.

Two additional borings were advanced on June 30, 2021 to the west (BH03) and east (BH04) of the containment berm. Soil was also field screened at 2-foot intervals with samples collected from the interval with the highest PID reading and from the terminus of the borings. Again, petroleum staining and odors were not observed at any interval while advancing these borings. Laboratory analytical results indicated that TPH was present at a concentration of 64 mg/kg in boring BH04 at a depth of 2 feet. No other analytes were detected above laboratory reporting limits in the remaining analyzed samples.

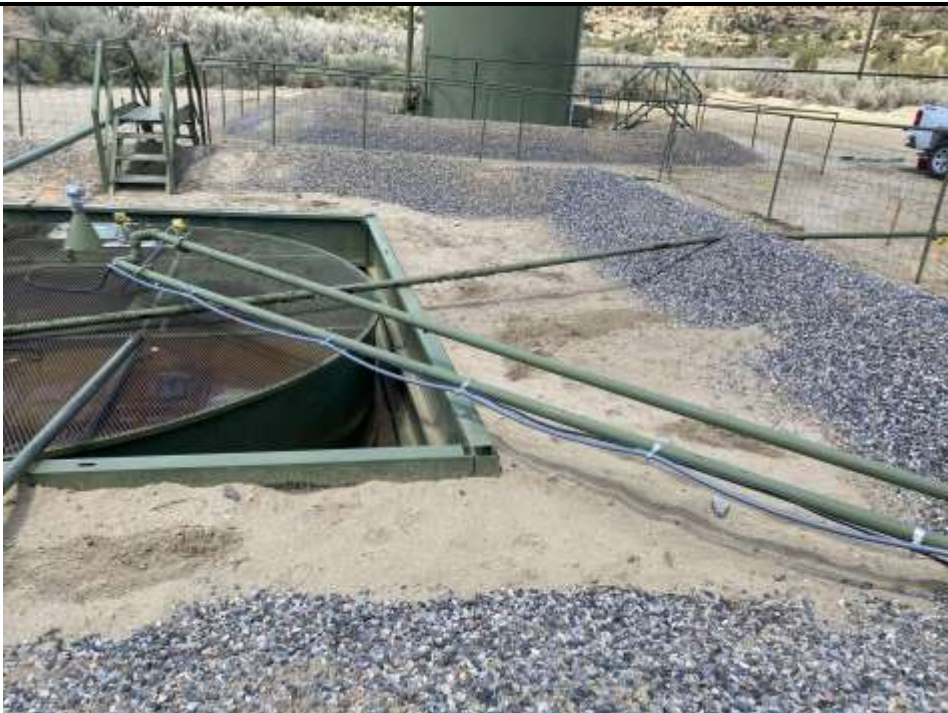
Photo No.	Date	
5	6/30/2021	
Confirmation sampling area FS01 on June 30, 2021.

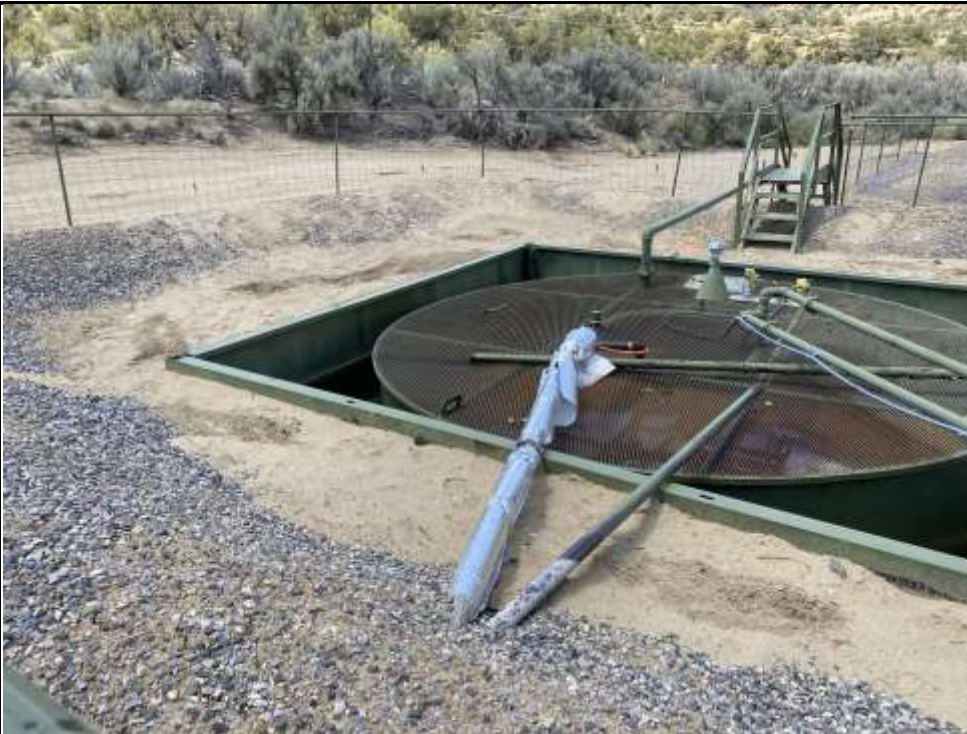
Photo No.	Date	
6	6/30/2021	
Confirmation sampling areas FS02 and FS03 on June 30, 2021.

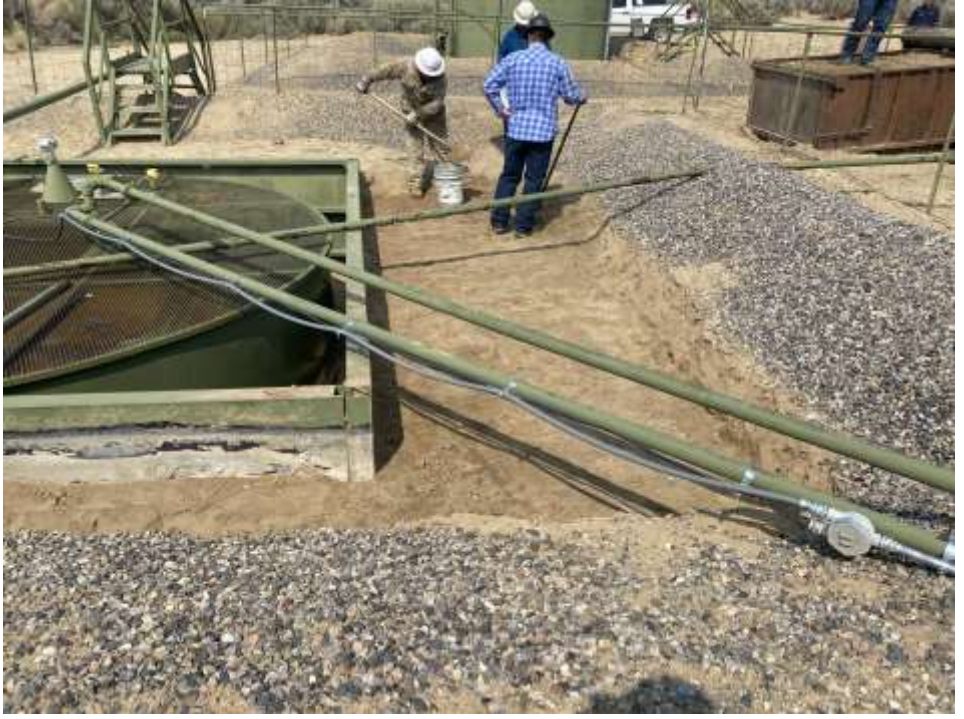
Photo No.	Date

7	7/13/2021	
Confirmation sampling area FS01 after an additional 10 inches of soil were removed on 7/13/2021. This area was resampled with the sample identification "FS01B".

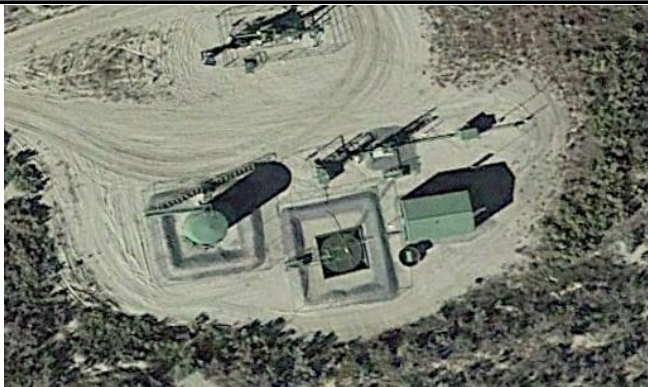
WSP USA Inc. 848 E. 2nd Ave. Durango, Colorado 81301 T 970.385.1096					
										BORING LOG			
												Boring/Well Number:	Project:
												Date:	Project Number:
Elevation:						Detector:		Drilling Method:		Sampling Method:			
						PID		Hand Auger		Grab			
Penetration Resistance	Moisture Content	Vapor (ppm)	HC Staining?	Sample #	Depth (ft. bgs.)	Sample Run	Recovery	Soil/Rock Type	Lithology/Remarks				
	Dry	87.5	None	BH01@6"	0			SM	0 - 6": SILTY SAND with gravel, light brown, dry, no odor, no staining				
	Moist	94.5	None		1				6" - 5.5': SILTY SAND, fine to medium grained, brown, moist, no odor, no staining				
	Moist	75.5	None		2			SM					
	Moist	75.5	None		3								
	Moist	75.5	None		4								
	Moist	102.1	None	BH01@6'	5								
	Moist	102.1	None		6			SM	5.5' - 8': SILTY SAND, very fine to fine grained, brown, moist, no odor, no staining				
	Moist	99.0	None	BH01@8'	7

8				Boring abandoned at 8 feet				
					9								
					10								
					11								
					12								
					13								
					14								
					15

WSP advanced two initial borings on June 25, 2021 within the containment on the north (boring BH01) and south (boring BH02) sides of the pit tank to assess potential impacts directly around the tank (Figure 4). Soil was field screened using a PID at 2-foot intervals. Because the release was caused by an overflow onto the ground, samples were collected from 6 inches bgs from each of these borings. Two additional samples were collected from each boring, one sample from the interval with the highest PID reading and one sample from the terminus of each boring. Samples were submitted to Hall Environmental Analysis Laboratory (Hall) for analysis of BTEX by United States Environmental Protection Agency (EPA) method 8021, TPH-gasoline range organics (GRO), TPH-diesel range organics (DRO), TPH-motor oil range organics (MRO) by EPA Method 8015, and chloride by EPA method 300.0. There were no field indications (based on odors or staining) that petroleum hydrocarbons were present at elevated concentrations. Laboratory analytical results indicated that TPH, BTEX, and chloride were not present in any of the samples at concentrations above laboratory reporting limits (Table 1).

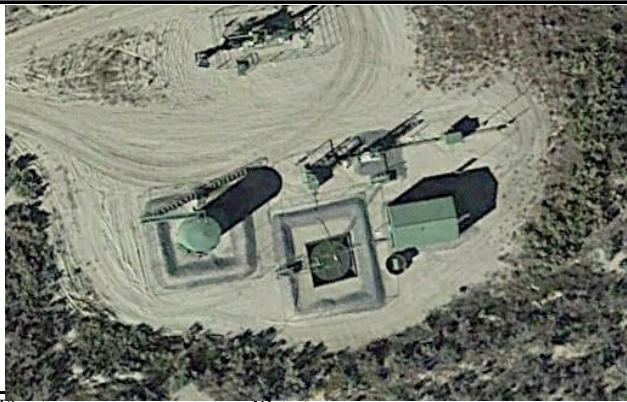
WSP USA Inc. 848 E. 2nd Ave. Durango, Colorado 81301 T 970.385.1096			
						BORING LOG							
						Boring/Well Number: BH02				Project: Howell G Com 300			
						Date: 6/25/2021				Project Number: TE017821022			
Logged By: Stuart Hyde				Drilled By: Stuart Hyde									
Elevation:		Detector:		PID		Drilling Method: Hand Auger		Sampling Method: Grab					
Penetration Resistance	Moisture Content	Vapor (ppm)	HC Staining?	Sample #	Depth (ft. bgs.)	Sample Run	Recovery	Soil/Rock Type	Lithology/Remarks				
	Dry	99.1	None	BH02@6"	0			SM	0 - 6": SILTY SAND with gravel, light brown, dry, no odor, no staining				
					1								
	Moist	186.2	None		2			SM	6" - 5': SILTY SAND, fine to medium grained, brown, moist, no odor, no staining				
					3								
	Moist	213.6	None		4								
					5								
	Moist	188.5	None		6			SM	5' - 9': SILTY SAND, very fine to fine grained, brown, moist, no odor, no staining

7								
	Moist	270.9	None		8								
					9								
	Moist	305.3		BH02@10'	10			SP	9' - 12': SAND, medium grained, well sorted, brown, moist, no odor, no staining				
					11								
	Moist	281.2		BH02@12'	12								
					13				Hand auger refusal at 12 feet				
					14								
					15

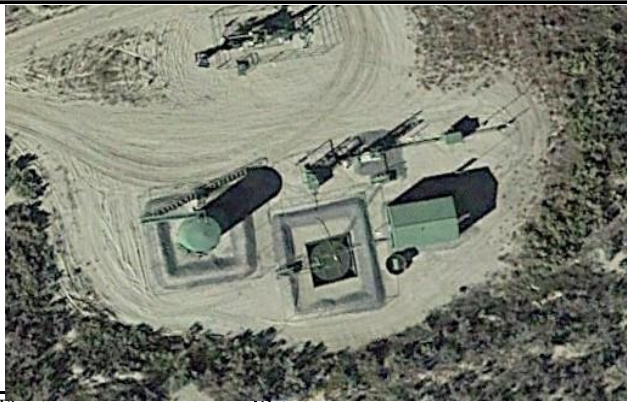
WSP USA Inc. 848 E. 2nd Ave. Durango, Colorado 81301 T 970.385.1096			
						BORING LOG							
						Boring/Well Number: BH03				Project: Howell G Com 300			
						Date: 6/30/2021				Project Number: TE017821022			
Logged By: Stuart Hyde				Drilled By: Stuart Hyde									
Elevation:		Detector:		PID		Drilling Method: Hand Auger		Sampling Method: Grab					
Penetration Resistance	Moisture Content	Vapor (ppm)	HC Staining?	Sample #	Depth (ft. bgs.)	Sample Run	Recovery	Soil/Rock Type	Lithology/Remarks				
	Dry		None	BH03@2'	0			SM	0 - 1': SILTY SAND, few gravel, light brown, dry, no odor, no staining				
					1								
	Moist	0.2	None		2			SM	1 - 3': SILTY SAND, fine to medium grained, brown, moist, no odor, no staining				
					3								
	Moist	0.2	None	BH03@8'	4			SP	3' - 7': SAND, fine to medium grained, well sorted, brown, moist, no odor, no staining				
					5								
	Moist	0.1	None		6

7								
	Moist	0.1	None		8			SM	7' - 8': SILTY SAND, fine to medium grained, brown, moist, no odor, no staining				
					9				Boring abandoned at 8 feet				
					10								
					11								
					12								
					13								
					14								
					15

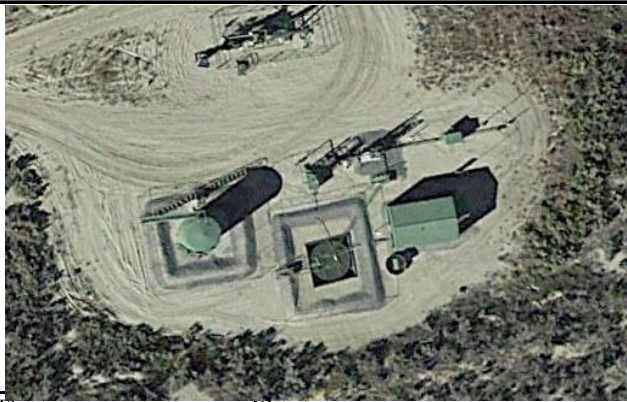
WSP USA Inc. 848 E. 2nd Ave. Durango, Colorado 81301 T 970.385.1096					
										BORING LOG			
												Boring/Well Number:	Project:
												Date:	Project Number:
Logged By:	Drilled By:	BH04	Howell G Com 300	6/30/2021	TE017821022	Stuart Hyde	Stuart Hyde						
Drilling Method:	Sampling Method:	Hand Auger	Grab	Elevation:	Detector:	PID	PID	PID					
Penetration Resistance	Moisture Content	Vapor (ppm)	HC Staining?	Sample #	Depth (ft. bgs.)	Sample Run	Recovery	Soil/Rock Type	Lithology/Remarks				
	Dry	0.1	None	BH04@2'	0			SM	0 - 1': SILTY SAND, few gravel, light brown, dry, no odor, no staining				
					1								
	Moist	0.3	None		2			SM	1 - 3': SILTY SAND, fine to medium grained, brown, moist, no odor, no staining				
					3								
	Moist	0.1	None	BH04@8'	4			SP	3' - 7': SAND, fine to medium grained, well sorted, brown, moist, no odor, no staining				
					5								
	Moist	0.0	None		6

7								
	Moist	0.0	None		8			SM	7' - 8': SILTY SAND, fine to medium grained, brown, moist, no odor, no staining				
					9				Boring abandoned at 8 feet				
					10								
					11								
					12								
					13								
					14								
					15
