## Closure Report

Long Arroyo OD State Com #2  
Chaves County, New Mexico  
API # 30-005-61729  
Incident # nAPP2123158626

Subject: **Closure Report**  
Long Arroyo OD State Com #2  
Lea County, New Mexico  
API # 30-005-61729  
Incident # nAPP2123158626

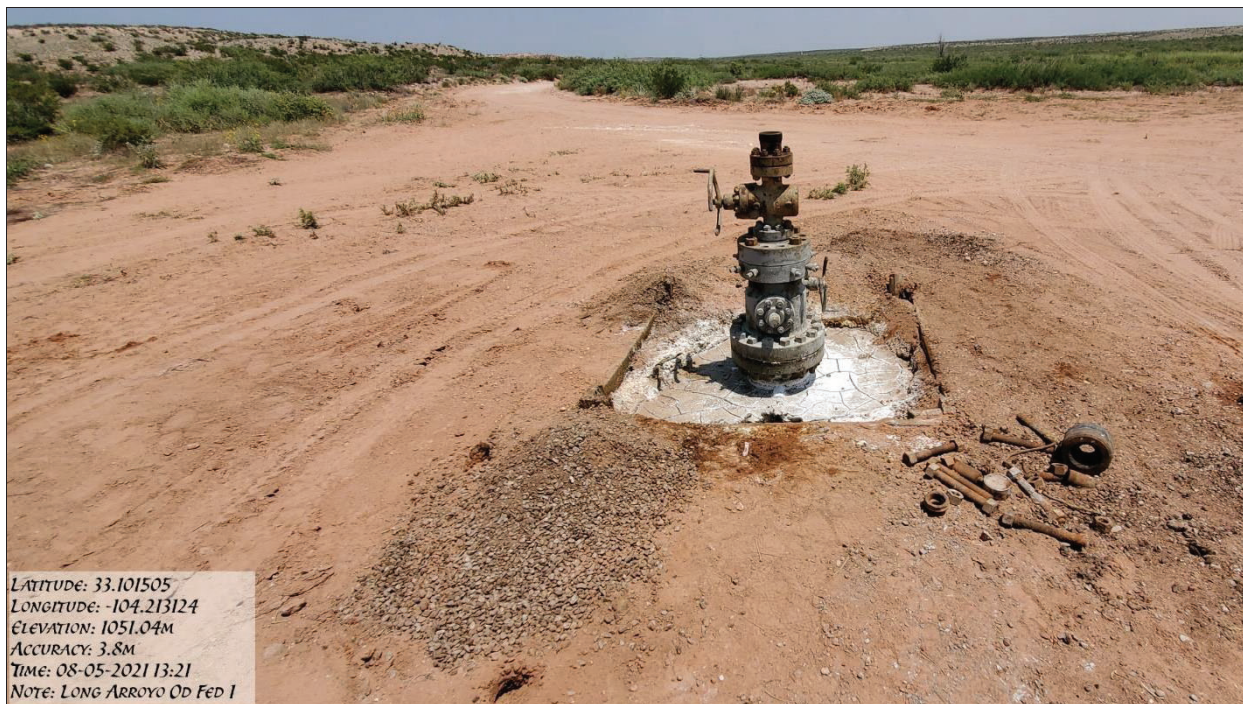
**Photograph No.2**  
**Description:**

View of Impacted Area at Well Head

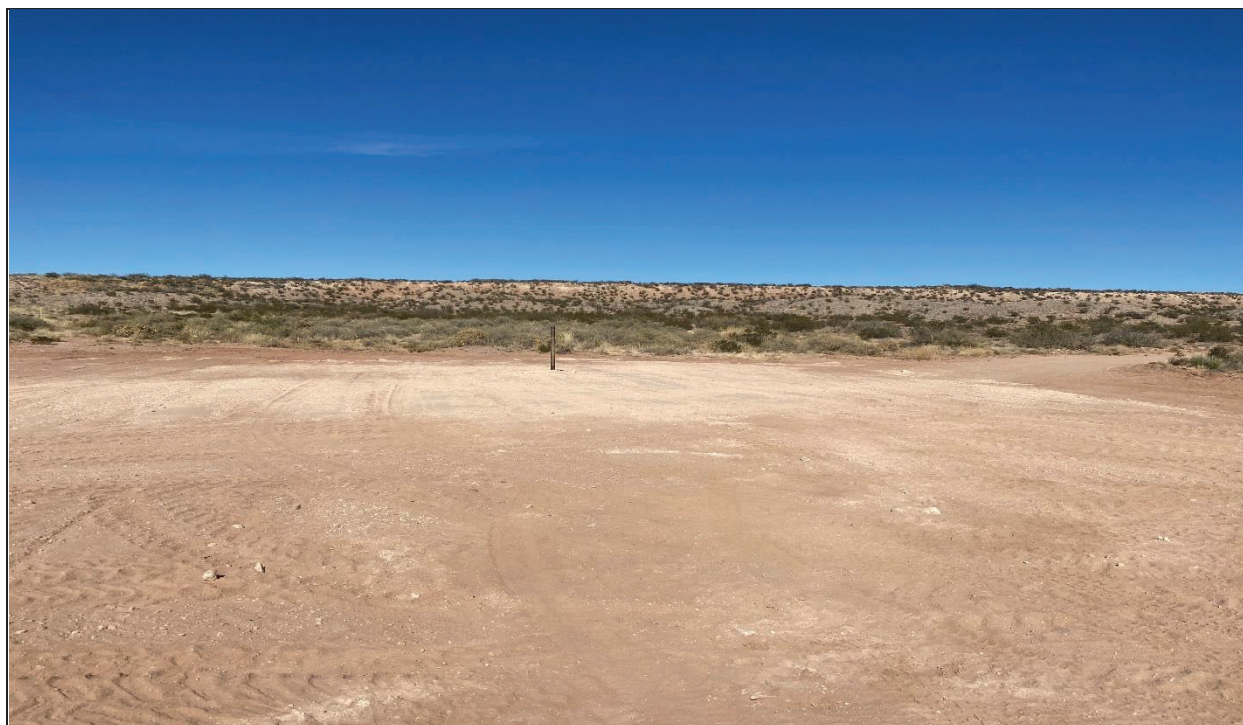
**Photograph No.5**  
**Description:**

Backfilled Remediation Area
