# **Release Notification**

RE: Spill Assessment and Closure Report for the B Loop Pipeline located in Section 4, Township 23N, Range 5 W Rio Arriba County, New Mexico

DJR Operating, LLC. B-Loop Pipeline Release Rio Arriba County, New Mexico March 9, 2020 Page 2

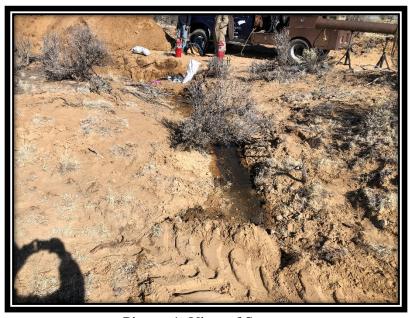
Envirotech personnel arrived on site on March 3, 2020 to perform spill assessment activities. The cause of the release was determined to be from a hole in the pipeline. The crude oil that was released traveled approximately 258 feet along a natural erosion and entered and unnamed ephemeral wash. DJR contracted roustabout personnel were excavating the petroleum contaminated soil (PCS) along the release path utilizing hand shovels and transferring the material with wheel barrels to a centralized staging area near the access road. The roustabout crew excavated the PCS to the point of manual excavation refusal due to encountering a competent sandstone base. The sandstone surfaces that exhibited petroleum staining were remediated with Simple Green® and scrub brushes. Site assessment activities are documented in the enclosed *Photography Log*.

Picture 1: View of Source

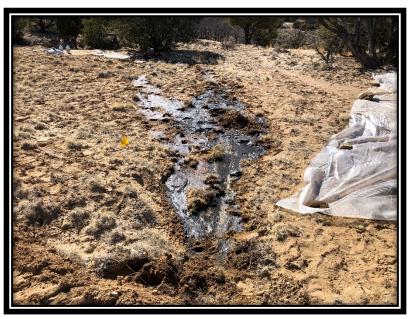
Picture 2: View of Impacted Area (View 1)

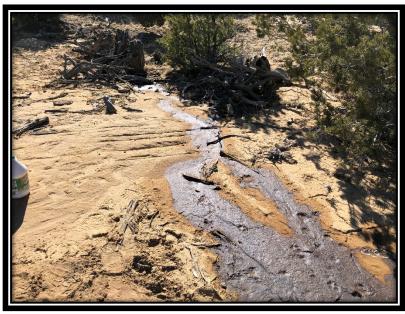
Picture 3: View of Impacted Area (View 2)

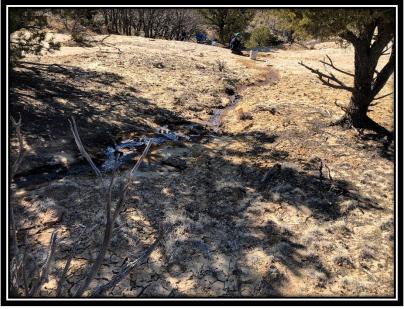
Picture 4: View of Impacted Area (View 3)

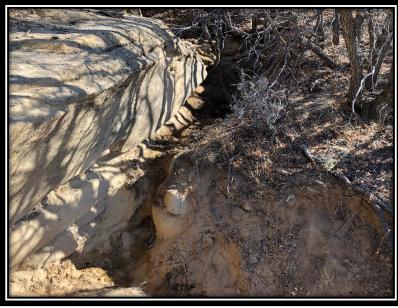
Picture 5: View of Terminal of Release

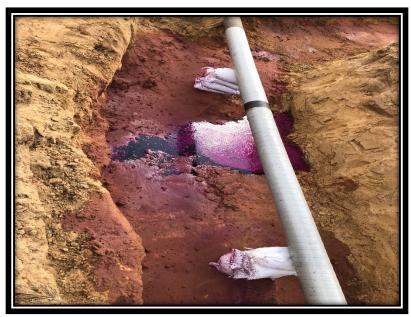
Picture 6: View of Potassium Permanganate Application (View 1)

Envirotech personnel returned to the site on March 5, 2020 to perform potassium permanganate application activities. A potassium permanganate solution was applied to the completed excavation and spill path to aid with in-situ remediation of the residual petroleum hydrocarbons on the sandstone surfaces. Subsequent to the application of the potassium permanganate solution, roustabout personnel backfilled the excavation with clean backfill and re-contoured the area to

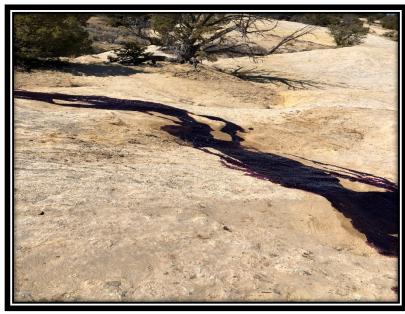
Picture 7: View of Potassium Permanganate Application (View 2)

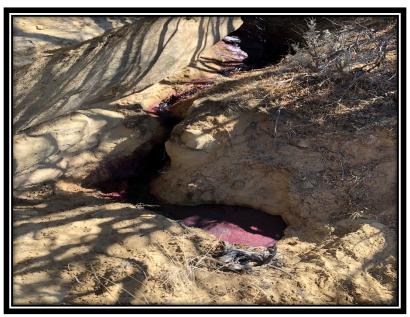
Picture 8: View of Potassium Permanganate Application (View 2)

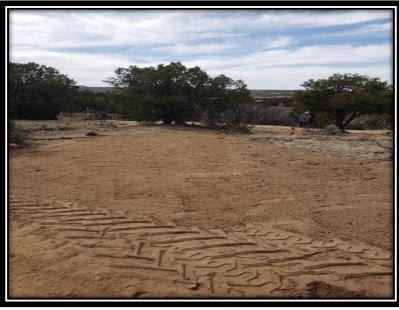
Picture 9: View of Backfilled Area (View 1)

match pre-existing conditions. Potassium permanganate application and backfilling activities are documented in the attached *Site Photography*.

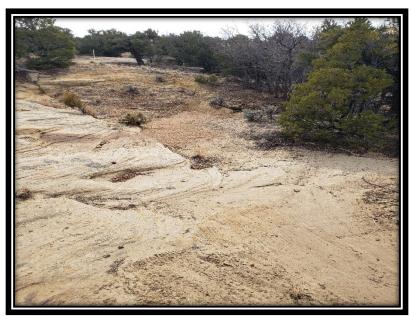
Picture 10: View of Backfilled Area (View 2)
