Release Notification

| Site Name: NORTHEAST BLANCO UNIT #231 | Site Type: Natural Gas Production Wellpad |

Northeast Blanco Unit 231
P# 30-045-33215
(F), S14, T31N, R7W
Release Point GPS: 36.901569°, -107.540612°

Produced Water Tank Release - Lab Results

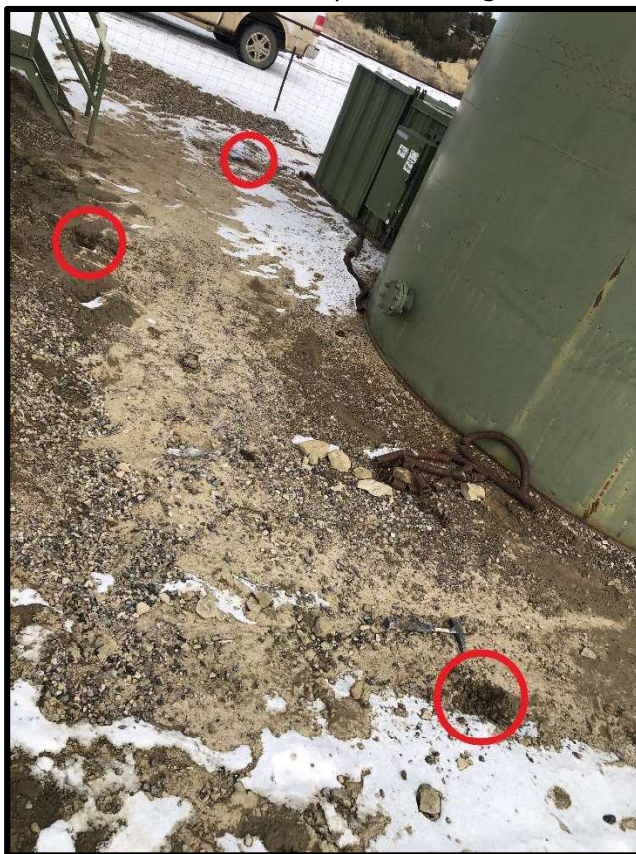
Photo 1 – SS01 Composite soil sample locations.

| MAP DESIGNATION # & SAMPLE ID | SAMPLE DATE | SAMPLE TIME | GRAB / COMPOSITE | TPH - gasoline (mg/Kg) | TPH - diesel range (mg/Kg) | TPH - cumulative (mg/Kg) | TPH - motor oil range (mg/Kg) | TPH - cumulative (mg/Kg) | Benzene (mg/Kg) | Toluene (mg/Kg) | Ethyl - benzene (mg/Kg) | Total Xylenes (mg/Kg) | BTEX - cumulative (mg/Kg) | Chloride (mg/Kg) |
|---|---|---|---|---|---|---|---|---|---|---|---|---|---|---|
| SS01 W of Tank | 12/31/20 | 12:00 | 3 pt. comp. | <4.7 | <8.5 | <8.5 | <42 | <42 | <0.023 | <0.047 | <0.047 | 0.100 | 0.100 | 190.0 |

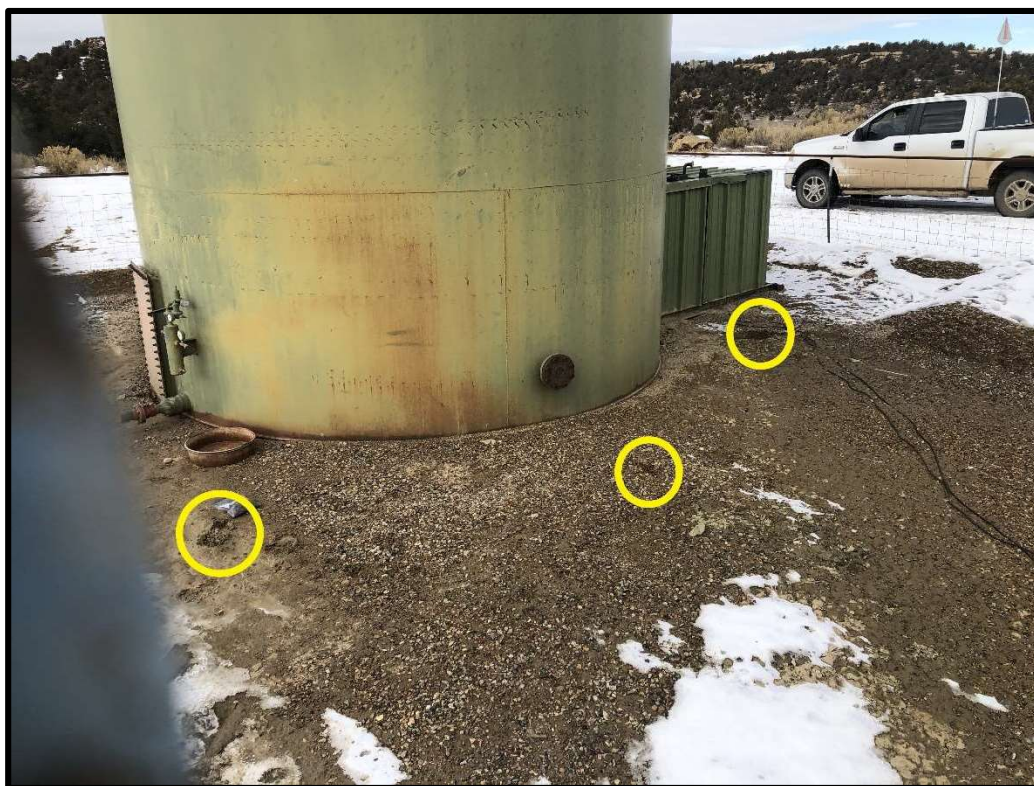
Photo 2 – SS02 Composite soil sample locations.

| MAP DESIGNATION # & SAMPLE ID | SAMPLE DATE | SAMPLE TIME | GRAB / COMPOSITE | TPH - gasoline (mg/Kg) | TPH - diesel range (mg/Kg) | TPH - cumulative (mg/Kg) | TPH - motor oil range (mg/Kg) | TPH - cumulative (mg/Kg) | Benzene (mg/Kg) | Toluene (mg/Kg) | Ethyl - benzene (mg/Kg) | Total Xylenes (mg/Kg) | BTEX - cumulative (mg/Kg) | Chloride (mg/Kg) |
|---|---|---|---|---|---|---|---|---|---|---|---|---|---|---|
| SS02 E of Tank | 12/31/20 | 12:05 | 3 pt. comp. | <4.7 | <8.9 | <8.9 | <45 | <45 | <0.024 | <0.047 | <0.047 | <0.094 | <0.094 | 270.0 |
