**RE: Deferral Request
 Remuda 500 Tank Battery
 Incident Number NAPP2125353154
 Eddy County, New Mexico**

WSP USA Inc. (WSP) on behalf of XTO Energy, Inc. (XTO), presents the following Deferral Request detailing site assessment, soil sampling, and excavation activities at the Remuda 500 Tank Battery (Site) in Unit O, Section 25, Township 23 South, Range 29 East, in Eddy County, New Mexico (Figure 1). The purpose of the site assessment, soil sampling, and excavation activities was to address impacts to soil resulting from a release of produced water and crude oil at the Site. Based on field observations, field screening activities, and soil sample laboratory analytical results, XTO is submitting this Deferral Request, describing remediation activities that have occurred and requesting deferral of final remediation for Incident Number NAPP2125353154 until the Site is reconstructed or the well pad is abandoned.

FIGURE 2
 PRELIMINARY SOIL SAMPLE LOCATIONS
 REMUDA 500 TANK BATTERY
 UNIT O SEC 25 T23S R29E
 EDDY COUNTY, NEW MEXICO
 XTO ENERGY, INC.

FIGURE 3
SOIL SAMPLE LOCATIONS
REMUDA 500 TANK BATTERY
UNIT O SEC 25 T23S R29E
EDDY COUNTY, NEW MEXICO
XTO ENERGY, INC.

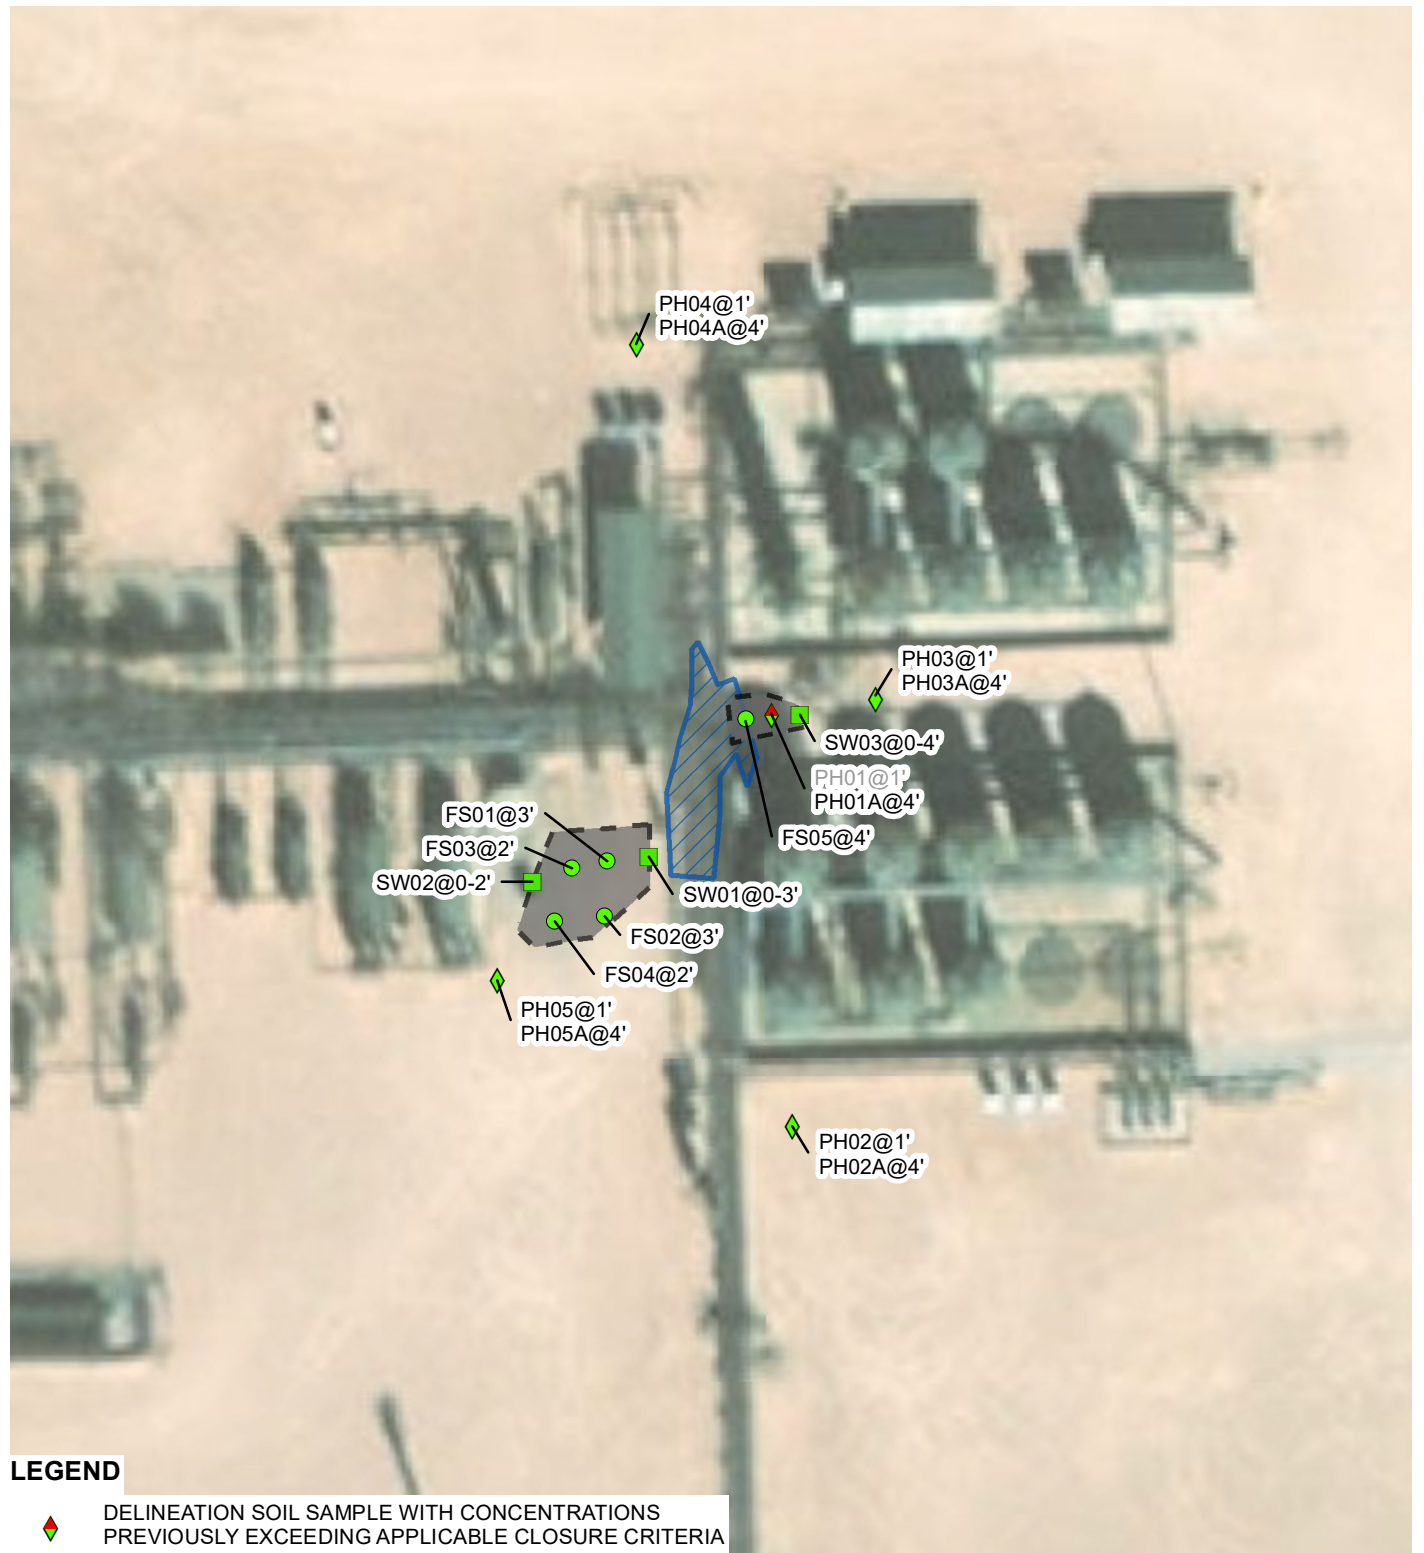
DEFERRAL AREA

EXCAVATION EXTENT

each pothole were documented on a lithologic/soil sampling log, which are included as Attachment 2. The delineation pothole locations are depicted on Figure 3.

place beneath the active production equipment, assuming a maximum depth of 4 feet based on the delineation pothole soil samples listed above, that were compliant with the Closure Criteria. The deferral request area is shown on Figure 3.

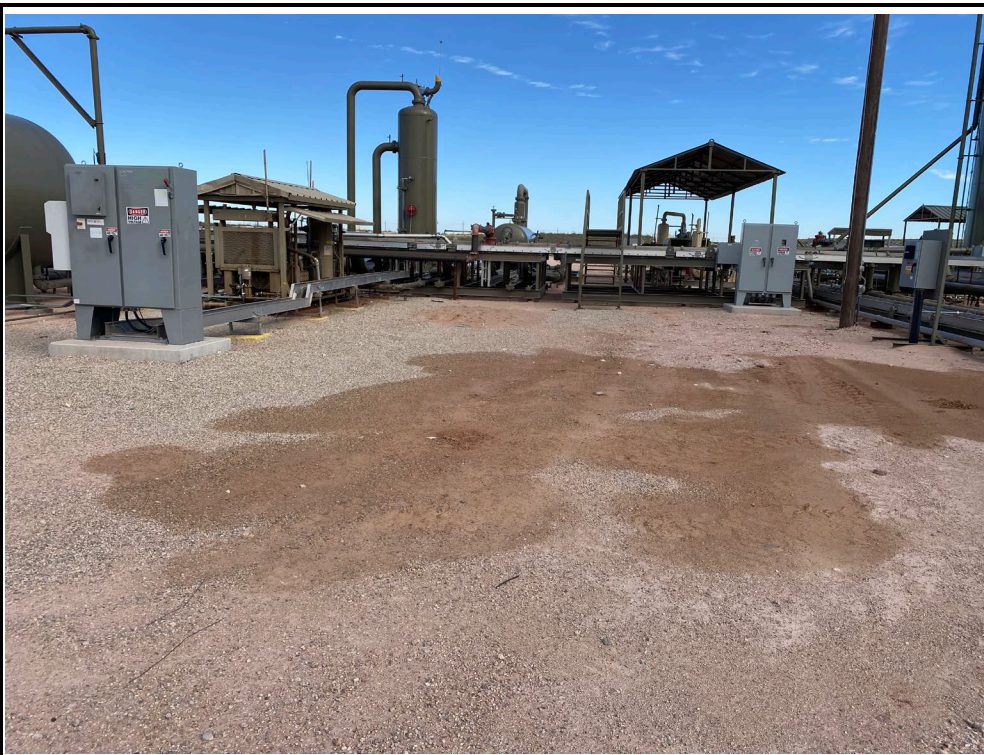
October 12, 2021

View of release extent facing North.

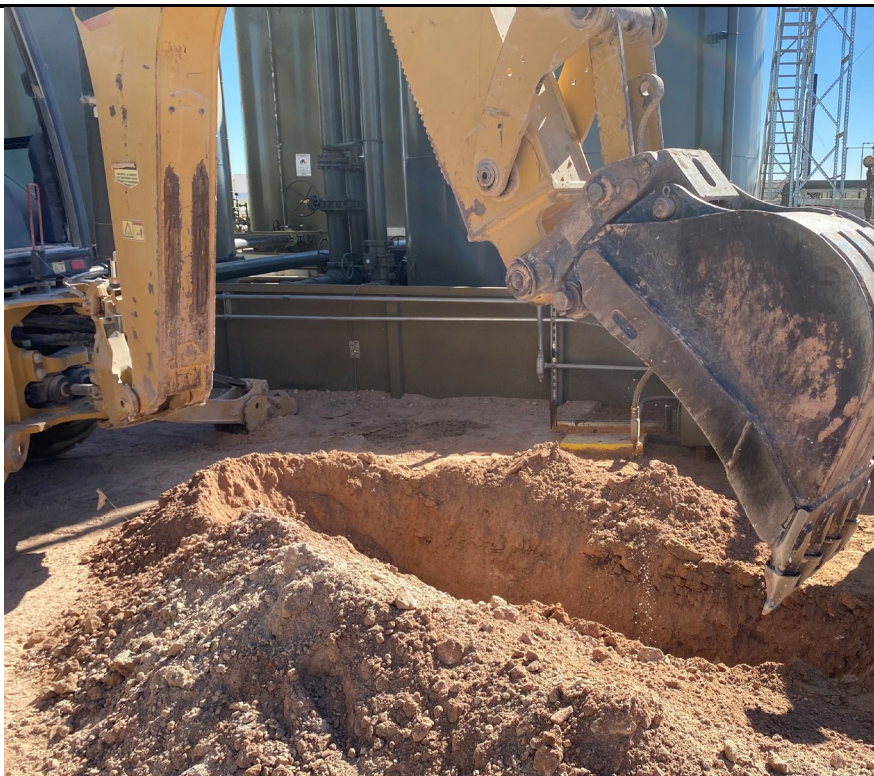
2

November 15, 2021

View of pothole facing North.

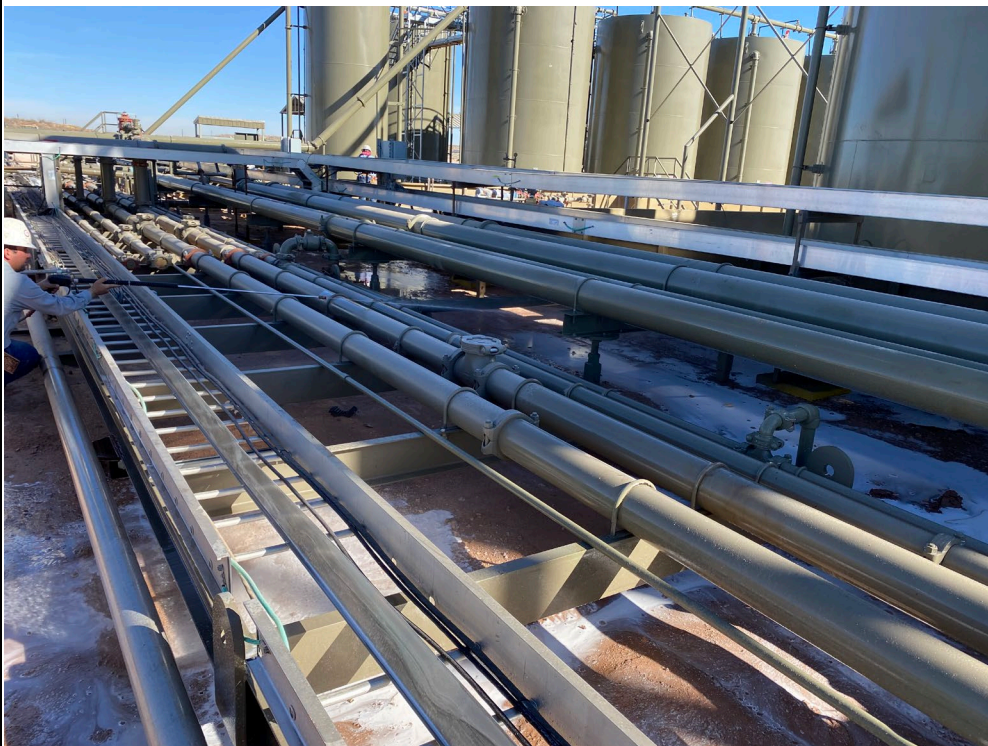
November 15, 2021

View of Micro-Blaze® application
facing North.

To enhance remediation of residual hydrocarbon impacted soil left in place between active production equipment and steel containments, WSP personnel oversaw the application of Micro-Blaze®, a chemical amendment of wetting agents, nutrients, and microbes that enhance microbial degradation of hydrocarbons. These areas were sprayed with 3 percent diluted solution of Micro-Blaze® and freshwater, followed by raking of the treated soil. The extent of the Micro-Blaze® application and raking area was mapped utilizing a handheld GPS unit and is depicted on Figure 3 as the Deferral Area. Photographic documentation was conducted during the Site visits and a photographic log is included in Attachment 3.

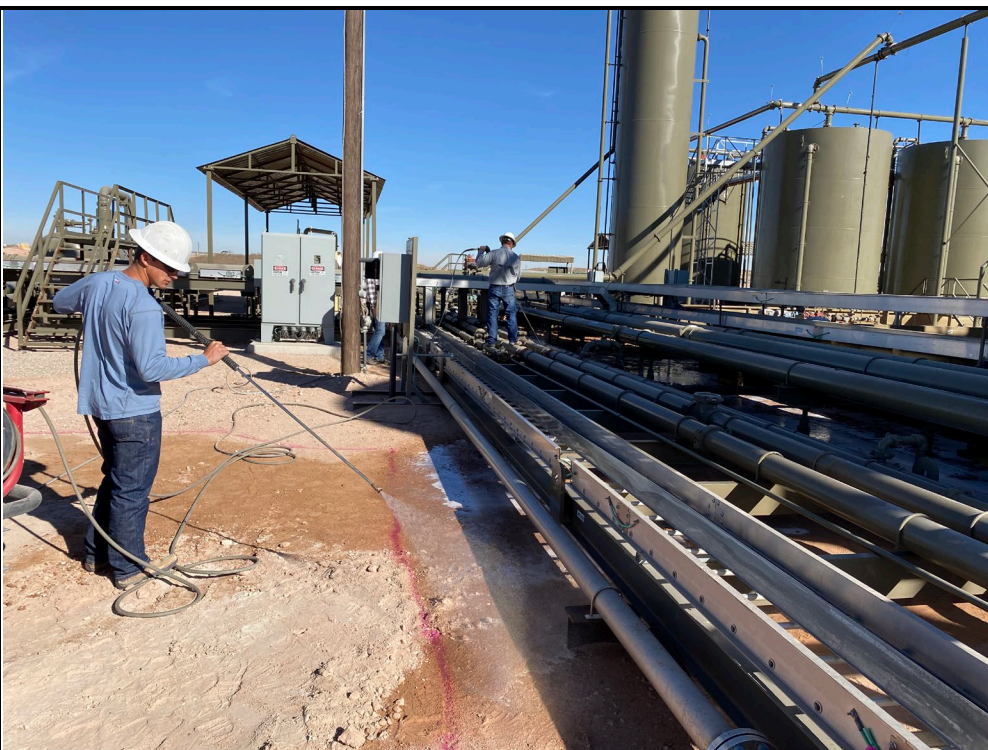
4

November 15, 2021

View of Micro-Blaze® application
facing North.
