Incident ID	nAPP2132141822
District RP	
Facility ID	
Application ID

Site Assessment/Characterization

State of New Mexico
Oil Conservation Division

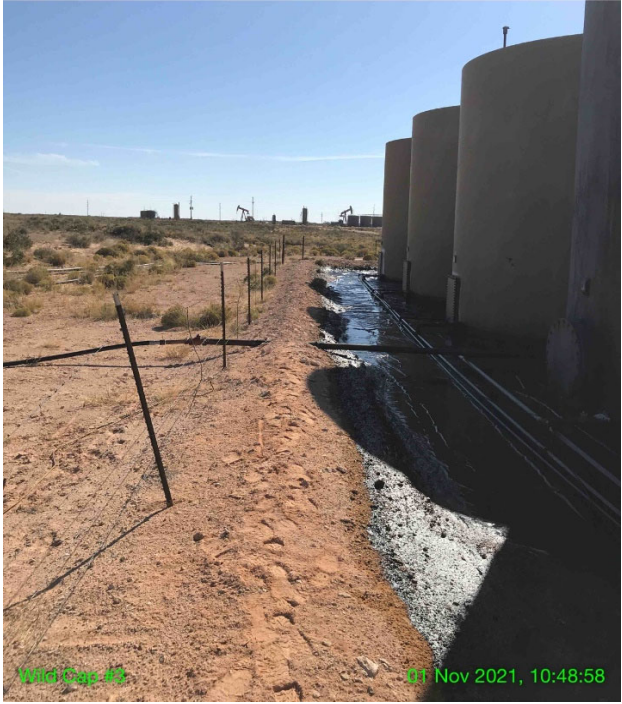
Photo Number: 1	<div><h3>North West Elevation</h3><p>☀ 124°SE (T) ● 32.616352°, -103.819303° ±16ft ▲ 3501ft</p>

<p>Wild Cap #3 01 Nov 2021, 10:48:58</p></div>
Photo Direction: Southeast	
Photo Description: View of the affected area.

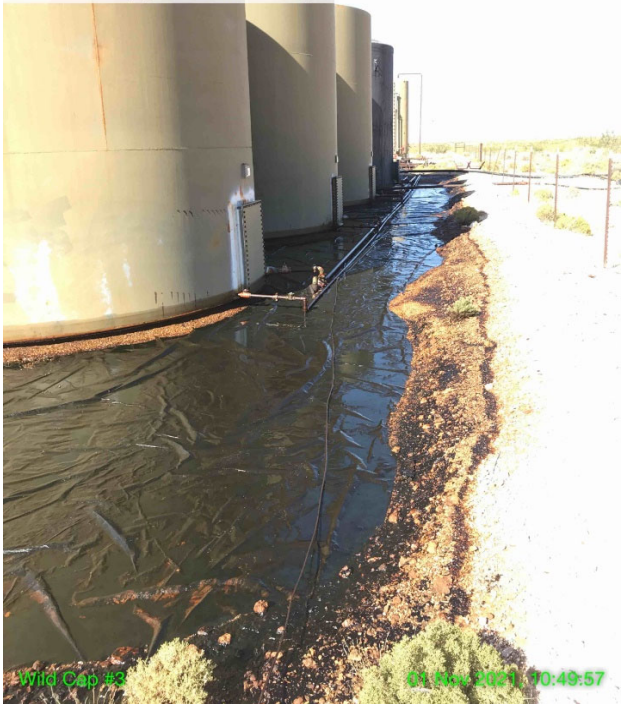
Photo Number: 2	<div><h3>South East Elevation</h3><p>☀ 305°NW (T) ● 32.616181°, -103.819042° ±16ft ▲ 3502ft</p>

<p>Wild Cap #3 01 Nov 2021, 10:49:57</p></div>
Photo Direction: Northwest	
Photo Description: View of the affected area.

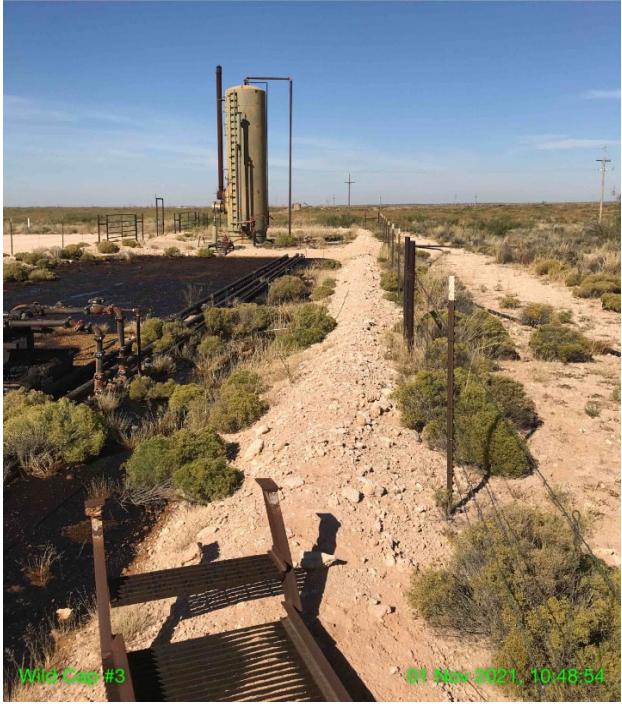
Photo Number: 3	<div>East Elevation ☼ 292°W (T) ● 32.616350°, -103.819305° ±16ft ▲ 3501ft

Wild Cat #3 01 Jan 2022, 10:48:54</div>
Photo Direction: West	
Photo Description: View of the affected area.

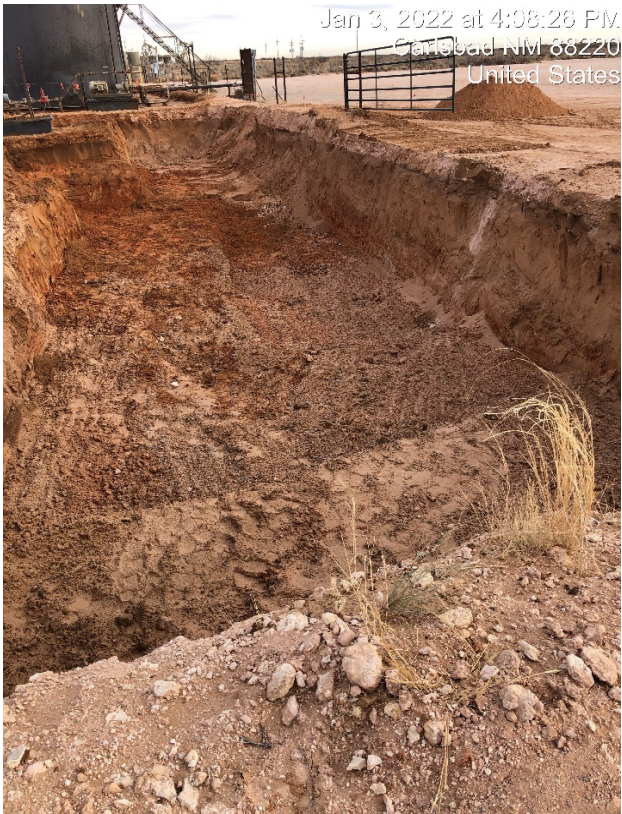
Photo Number: 5

Photo Direction: Southeast	
Photo Description: View of the excavated area.

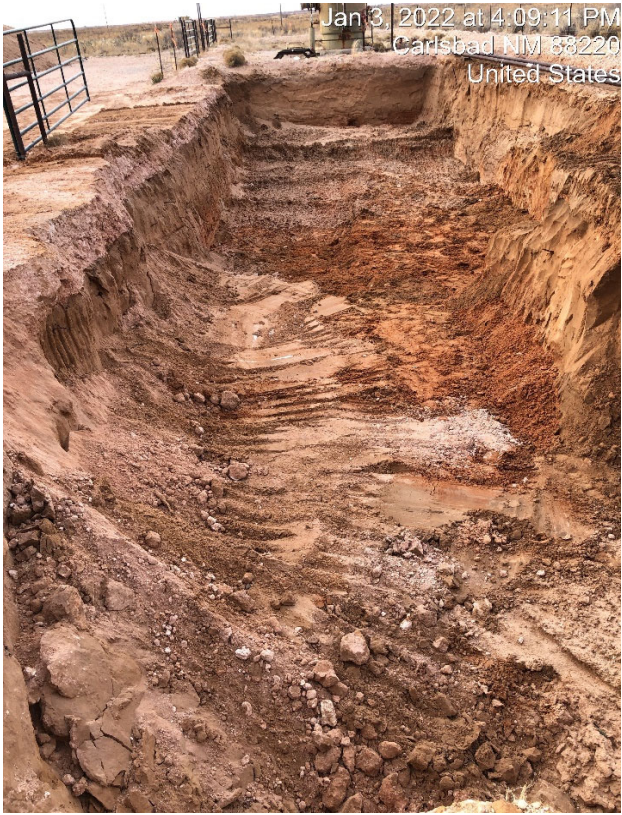
Photo Number: 6

Photo Direction: Northwest	
Photo Description: View of the excavated area.

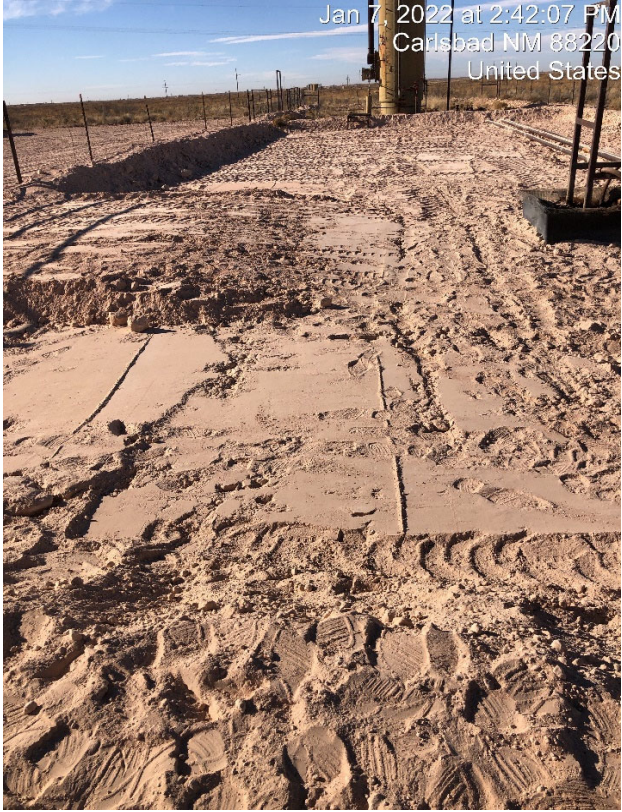
Photo Number: 7

<p>Jan 7, 2022 at 2:42:07 PM Carlsbad NM 88220 United States</p>
Photo Direction: Northwest	
Photo Description: View of the remediated area after backfill and regrading.

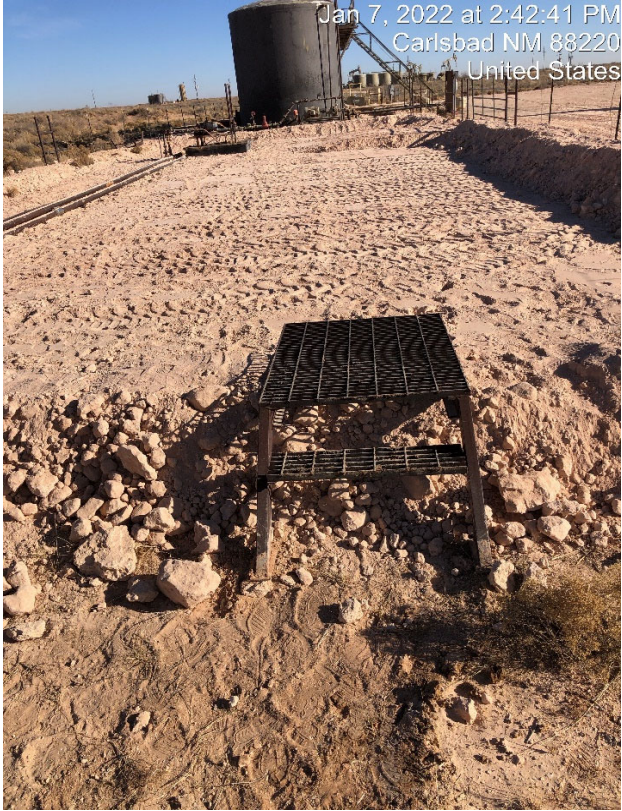
Photo Number: 8

<p>Jan 7, 2022 at 2:42:41 PM Carlsbad NM 88220 United States</p>
Photo Direction: Southeast	
Photo Description: View of the remediated area after backfill and regrading.
