## Remediation Summary and Closure Request

**Durango Midstream LLC  
6" Old Lusk\_7/19/21\_001\_0  
Eddy County, New Mexico**

**Unit Letter "I", Section 1, Township 18 South, Range 31 East  
Latitude 32.774510 North, Longitude 103.815045 West  
NMOCD Incident # nAPP2120154058**

The release occurred on an active pipeline; Latitude 32.774510 North, Longitude 103.815045 West. The Initial NMOCD Form C-141 indicated that on July 19, 2021 approximately thirty and one half bbls of produced water were released when a pipeline ruptured. A crew was dispatched to the release site and the line was repaired; however, no fluid was recovered. Previously submitted pages of the NMOCD Form C-141 are available on the NMOCD Imaging System. NMOCD Form C-141 Closure page is included as Attachment V.

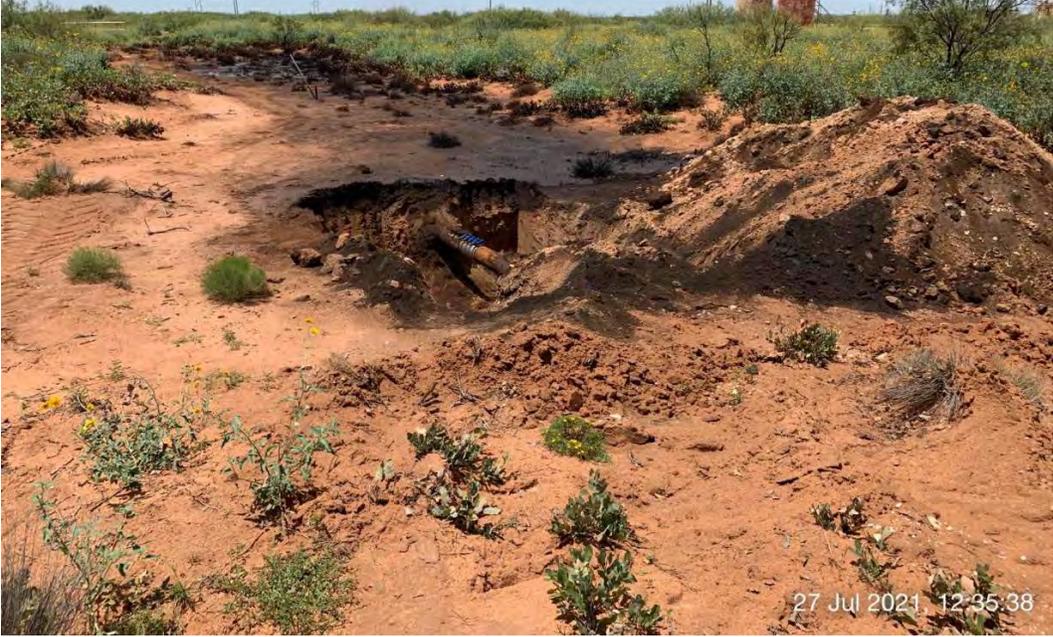
<b>Description:</b> Release area

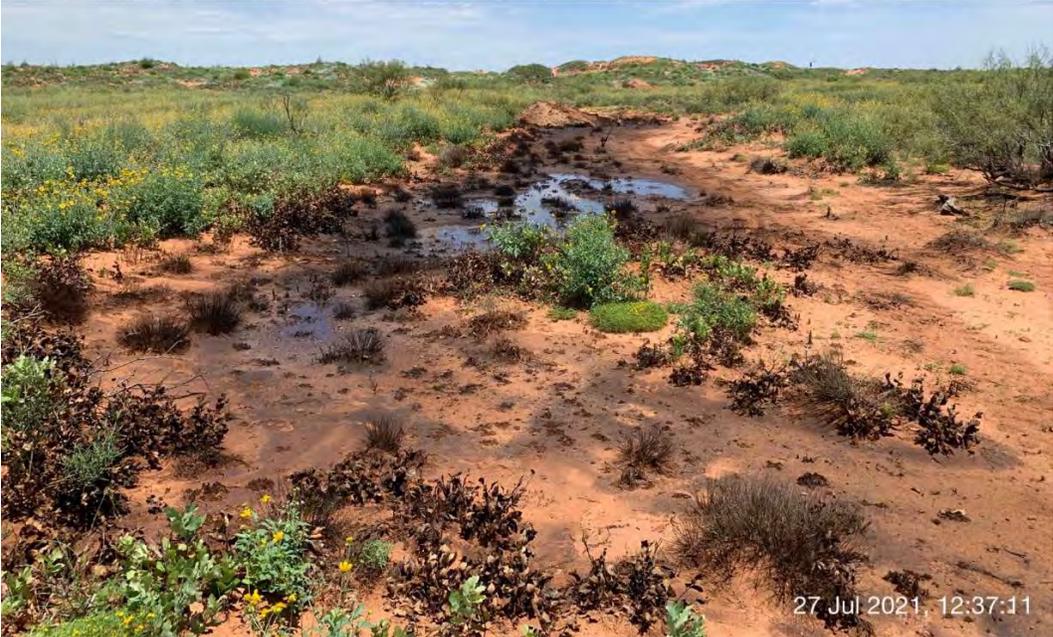
<b>Photo:</b> 2

<b>Description:</b> Release area

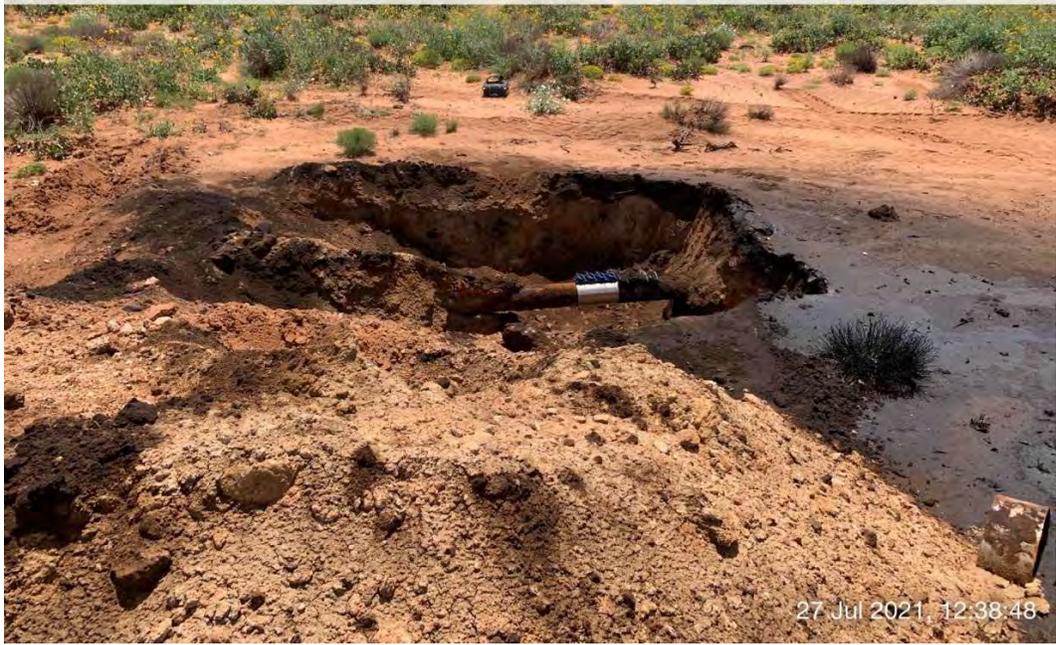
<b>Direction:</b> Southeast	☀ 140°SE (T) ● 32°46'28"N, 103°48'54"W ±13ft ▲ 3815ft
<b>Description:</b> Release area

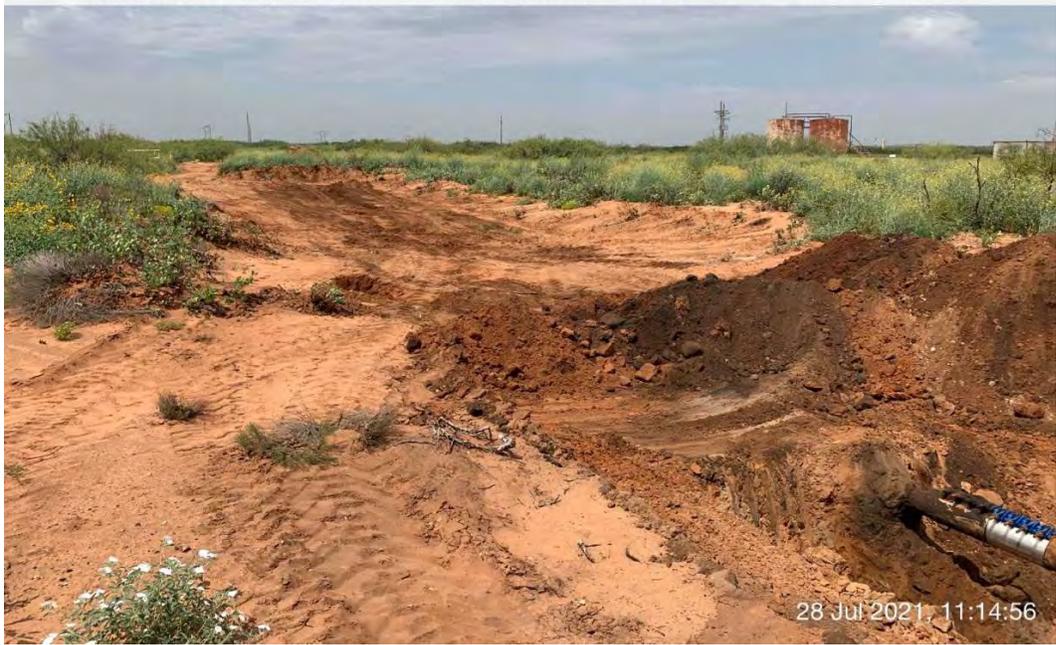
<b>Photo:</b> 4

<b>Direction:</b> West	☀ 255°W (T) ● 32°46'28"N, 103°48'53"W ±13ft ▲ 3817ft
<b>Description:</b> Release area scraped up and sampled.

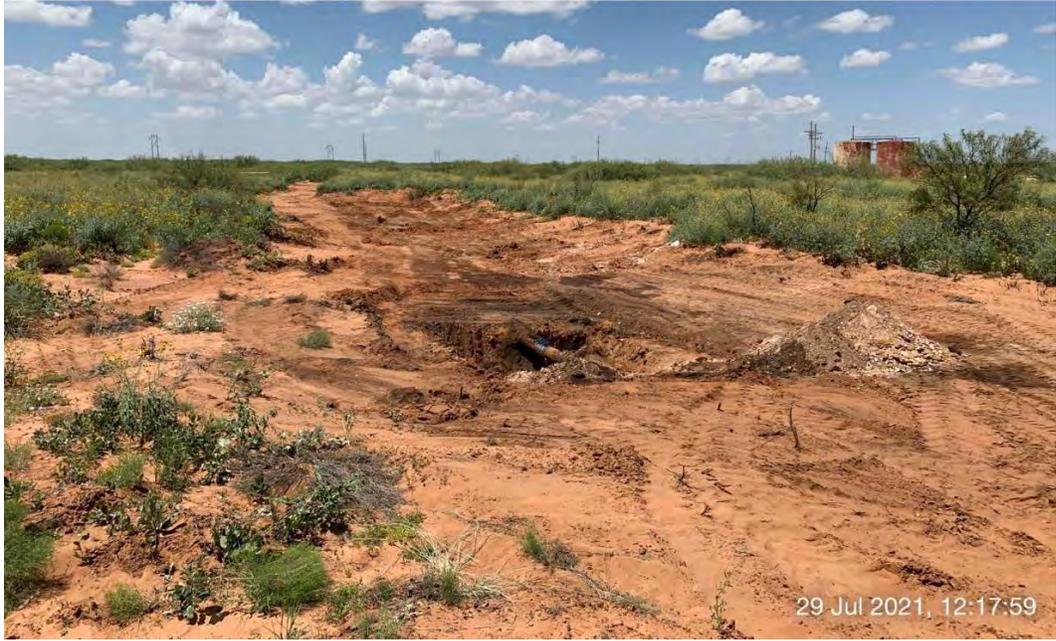
<b>Photo:</b> 5

<b>Description:</b> Excavation activities

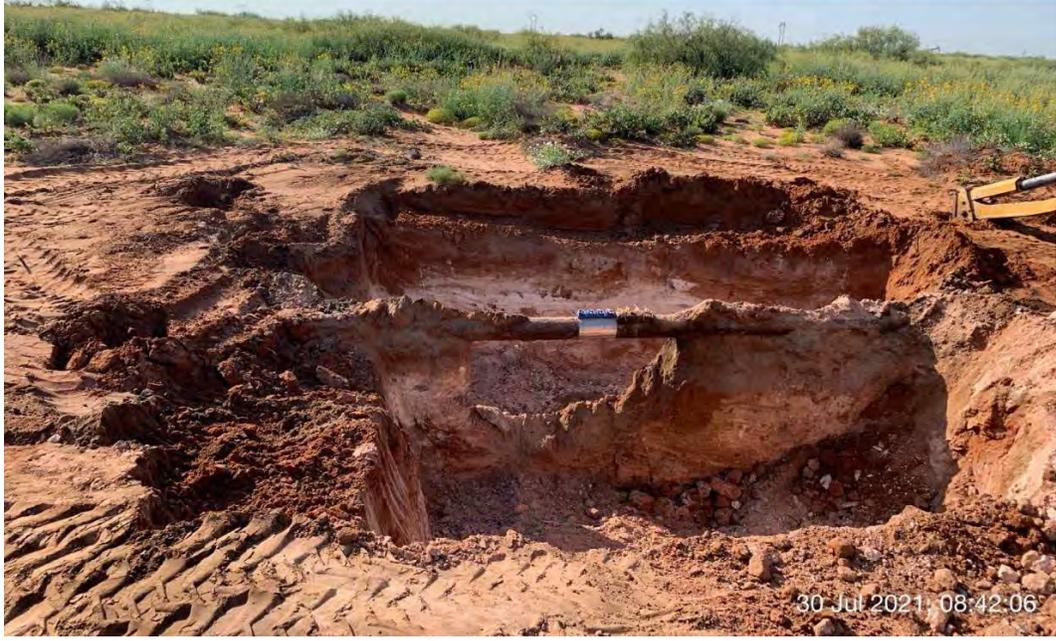
<b>Photo:</b> 6

<b>Description:</b> Excavation activities

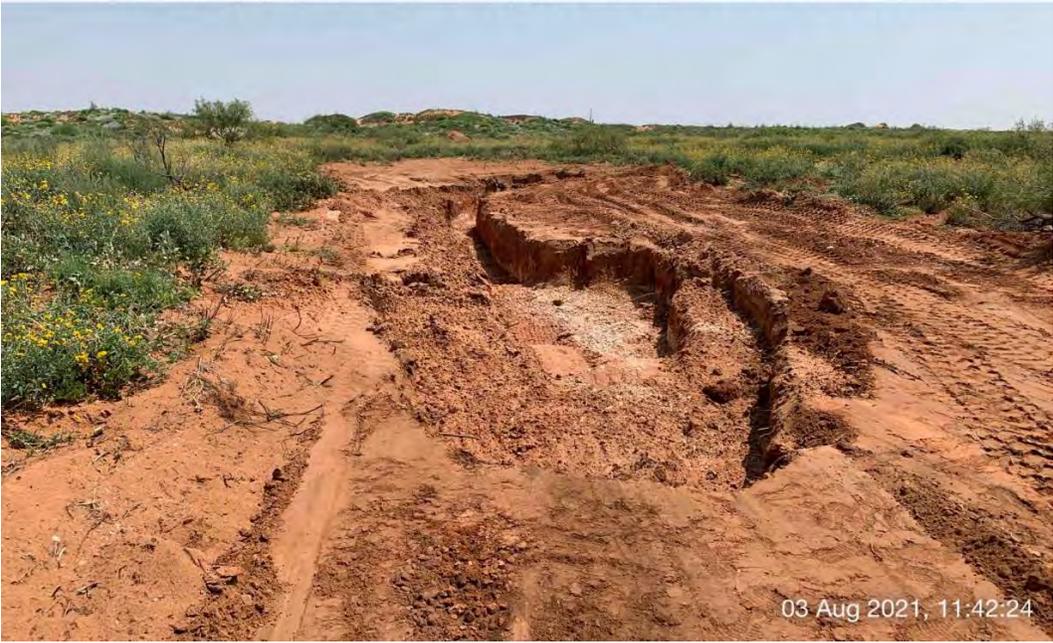
<b>Photo:</b> 7

<b>Direction:</b> Northeast	☉ 60°NE (T) ● 32°46'27"N, 103°48'55"W ±32ft ▲ 3815ft
<b>Description:</b> Excavation activities

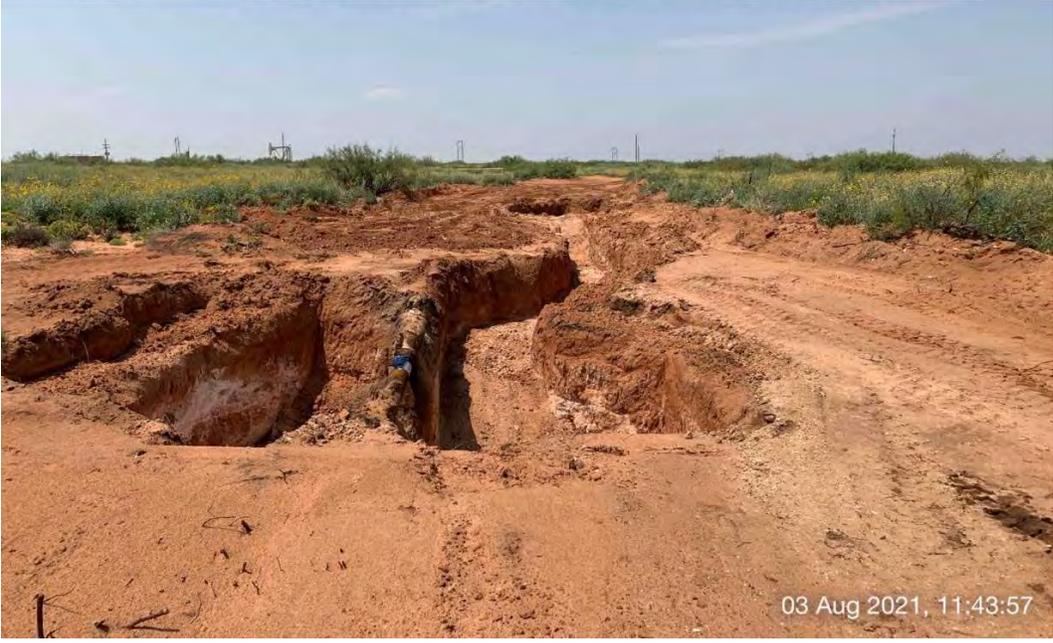
<b>Photo:</b> 8

<b>Direction:</b> Southwest	☉ 223°SW (T) ● 32°46'28"N, 103°48'53"W ±22ft ▲ 3815ft
<b>Description:</b> Excavation activities

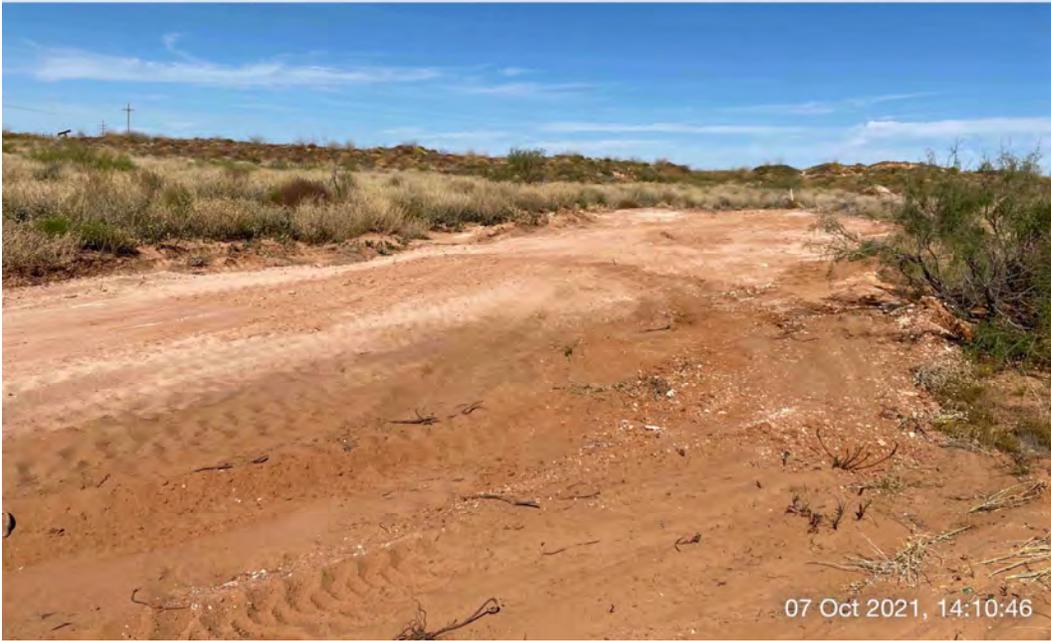
<b>Direction:</b> Northeast	☀ 21°N (T) ● 32°46'27"N, 103°48'54"W ±13ft ▲ 3816ft
<b>Description:</b> Backfill complete

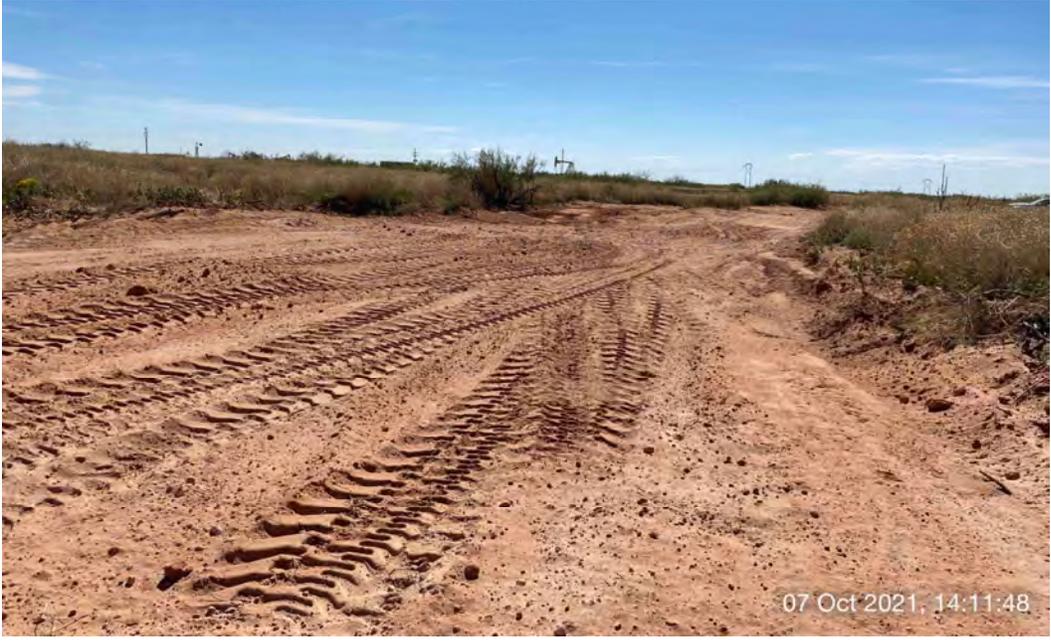
<b>Photo:</b> 14

<b>Direction:</b> Southwest	☀ 204°SW (T) ● 32°46'28"N, 103°48'54"W ±16ft ▲ 3815ft
<b>Description:</b> Backfill complete
