Release Notification

Site Name	Poker Lake Unit 147	Site Type	Well Location
Date Release Discovered	01/28/20	API# (if applicable)	30-015-31177 (Poker Lake Unit 147)

Cause of Release: The Poker Lake Unit 147 well unloaded overnight causing the water tank to overflow 11.39 barrels of produced water into an unlined berm. Vacuum truck was dispatched and recovered 10 barrels with 1.39 barrels remaining in the soil. A third party contractor will be retained for remediation activities.

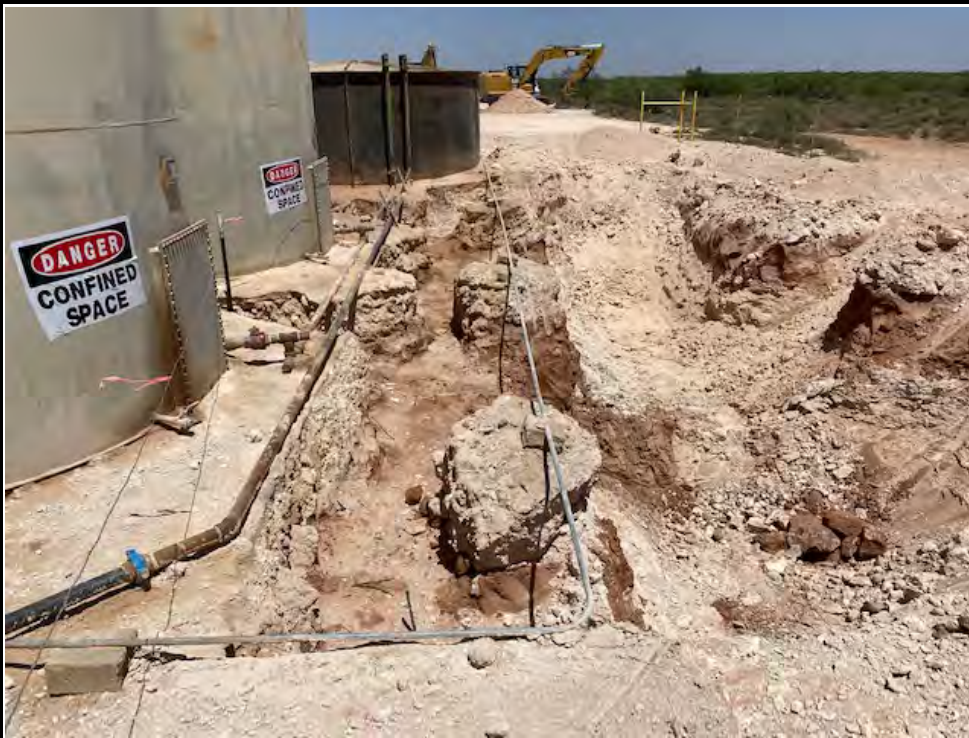
Photo No.	Date	
6	June 6, 2020	
View of southern excavation looking east.

A photograph showing a wide, deep excavation pit. The pit is filled with loose, light brown soil and some debris. A large, dark-colored cylindrical piece of equipment is visible on the left side of the pit. A yellow excavator is visible in the background, working on the right side of the pit. A sign that reads "DANGER CONFINED SPACE" is attached to the equipment on the left. The sky is clear and blue.

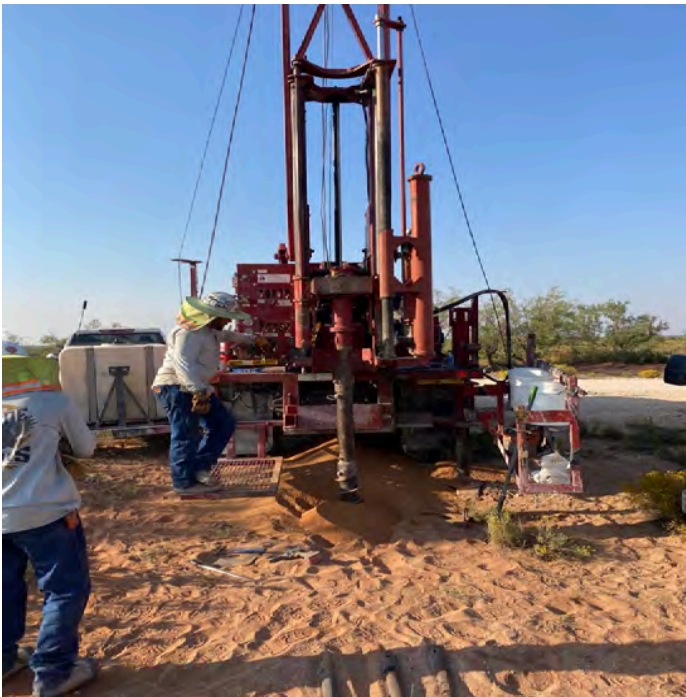
Photo No.	Date	
8	October 8, 2020	
View of location of BH01 along lease road that leads to well pad facing northwest.

A photograph showing a drilling rig or similar equipment on a sandy area. Two workers in hard hats and safety gear are visible near the equipment. The background shows a clear blue sky and some sparse vegetation.
