**Re: Release Characterization and Closure Request
ConocoPhillips
Heritage Concho
Pan Head Fee 21H Release
Unit Letter D, Section 11, Township 17 South, Range 32 East
Lea County, New Mexico
Incident ID# NJXK1610631827
1RP-4249**

Tetra Tech, Inc. (Tetra Tech) was contacted by ConocoPhillips (COP) to assess a Heritage Concho release and subsequent remedial actions taken at the Pan Head Fee 21H (API No. 30-025-40886). The release footprint is located in Public Land Survey System (PLSS) Unit Letter D, Section 11, Township 17 South, Range 32 East, in Lea County, New Mexico (Site). The approximate release point occurred at coordinates 32.8554306°, -103.7446976°, as shown on Figures 1 and 2.

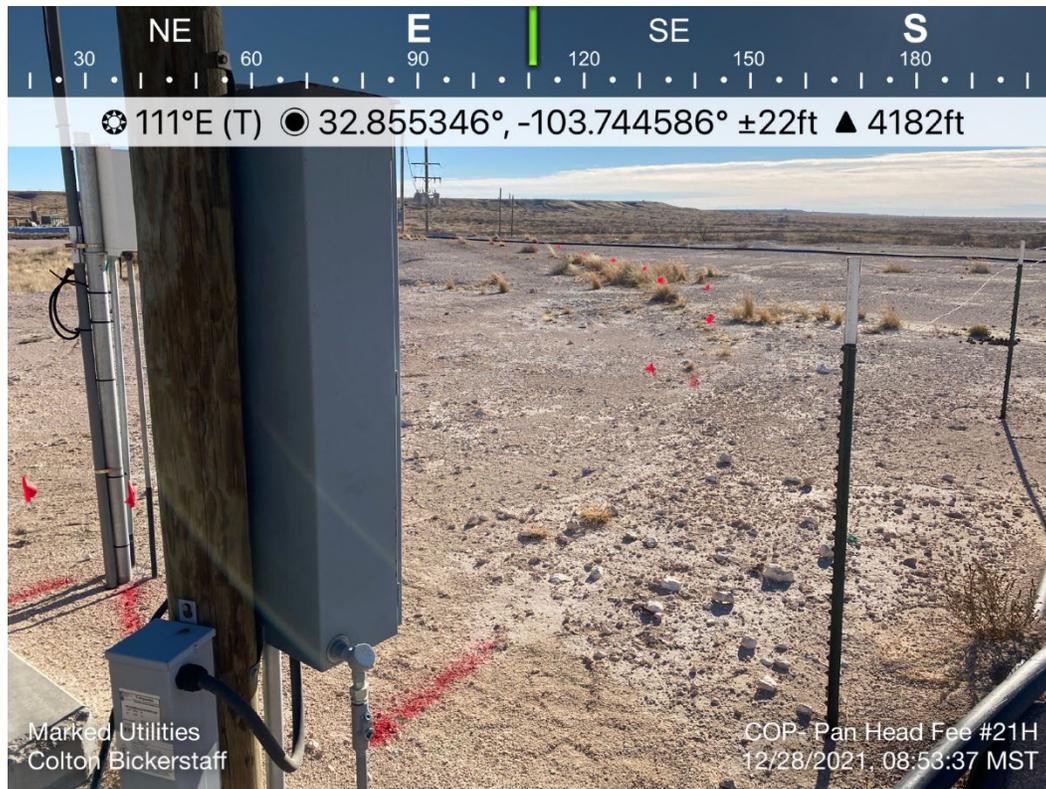
TETRA TECH, INC. PROJECT NO. 212C-MD-02618	DESCRIPTION	View east-southeast. Marked buried utility from pumping unit.	2
	SITE NAME	Pan Head Fee 21H	12/28/2021

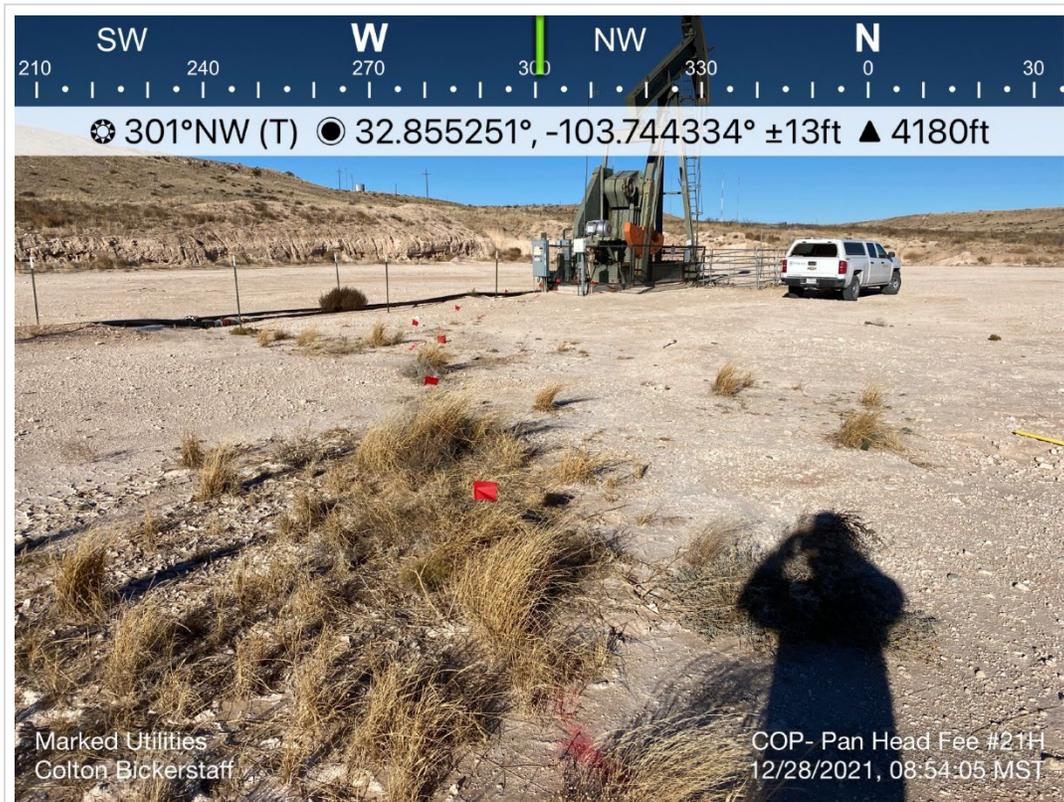
TETRA TECH, INC. PROJECT NO. 212C-MD-02618	DESCRIPTION	View west-northwest. Southeast portion of pad and pumping unit.	3
	SITE NAME	Pan Head Fee 21H	12/28/2021

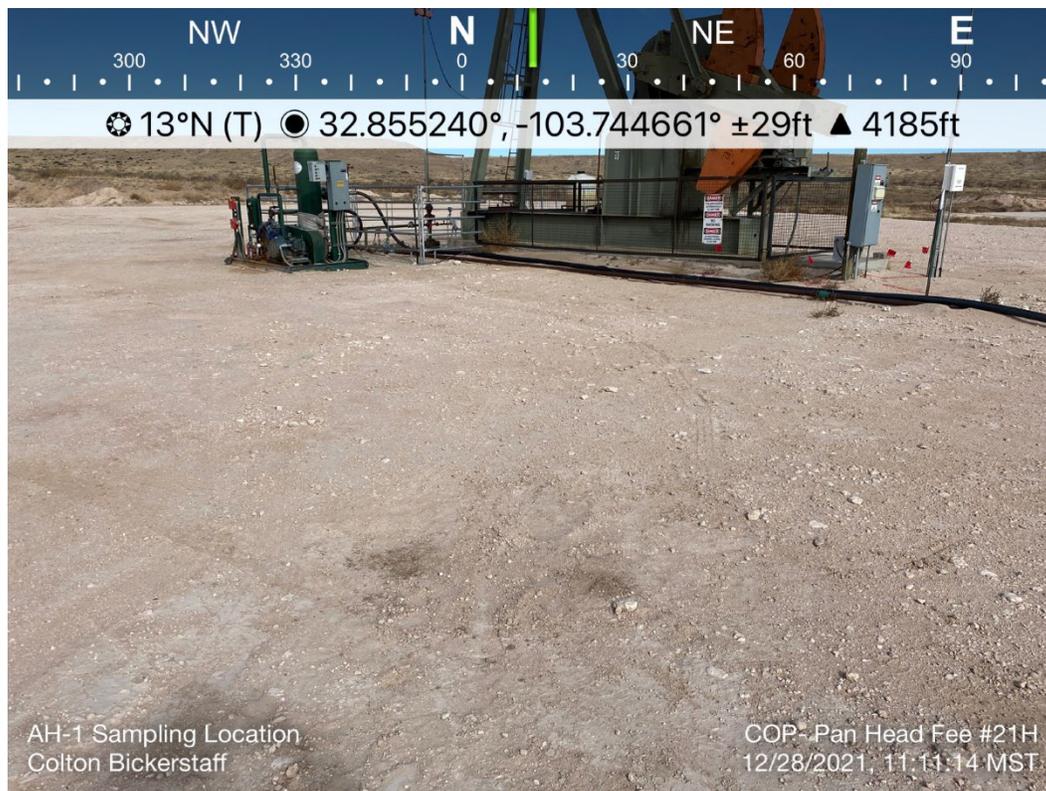
TETRA TECH, INC. PROJECT NO. 212C-MD-02618	DESCRIPTION	View north. AH-1 sampling location.	4
	SITE NAME	Pan Head Fee 21H	12/28/2021

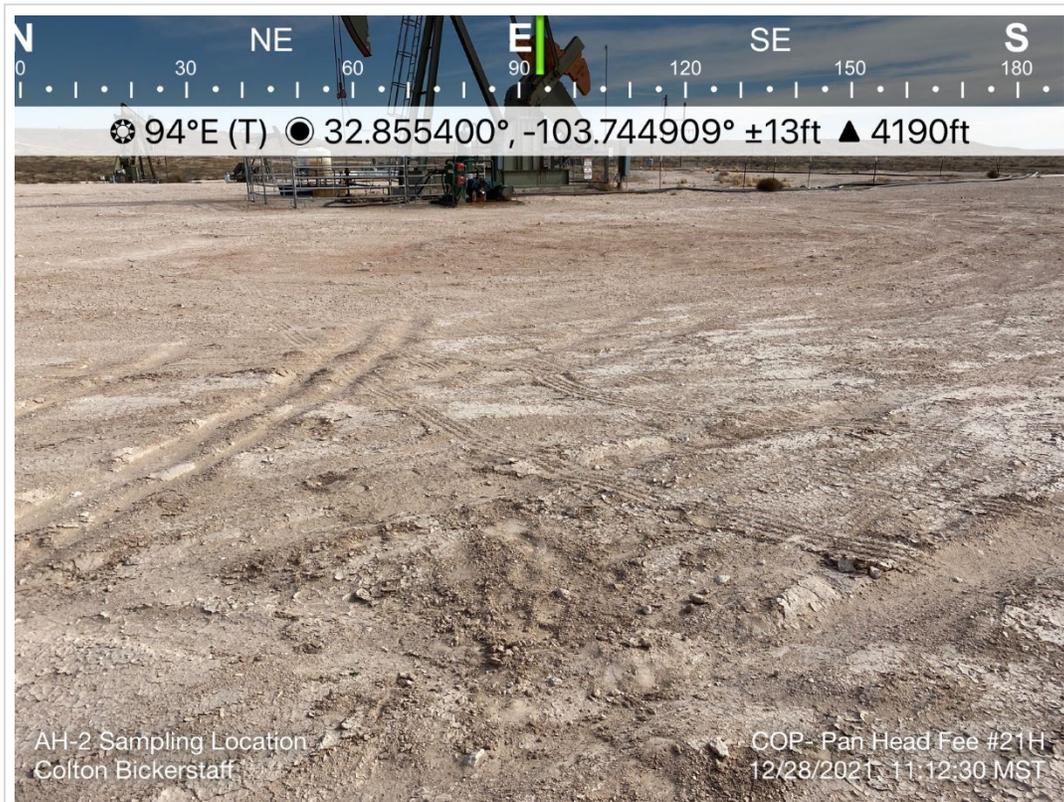
TETRA TECH, INC. PROJECT NO. 212C-MD-02618	DESCRIPTION	View east. AH-2 sampling location.	5
	SITE NAME	Pan Head Fee 21H	12/28/2021

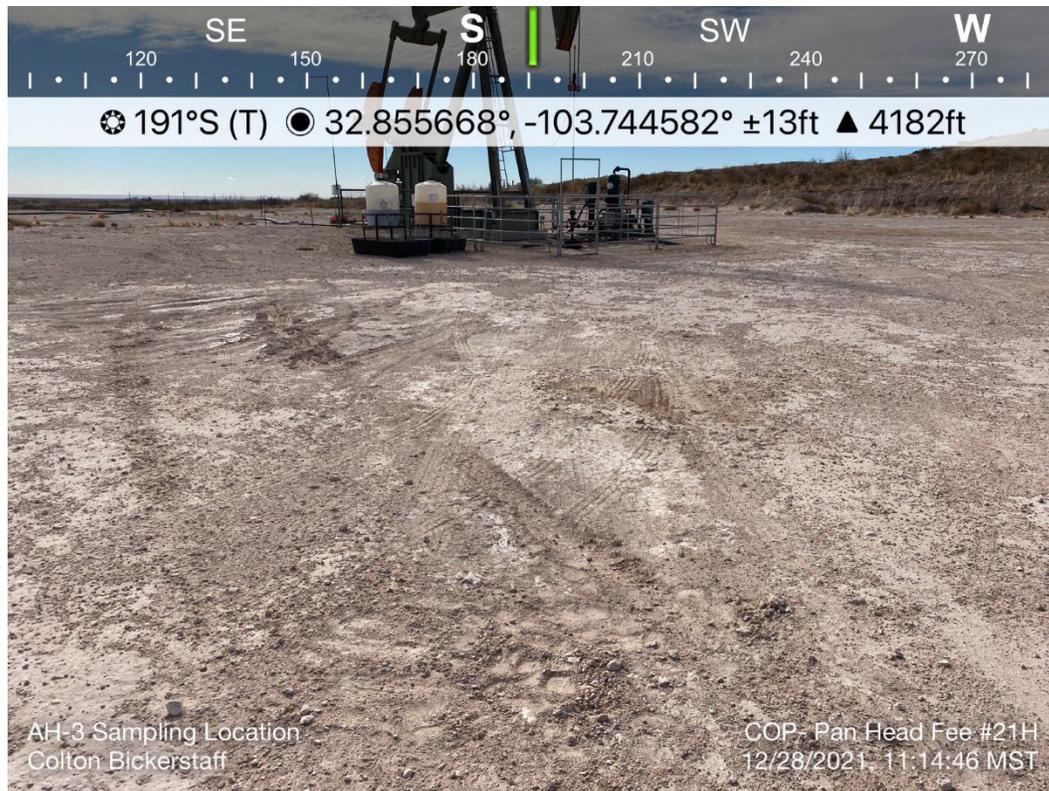
TETRA TECH, INC. PROJECT NO. 212C-MD-02618	DESCRIPTION	View south. AH-3 sampling location.	6
	SITE NAME	Pan Head Fee 21H	12/28/2021

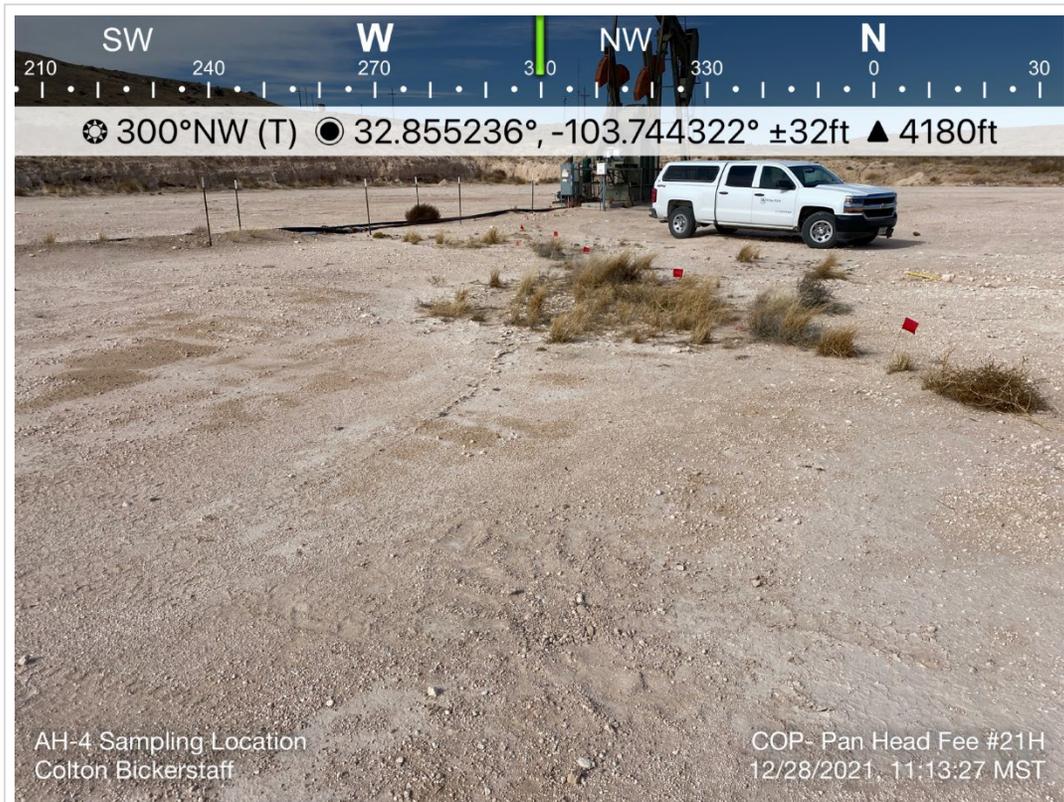
TETRA TECH, INC. PROJECT NO. 212C-MD-02618	DESCRIPTION	View west-northwest. AH-4 sampling location.	7
	SITE NAME	Pan Head Fee 21H	12/28/2021
