Release Notification

Site Name Ross Ranch 33-25-30	Site Type CTB
Date Release Discovered 9/21/2021	API# (if applicable)

**RE: Closure Request
Ross Ranch 33-25-30
Incident Number NAPP2127835608
Eddy County, New Mexico**

PHOTOGRAPHIC LOG		
XTO Energy, Inc.	ROSS RANCH 33-25-30 Eddy County, New Mexico	NAPP2127835608

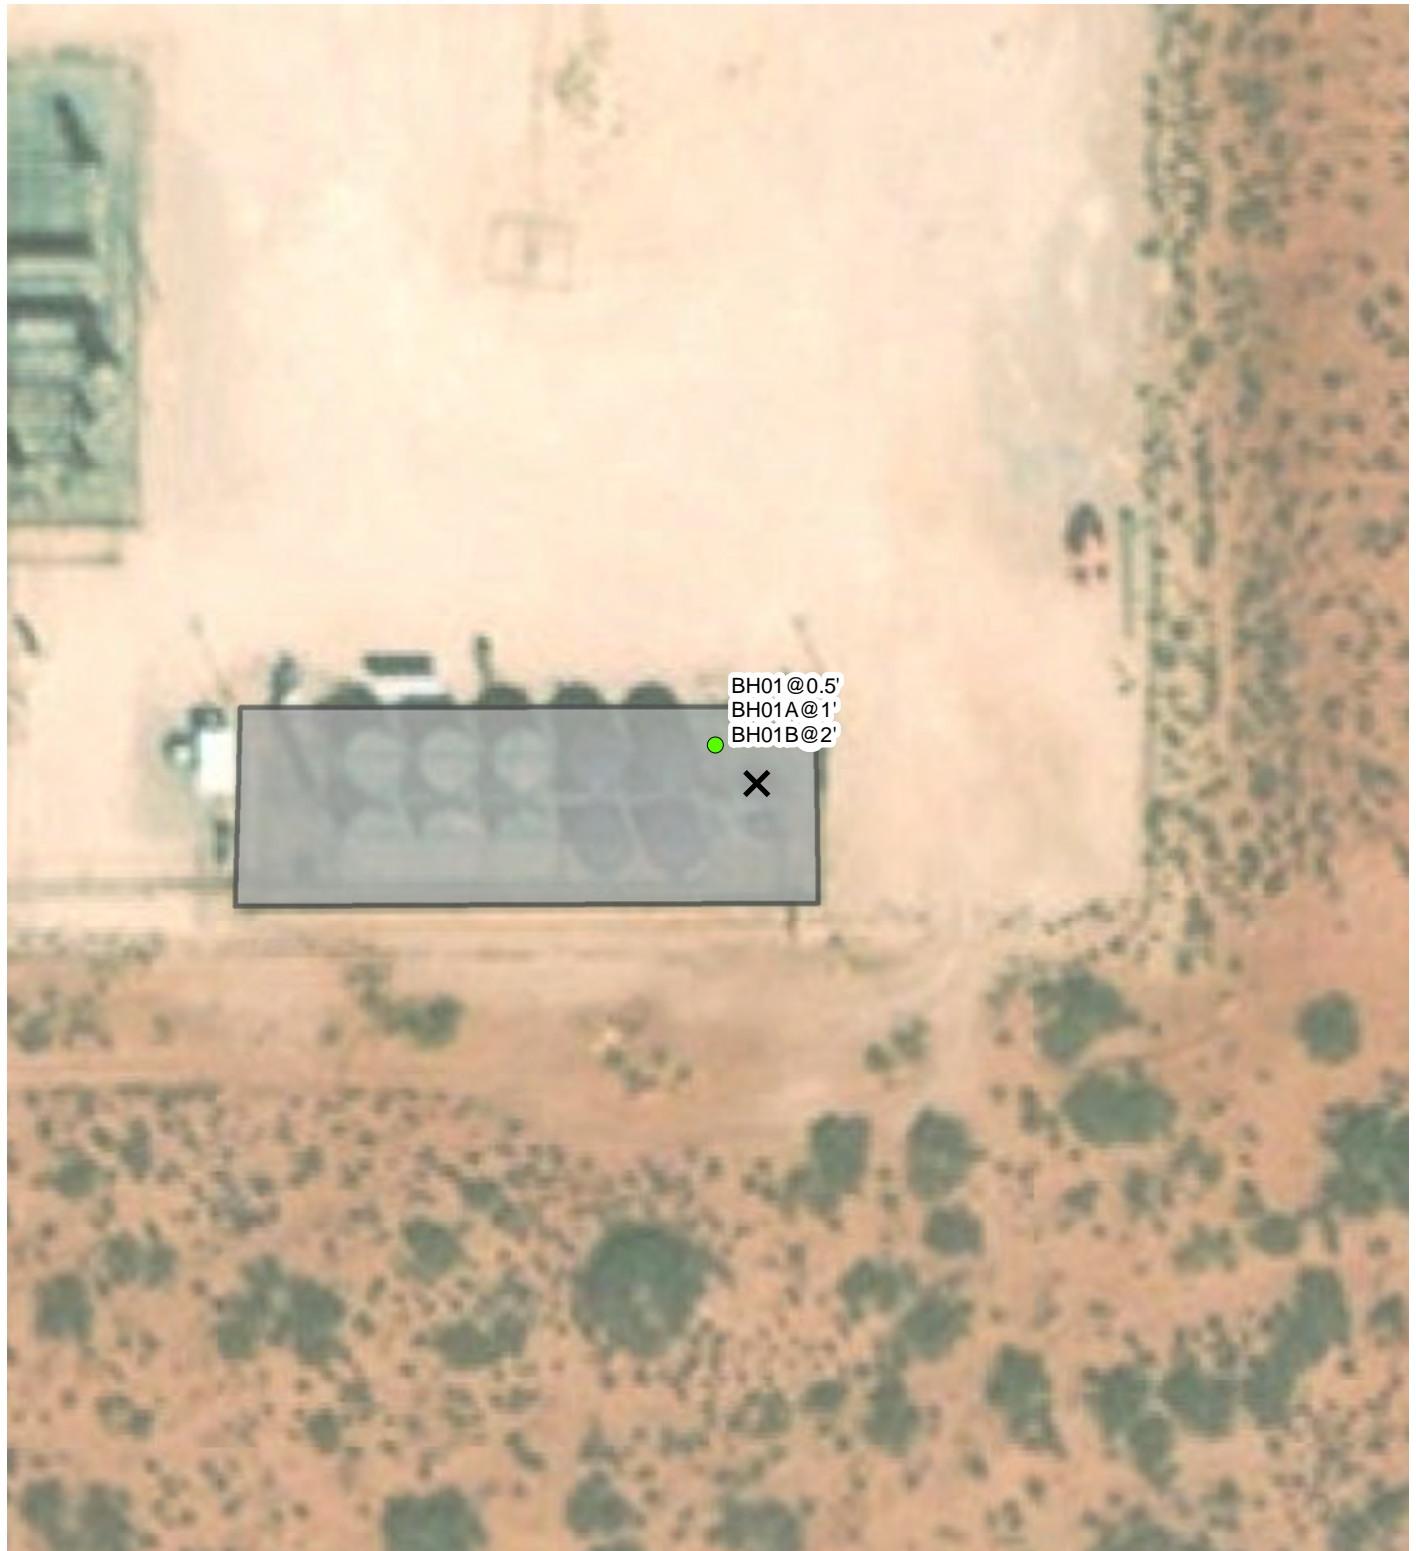
FIGURE 2
DELINEATION SOIL SAMPLE LOCATIONS
 ROSS RANCH 33-25-30
 UNIT D SEC 33 T25S R30E
 EDDY COUNTY, NEW MEXICO
XTO ENERGY, INC.

NOTE: INCIDENT NUMBER NAPP2127835608
 SAMPLE ID@DEPTH BELOW GROUND SURFACE (FEET)

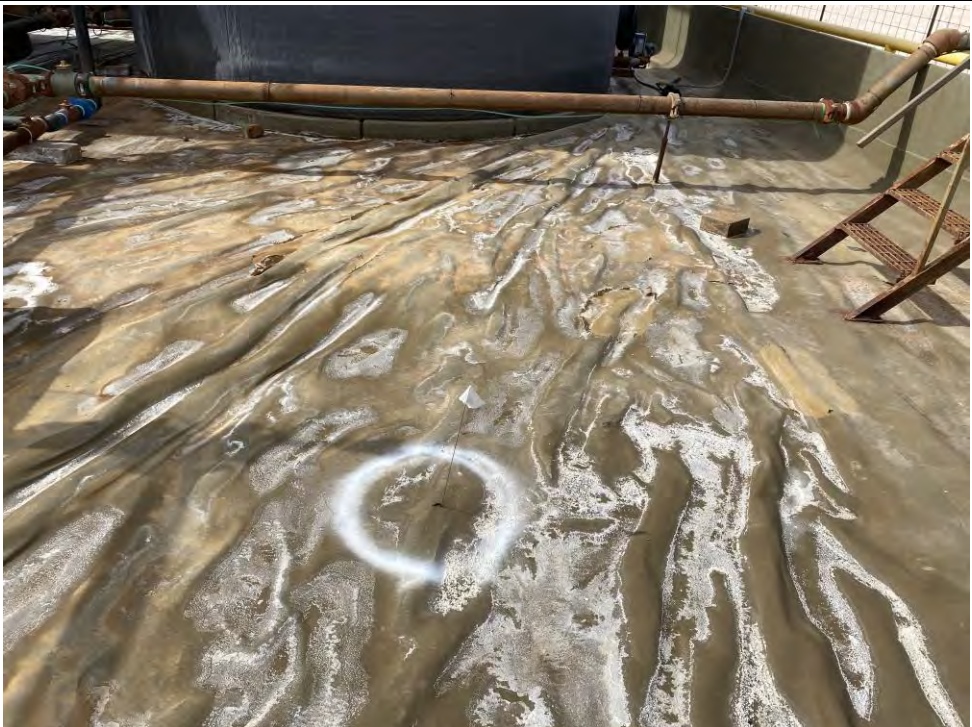
A photograph showing a large, irregular tear in a dark, possibly black, liner material. The tear is surrounded by a white, powdery substance. A white circle is drawn on the liner, highlighting the area of the tear. The liner is situated in a large, open area, possibly a containment pond or tank, with various pipes and structures visible in the background.
1	November 8, 2021	
View of tear in liner prior to delineation activities.

Following the failed liner integrity inspection at the Site, WSP personnel advanced one borehole, (BH01), within the lined containment to assess for the presence or absence of soil impacts resulting from the September 21, 2021 produced water release within lined containment. Three delineation soil samples were collected from borehole BH01, at depths of approximately 0.5 feet, 1 foot, and 2 feet bgs. Laboratory analytical results for the delineation soil samples indicated that benzene, BTEX, TPH-DRO/TPH-GRO, TPH and chloride concentrations were compliant with the Closure Criteria. In addition, delineation soil samples BH01A and BH01B collected at 1 foot and 2 feet bgs were compliant with the most stringent Table 1 Closure Criteria. The release was contained laterally by the lined containment and all released fluids were recovered during initial response activities. The tear in the liner was subsequently repaired.

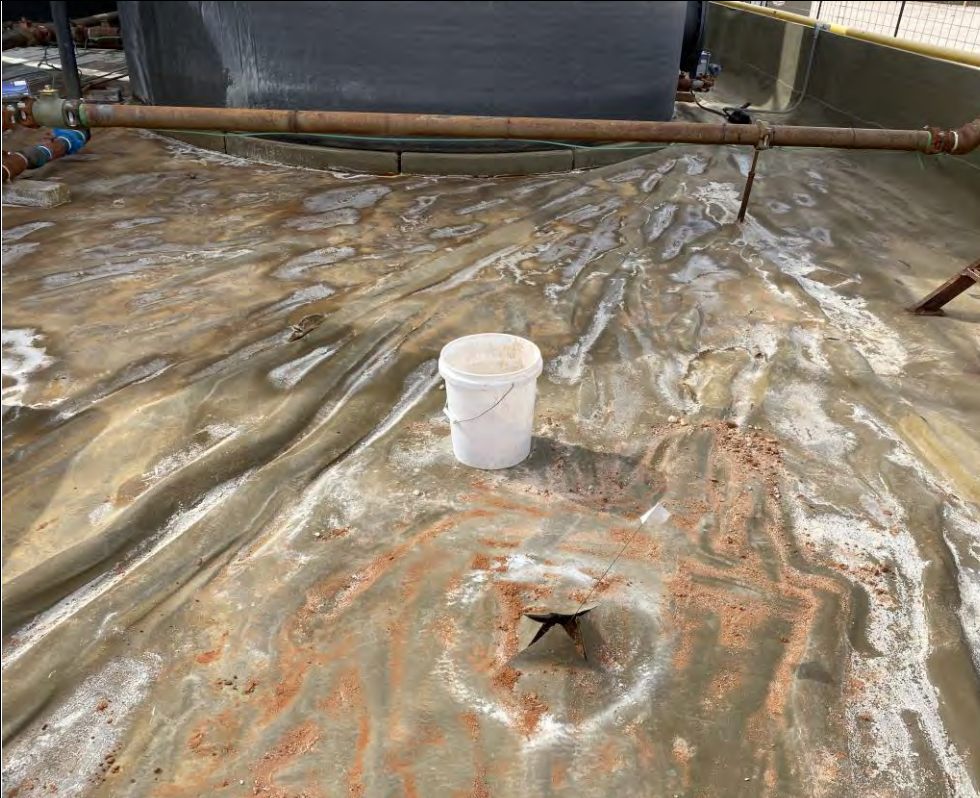
A photograph showing a large, irregular tear in a dark, possibly black, liner material. The tear is surrounded by a white, powdery substance. A white bucket is placed on the liner near the tear. The liner is situated in a large, open area, possibly a containment pond or tank, with various pipes and structures visible in the background.
2	November 8, 2021	
View of tear in liner for delineation activities.

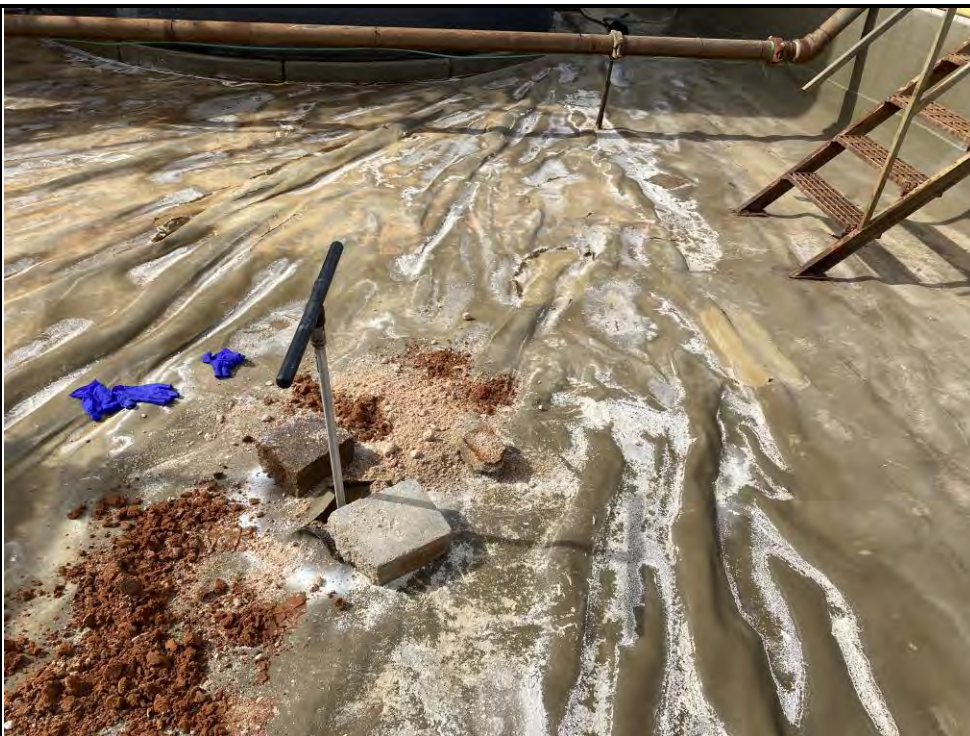
3	November 8, 2021	
View of borehole delineation activities.

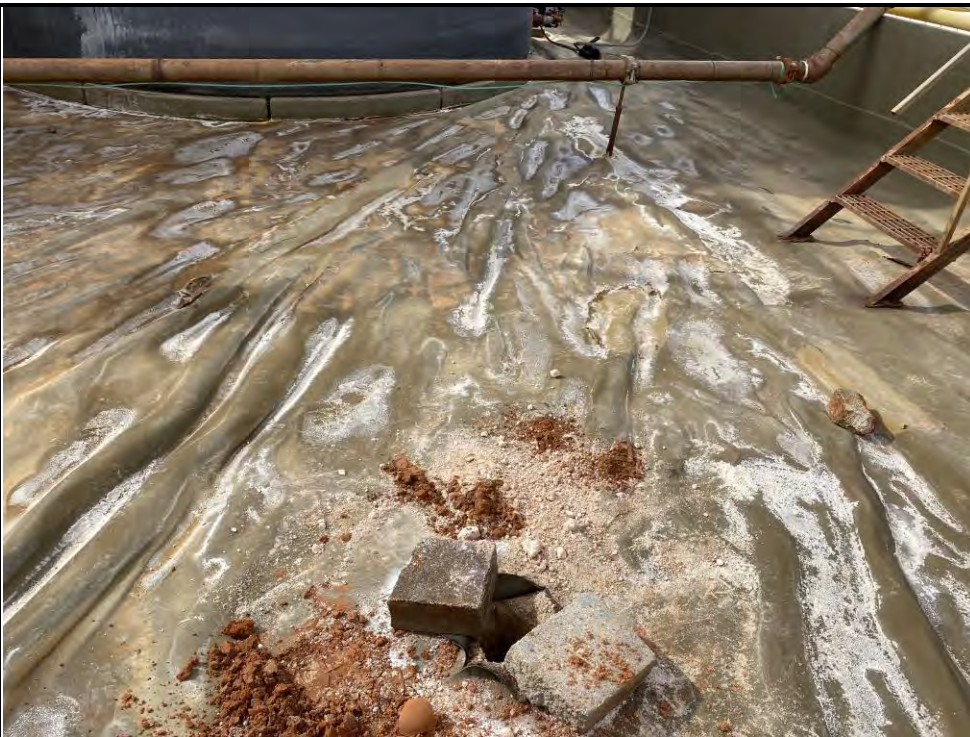
4	October 12, 2021	
View of completed delineation activities.
