Project #19034-0006

RE: Abandoned Produced Water Line Remediation Closure Report; Penasco Water Line, Incident # nAPP2133649705

**Backfill Photography
EOG Resources
Penasco Water Line
NMOCD Incident # nAPP2133649705
Release Closure Report
Sections 20, T18S, R26E
Eddy County, New Mexico
Project #19034-0006
February 15, 2022**

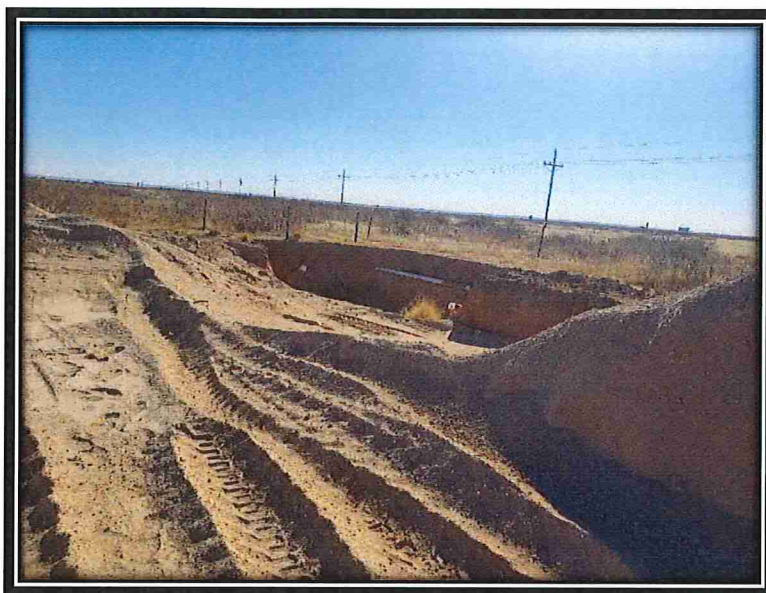
Picture 1: 11/17/2021 Release Area looking Southeast

During the remediation excavation, on November 17, 2021, an underground abandoned water line constructed of polyvinyl chloride (PVC) located in the southeast corner of the impacted area was struck with the backhoe during excavation activities, releasing approximately 30 barrels of water that was contained in the excavation. A vacuum truck containerized the water, which will be transported to Gandy Marley, Inc. located in Roswell, New Mexico for disposal. Disposal documentation will be provided by EOG's contractor under separate cover.

The subject release area was excavated to approximately 6 feet below ground surface (bgs). The damaged abandoned water line was cut and capped in place, and the larger remediation excavation for the Penasco Water Line 2013 spill continued, see **Appendix A, Site Photography**.

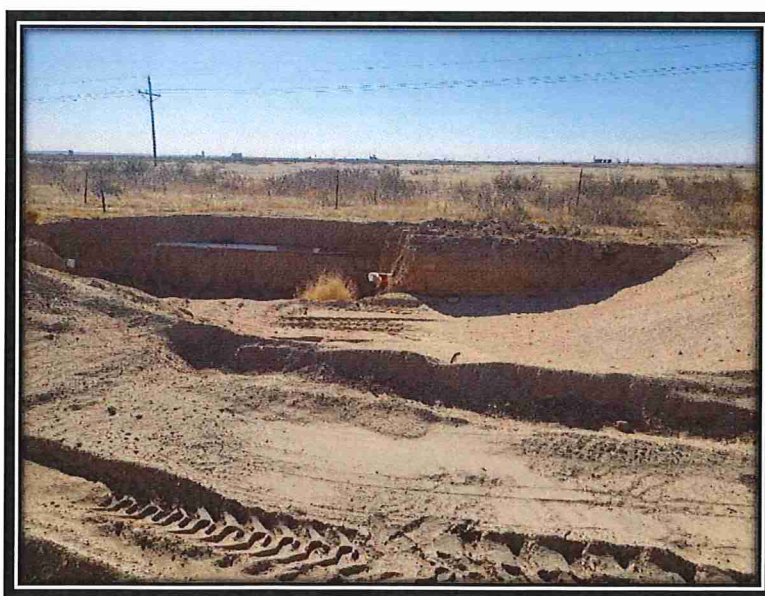
Picture 2: 11/17/2021 Release Area looking South
