Release Notification

**RE: Closure Request
Pierce Canyon 17
Incident Number NAPP2134945825
Eddy County, New Mexico**

FIGURE 2
 DELINEATION SOIL SAMPLE LOCATIONS
 PIERCE CANYON 17
 UNIT P SEC 17 T25S R30E
 EDDY COUNTY, NEW MEXICO
 XTO ENERGY, INC.

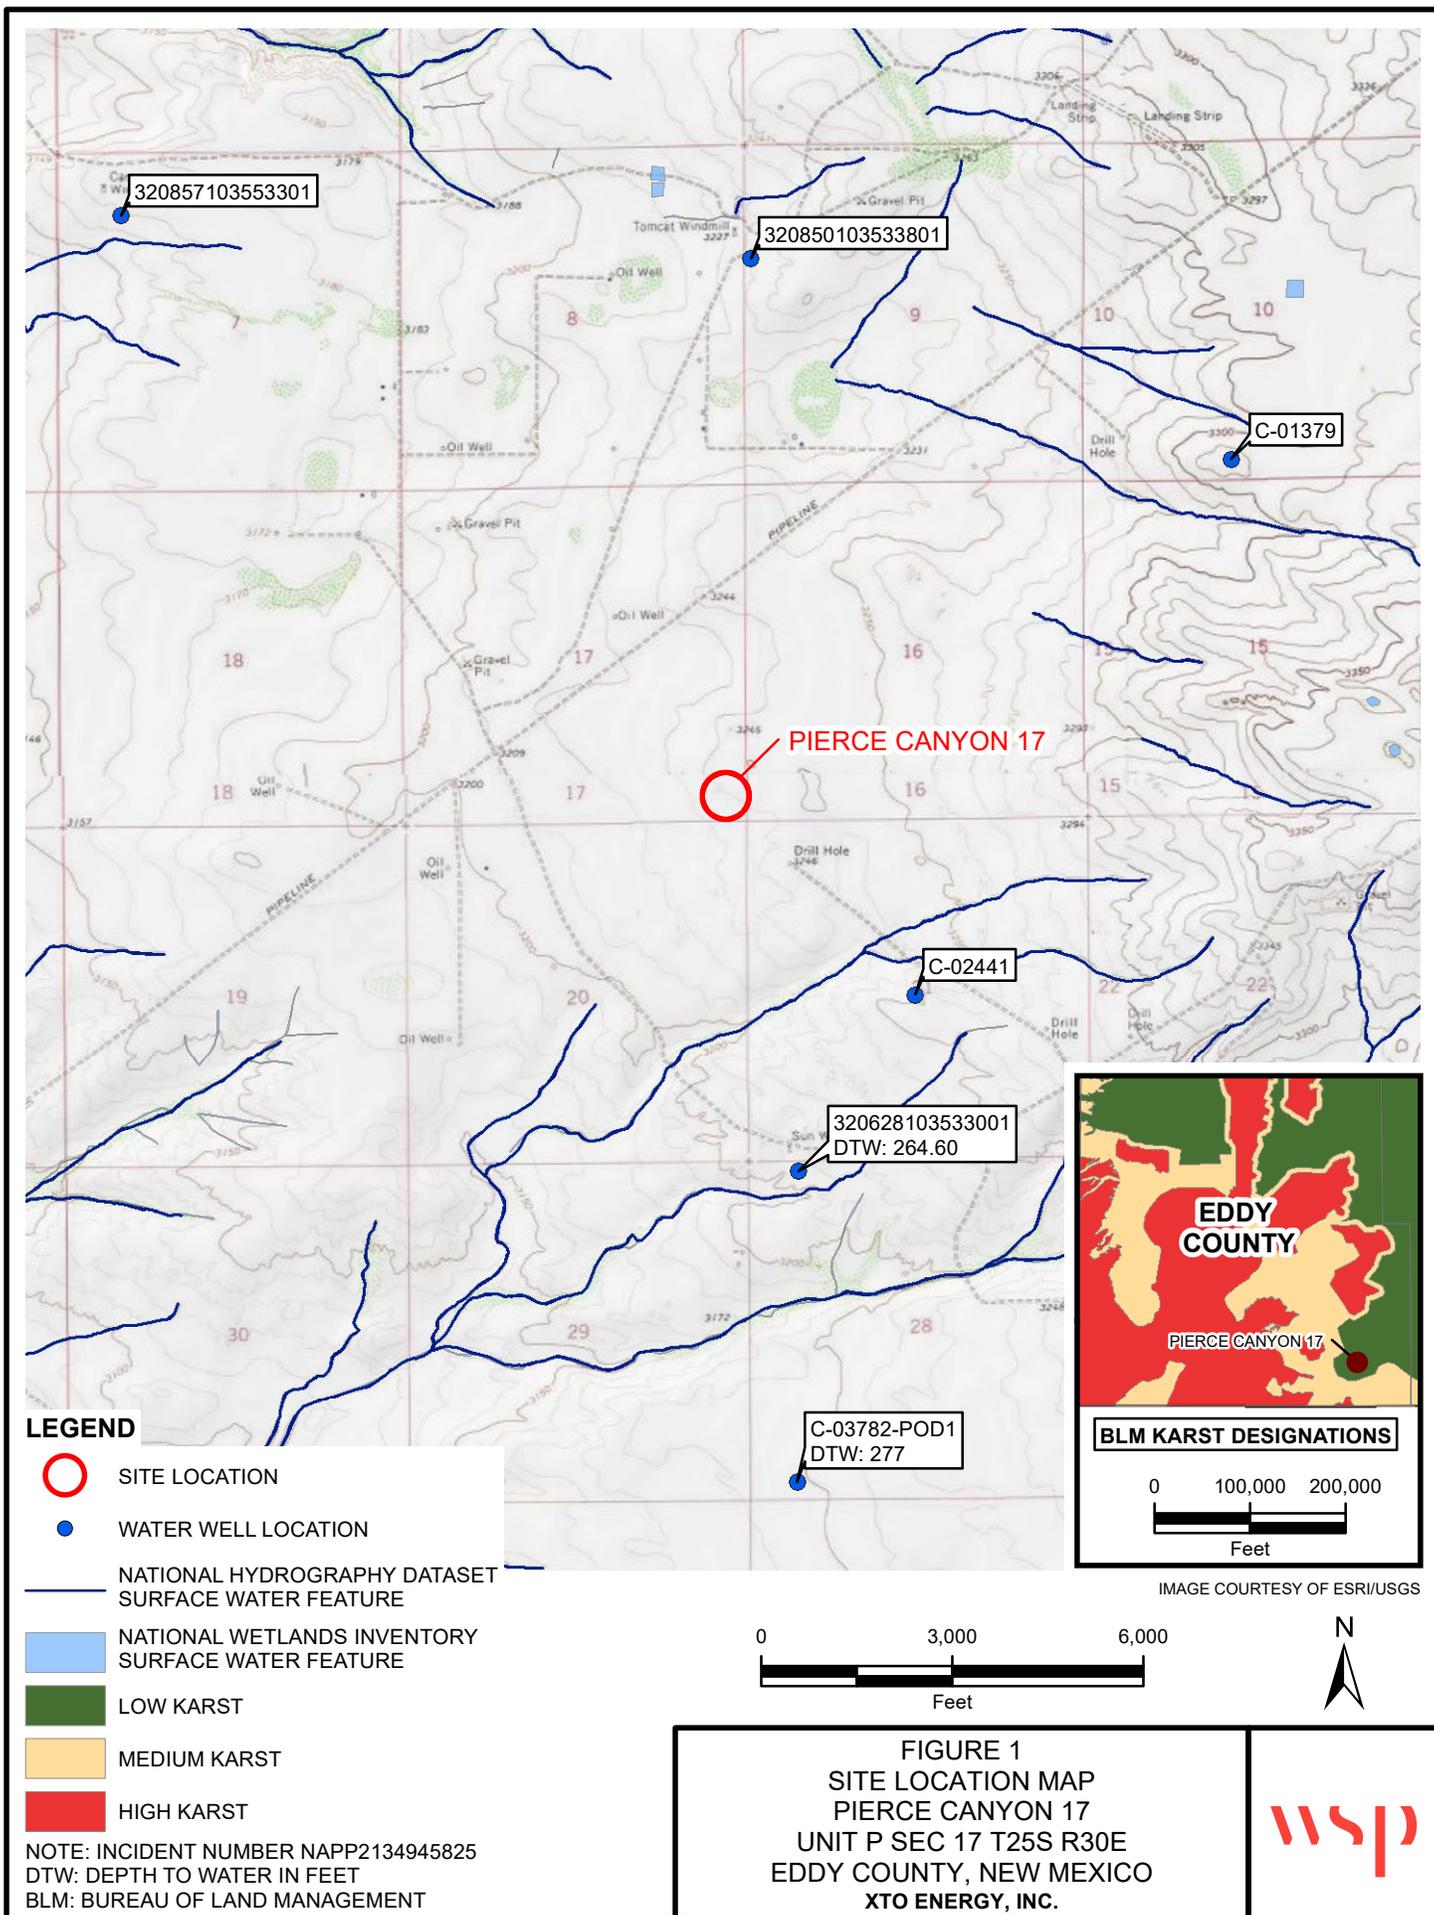
All wells used for depth to groundwater determination are depicted on Figure 1. The referenced well records are included in Attachment 1.

The closest continuously flowing or significant watercourse to the Site is a dry wash, located approximately 2,996 feet southeast of the Site. The Site is greater than 200 feet from a lakebed, sinkhole, or playa lake and greater than 300 feet from an occupied residence, school, hospital, institution, church, or wetland. The Site is greater than 1,000 feet to a freshwater well or spring and is not within a 100-year floodplain or overlying a subsurface mine. The Site is not underlain by unstable geology (low potential karst designation area). Site receptors are identified on Figure 1.

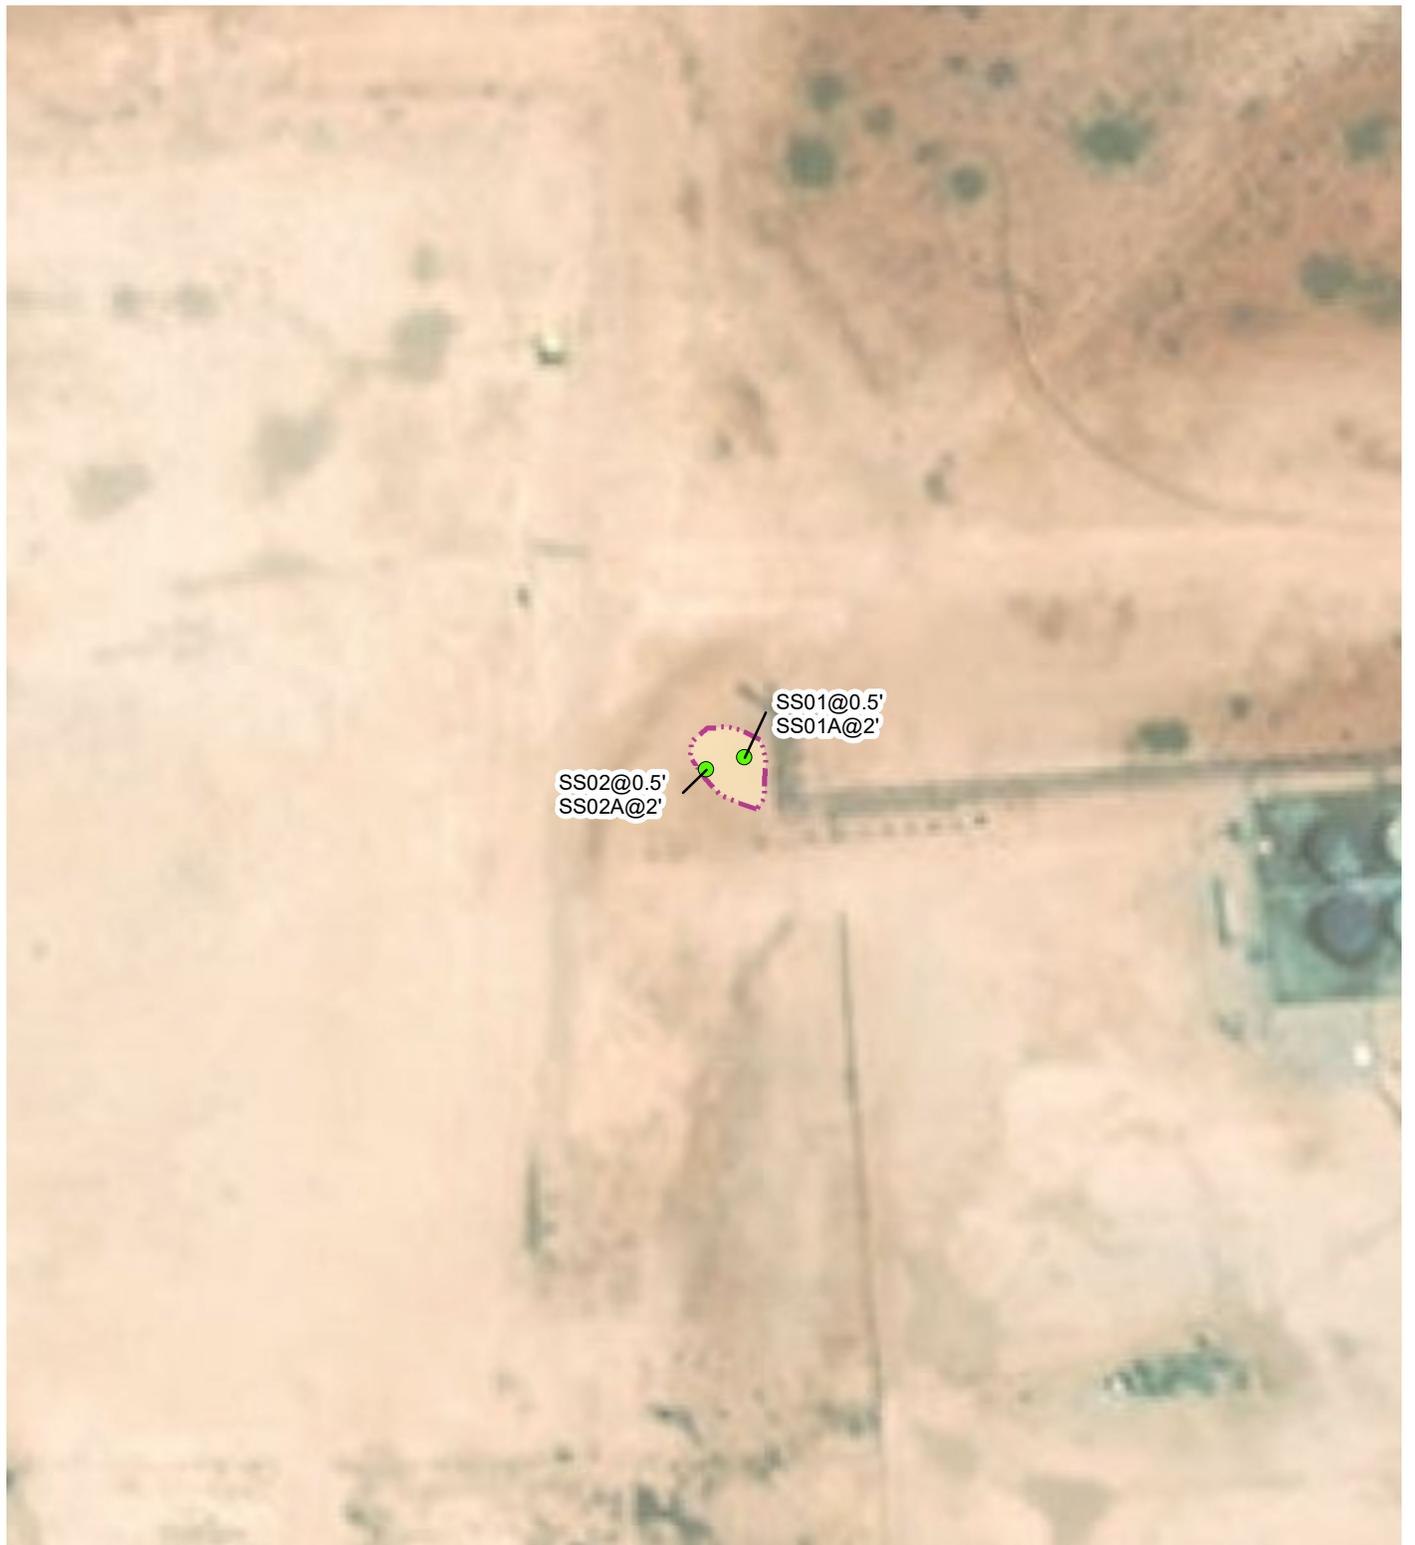
- DELINEATION SOIL SAMPLE IN COMPLIANCE WITH APPLICABLE CLOSURE CRITERIA
- RELEASE EXTENT

NOTE: INCIDENT NUMBER NAPP2134945825
 SAMPLE ID@DEPTH BELOW GROUND SURFACE (FEET)

On February 22, 2022, WSP personnel were at the Site to evaluate the release extent based on information provided on the Form C-141, visual observations, and information provided by on-site XTO personnel. Two potholes were advanced to a depth of 2 feet bgs within the release extent, to assess for the presence or absence of impacted soil. Two delineation samples (SS01/SS01A and SS02/SS02A) were collected from each pothole at depths of 0.5 feet and 2 feet bgs, respectively. The delineation soil samples were field screened for volatile aromatic hydrocarbons and chloride utilizing a calibrated photoionization detector (PID) and Hach® chloride QuanTab® test strips, respectively. Field screening results and observations for the pothole delineation samples were logged on lithologic/soil sampling logs, which are included in Attachment 2. Field screening results indicated no impacts to soil; however, surficial staining from the fire was scraped up and removed from the Site. The release extent and soil sample locations were mapped utilizing a handheld Global Positioning System (GPS) unit and are depicted on Figure 2. Photographic documentation is included in Attachment 3.

Laboratory analytical results for delineation soil samples SS01/SS01A and SS02/SS02A indicated that benzene, BTEX, TPH-GRO/TPH-DRO, TPH, and chloride concentrations were compliant with the Site Closure Criteria and compliant with the most stringent Table 1 Closure Criteria. Laboratory analytical results are summarized in Table 1 and the complete laboratory analytical reports are included as Attachment 4.

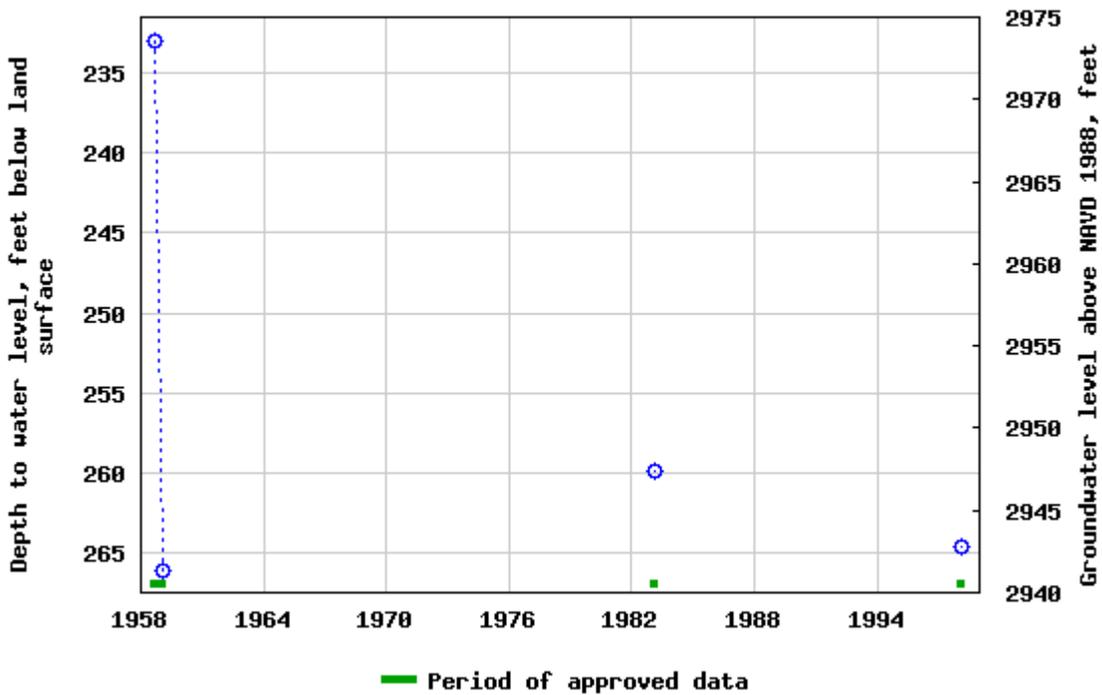
USGS 320628103533001 25S.30E.21.333424

Land-surface elevation 3,207 feet above NAVD88

The depth of the well is 288 feet below land surface.

Breaks in the plot represent a gap of at least one year between field measurements.
[Download a presentation-quality graph](#)

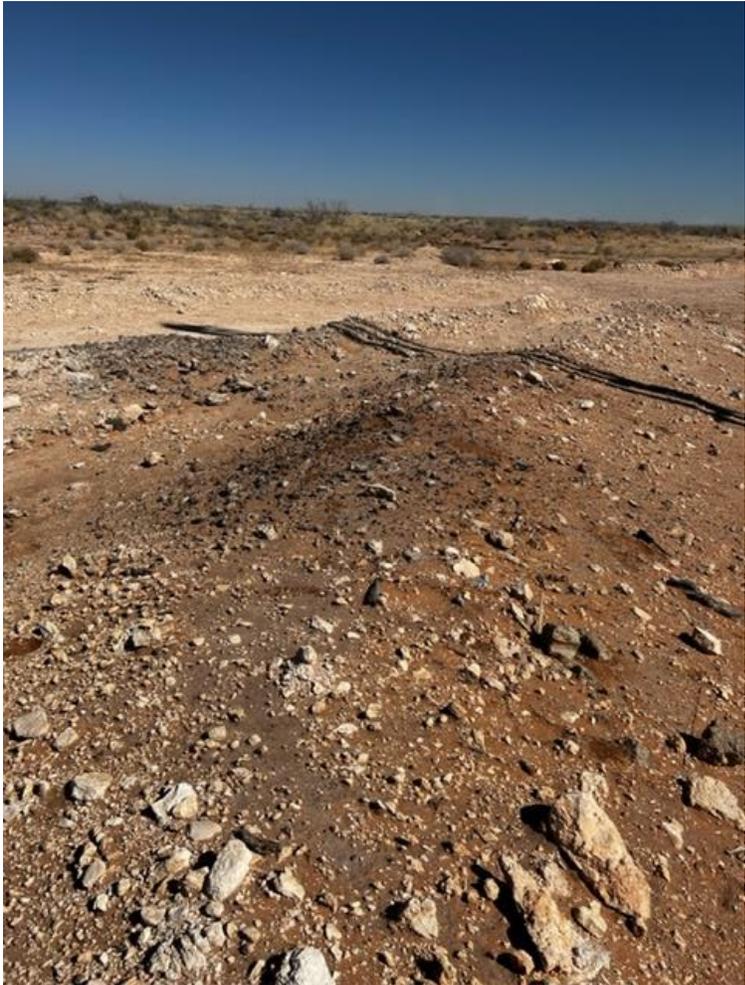
Photo No.	Date	
1	February 22, 2022	
View of release extent facing northwest.

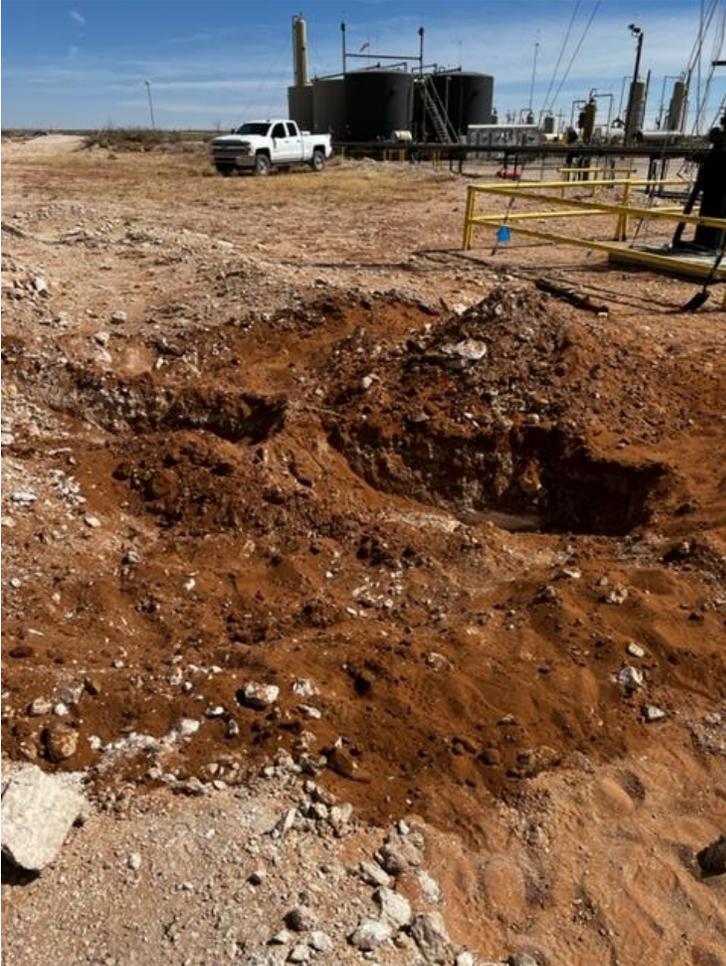
Photo No.	Date	
2	February 22, 2022	
View of surface staining removal facing southwest.
