## Release Notification

Site Name	Rosa Unit 315A	Site Type	Well Site
Date Release Discovered	9/6/2019	API# (if applicable)	30-039-29983

**Incident # nCS1929538744**

**Well Site: Rosa Unit 315A Located in Section 30, Township 31 North, Range 4 West, 5 FNL & 1675 FWL, Rio Arriba New Mexico.**

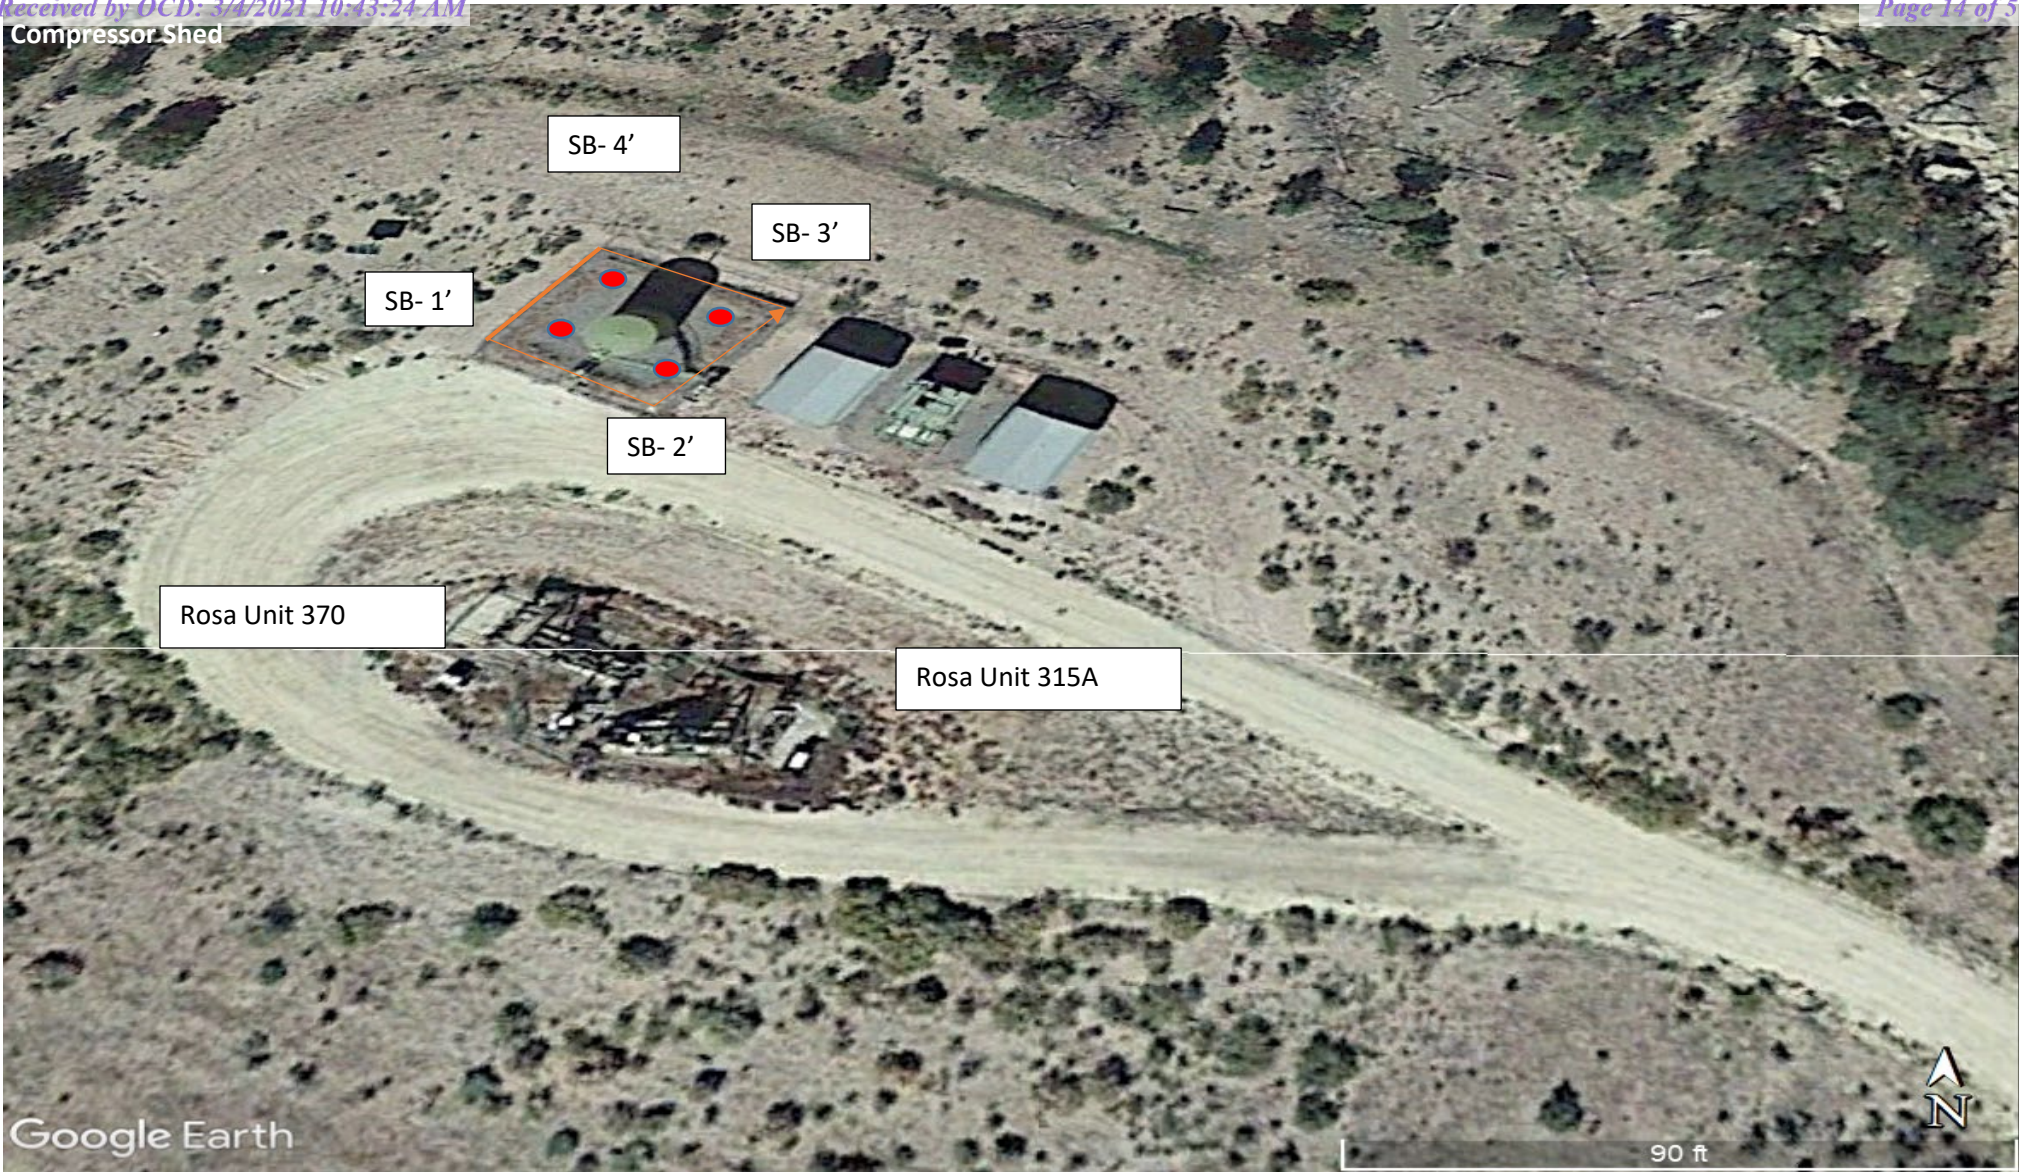
Aerial Site Map

Secondary Containment

Soil Boring

Notification for final sampling was requested to be performed on July 2, 2020. LOGOS arrived at the site to conduct site delineation activities from the release/historical produced water release that occurred at the **Rosa Unit 315A well site (30-039-29983)**. The operator utilized a hand auger (4) soil borings, SB-1 thru SB-4, were advanced into the subsurface within the earthen berm containment. Delineation activities are documented in the enclosed Aerial Site map, and Figure 1 – Site pictures.

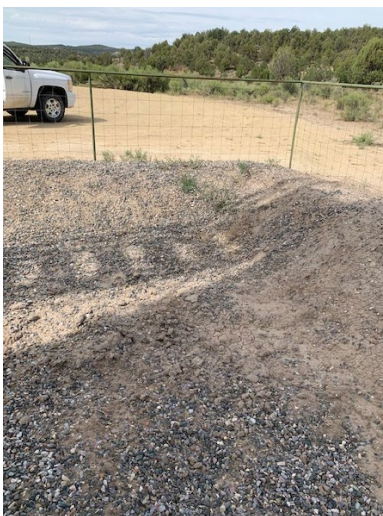
**SB-1**

## Sample Taken - July 2, 2020

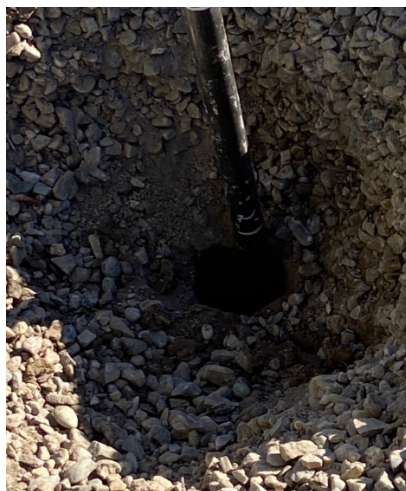
SB-1

### Sample Taken – December 9, 2020
