November 19, 2021

Vertex Project #: 21E-03278-09

Spill Closure Report: Rio Pecos GB Com #1
Section 29, Township 18 South, Range 27 East
API: 30-015-21889
County: Eddy
Incident Report: NAB1802538319/2RP-4580

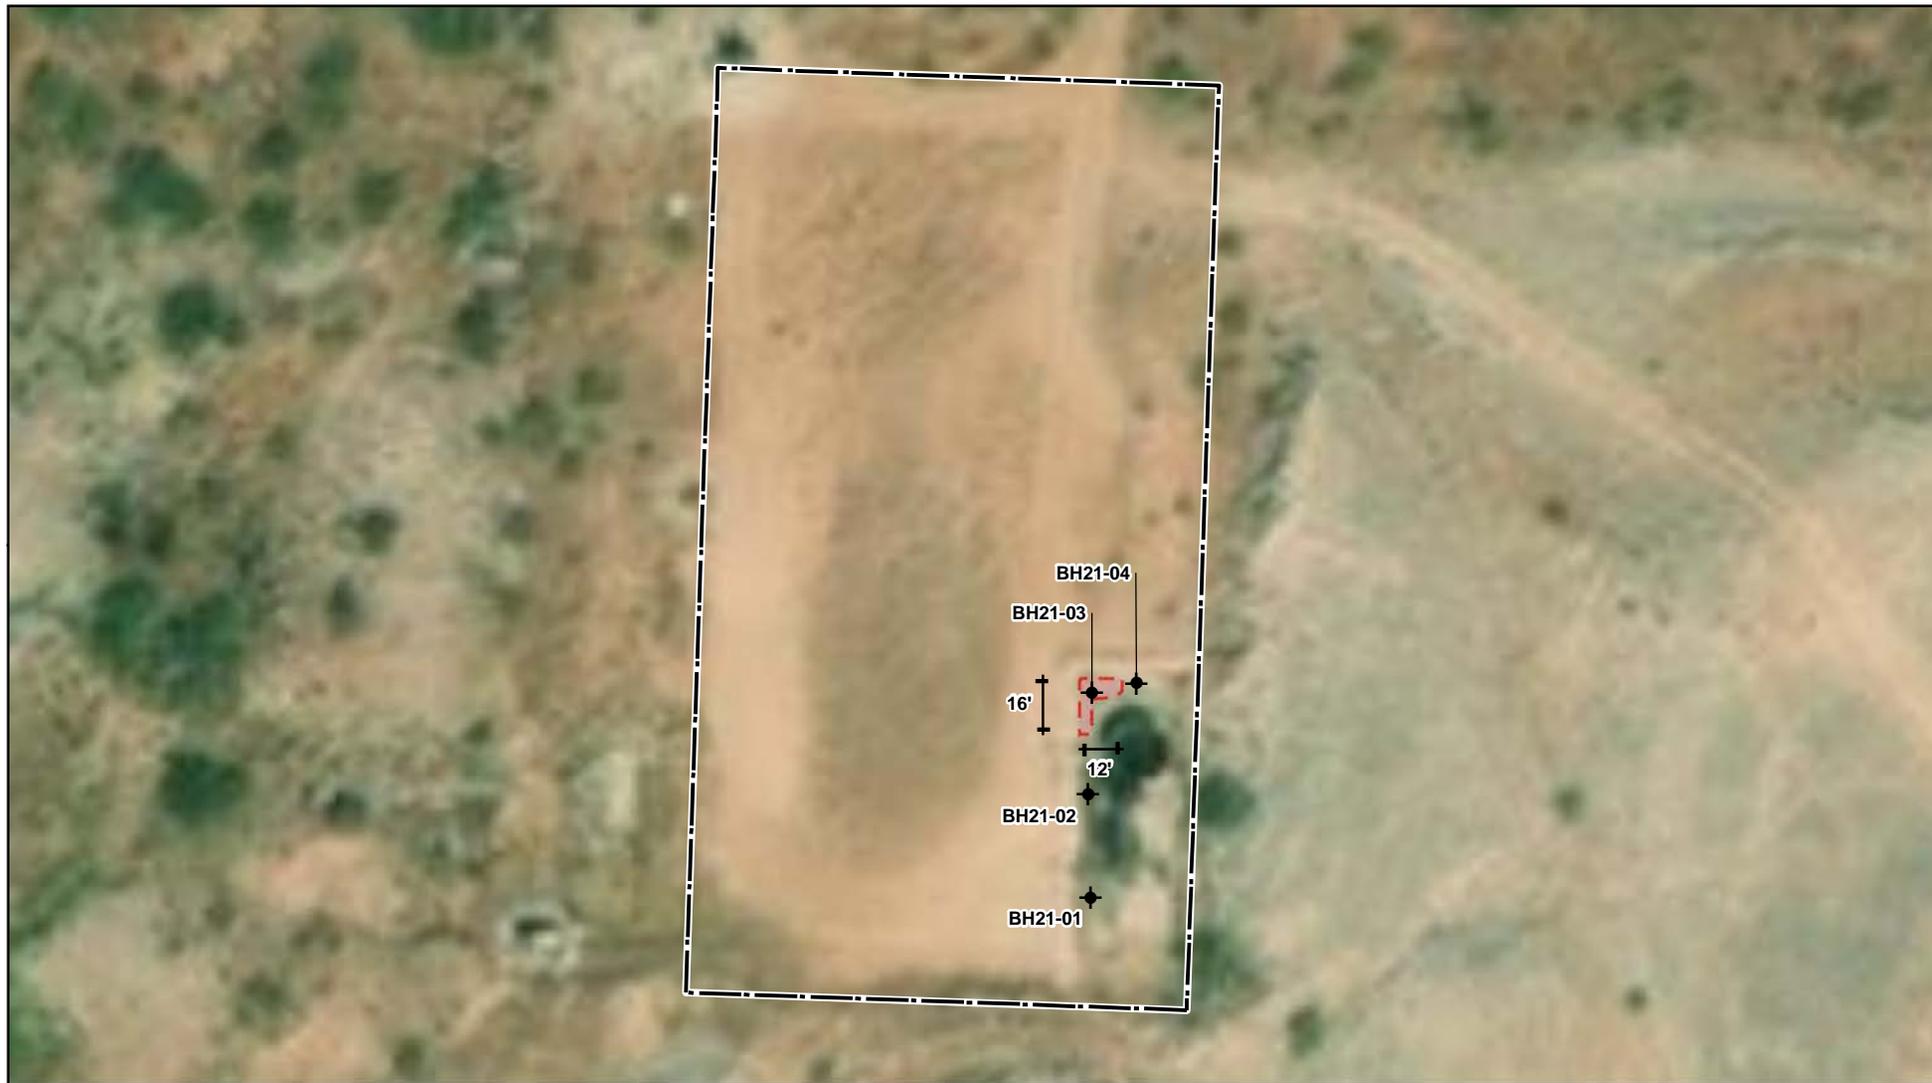
Document Path: G:\1-Projects\US PROJECTS\EOG Resources Inc\21E-03278009 -Rio Pecos GB Com #1\Figure 1 Initial Characterization Rio Pecos GB Com 1.mxd

The site is located approximately 4.82 miles east of Dayton, New Mexico. The legal location for the site is Section 29, Township 18 South and Range 27 East in Eddy County, New Mexico. The spill area is located on State property. An aerial photograph and site schematic are included in Attachment 2.

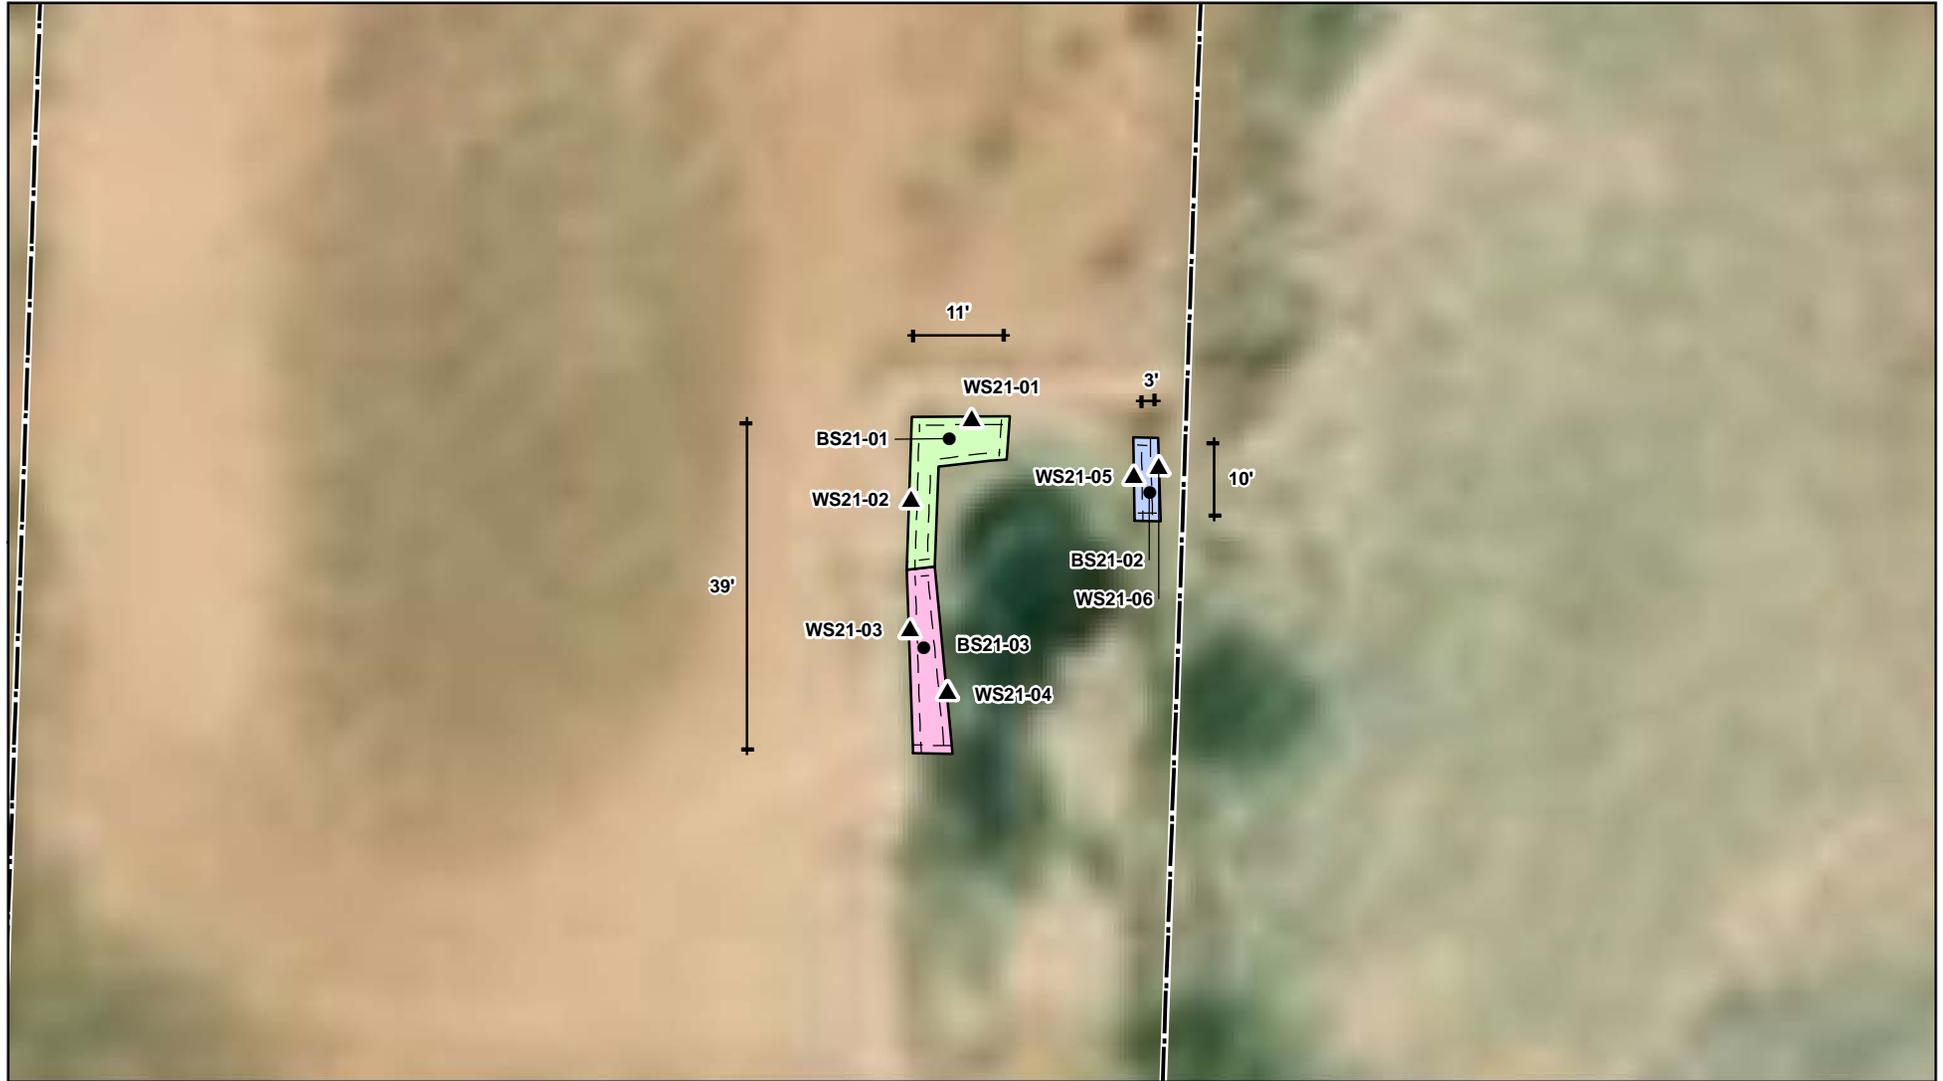
Document Path: G:\1-Projects\US PROJECTS\EOG Resources Inc\21E-03278009 -Rio Pecos GB Com #1\Figure 2 Confirmatory Schematic Rio Pecos GB Com 1.mxd

Additional sampling took place in the northeastern portion of the containment, noted as an area of concern by EOG, to determine if contamination was present. Excavation of the area was extended an additional 0.5 feet. Areas that were determined above closure criteria were also excavated (Attachment 2 – Figure 2).

- Base Sample
- ▲ Wall Sample
- ⬡ Approximate Lease Boundary
- █ Excavation (0-0.5' - 83 sq. ft.)
- █ Excavation (0-1' - 99 sq. ft.)
- █ Excavation (0.5' - 28 sq. ft.)

Remediation efforts began on October 29, 2021, and backfill was completed on November 10, 2021. Vertex personnel supervised the excavation of impacted soils. Field screening was completed on a total of nine sample points and consisted of analysis using a Photo Ionization Detector (volatile hydrocarbons), Dextsil Petroflag using EPA SW-846 Method 9074 (extractable hydrocarbons) and titration (chlorides). Field screening results were used to identify areas requiring further remediation from those areas showing concentrations below determined closure criteria levels. Soils were removed to a depth of 1 foot bgs. Impacted soil was transported by a licensed waste hauler and disposed of at an approved waste management facility. Field screening results are presented in Attachment 5, as well as in the DFRs in Attachment 3.

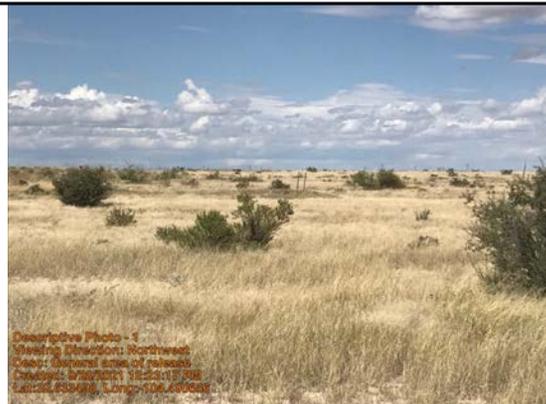
Descriptive Photo - 1
Viewing Direction: Northwest
Caption: General area of release
Created: 2/28/2021 11:23:17 PM
Latitude: 33.9487, Longitude: -104.49163

General area of release

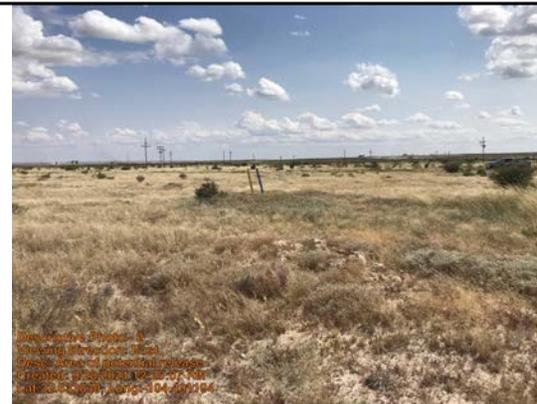
Descriptive Photo - 2
Viewing Direction: East
Caption: Area of potential release
Created: 2/28/2021 12:12:07 PM
Latitude: 33.9487, Longitude: -104.49163

Area of potential release

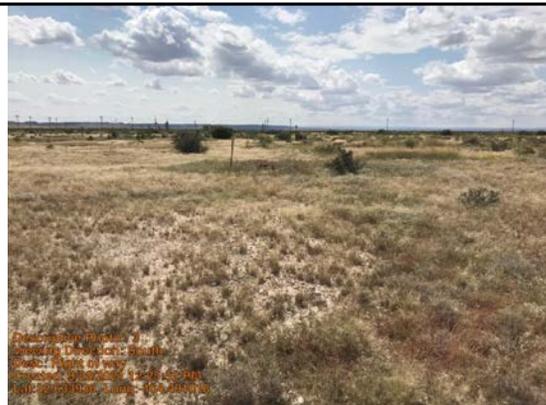
Descriptive Photo - 3
Viewing Direction: South
Caption: Right of way
Created: 2/28/2021 11:26:42 AM
Latitude: 33.9487, Longitude: -104.49163

- 12:22** Tinhorn is on right of way. Dirt road is southeast of POR
- 12:27** Area has good vegetation. No staining visible or areas showing the ground pushed up from a release
- 12:28** Area is marked with white flags for about a 100x100 area

Right of way

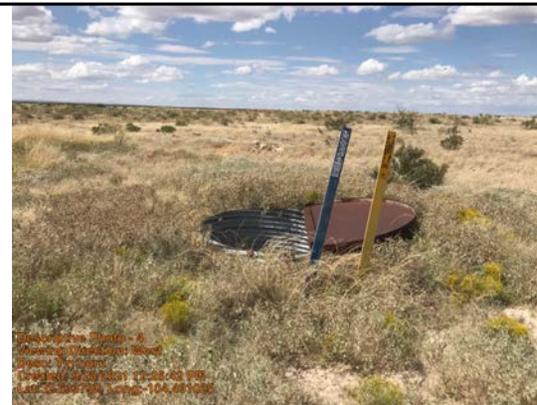
Descriptive Photo - 4
Viewing Direction: West
Caption: Tin horn
Created: 2/28/2021 11:28:42 AM
Latitude: 33.9487, Longitude: -104.49163

Tin horn

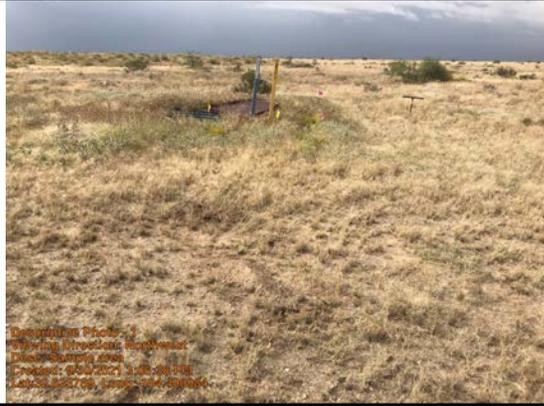
Descriptive Photo - 1
Viewing Direction: Northwest
Date: Sample Area
Created: 2/11/2021 1:48:38 PM
Lat: 33.434766 Long: -104.682119

- 11:11** Collection of samples to determine if any contamination is present
- 15:06** Samples have no odor or visuals of staining. Very loamy type soil

Sample area

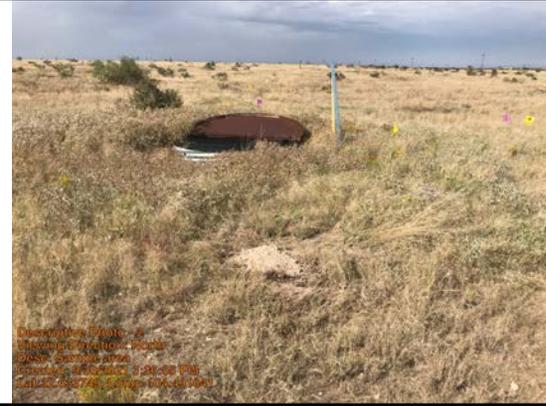
Descriptive Photo - 2
Viewing Direction: North
Date: Sample Area
Created: 2/11/2021 1:48:38 PM
Lat: 33.434766 Long: -104.682119

Sample area

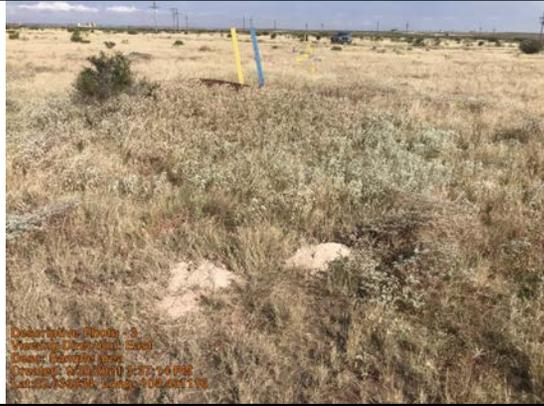
Descriptive Photo - 3
Viewing Direction: East
Date: Sample Area
Created: 2/11/2021 1:48:38 PM
Lat: 33.434766 Long: -104.682119

Sample area

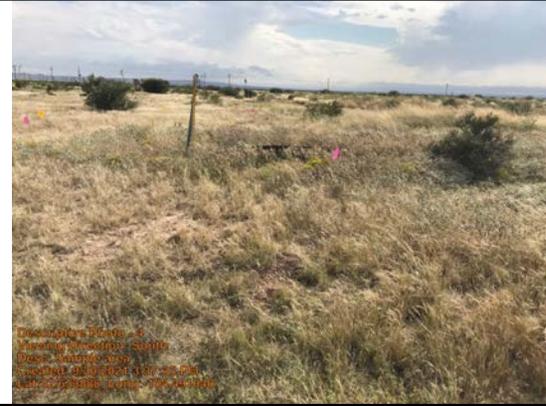
Descriptive Photo - 4
Viewing Direction: South
Date: Sample Area
Created: 2/11/2021 1:48:38 PM
Lat: 33.434766 Long: -104.682119

Sample area

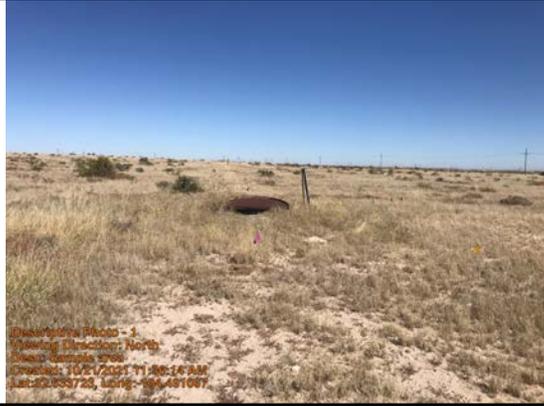
Viewing Direction: North

Sample area

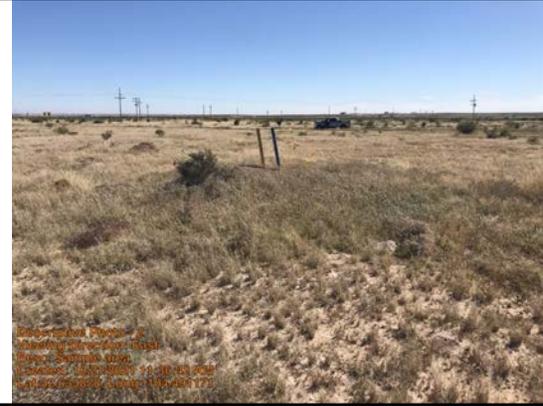
Viewing Direction: East

Sample area

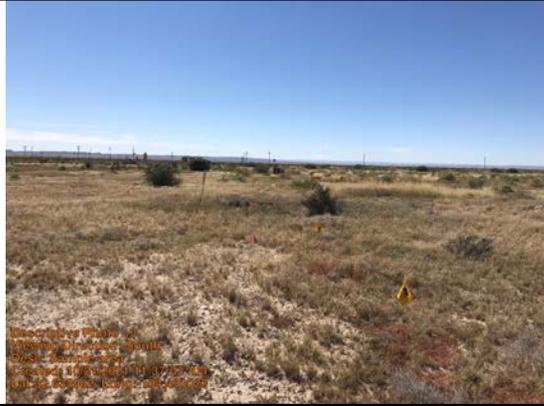
Viewing Direction: South

Sample area

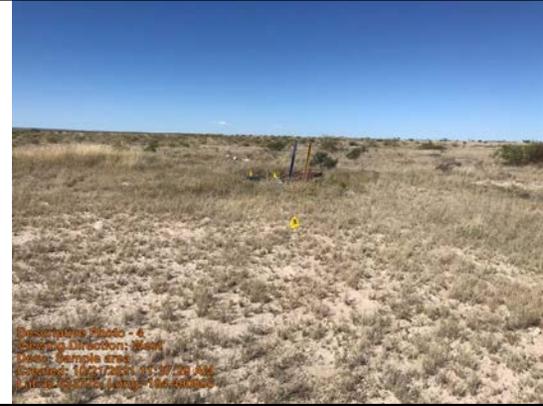
Viewing Direction: West

Sample area

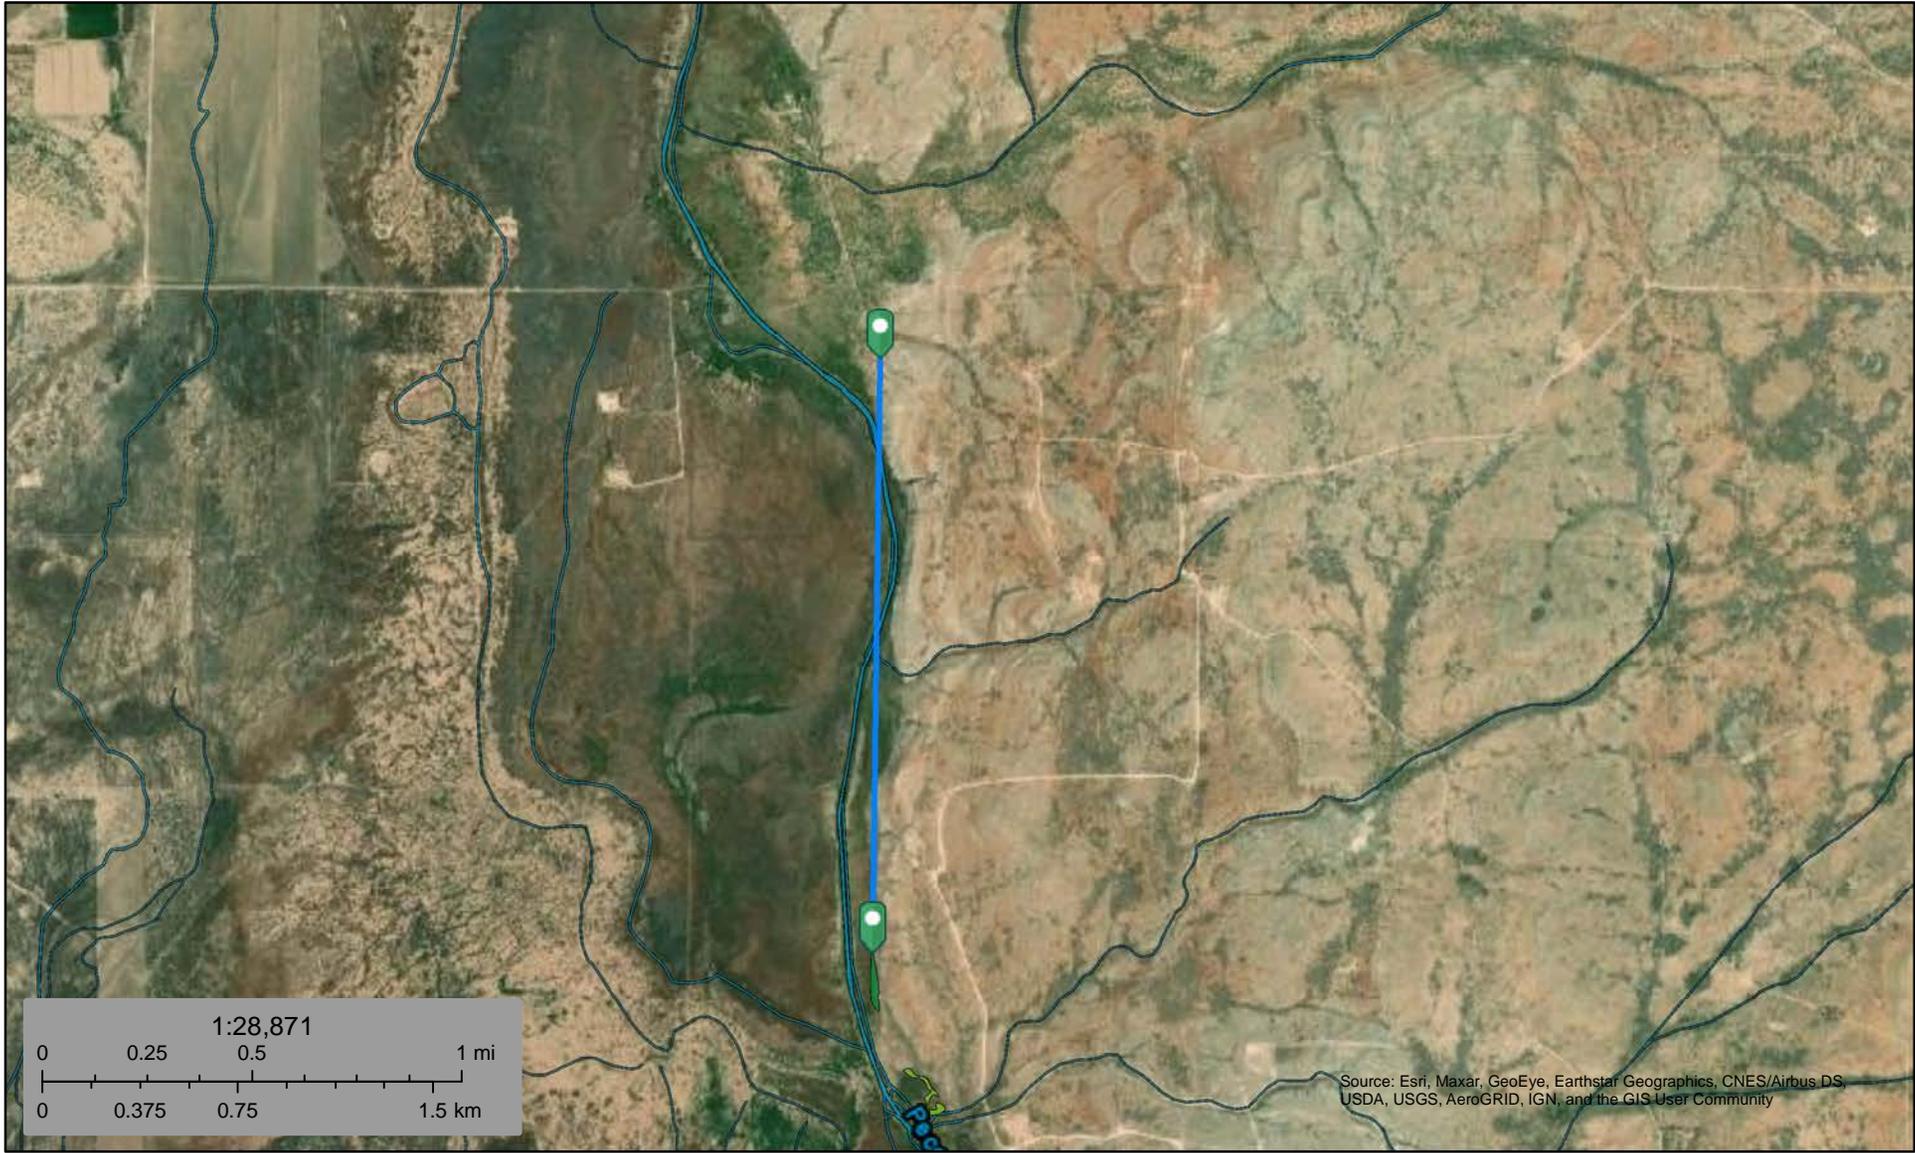
Rio Pecos Wetland 6264ft

Wetlands

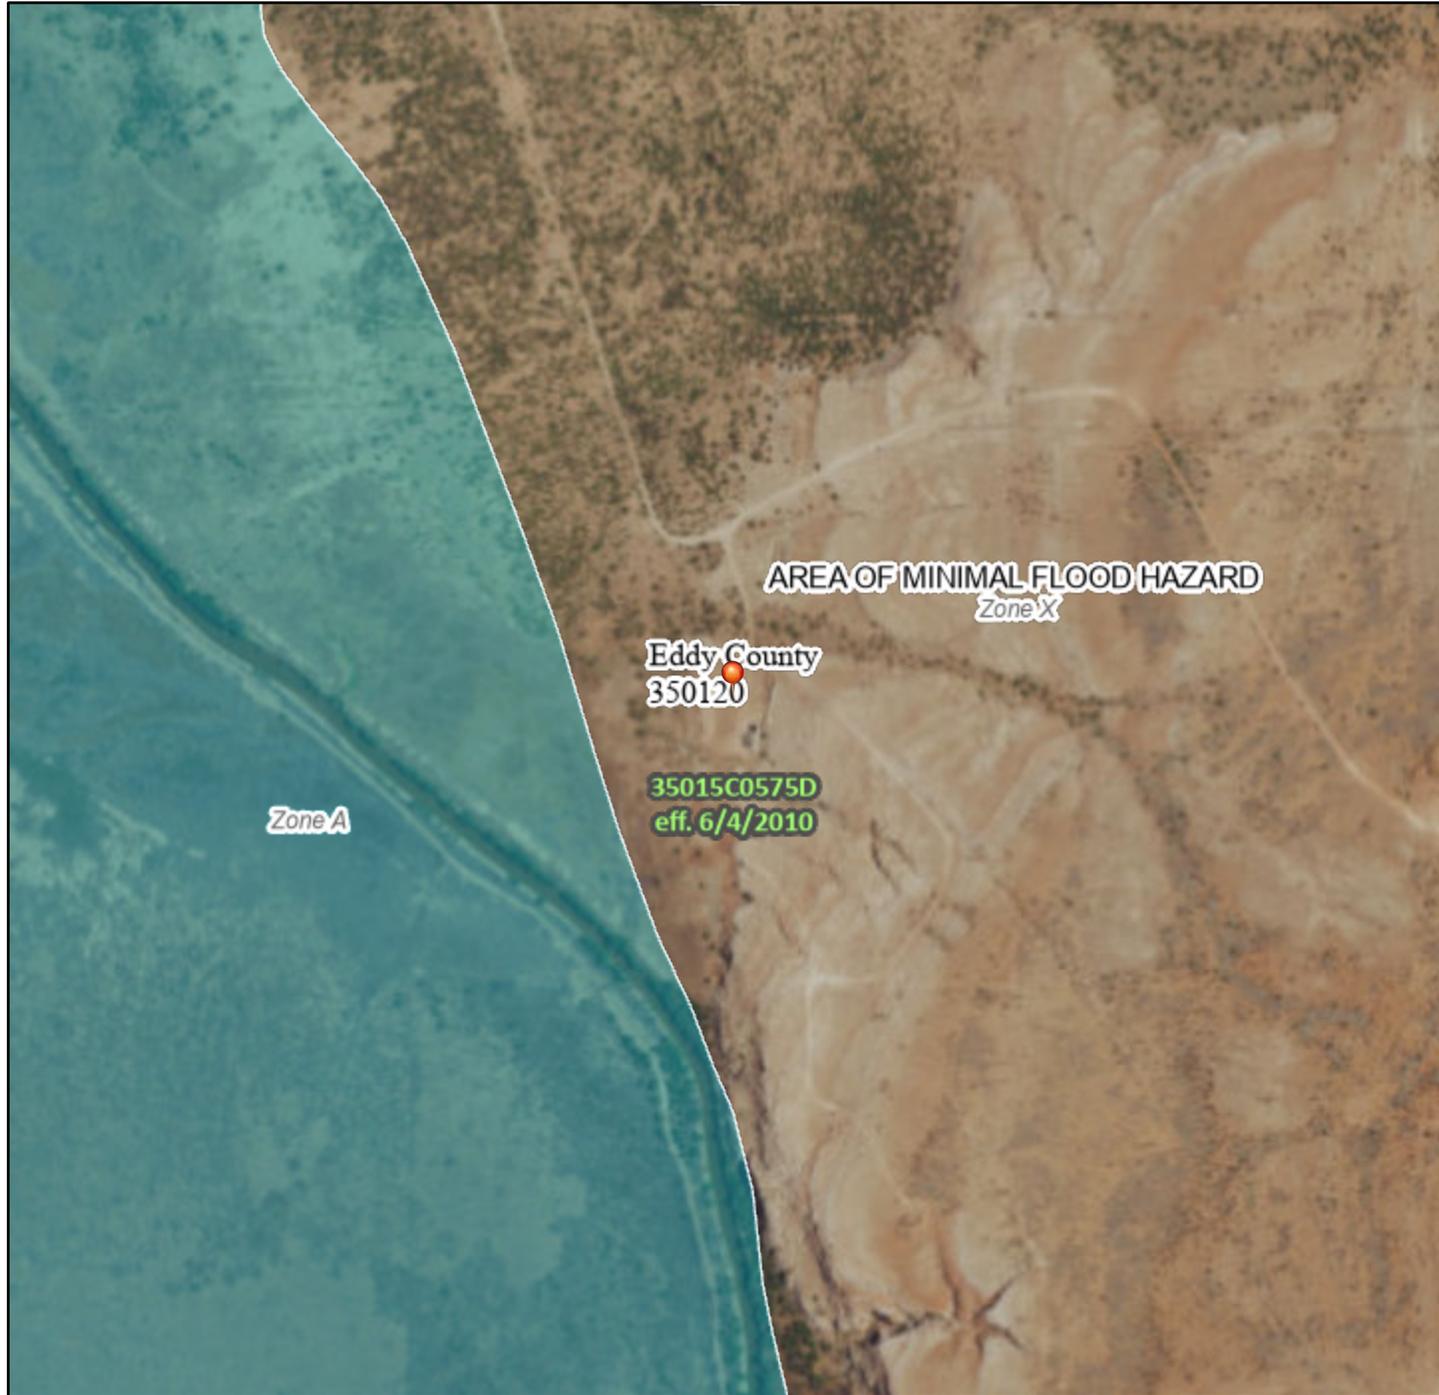
National Flood Hazard Layer FIRMette

The flood hazard information is derived directly from the authoritative NFHL web services provided by FEMA. This map was exported on 9/9/2021 at 12:47 PM and does not reflect changes or amendments subsequent to this date and time. The NFHL and effective information may change or become superseded by new data over time.
