## Release Notification

Site Name Pan Am Pardue AIZ Federal #1	Site Type Battery
Date Release Discovered 04/07/2021	API# (if applicable) 30-015-10728

Historical impacts discovered during the P&A of the well. Release volume and date are unknown.

**Site Photograph**  
**EOG Pan Am AIZ Federal #1**  
**Release Site.**

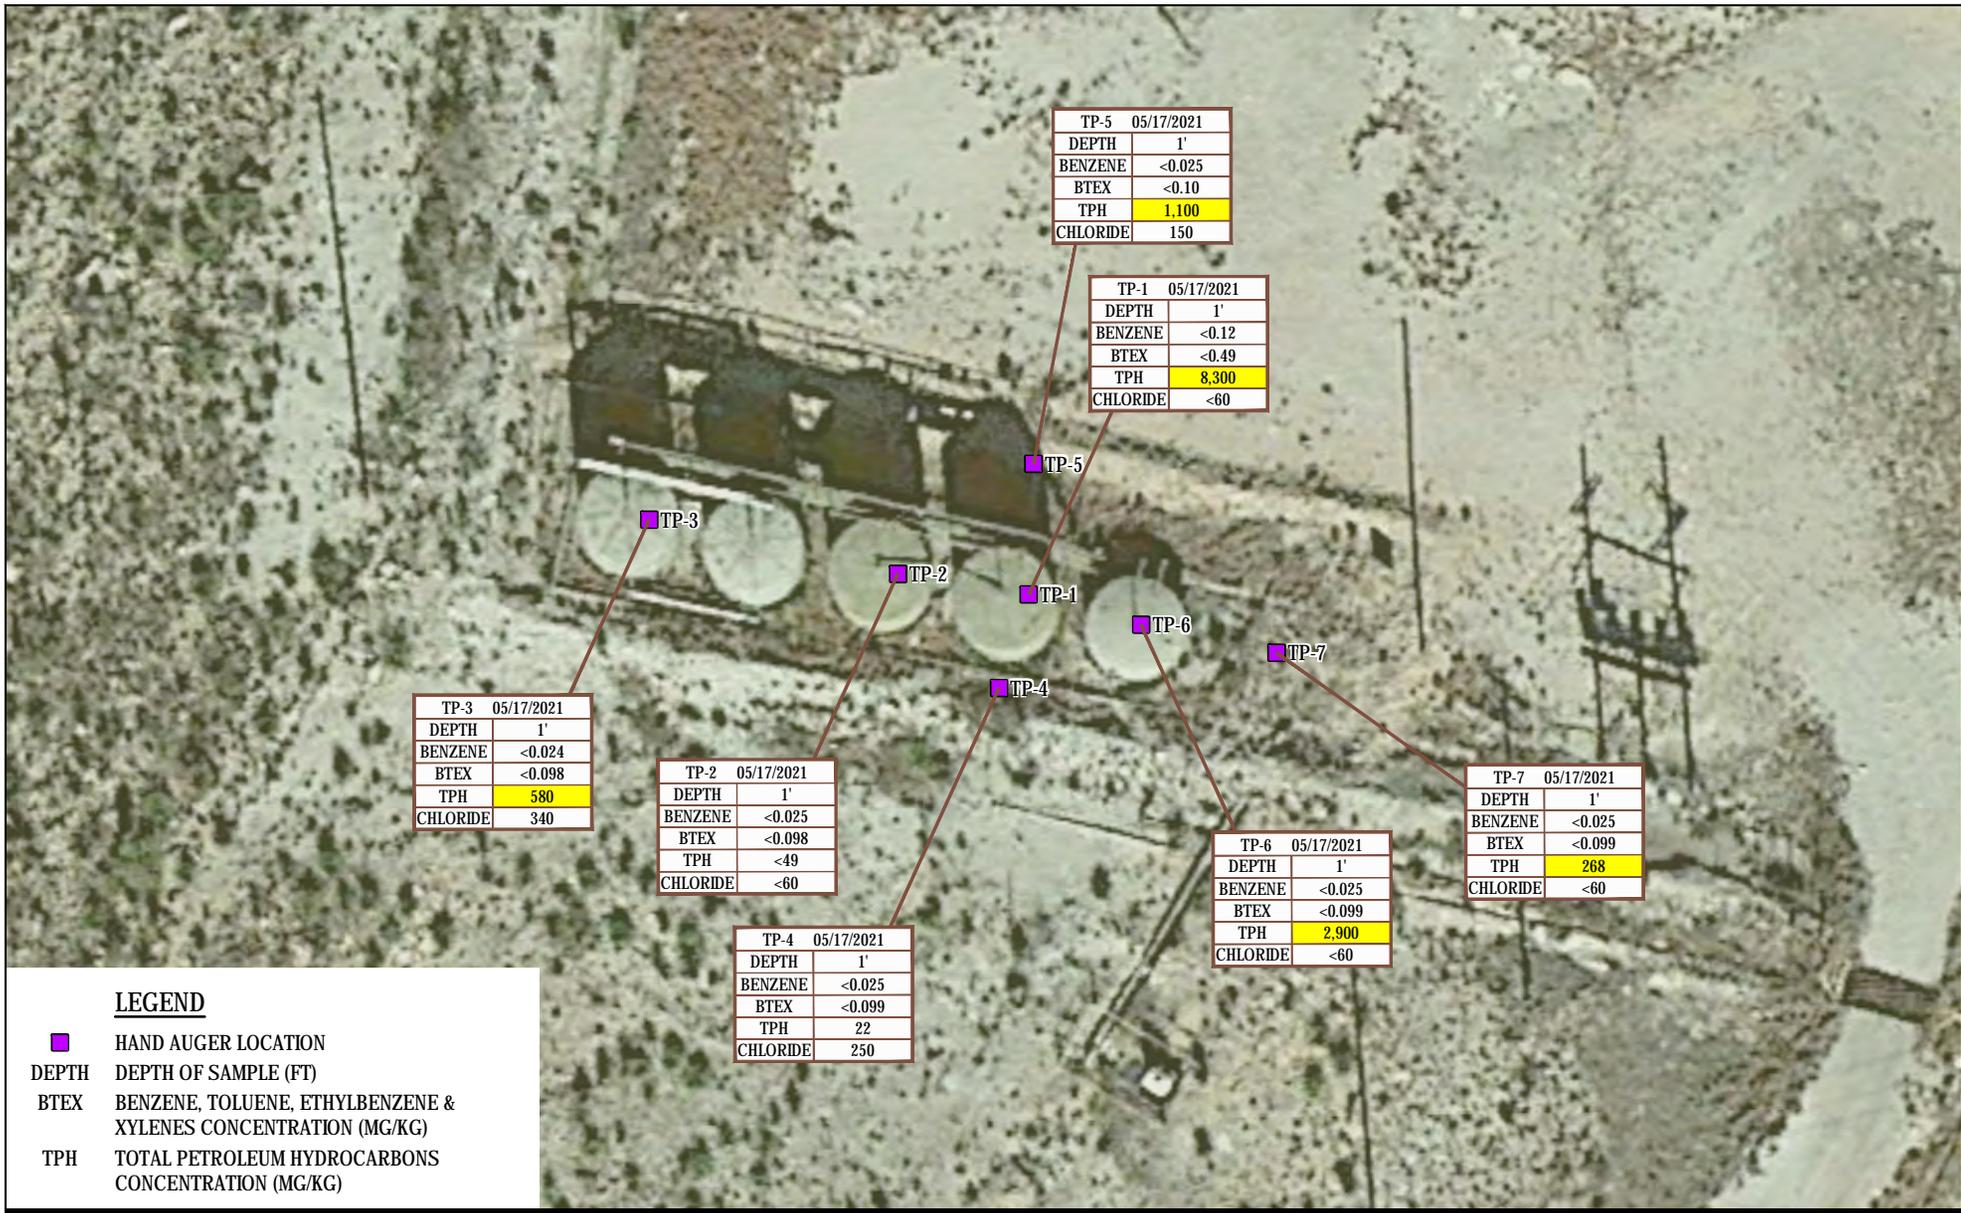
**FIGURE 2**

SITE ASSESSMENT:  
SOIL ANALYTICAL RESULTS MAP

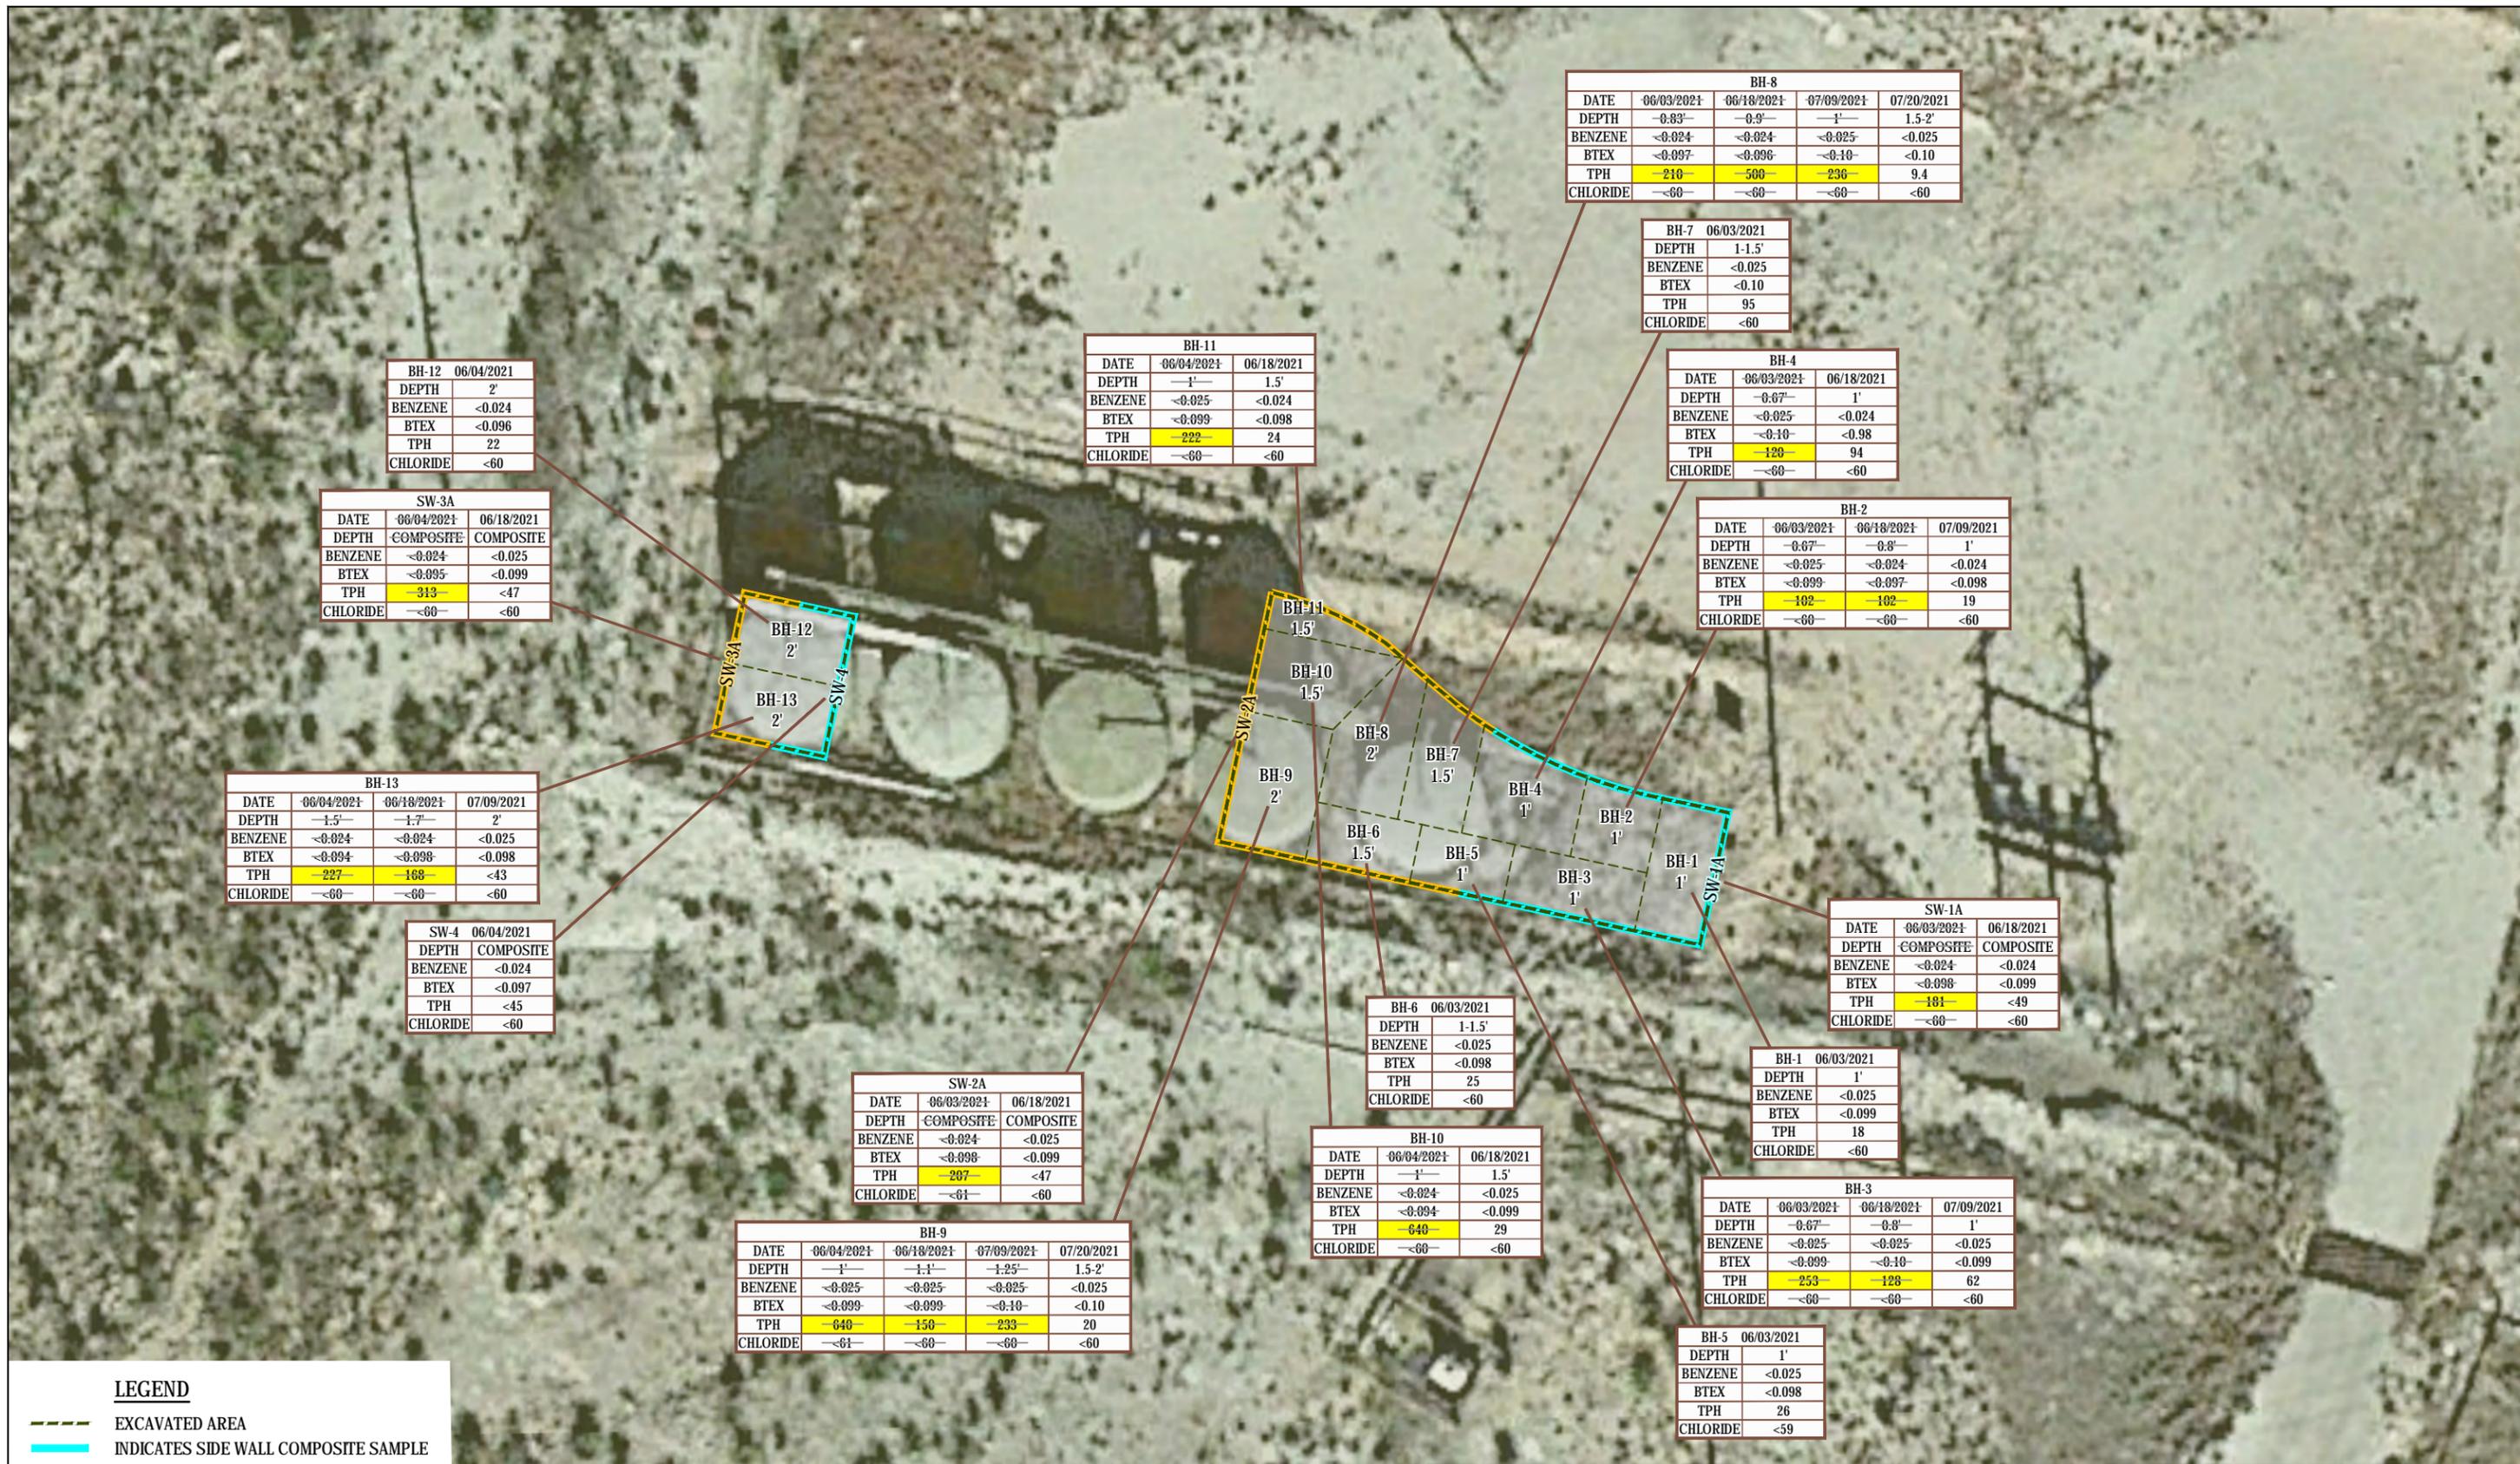
- EXCAVATED AREA
- INDICATES SIDE WALL COMPOSITE SAMPLE
- INDICATES SIDE WALL COMPOSITE SAMPLE
- DEPTH DEPTH OF SAMPLE (FT)
- BTEX BENZENE, TOLUENE, ETHYLBENZENE & XYLENES CONCENTRATION (MG/KG)
- TPH TOTAL PETROLEUM HYDROCARBONS CONCENTRATION (MG/KG)
- COMPOSITE SAMPLE POINT EXCAVATED
