## Release Notification

| Site Name: Jicarilla 35 8 | Site Type: Well |

**Well Name: Jicarilla 35 8 Located in Section 36, Township 25 North, Range 5 West, Rio Arriba, New Mexico.**

**RE: Rupture disc on separator failed causing produced oil and water to spray covering an area approximately 10' x 20' and a trail of mixed oil/water running approximately 60' off separator pad. The release estimated at 4bbls of mixed produced oil and water. LOGOS plans to clean up the stained area and remove soil and brush. Jicarilla requested LOGOS to remove the separator to clean historic staining under and around the separator.**

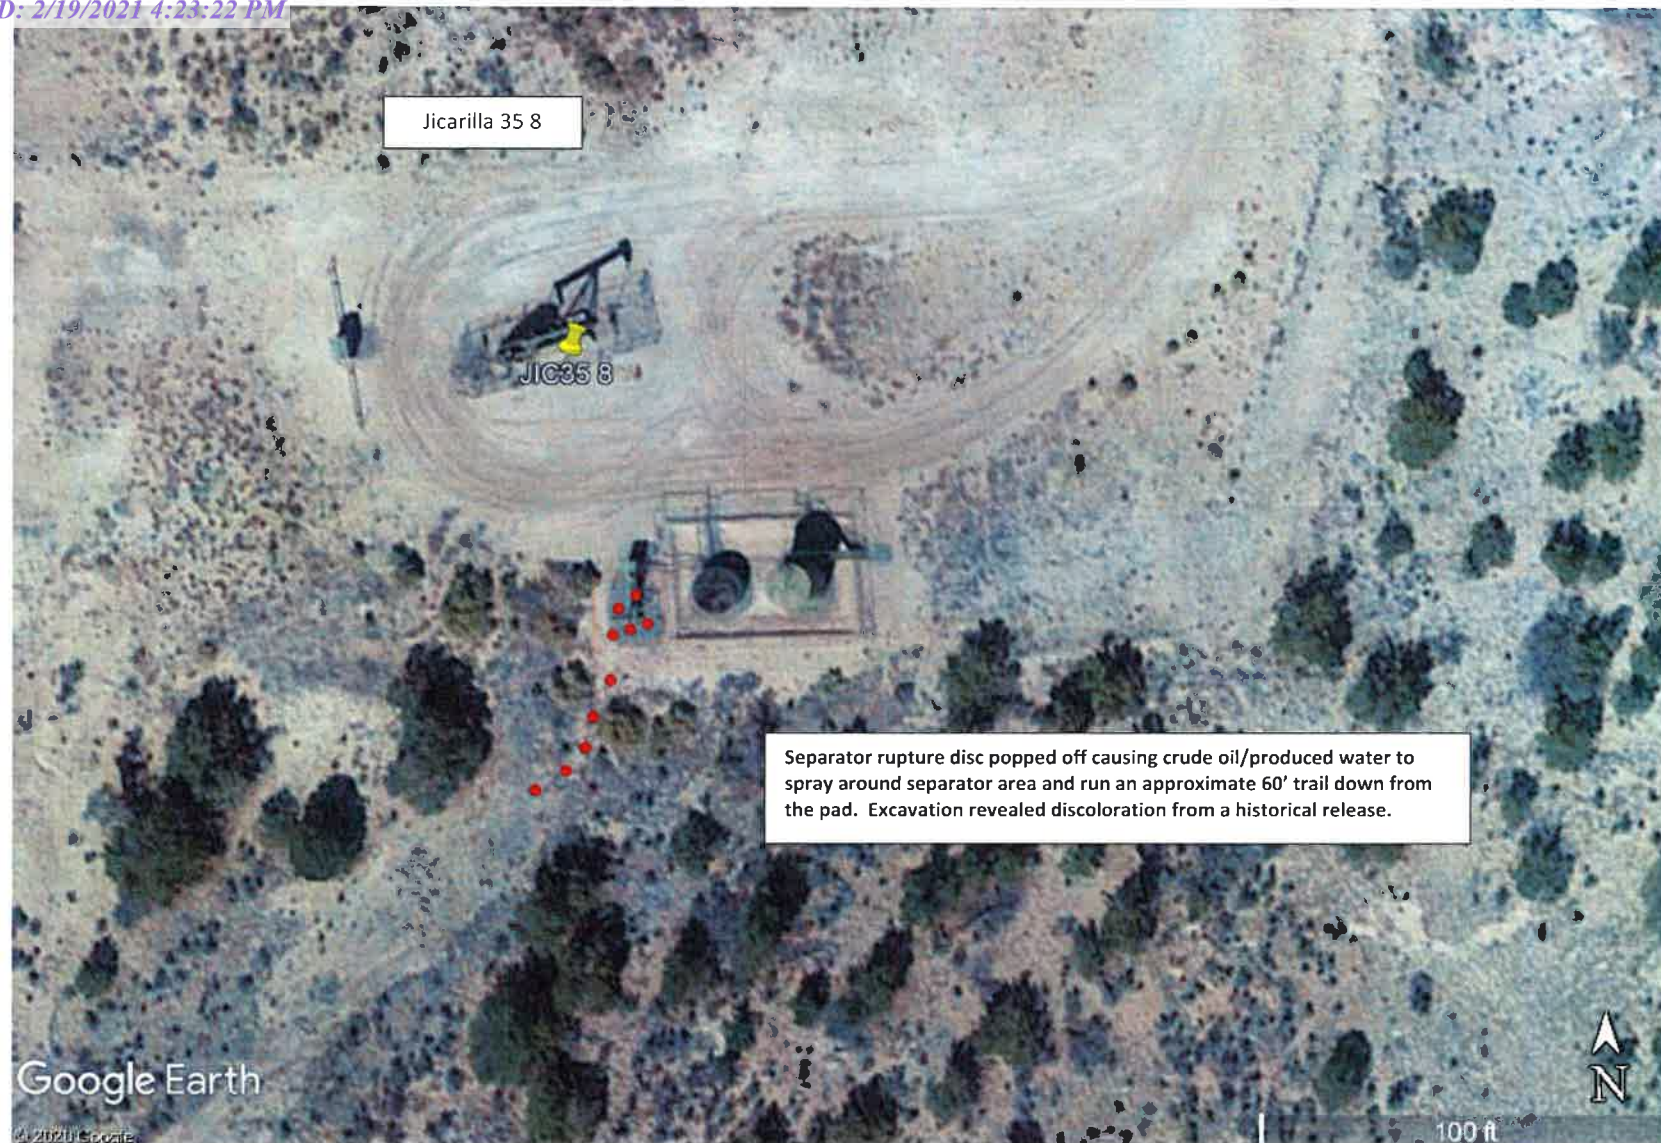
Aerial Site Map

composite samples were collected, as documented in the enclosed Aerial Site map. The one 5-point sample from the trail (Lab #1) passed but the second 5-point sample from the separator (Lab #2) did not pass.

Soil Grab Sampling

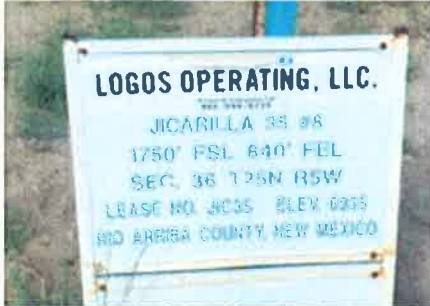
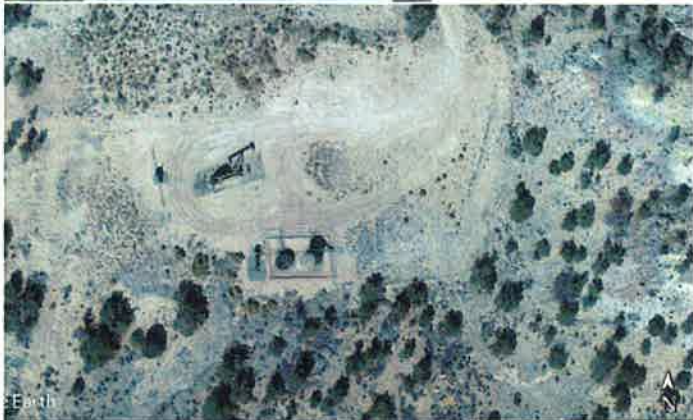
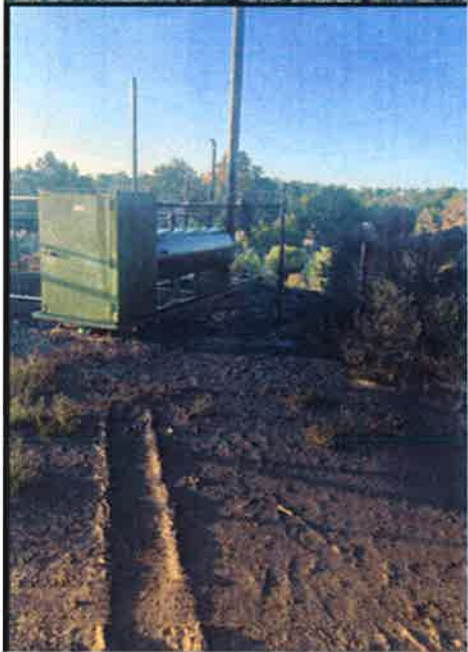
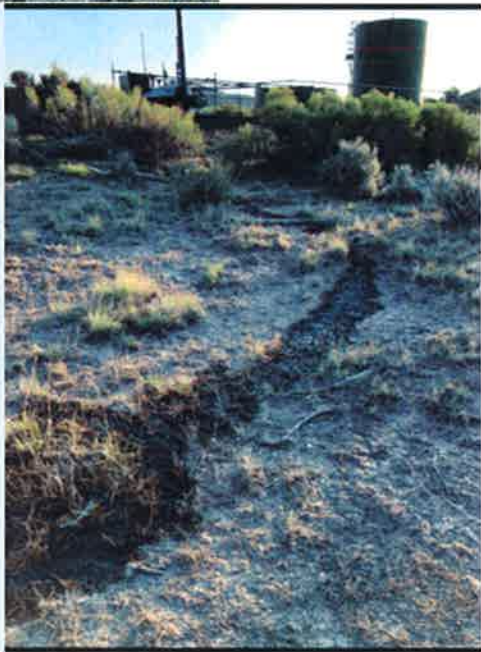
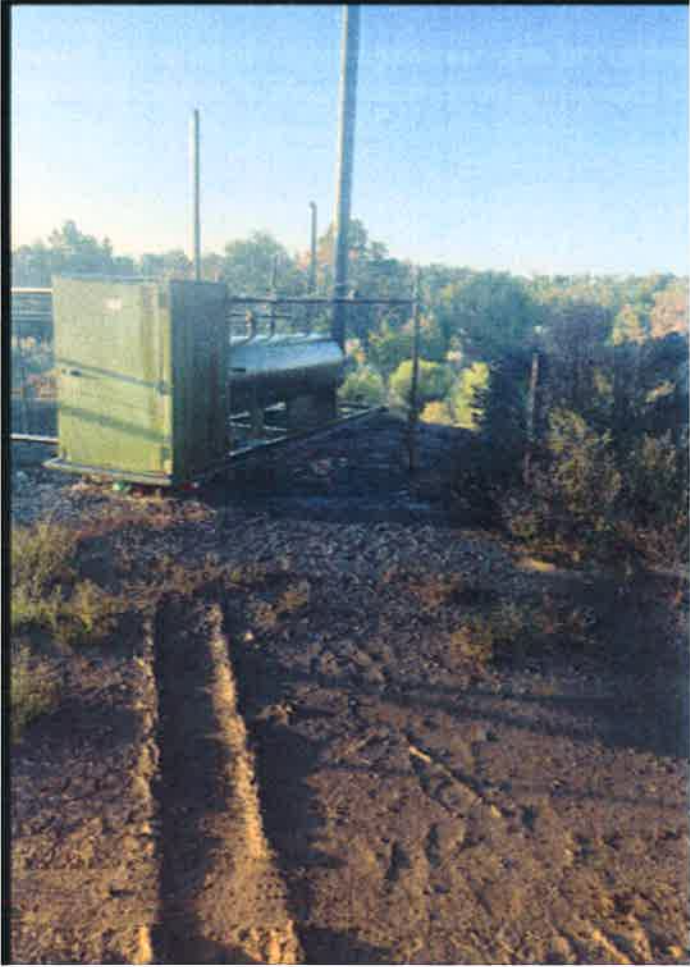
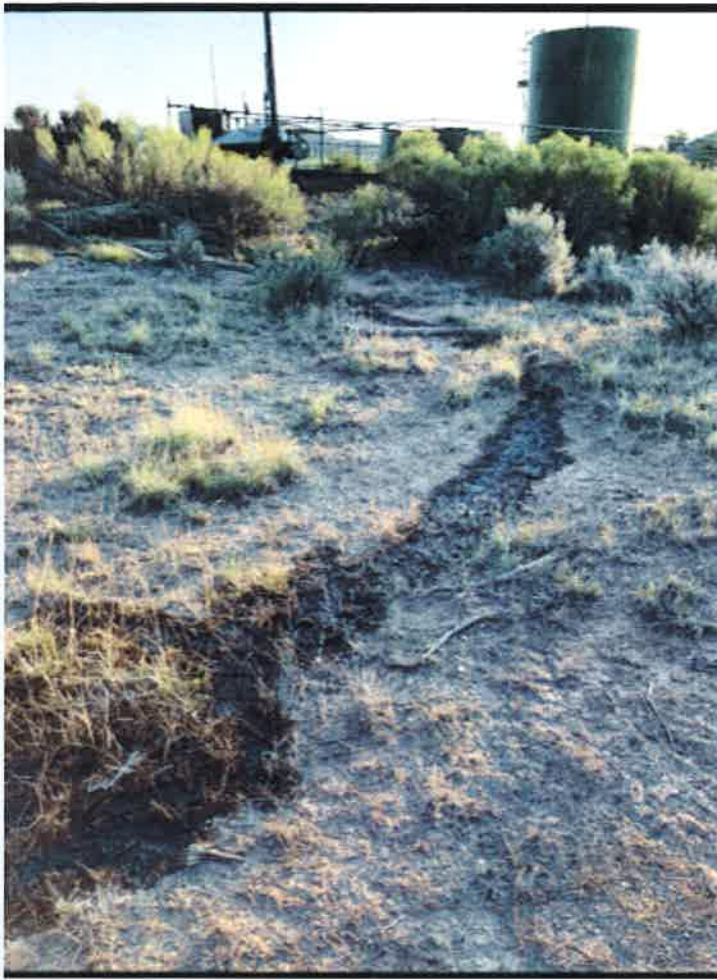
JICARILLA 35 8 – 08/4/20 SITE AREA SPILL

Rupture disc on separator failed causing produced oil and water to spray covering an area approximately 10' x 20' and a trail of mixed oil/water running approximately 60' off separator pad. LOGOS plans to clean up the stained area and remove soil and brush. Jicarilla requested LOGOS to remove the separator to clean historic staining under and around the separator.

Operator arrived on location 8/4/20 around 11am and found fluid spraying and leaking from separator. Rupture disc on separator failed. The area that was affected was 20' around the separator and approximately 60' past the separator. It had made a trail of oil going down off location. Estimated at approximately ½ bbl of oil. Picked up oil soaked soil and raked in oil sponge. Separator was repaired.

On August 4, 2020, operator arrived on location around 11am and found fluid spraying and leaking from separator. Well was shut in. LOGOS picked up oil-soaked soil and raked in oil sponge. Separator was repaired. The surface owner (Jicarilla) was notified on August 5, 2020 of the release.

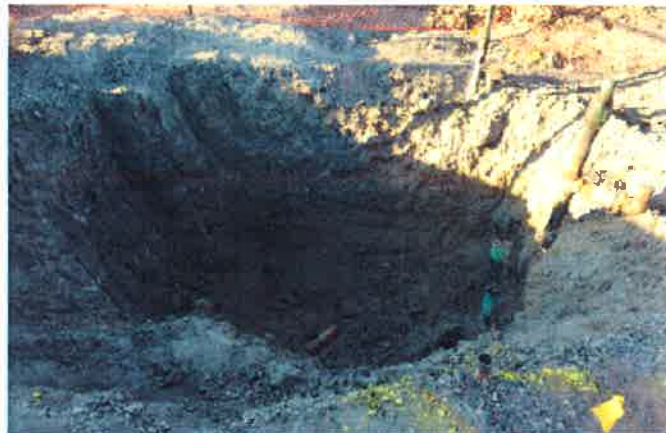
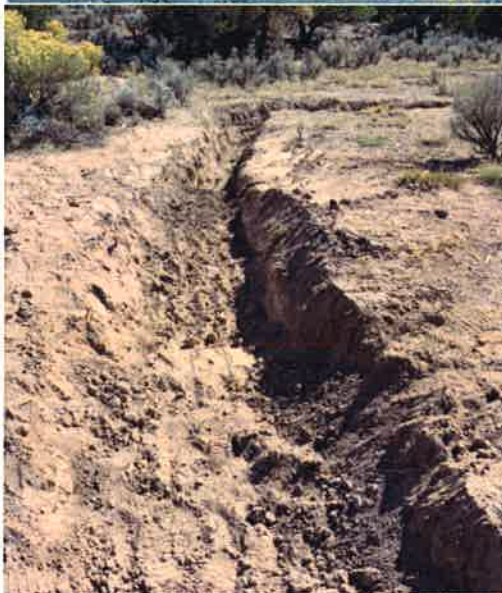
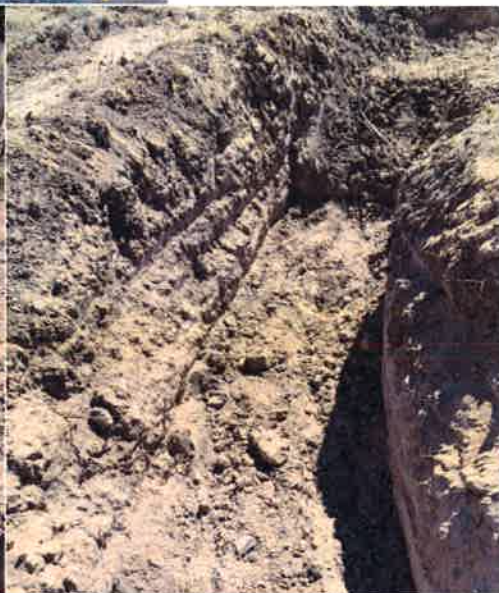
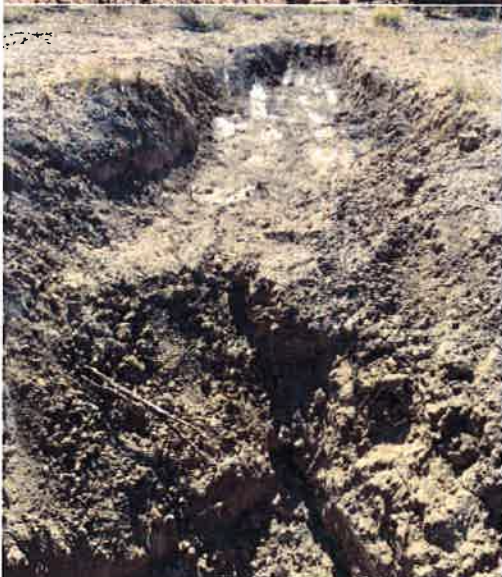
JICARILLA 35 8 – SITE AREA REMEDIATING

On September 28, 2020, LOGOS had Kelley Oilfield Services continue to remove contaminated soil from the trail, an approximate 60'x2' and 2' deep. And from below where the separator had sat, an approximate 6'x9' and 4.5' deep. Kelley's hauled an additional 20 yards to the Envirotech landfarm. LOGOS notified and scheduled a composite grab sample with Keith Manwell (Jicarilla). LOGOS was unaware to notify OCD at the time for confirmation sample per results received on October 5<sup>th</sup>, due to staff change. Keith Manwell was onsite for all confirmation samplings with Envirotech. Two 5-point

On October 14, 2020 Kelley Oilfield Services dug an additional foot of contaminated soil from the separator area, an approximate 6'x9' and 5.5' deep. Kelley's hauled and disposed 3 more yards to the Envirotech landfarm, for a total of 50 yards. Jicarilla and OCD were notified and scheduled on October 14, 2020 for the 2nd confirmation sample in the separator area. Envirotech then performed the confirmation sampling. One 5-point composite sample was collected, as documented in the enclosed Aerial Site map, and Figure 1 – Site pictures. The sample testing report was received on 10/21/20, the sample passed.
