Site Name Lateral C-14	Site Type Natural Gas Gathering Pipeline
Date Release Discovered: 10/10/2020	Serial Number (if applicable): N/A

CLOSURE REPORT

Lateral C-14 (10/10/20)
NW 1/4, S25 T27N R9W
San Juan County, New Mexico

January 8, 2021
Ensolum Project No. 05A1226121

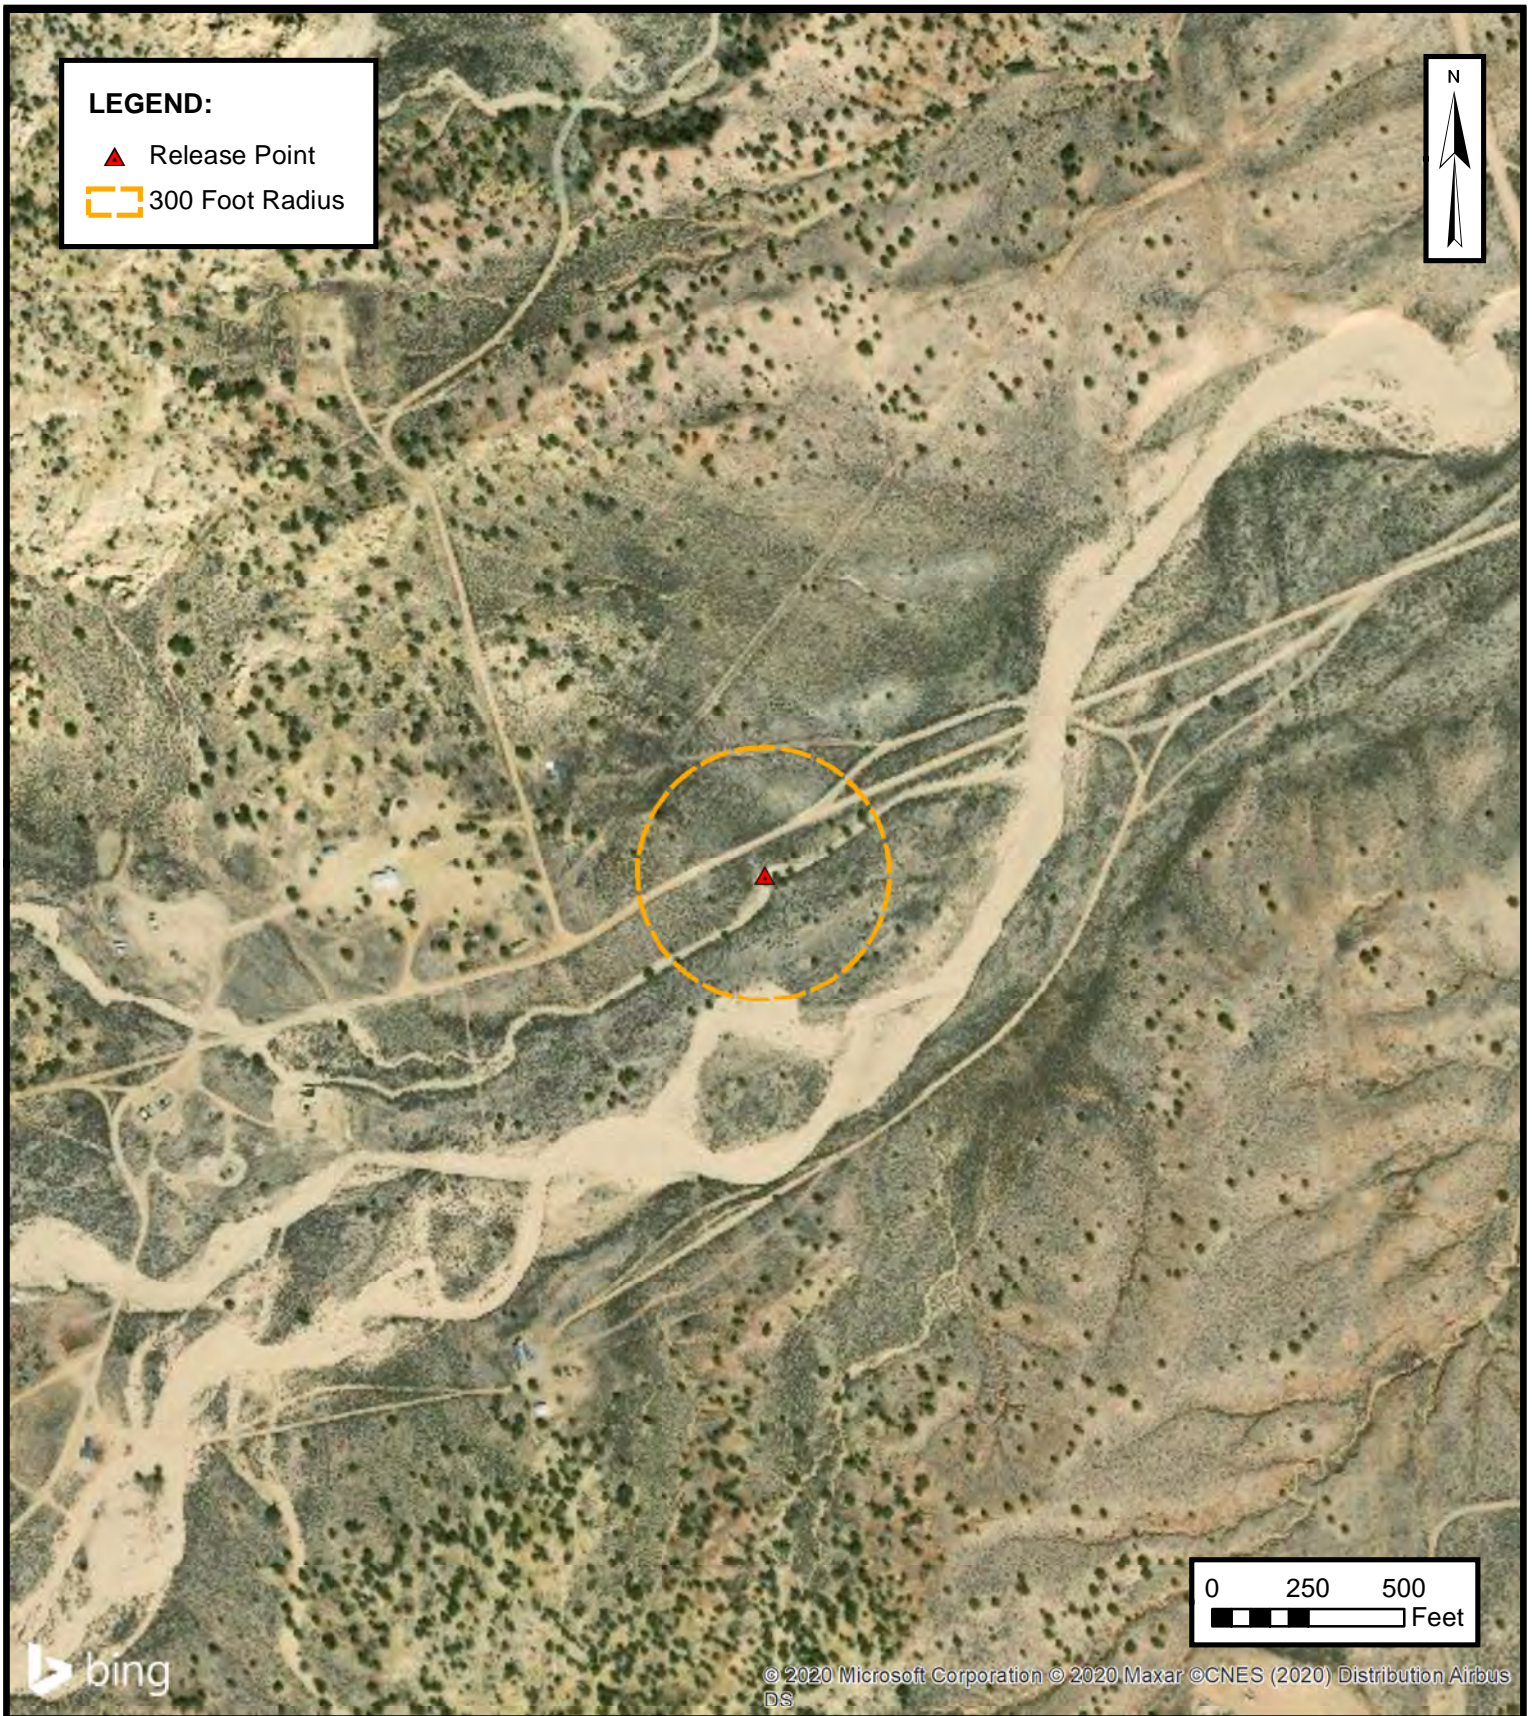
**FIGURE
D**

- The Site is not located within 300 feet of a permanent residence, school, hospital, institution, or church. The nearest permanent residence is located approximately 800 feet (northwest) from the Site (**Figure D, Appendix B**).

**300 FOOT RADIUS
OCCUPIED STRUCTURE IDENTIFICATION**
ENTERPRISE FIELD SERVICES, LLC
LATERAL C-14 (10/10/20)
NW ¼, S25 T27N R9W, San Juan County, New Mexico
36.552796° N, 107.741504° W

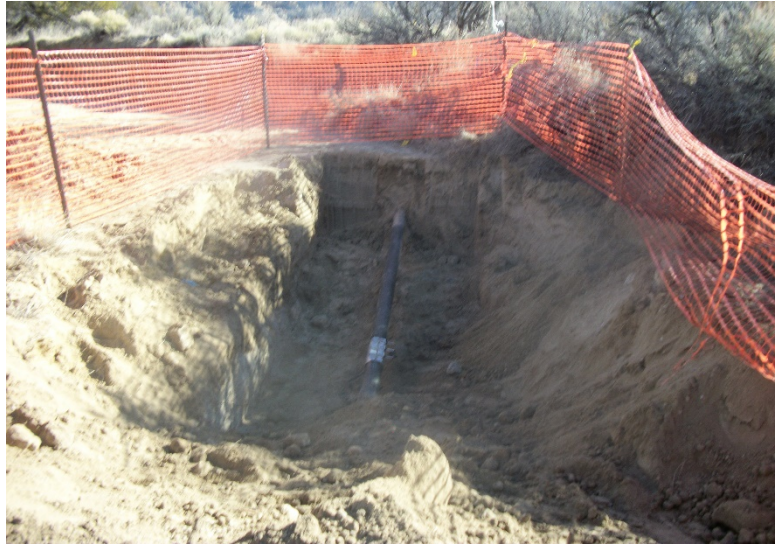
**Photograph 1**

The final excavation measured approximately nine (9) feet long and five (5) feet wide at the maximum extents. The maximum depth of the excavation measured approximately three (3) feet bgs.

The lithology encountered during the completion of remediation activities consisted primarily of unconsolidated silty sand.

Photograph Description: View of the excavation.

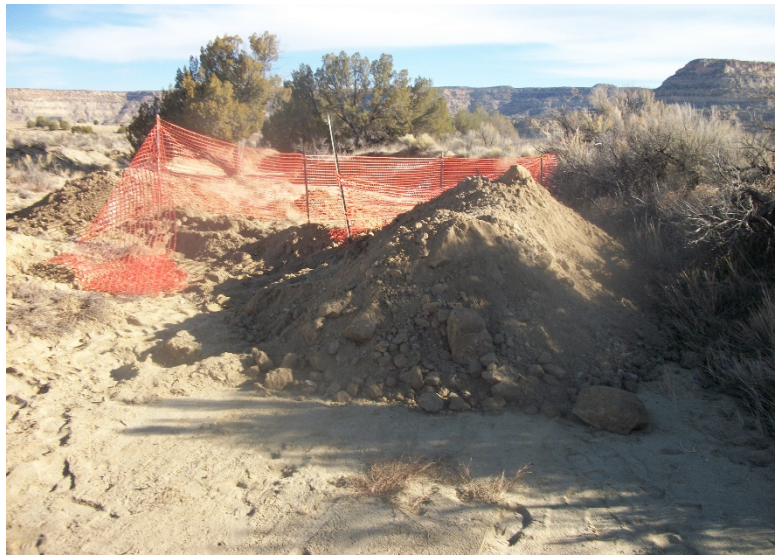
**Photograph 2**

Photograph Description: View of the stockpiled soils.

The excavation was backfilled with laboratory-confirmed stockpiled soil and then contoured to surrounding grade.

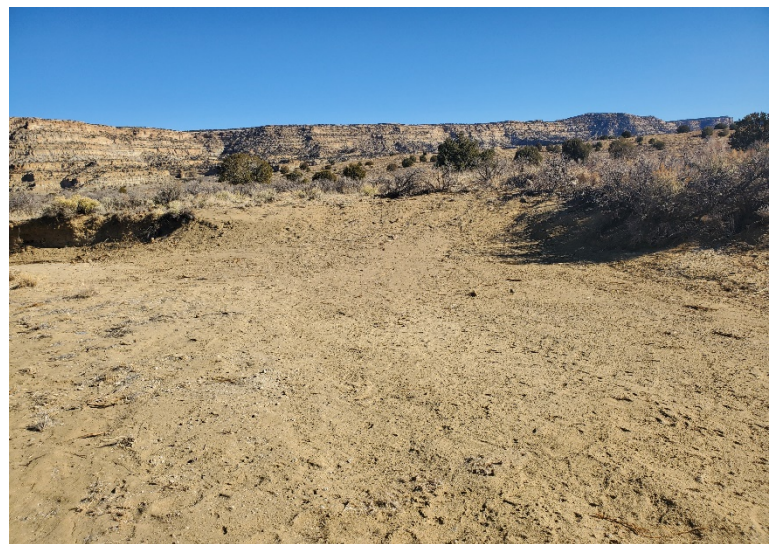
**Photograph 3**

Photograph Description: View of the excavation after initial restoration.

The excavation was backfilled with laboratory-confirmed stockpiled soil and then contoured to surrounding grade.
