**RE: Closure Request  
Lotus Lateral Poly 8"  
Incident Number NAPP2123850791  
Lea County, New Mexico**

WSP USA Inc. (WSP), on behalf of Lucid Energy Delaware, LLC (Lucid), presents the following Closure Request detailing site assessment, excavation, and soil sampling activities at the Lotus Lateral Poly 8" (Site) located in Unit G, Section 29, Township 22 South, Range 32 East, in Lea County, New Mexico (Figure 1). The purpose of the site assessment, excavation, and soil sampling activities was to address impacts to soil following the release of natural gas and pipeline liquid at the Site. Based on the excavation activities and confirmation soil sample laboratory analytical results, Lucid is submitting this Closure Request, and requesting no further action (NFA) for Incident Number NAPP2123850791.

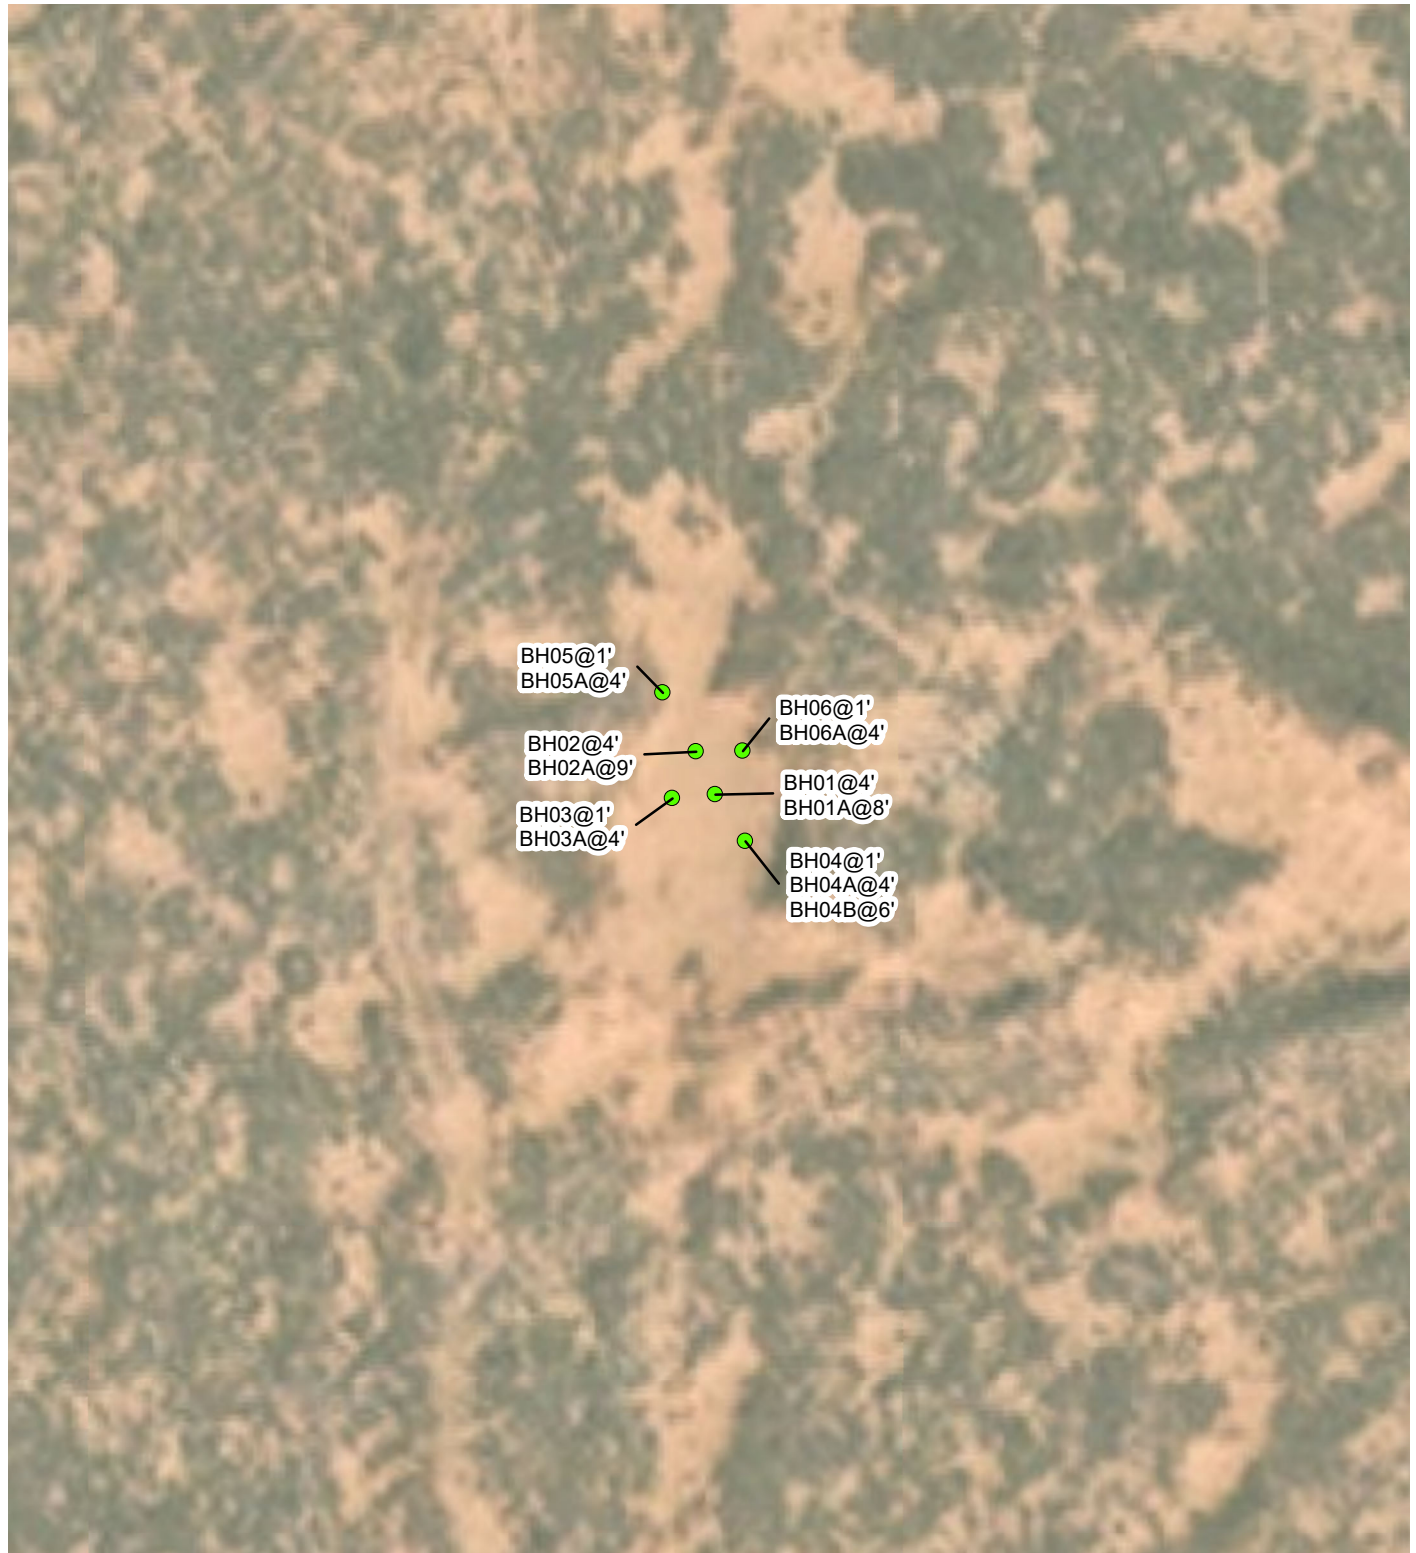
**FIGURE 2**  
**DELINEATION SOIL SAMPLE LOCATIONS**  
 LOTUS LATERAL POLY 8"  
 UNIT G SEC 29 T22S R32E  
 LEA COUNTY, NEW MEXICO  
 LUCID ARTESIA COMPANY, LLC

On September 30, 2021, WSP personnel visited the Site to evaluate the release extent based on information provided on the Form C-141 and visual observations. Boreholes BH01 through BH06 were advanced via hand auger within the release extent to depths ranging from 4 to 9 ft bgs to assess the vertical extent of impacted soil. Discrete delineation samples were collected from each borehole at depths ranging from 1-foot to 9 feet bgs. Soil from the boreholes was field screened for volatile aromatic hydrocarbons and chloride utilizing a calibrated photoionization detector (PID) and Hach® chloride QuanTab® test strips, respectively. Field screening results and observations were logged on lithologic/soil sampling logs, which are included in Attachment 2. The delineation soil samples were placed directly into pre-cleaned glass jars, labeled with the location, date, time, sampler initials, method of analysis, and immediately placed on ice. The soil samples were transported at or below 4 degrees Celsius (°C), under strict chain-of-custody (COC) procedures to Eurofins Laboratories (Eurofins) in Carlsbad, New Mexico, for analysis of BTEX following United States Environmental Protection Agency (EPA) Method 8021B; TPH following EPA Method 8015M/D; and chloride following EPA Method 300.0. The delineation sample locations were mapped utilizing a handheld GPS unit and are presented on Figure 2.

Laboratory analytical results for borehole delineation samples indicated that BH01 at 4 ft, exceeded the TPH Closure Criteria. Concentration of benzene, BTEX, and chloride in all boreholes were compliant with the Site Closure Criteria. Based on the laboratory analytical results, excavation activities were warranted

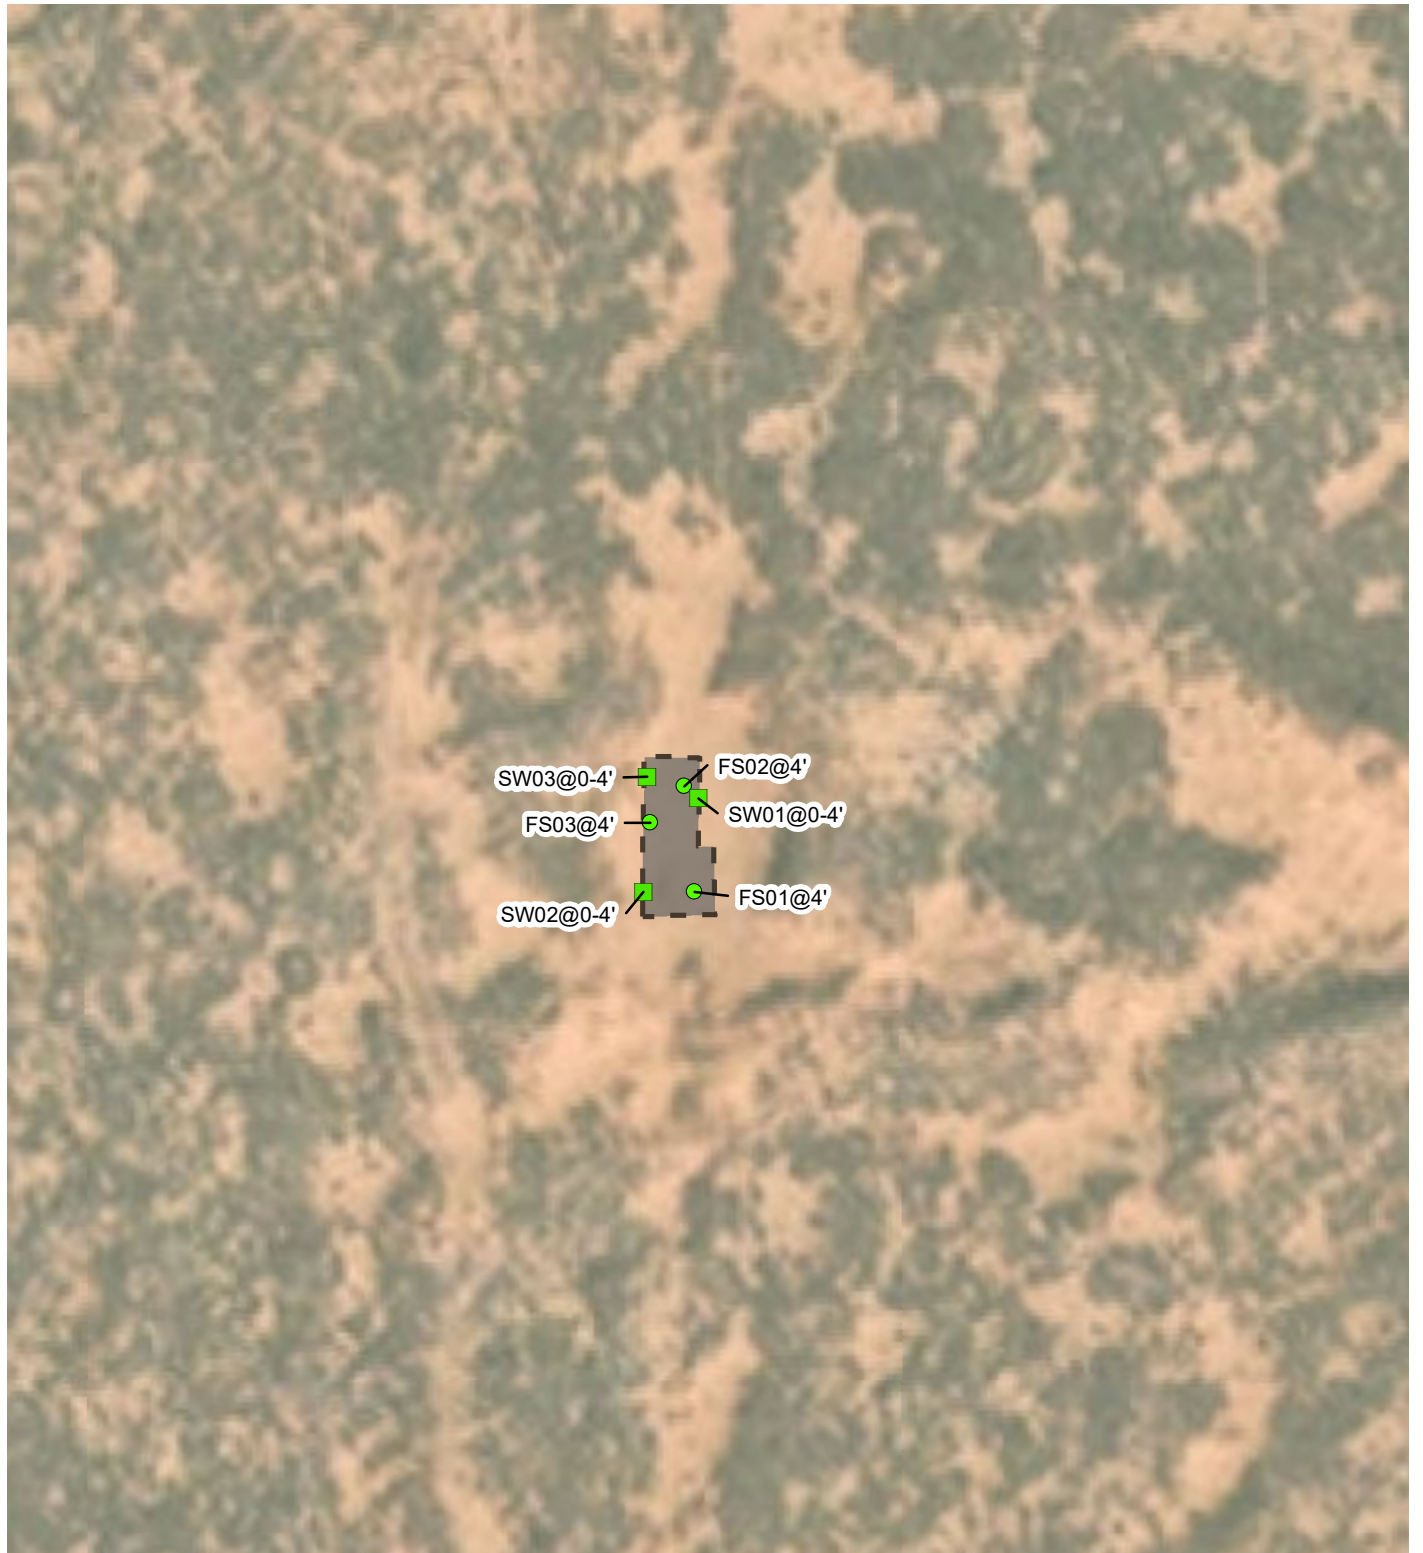
**FIGURE 3**  
 EXCAVATION SOIL SAMPLE LOCATIONS  
 LOTUS LATERAL POLY 8"  
 UNIT G SEC 29 T22S R32E  
 LEA COUNTY, NEW MEXICO  
 LUCID ARTESIA COMPANY, LLC

Laboratory analytical results from excavation soil samples FS01 through FS03 and SW01 through SW03 indicated benzene, BTEX, TPH, and chloride concentrations were compliant with the Closure Criteria. Laboratory analytical results are summarized in Table 1 and the complete laboratory analytical reports are included as Attachment 4.

The excavation area measured approximately 673 square feet. A total of approximately 100 cubic yards of impacted soil was removed during the excavation activities. The impacted soil was transported and properly disposed of at the R360 Facility in Hobbs, New Mexico. After completion of confirmation sampling, the excavation area was backfilled.

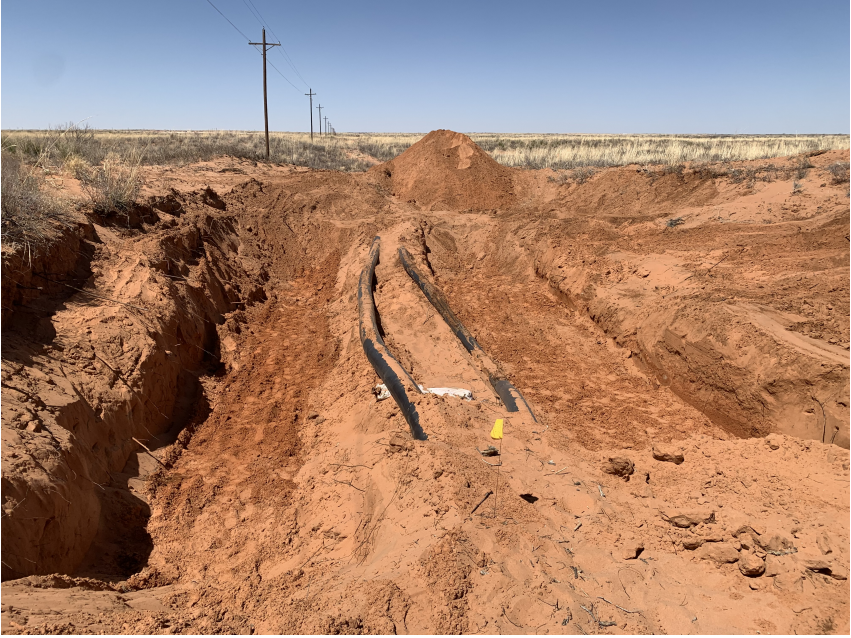
<b>Photo No.</b> 3	<b>Date</b> April 14, 2022

Photo taken during excavation activities.
