SITE REMEDIATION AND CLOSURE REPORT

Pintail Water Reuse

Incident ID No. NAPP2135543093

Paragon Environmental LLC

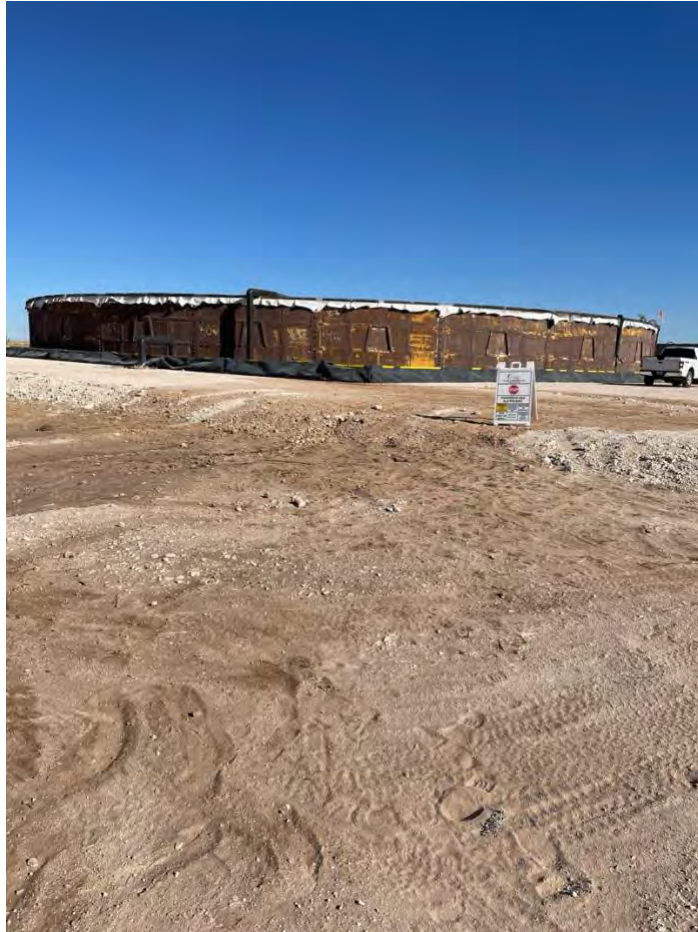
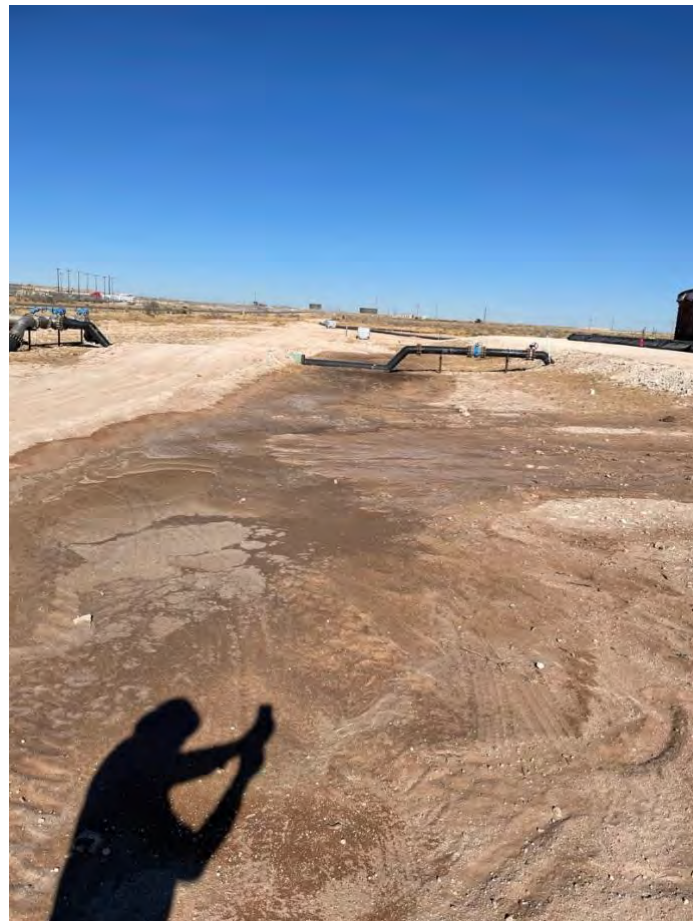
Before Remediation

Cause: Equipment failure on the water tank resulted in a release of approximately 21 barrels (bbls) of produced water. The equipment was isolated while repairs were made and put back in service. A vacuum truck was dispatched to aid in the recovery of the fluids.

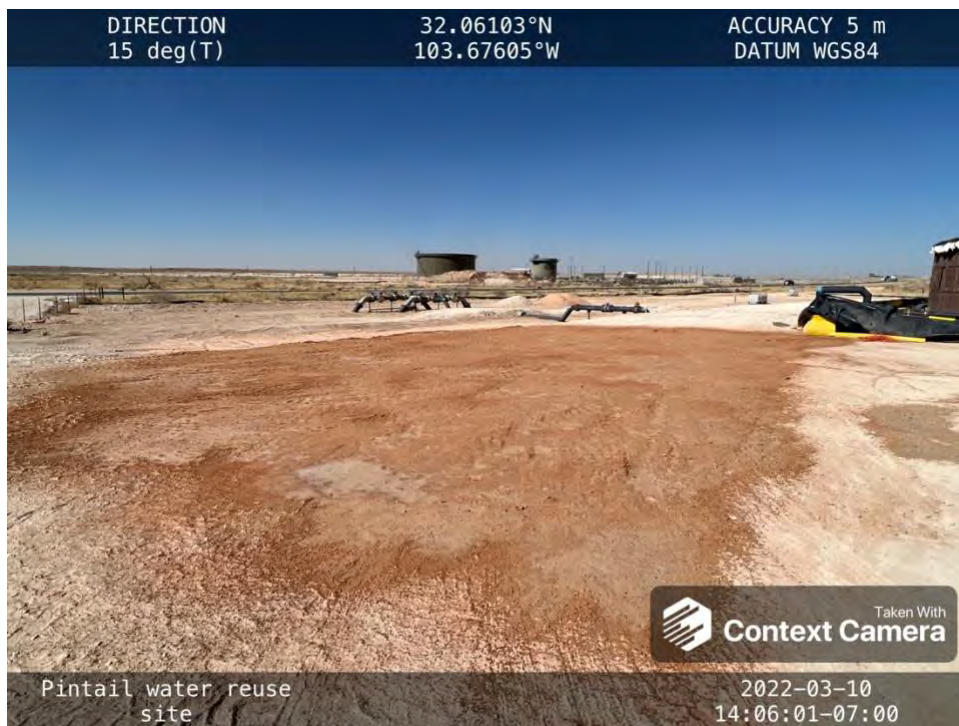
Completed

We proceeded to backfill with the material we obtained from Lea Land based on the clean confirmation samples. We machine compacted the soils and contoured them to match the surrounding areas.
