SUBJECT: Remediation Closure Report for the State AA #001 SWD Release (1RP-5257), Lea County, New Mexico

Table 1: Release Information and Closure Criteria			
Name	State AA #001	Company	Marathon Oil Permian LLC
API Number	30-025-02605	Location	32.43342, -103.433816
Incident Number	2RP-5257		
Estimated Date of Release	October 18, 2018	Date Reported to NMOCD	November 2, 2018
Land Owner	State	Reported to	NMOCD, NMSLO
Source of Release	Hole on bottom of produced water tank		
Released Volume	232 bbl	Released Material	Produced Water
Recovered Volume	0 bbl	Net Release	232 bbls
NMOCD Closure Criteria	<50 feet to groundwater		
SMA Response Dates	October 22, 2018, March 7, April 25, August 21-September 16 2019

Remediation Closure Report (1RP-5257)

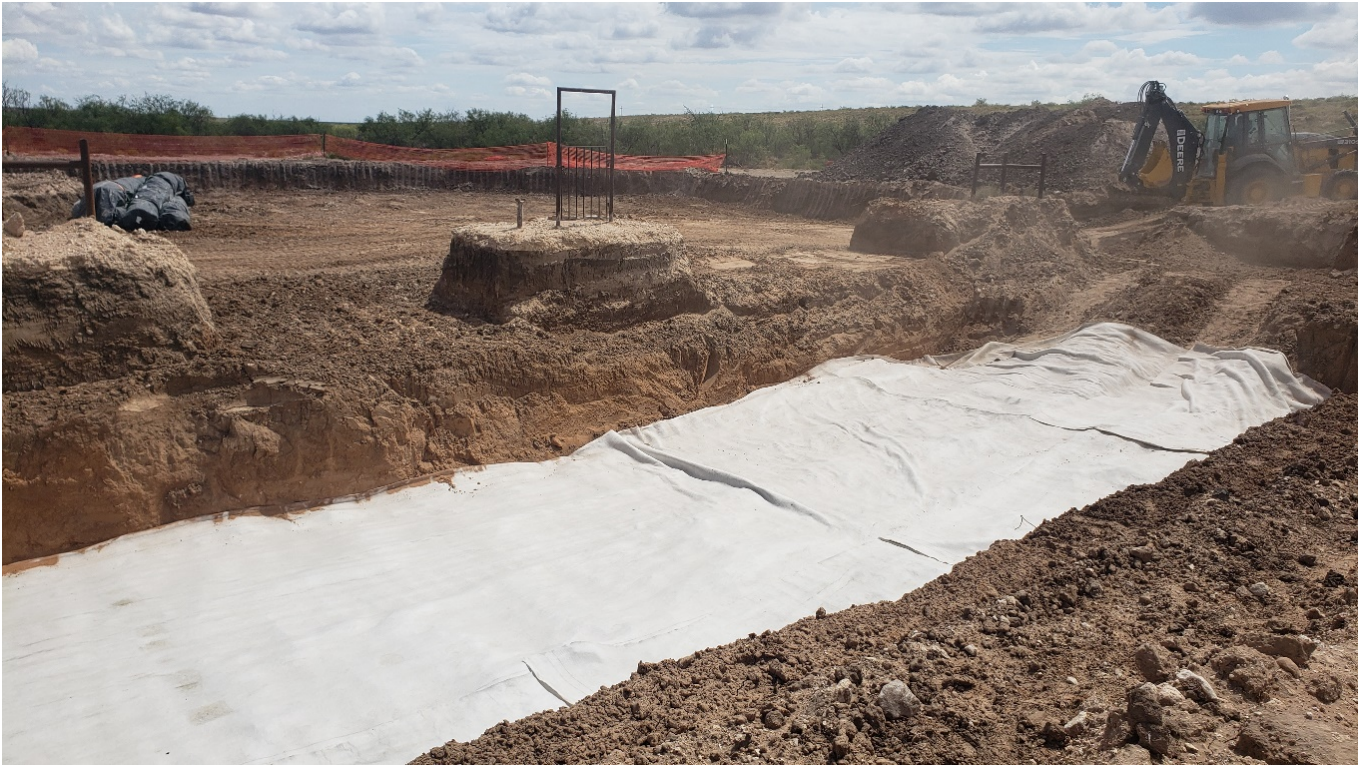
September 13, 2019

Tank Battery with bentonite liner Facing Southeast

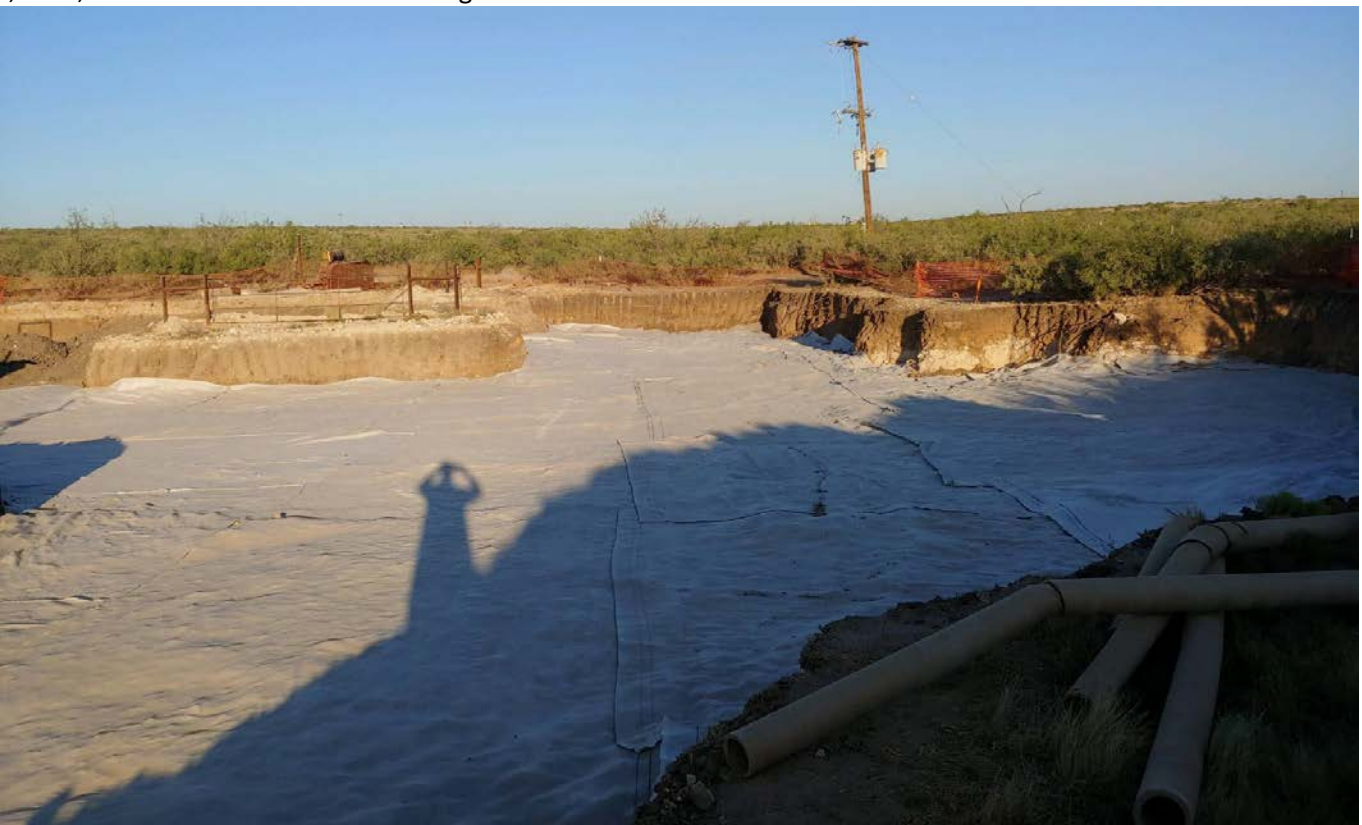
September 18, 2019

BH1, SW2, SW3 with bentonite liner Facing West

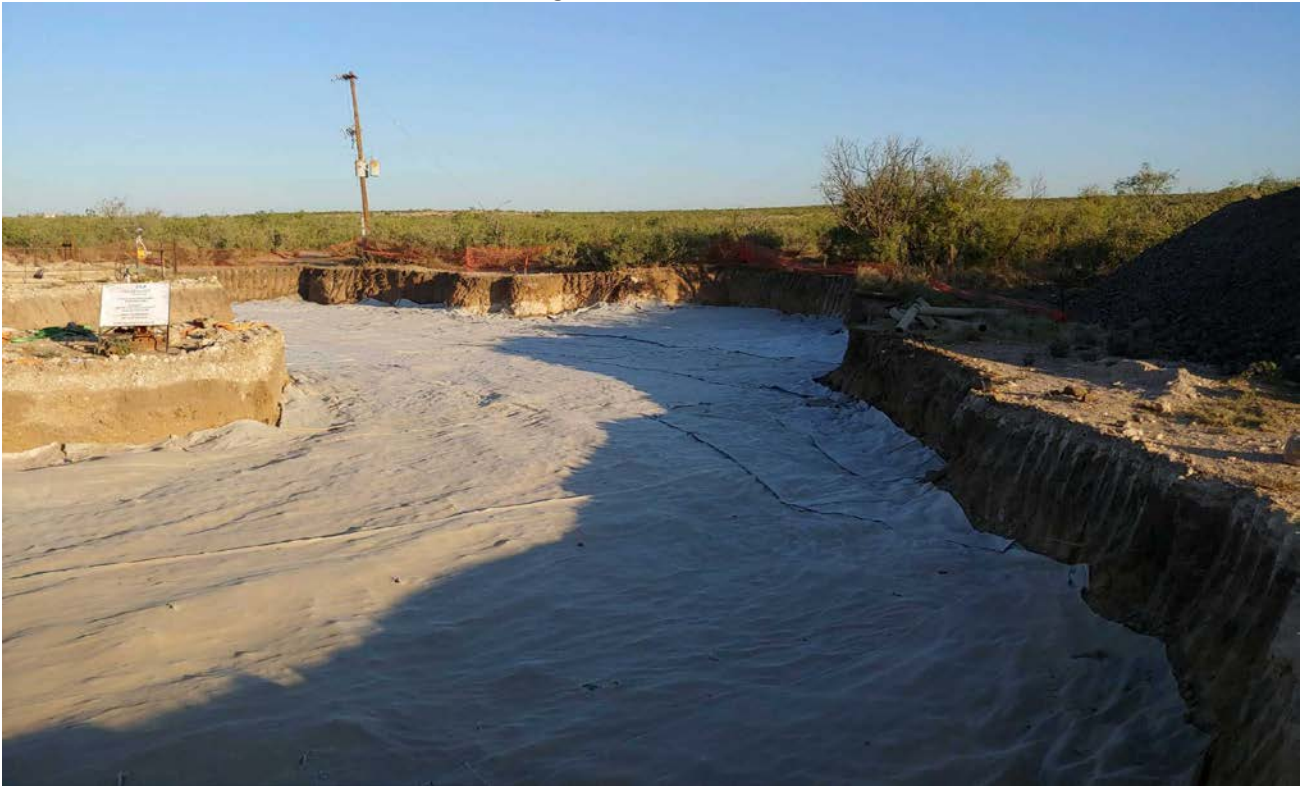
September 18, 2019

BH2, BH3, BH4, SW3, SW4 with bentonite liner facing Northwest

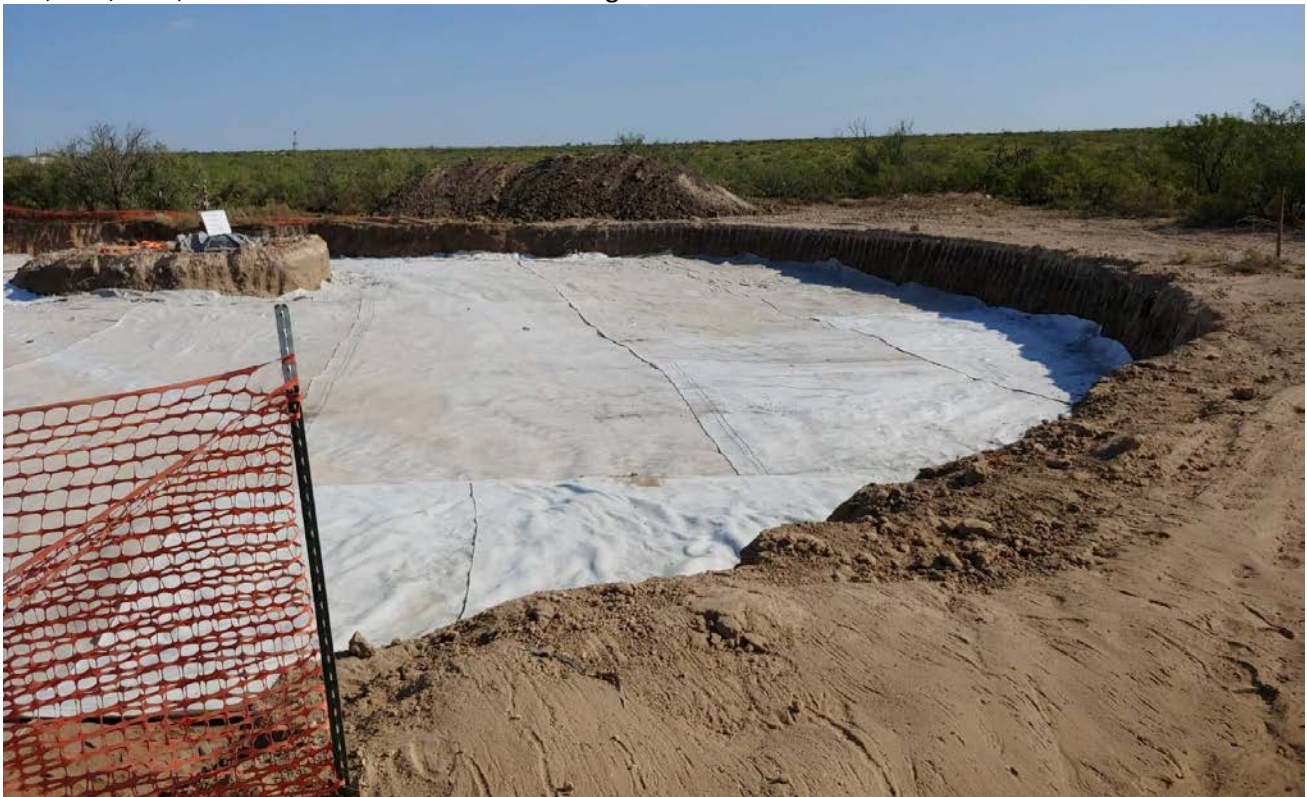
September 17, 2019

BH3, BH4, BH5, SW4, and SW5 with bentonite liner facing Northeast

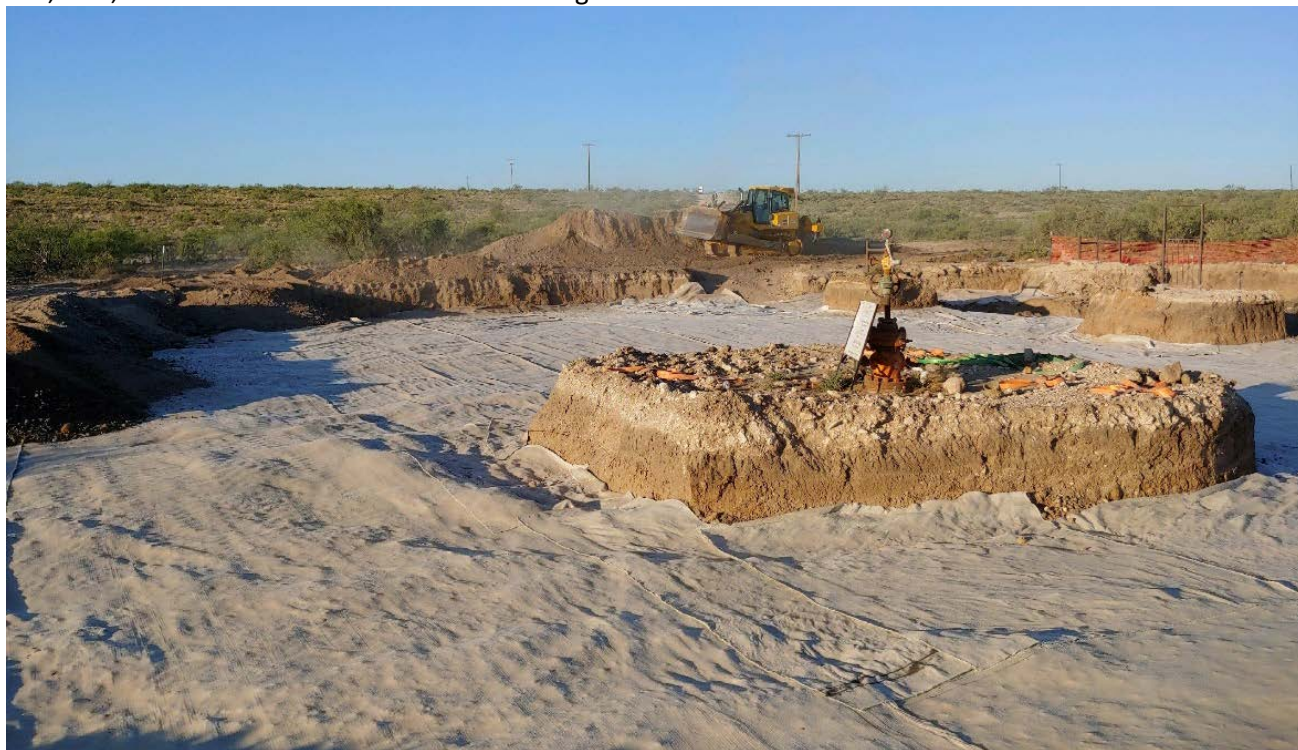
September 18, 2019

BH4, BH5, BH6, SW5 & SW6 with bentonite liner facing south
