Etech Environmental & Safety Solutions, Inc. (Etech), on behalf of Chevron Corporation, has prepared this Closure Request Report for the release site known as Baish Federal #012. The legal description of the release site is Unit Letter "C", Section 9, Township 18 South, Range 31 East, in Eddy County, New Mexico. The GPS coordinates are 32.76626° North and 103.87785° West. A "Site Location Topographic Map" is provided as Figure 1. A copy of the New Mexico Oil Conservation Division (NMOCD) Release Notification and Corrective Action (Form C-141) is provided in Appendix D.

Site Location Topographic Map  
Chevron Corporation  
Baish Federal #012  
GPS: 32.76626, -103.87785  
Eddy County

**Project Name:** Baish Federal #012  
**Project No:** 15308

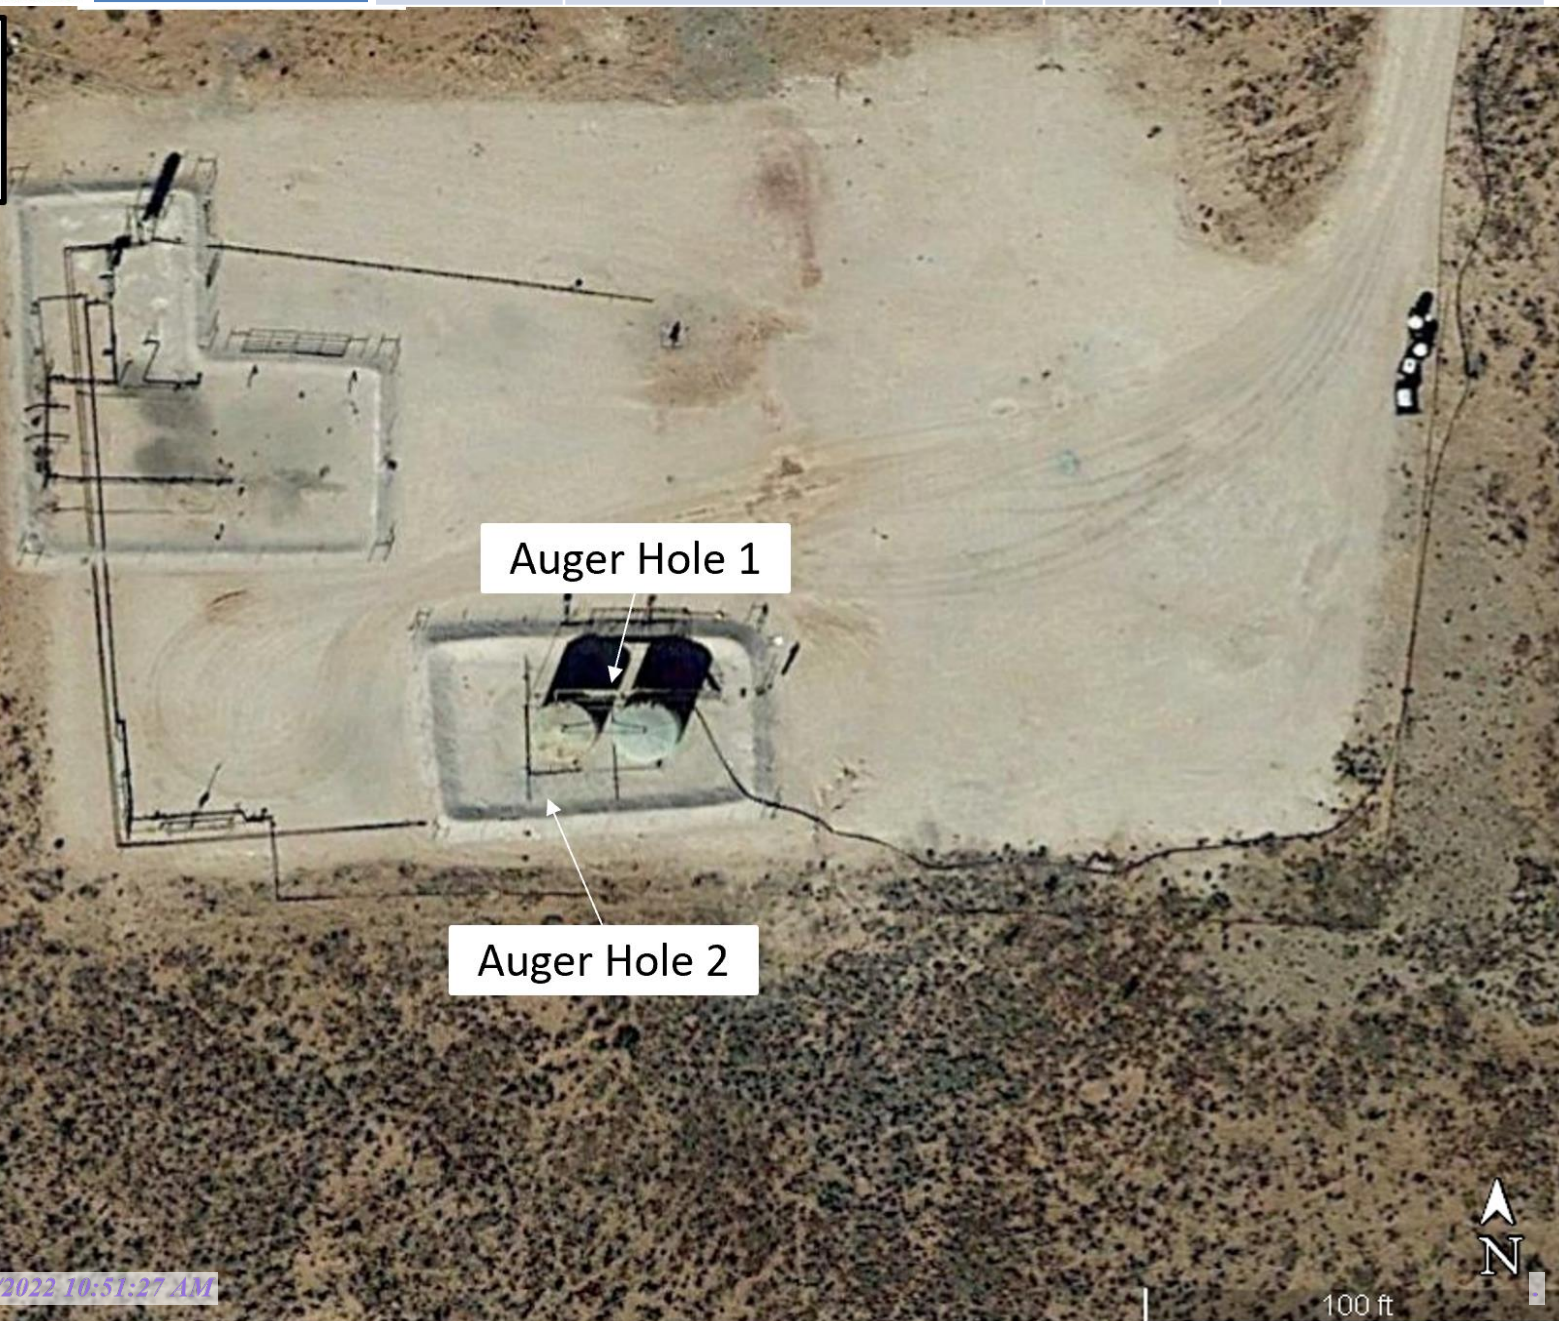
On January 5, 2022, Etech conducted an assessment and sampling event at the Baish Federal #012 to determine the condition of the soil where it was inferred the spill had occurred. Two (2) soil borings were installed, and samples were collected at six (6) inch and forty-eight (48) inch intervals bgs unless refusal was met (refer to Figure 3). Samples were submitted to Xenco Eurofins to be analyzed for TPH, chloride, and BTEX concentrations. A "Site and Sample Location Map" is provided as Figure 3.
