RELEASE CLOSURE REPORT  
XTO ENERGY, INC. – EMSU #266 (API#: 30-025-26101)

1RP-4546

**Re: Release Closure Report**  
**XTO Energy, Inc.**  
**Eunice Monument South Unit (EMSU) #266**  
**RP #: 1RP-4546**  
**Approximate Geographic Coordinates: 32.501578°N, -103.243517°W**  
**Unit Letter U, Section 2, Township 21S, Range 36E**  
**Lea County, New Mexico**

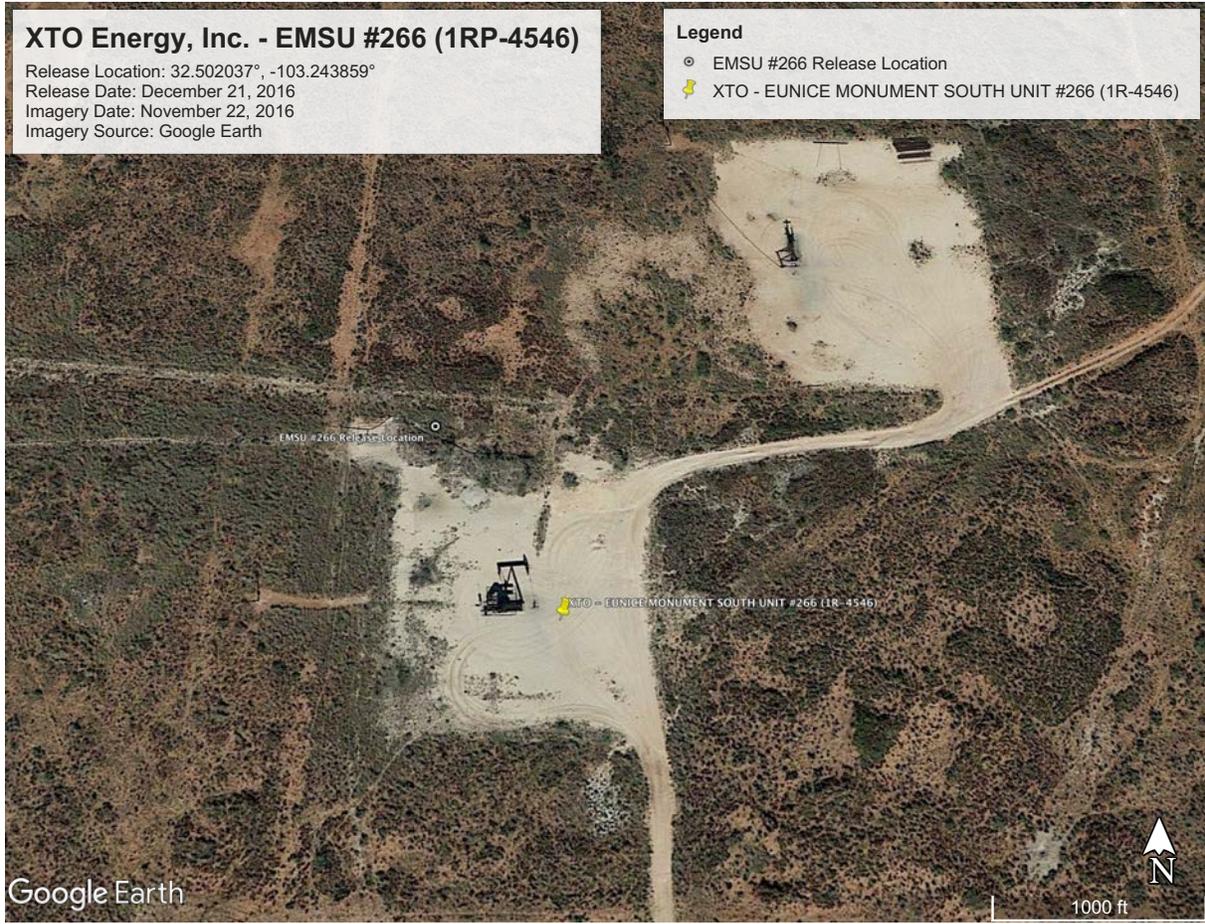
**Figure 3.** Georeferenced Google Earth Image Depicting Release Point Identified in the Initial C-141. The subject site is shown in its pre-release condition.

As shown in Figure 3 through Figure 6, the remedial work that was performed has resulted in the re-establishment of vegetation at the subject site and the excavation that was present has been filled and graded to match the topography of the surrounding area. The geo-tagged site photos that follow provide additional close-up views of vegetation and topography.

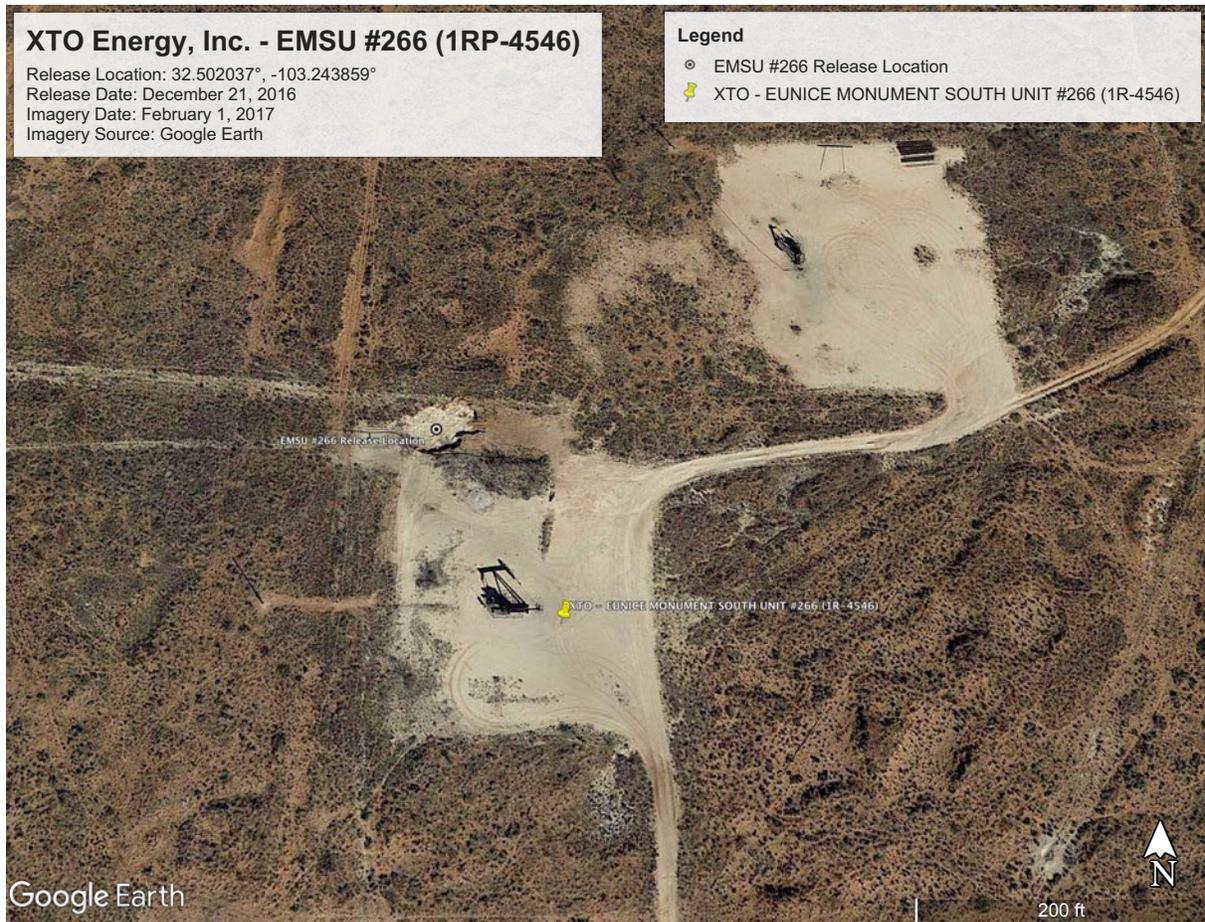
**Figure 4.** Georeferenced Google Earth Image Depicting Release Point Identified in the Initial C-141. The subject site is shown after the release at a period when remedial activities were likely performed to address the release. Note that an excavated area is visible at the release location.

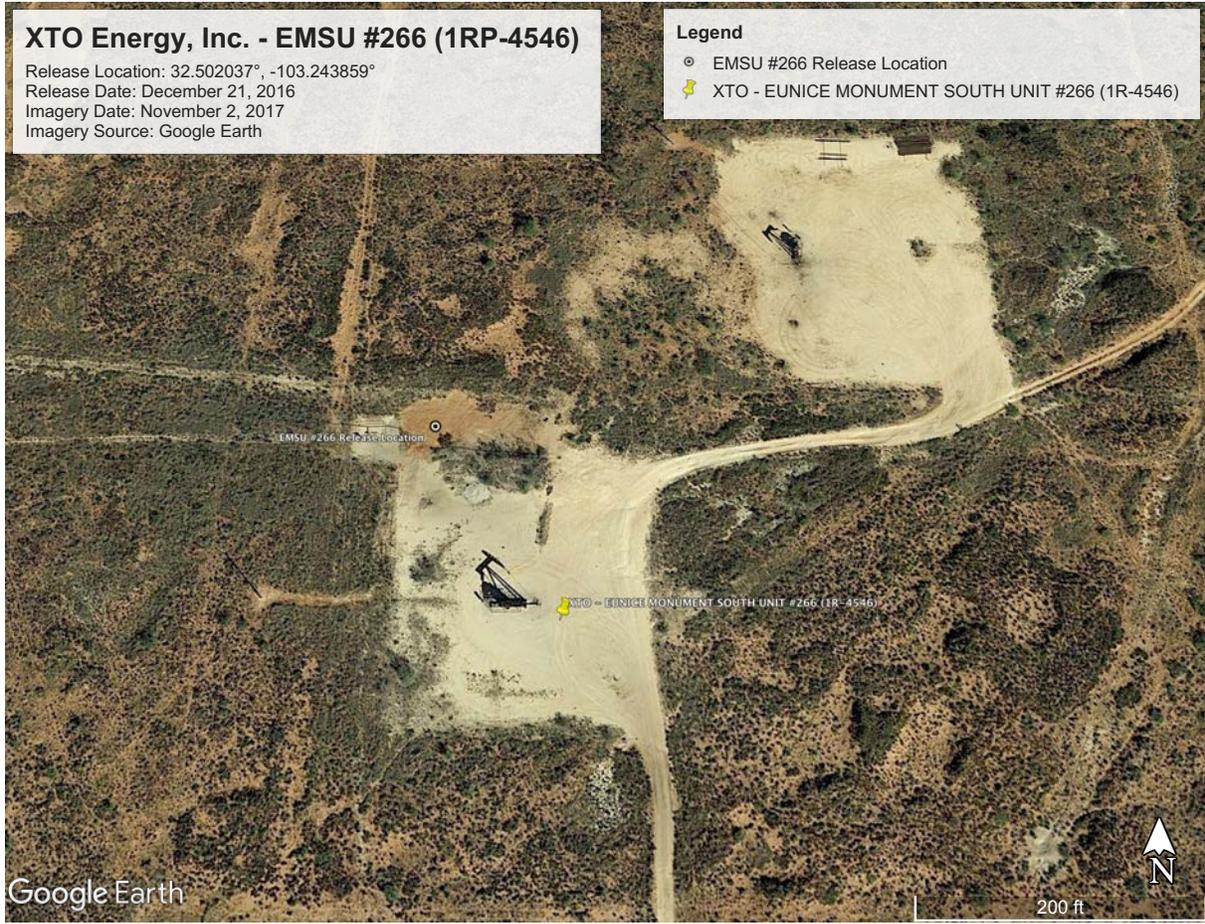
**Figure 5.** Georeferenced Google Earth Image Depicting Release Point Identified in the Initial C-141. Fresh soil appears to be visible and the excavation appears to have been filled with fresh soil.

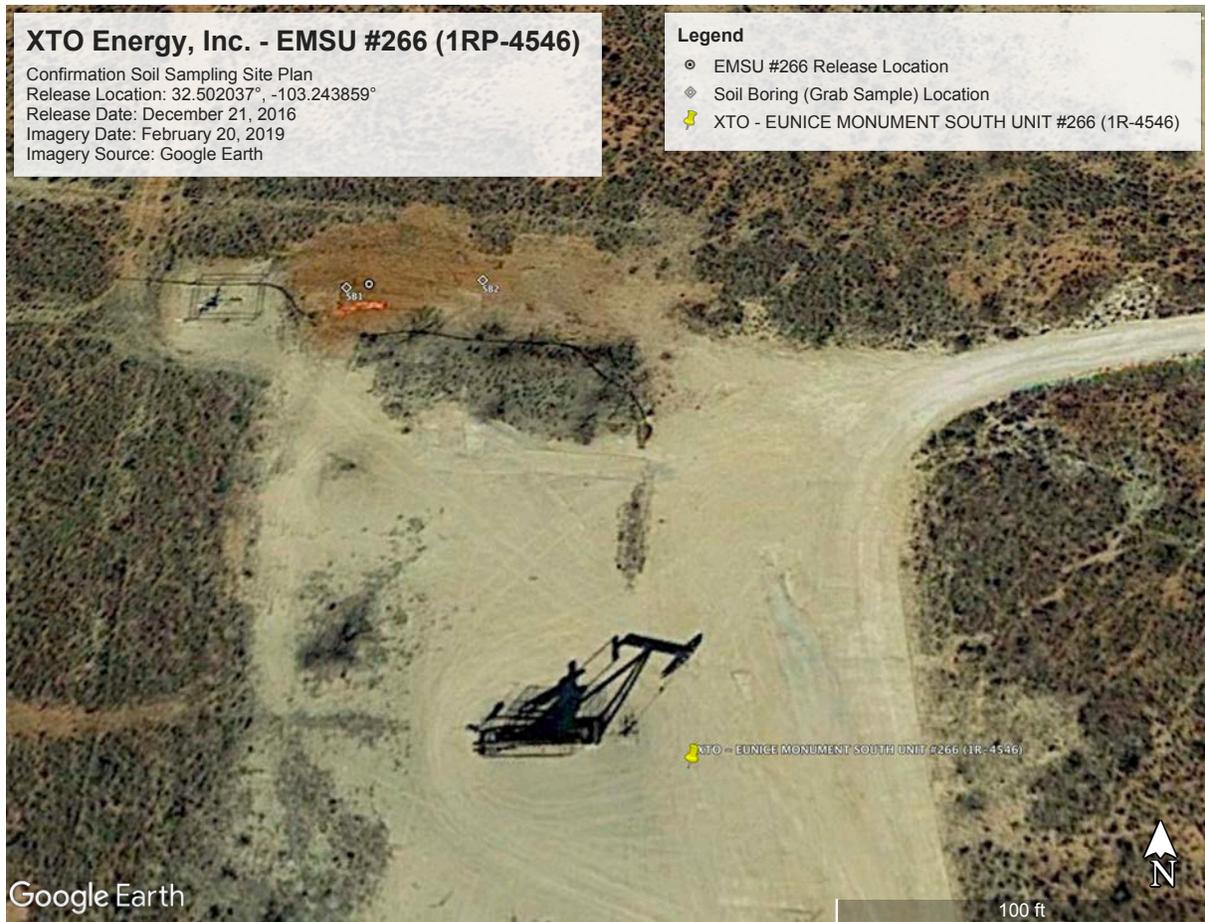
**Figure 6.** Georeferenced Google Earth Image Depicting Release Point Identified in the Initial C-141. This is the most current aerial image of the subject site that is available at the time of report preparation. The image is from February of 2019 and shows that vegetation appears to have been re-established, though vegetation appears to be minimal in this image likely due to cooler winter temperatures.

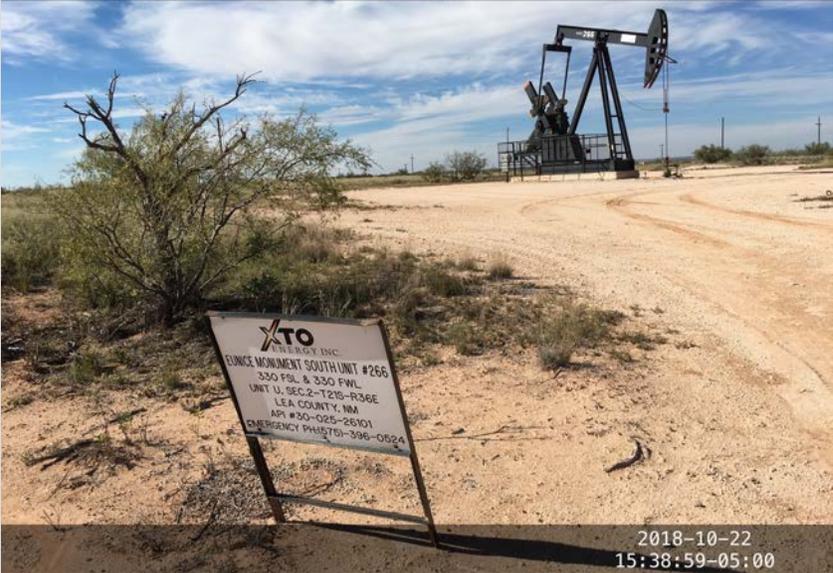
<p>2018-10-22 15:38:59-05:00</p>	<p>The well pad and placard for the subject site is visible.</p> <p>This photograph was captured in October 2018 during a pre-sampling site survey to assess the location.</p>
<p>DIRECTION 32.50203°N ACCURACY 5 m W (T) 103.24356°W DATUM WGS84</p>

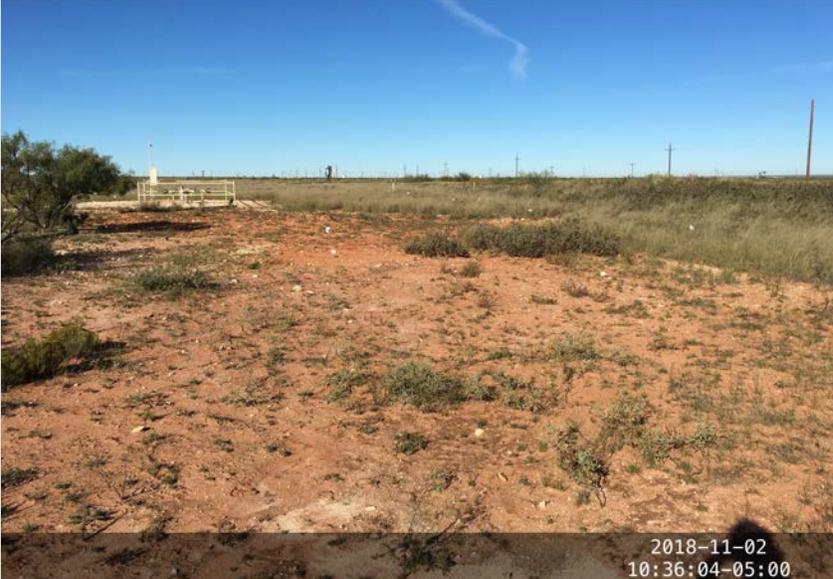
<p>2018-11-02 10:36:04-05:00</p>	<p>The subject site is visible. The photograph shows that vegetation is present at the subject site and that the topography matches the surrounding area.</p>

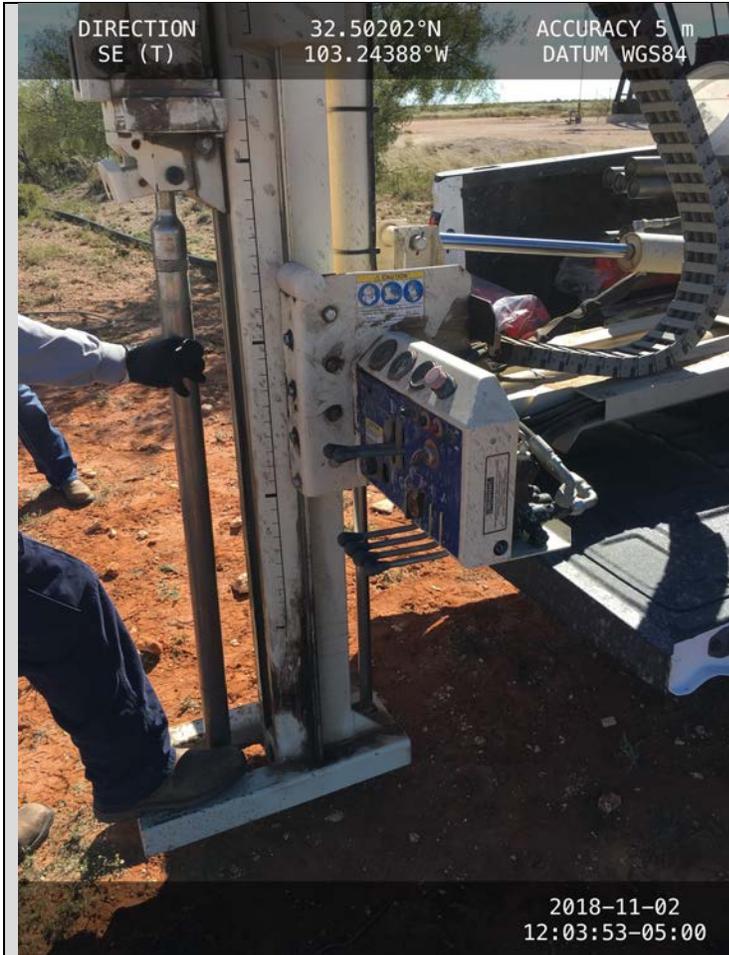
Soil boring 1 (SB1) sample location is pictured here. No visual or olfactory indications of contamination were present.

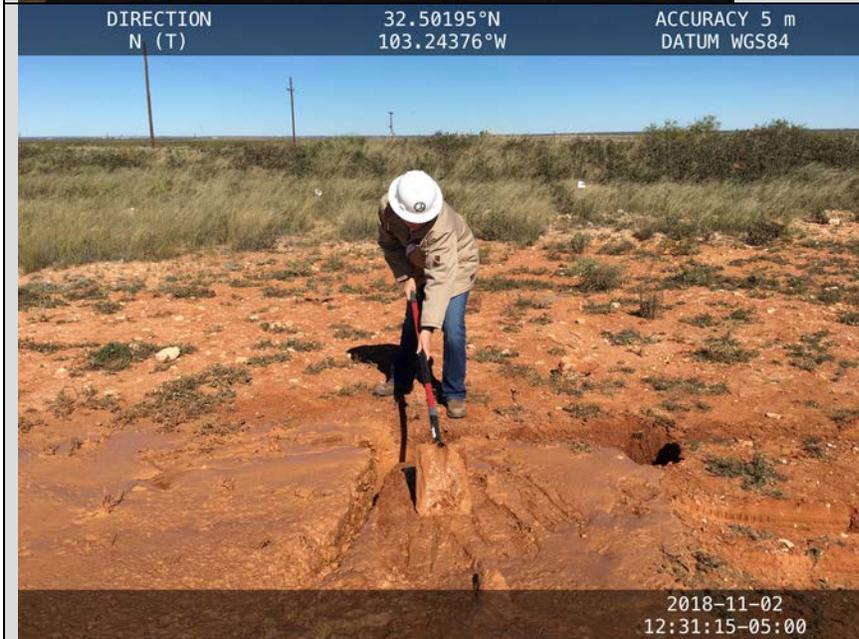
In addition to the standard one-call notification, a hydro-vac was utilized to clear the location prior to sampling due to safety concerns including the presence of flowlines and underground piping. The site is also located near electrical power lines.

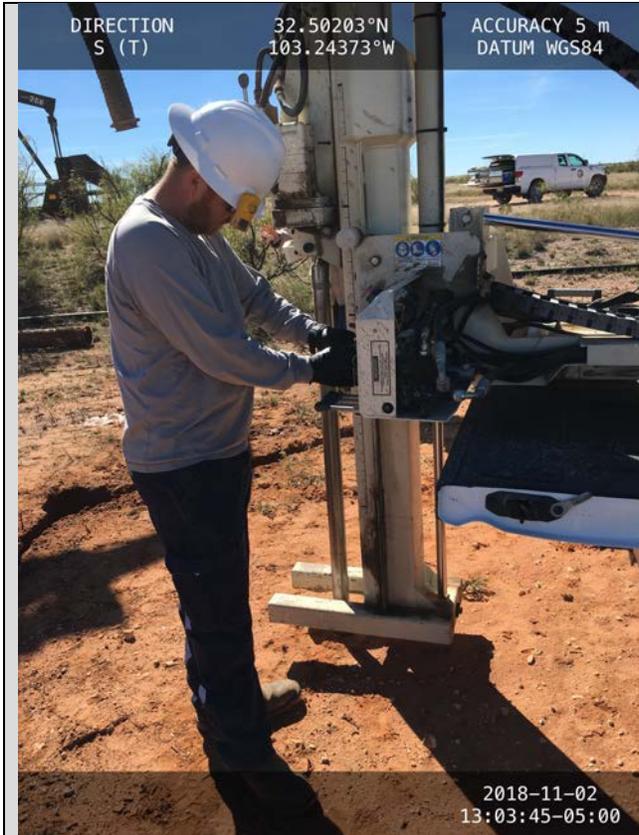
Soil boring 2 (SB2) sample location is pictured here. No visual or olfactory indications of contamination were present.

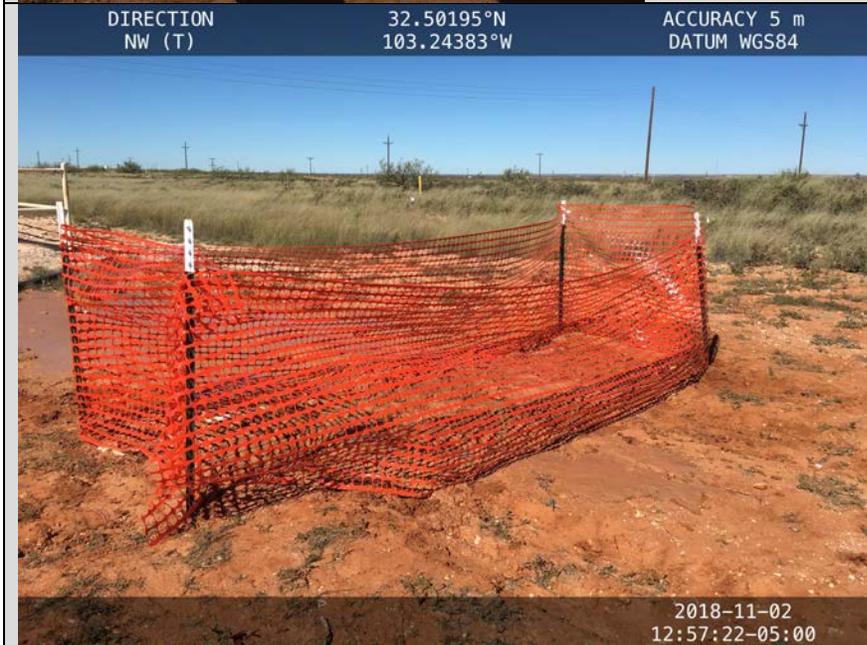
After confirmation soil sampling was complete, the areas that were hydro-vac'ed were enclosed with orange mesh safety fencing as a protective measure.

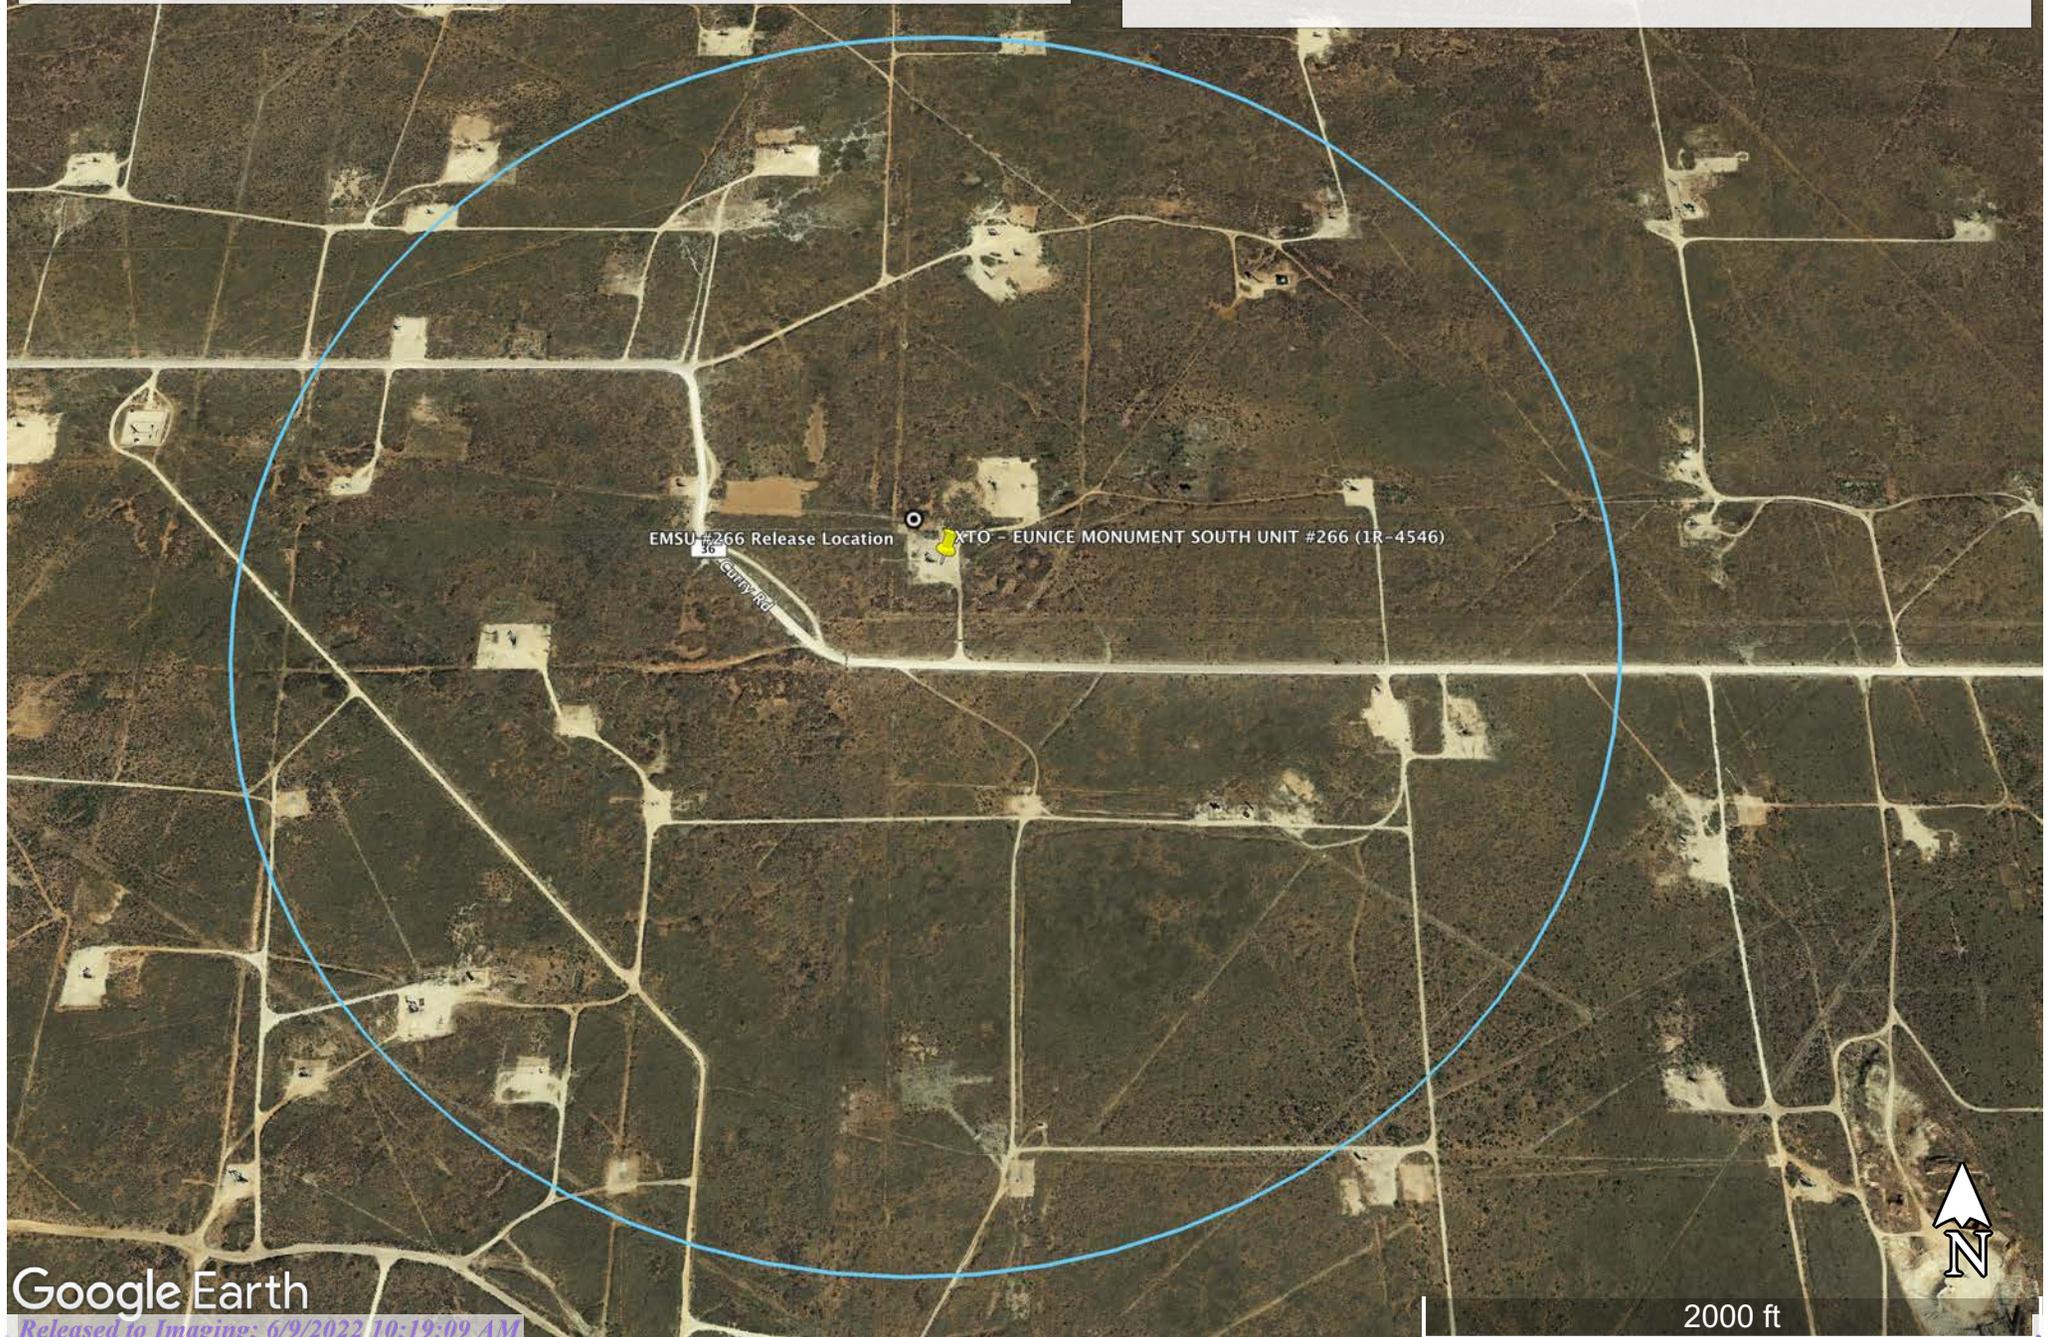
Attachment C  
Release Site Plan  
Depicting Sample Locations

Confirmation Soil Sampling Site Plan

SB1  
 SB2  
 EMSU #266 Release Location
