Release Notification

Site Name Madsen Gas Com #1E	Site Type Natural Gas Gathering Pipeline
Date Release Discovered: 02/05/2015	Serial # (if applicable) N/A

Enterprise Field Services, LLC
Soil Remediation and Groundwater Monitoring Report
Masden Gas Com #1E (2/05/2015)
Ensolum Project No. 05A1226026

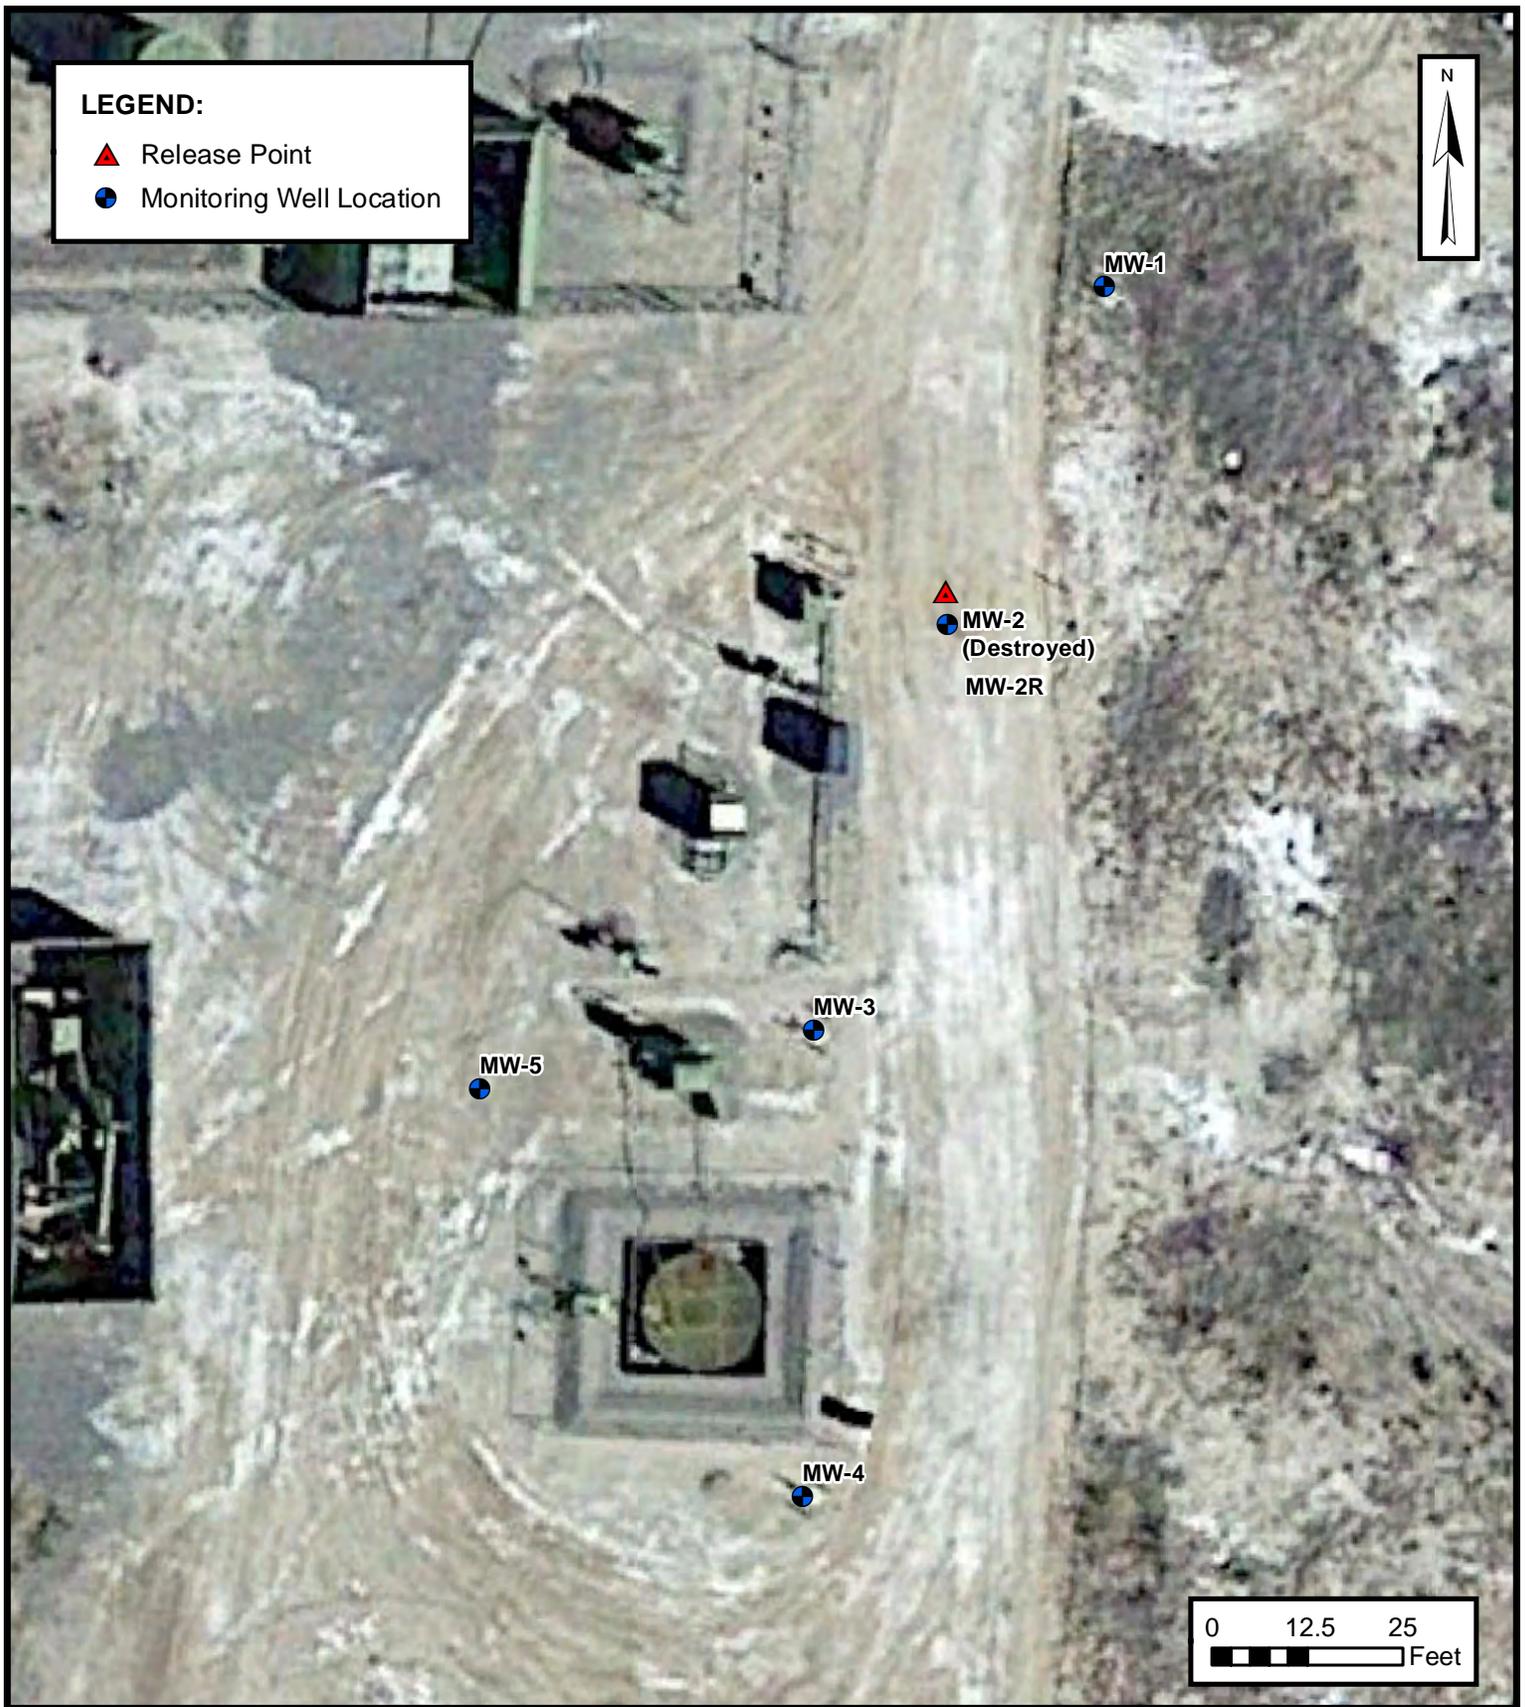
FIGURE
1

SITE VICINITY MAP

ENTERPRISE FIELD SERVICES, LLC
MASDEN GAS COM #1E
NW ¼, S28 T29N R11W, San Juan County, New Mexico
36.70096° N, 108.00164° W

The Site location is depicted on **Figure 1 of Appendix A** which was reproduced from a portion of a United States Geological Survey (USGS) 7.5-minute series topographic map. A **Site Vicinity Map**, created from an aerial photograph, depicts the approximate locations of the monitoring wells in relation to pertinent structures and general Site boundaries, is included as **Figure 2 of Appendix A**.

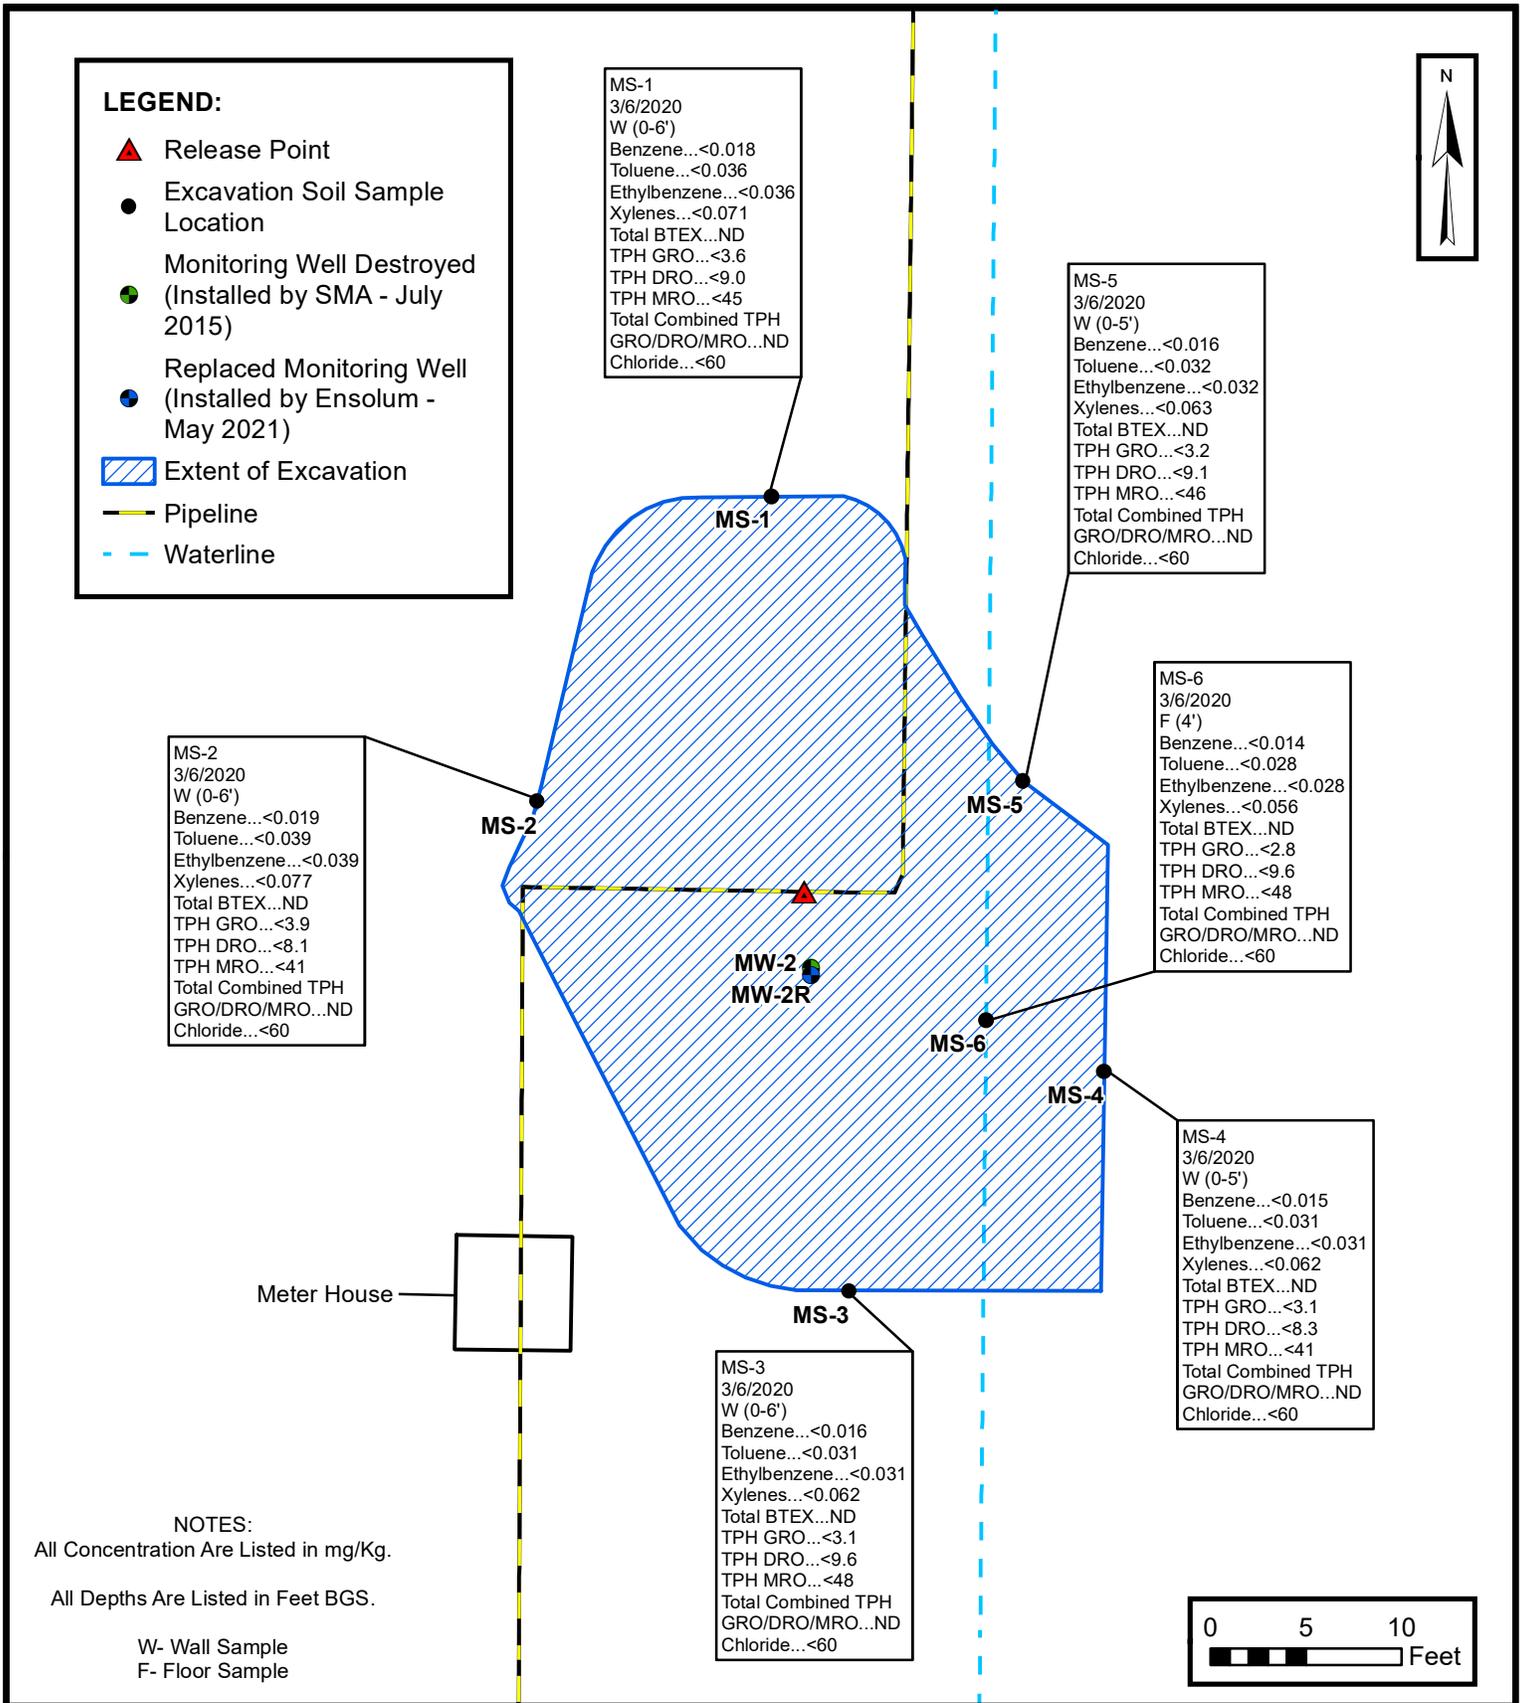
FIGURE
2

2020 EXCAVATION WITH SOIL ANALYTICAL RESULTS

On March 5, 2020, Enterprise initiated pipeline repair activities at the Site to facilitate the replacement of a section of pipe under the road next to the well pad. During these activities Enterprise elected to attempt to remove potential residual soil impact from the 2015 release. During the remediation and corrective action activities, Sunland Construction, Inc., (Sunland) provided heavy equipment and labor support, while Ensolum provided environmental consulting support. Monitoring well MW-2 was inadvertently destroyed during excavation activities.

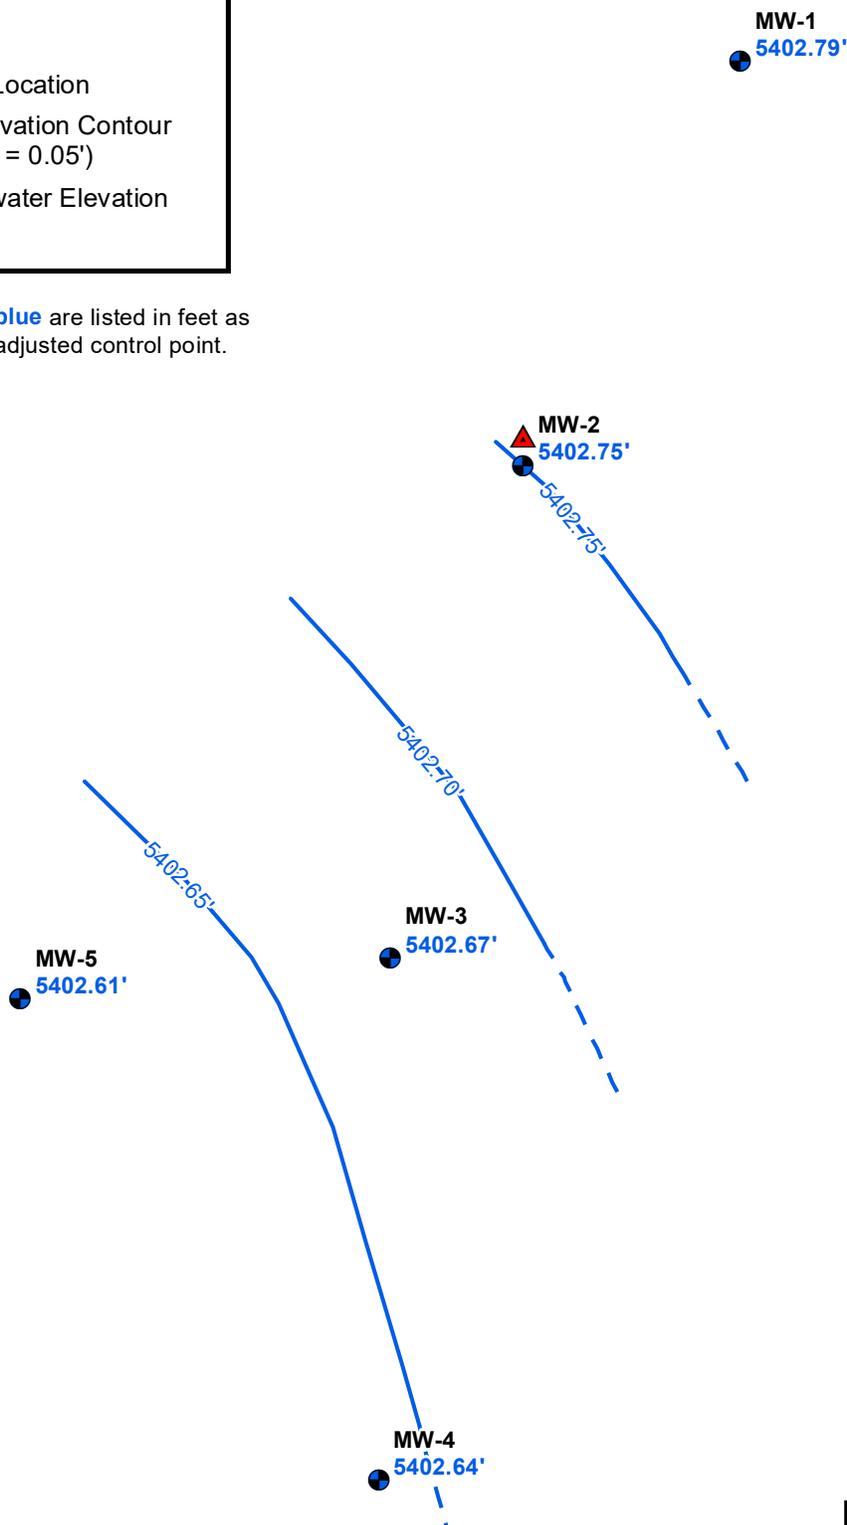
FIGURE
4A

Groundwater elevations in **blue** are listed in feet as measured from set OPUS adjusted control point.

GROUNDWATER GRADIENT MAP
NOVEMBER 2016
 ENTERPRISE FIELD SERVICES, LLC
 MASNEN GAS COM #1E
 NW ¼, S28 T29N R11W, San Juan County, New Mexico
 36.70096° N, 108.00164° W
 PROJECT NUMBER: 05A1226026

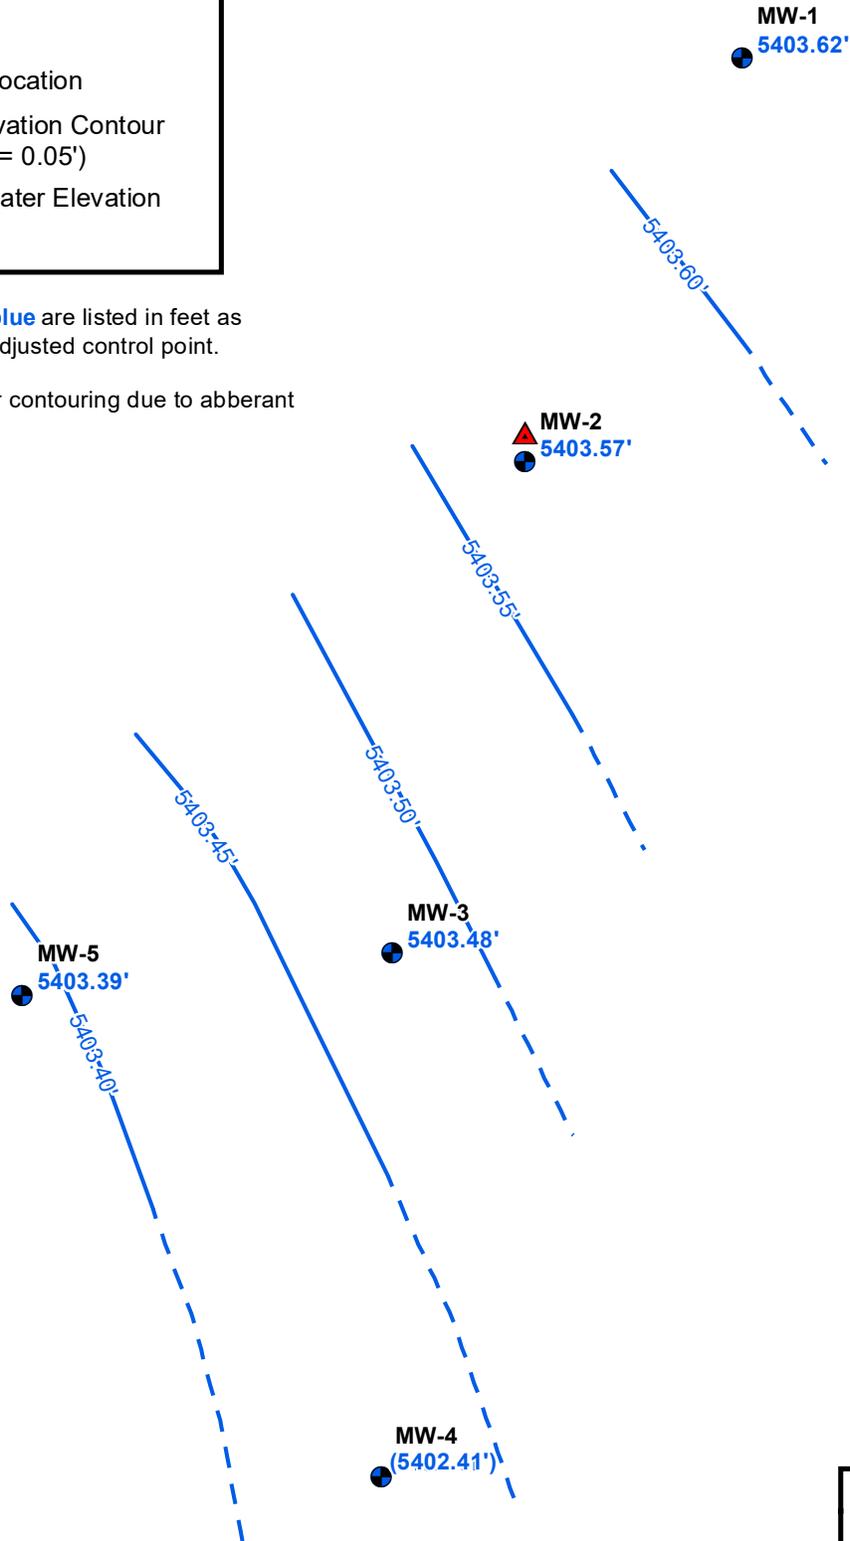
FIGURE
4B

(5402.41') Data not used for contouring due to aberrant gauging data.

GROUNDWATER GRADIENT MAP
FEBRUARY 2017
 ENTERPRISE FIELD SERVICES, LLC
 MASNEN GAS COM #1E
 NW ¼, S28 T29N R11W, San Juan County, New Mexico
 36.70096° N, 108.00164° W
 PROJECT NUMBER: 05A1226026

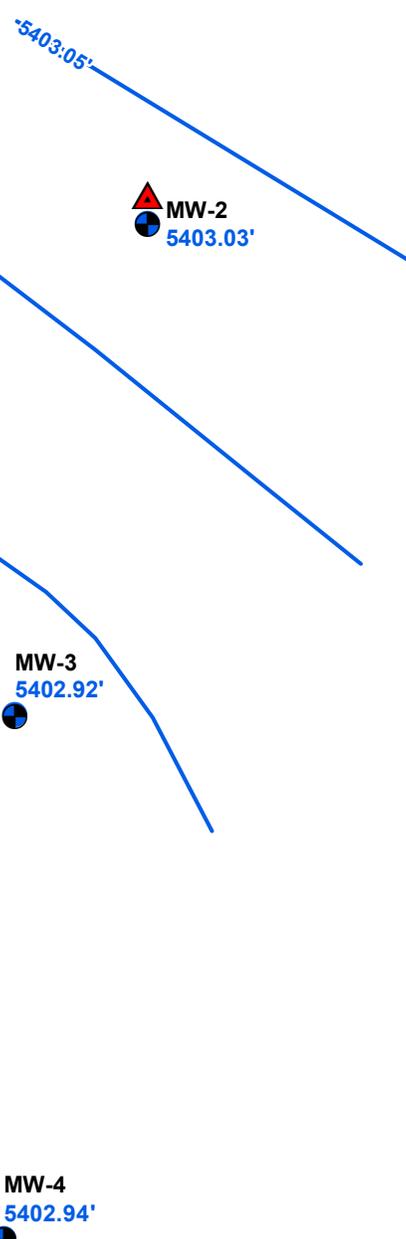
**FIGURE
4E**

**GROUNDWATER GRADIENT MAP
JANUARY 2018**
 ENTERPRISE FIELD SERVICES, LLC
 MASDEN GAS COM #1E
 NW ¼, S28 T29N R11W, San Juan County, New Mexico
 36.70096° N, 108.00164° W
 PROJECT NUMBER: 05A1226026

NOTE:
Groundwater elevations in **blue** are listed in feet as measured from set OPUS adjusted control point.

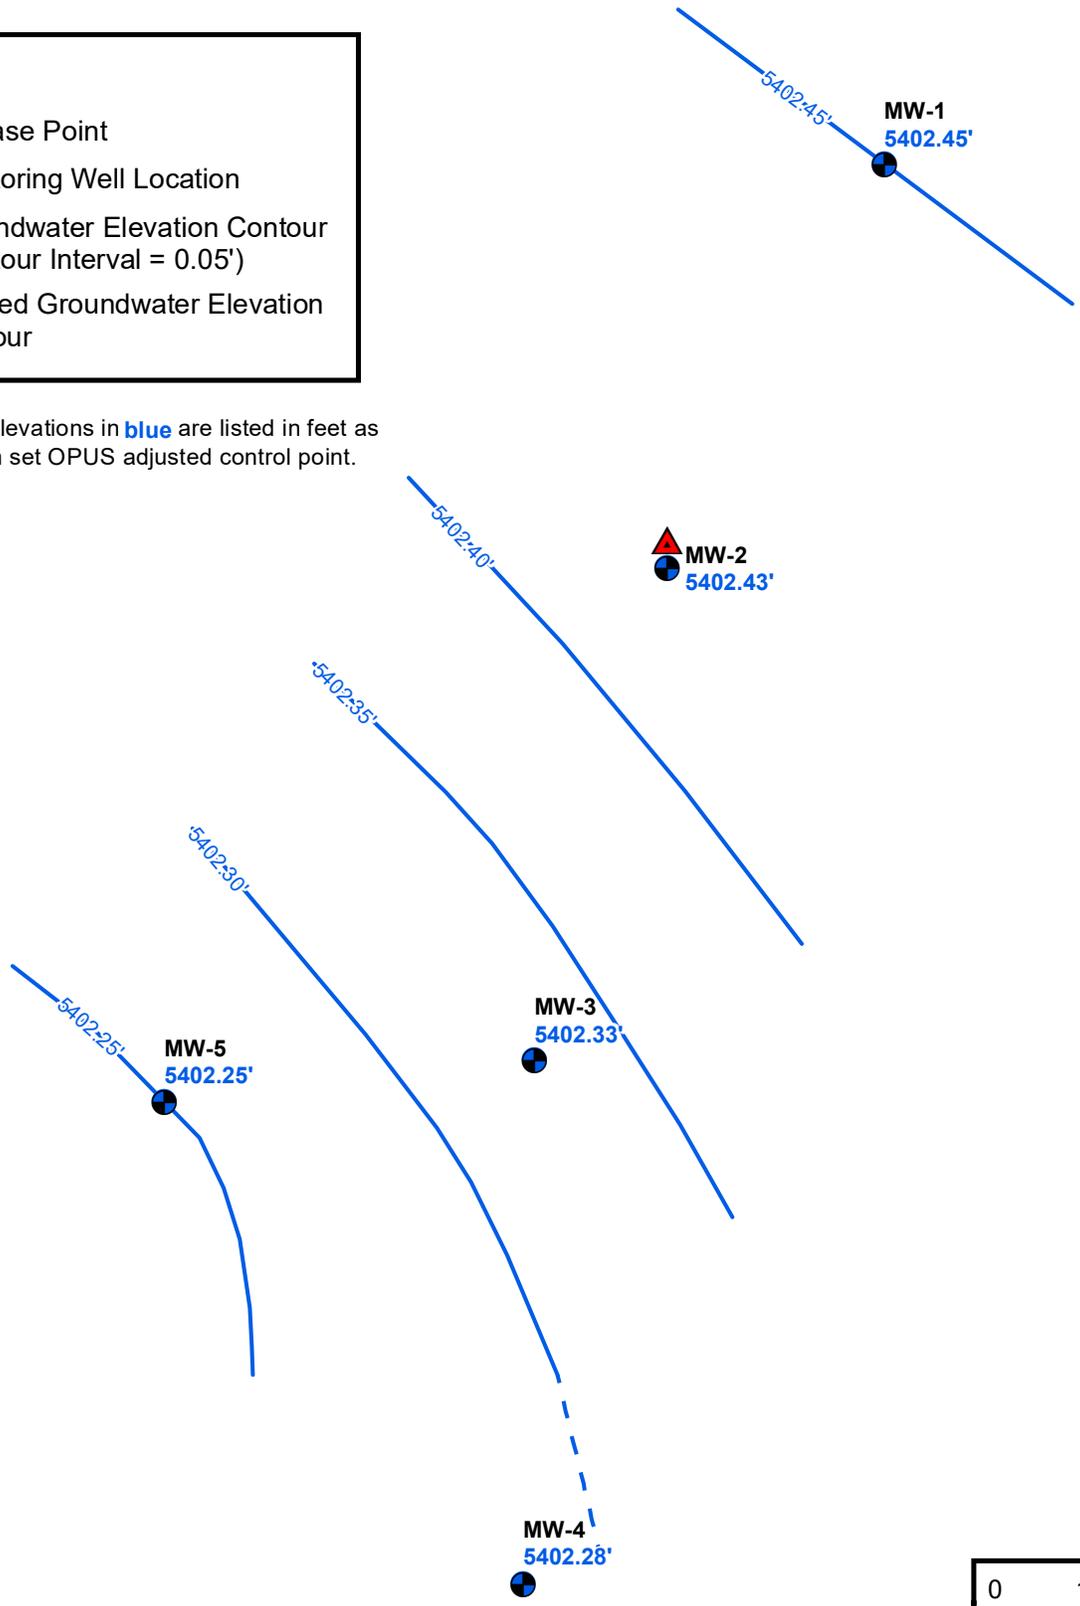
FIGURE
4G

GROUNDWATER GRADIENT MAP
JULY 2018
 ENTERPRISE FIELD SERVICES, LLC
 MASDEN GAS COM #1E
 NW ¼, S28 T29N R11W, San Juan County, New Mexico
 36.70096° N, 108.00164° W
 PROJECT NUMBER: 05A1226026

Groundwater elevations in **blue** are listed in feet as measured from set OPUS adjusted control point.

(5402.55') - Data not used for contouring due to aberrant gauging data.

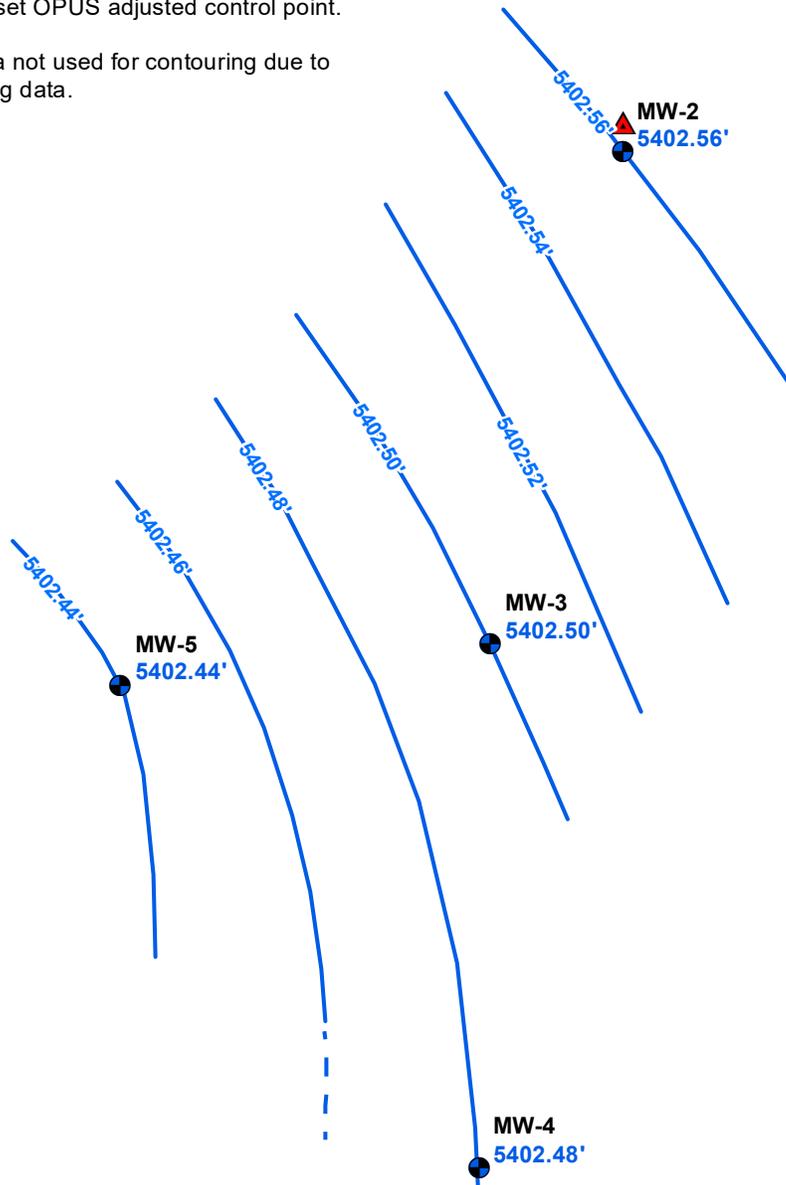
GROUNDWATER GRADIENT MAP
OCTOBER 2018
 ENTERPRISE FIELD SERVICES, LLC
 MASNEN GAS COM #1E
 NW ¼, S28 T29N R11W, San Juan County, New Mexico
 36.70096° N, 108.00164° W

(5403.11') - Monitoring Well MW-2 data was not used for contouring. MW-2 was damaged by vehicular traffic.

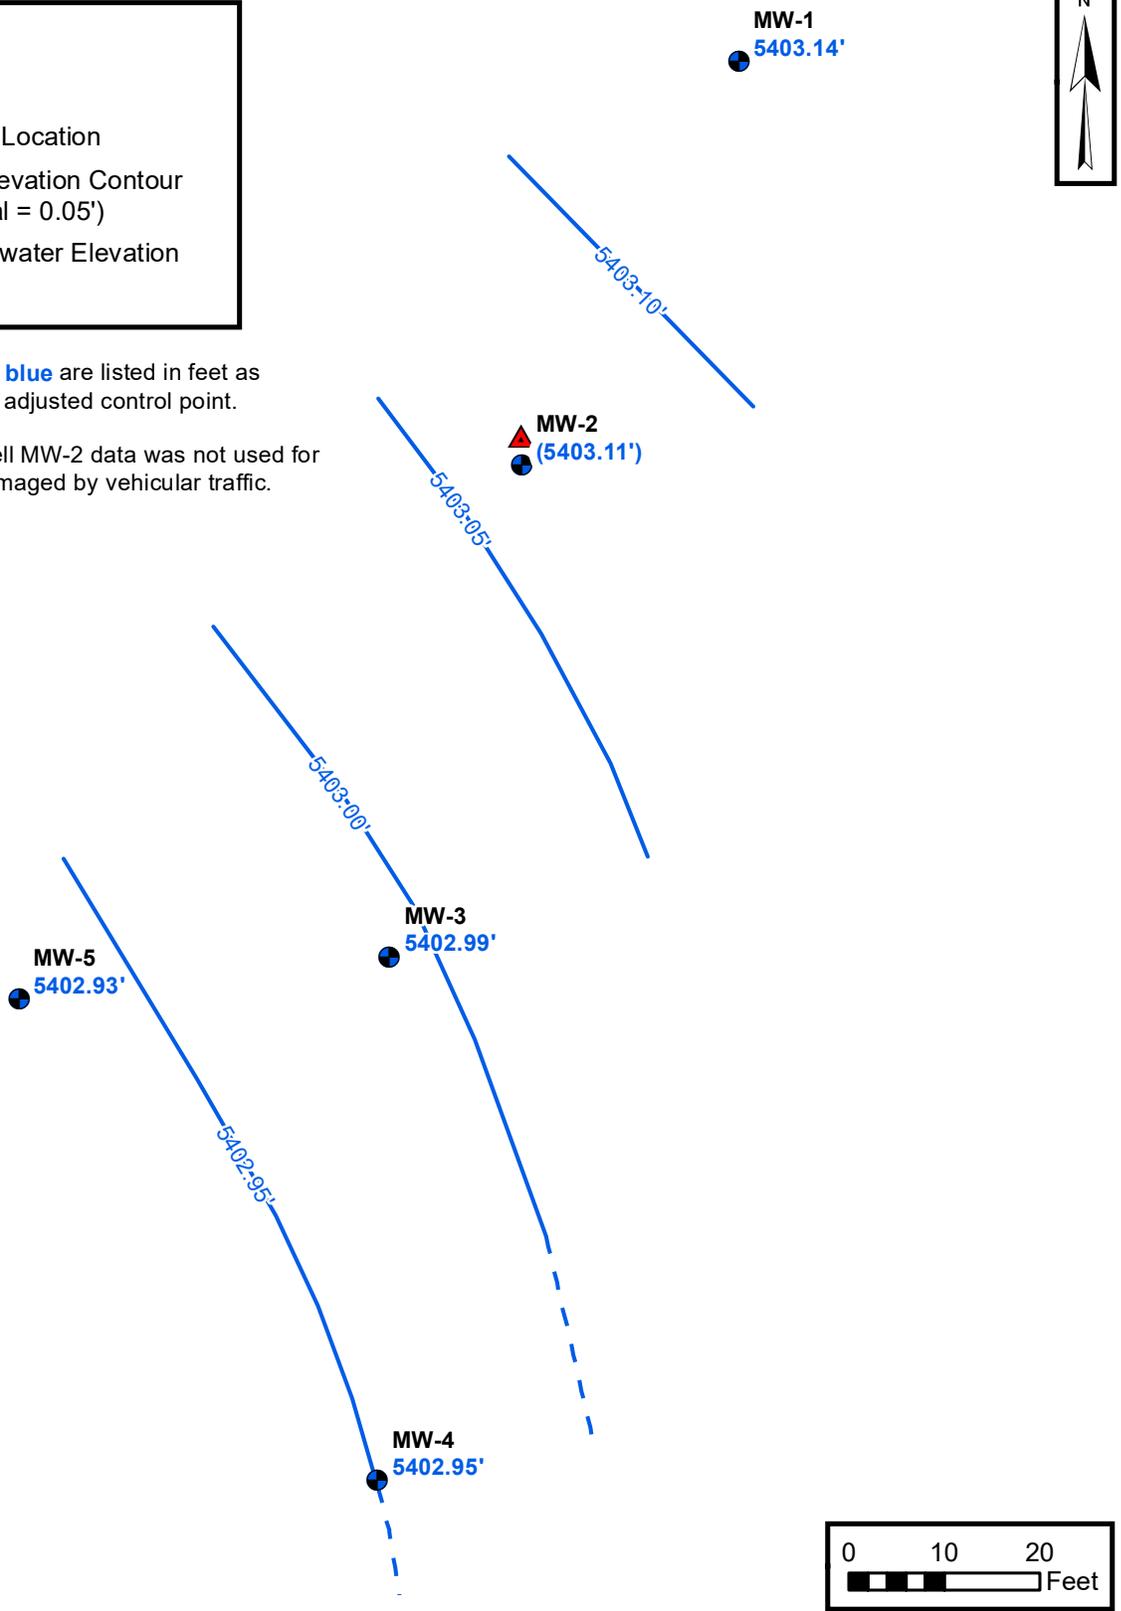
**GROUNDWATER GRADIENT MAP
 JANUARY 2019**
 ENTERPRISE FIELD SERVICES, LLC
 MASNEN GAS COM #1E
 NW ¼, S28 T29N R11W, San Juan County, New Mexico
 36.70096° N, 108.00164° W

NOTES:
 Groundwater elevations in **blue** are listed in feet as measured from set OPUS adjusted control point.
 (5402.60') - Monitoring Well MW-2 data was not used for contouring. MW-2 was damaged by vehicular traffic.

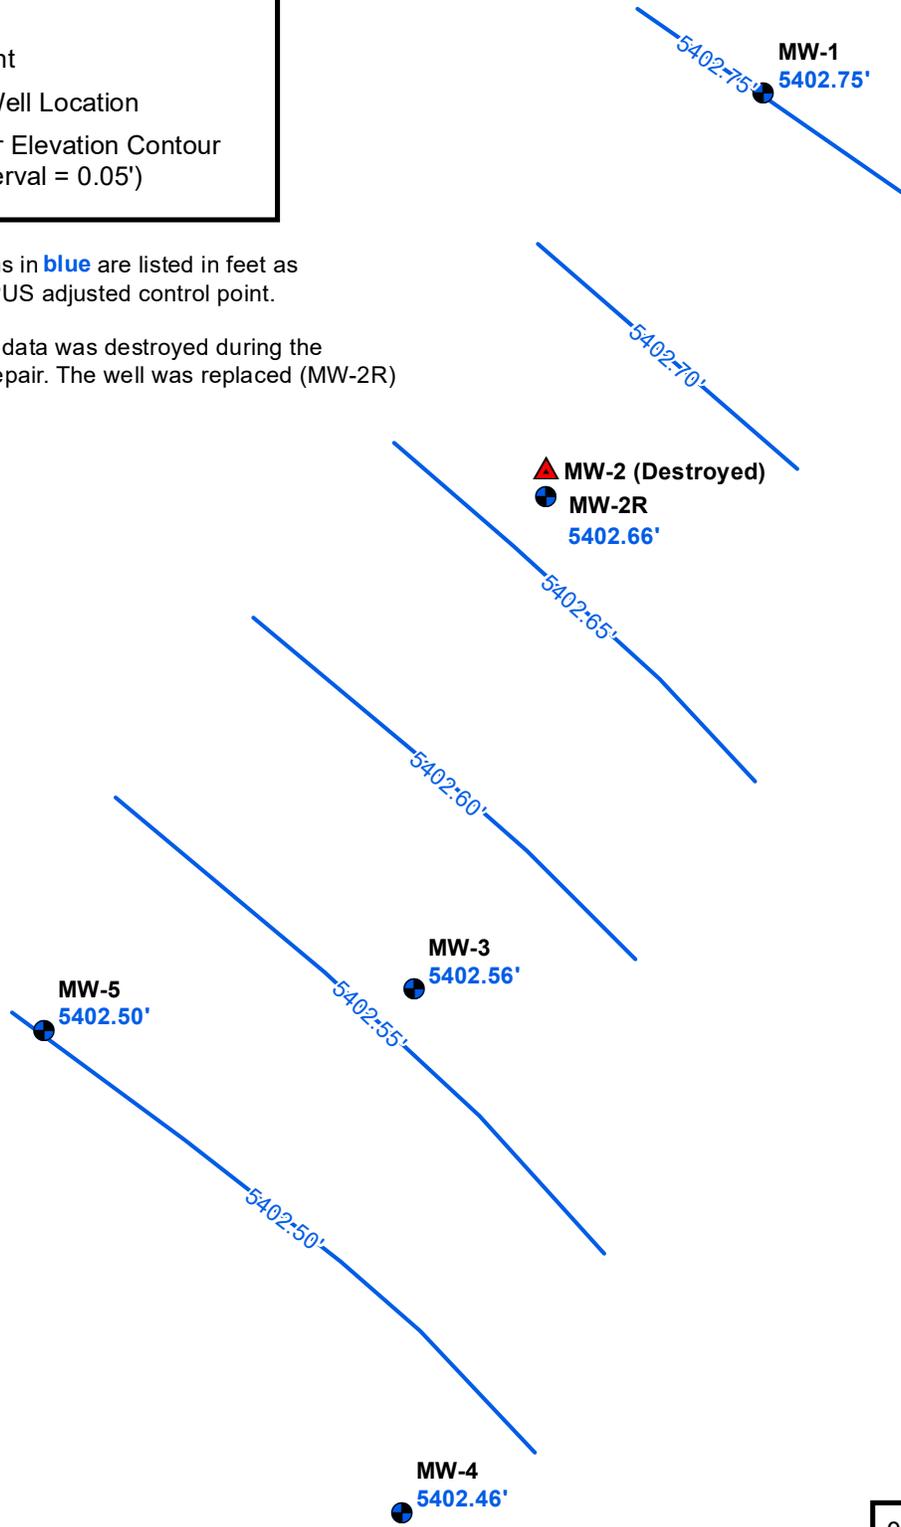
FIGURE
4N

GROUNDWATER GRADIENT MAP
JULY 2021
 ENTERPRISE FIELD SERVICES, LLC
 MASNEN GAS COM #1E
 NW ¼, S28 T29N R11W, San Juan County, New Mexico
 36.70096° N, 108.00164° W
 PROJECT NUMBER: 05A1226026

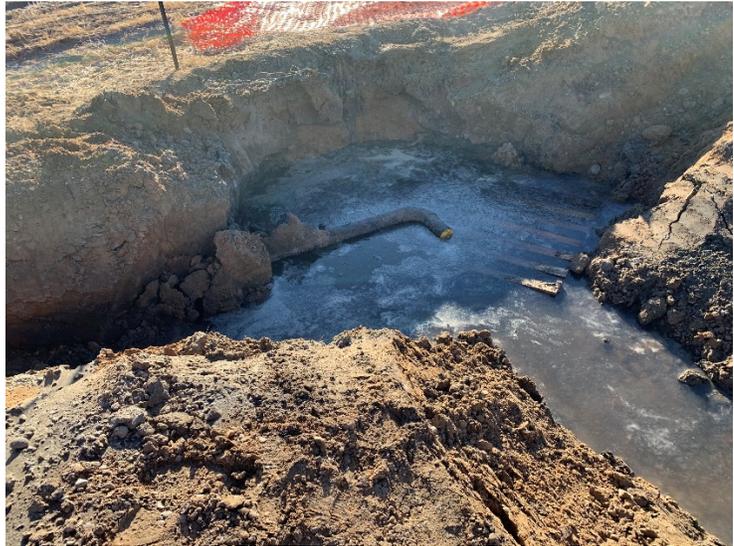
Photograph 1

Photograph Description: View of in-process excavation activities.

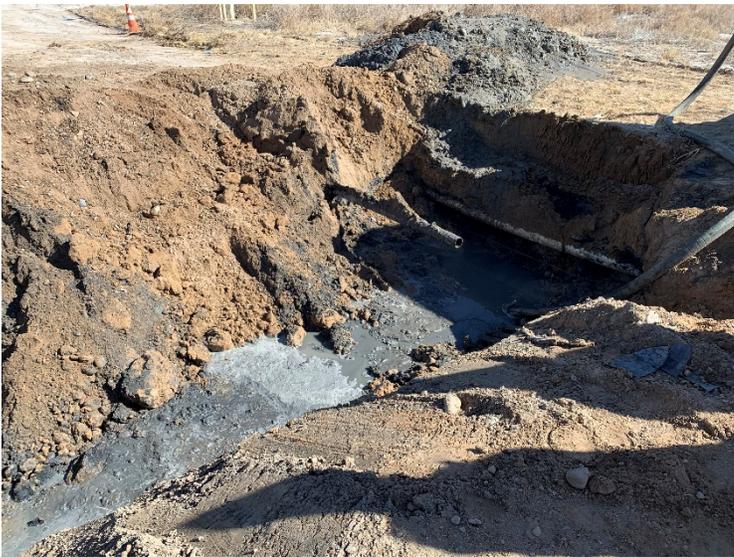
Photograph 2

Photograph Description: View of in-process excavation activities.

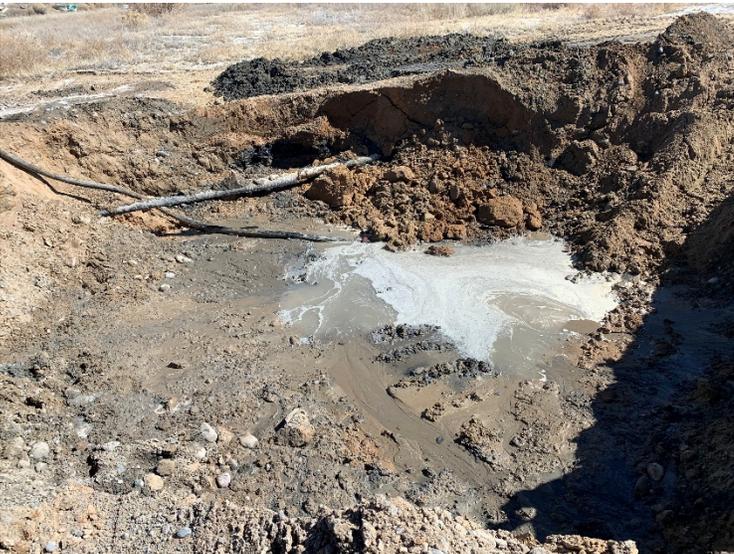
Photograph 3

Photograph Description: View of in-process excavation activities.

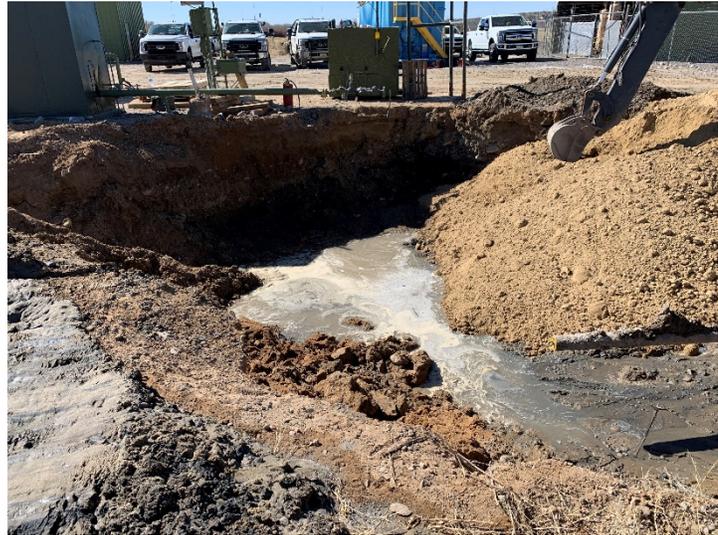
Photograph Description: View of in-process excavation activities.

Part of the excavation was backfilled with clean fill in order to accommodate pipeline repairs.

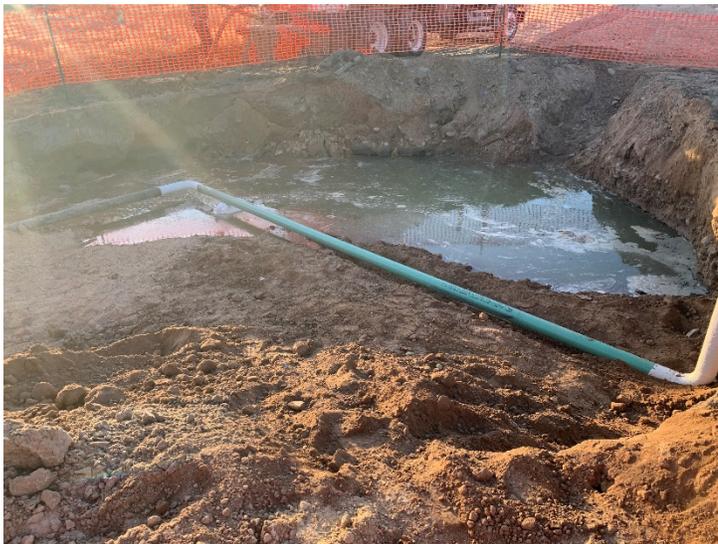
Photograph 5

Photograph Description: View of the final pipeline repair.

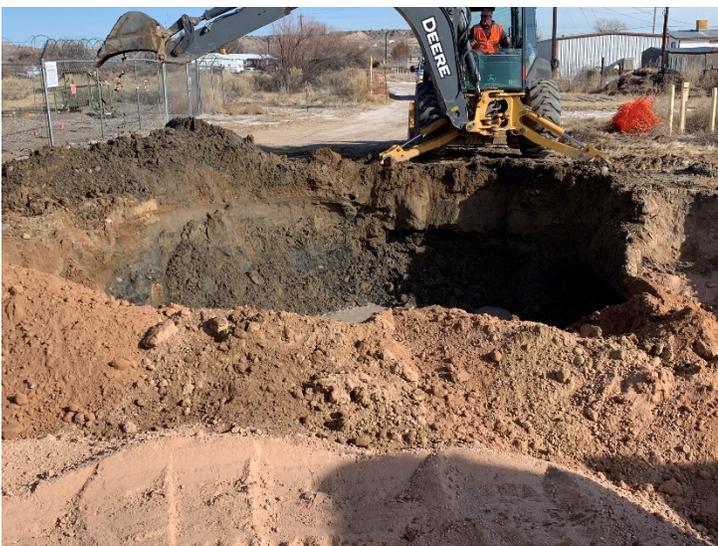
Photograph 6

Photograph Description: View of in-process excavation activities, after the final pipeline repair.

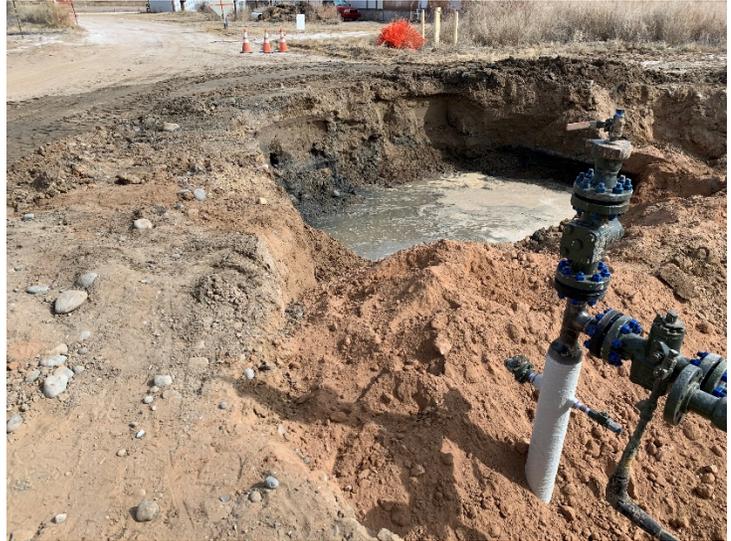
Photograph 7

Photograph Description: View of the final extent of the excavation.

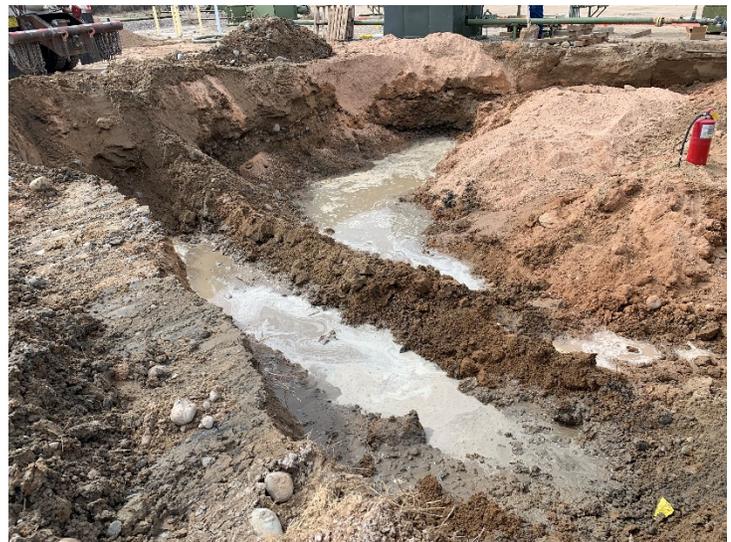
Photograph 8

Photograph Description: View of the final extent of the excavation.
