**Re: Closure Report  
Flagler 8 Fed Com 2H  
Devon Energy Production Company  
Site Location: Unit M, S8, T25S, R33E  
(Lat 32.1383519°, Long -103.6017077°)  
Lea County, New Mexico**

On behalf of Devon Energy Production Company (Devon), New Tech Global Environmental, LLC (NTGE) has prepared this letter to document site assessment and remedial action activities at the Flagler 8 Fed Com 2H (Site). The Site is located approximately 24 miles west of Jal, New Mexico in Lea County (Figures 1 and 2).

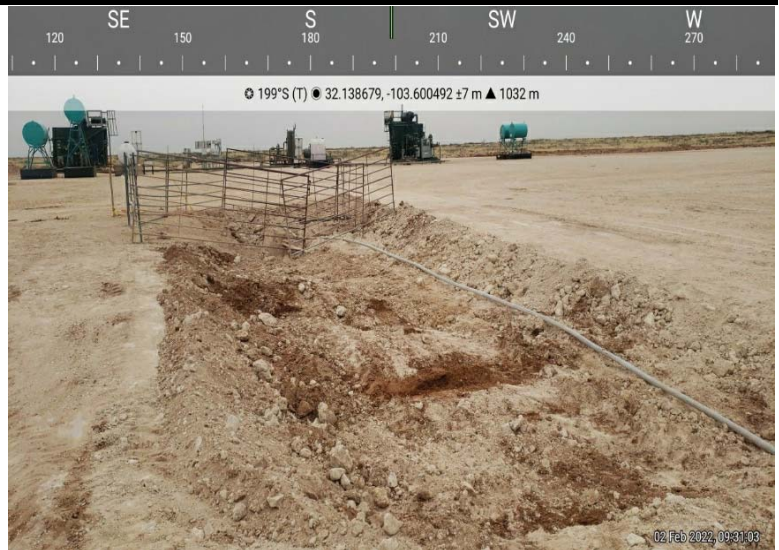
**Photograph No. 2**

**Description:**  
View of excavation.

On January 25-27, 2022, remedial action activities were conducted to address the extent of potential impacts. The excavation was advanced adjacent to the point of release to a depth of 1.5 ft bgs and was extended horizontally based on soil field screening results. A total of six (6) confirmation samples (CS-1 through CS-6) were collected from the excavation base and four (4) confirmation samples (SW-1 through SW-4) were collected from the excavation sidewalls ensure impacted soil was removed. The confirmation samples were collected in accordance with the one sample per 200 ft<sup>2</sup> guideline established in the regulatory criteria. The confirmation sample locations and final excavation extent are illustrated on Figure 4. A photographic log documenting remedial action activities is attached.

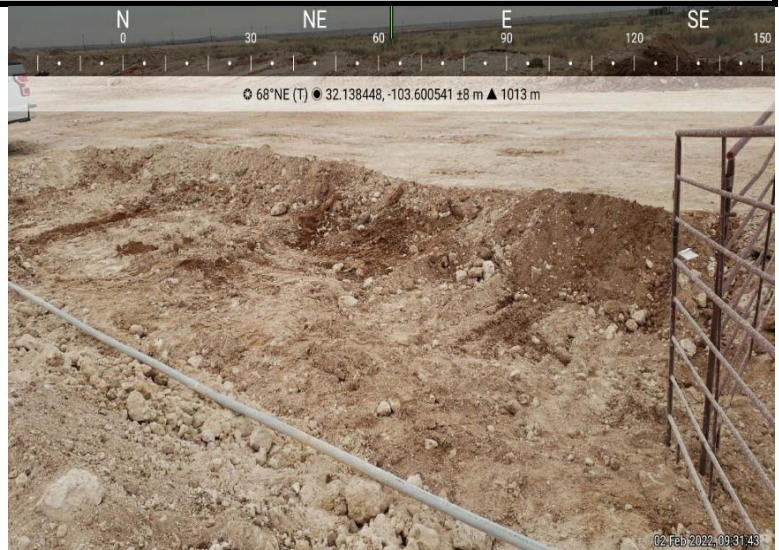
**Photograph No. 3**

**Description:**  
View of excavation.
