Release Notification

RE: CLOSURE REPORT
Horton Compressor Station Release
Facility ID No. fCS00000000189
NMOCD Incident No. NAPP2105050187
NE¼ SW¼, Section 27, T32N, R12W
San Juan County, New Mexico

Horton C.S. Release Excavation Clearance Report

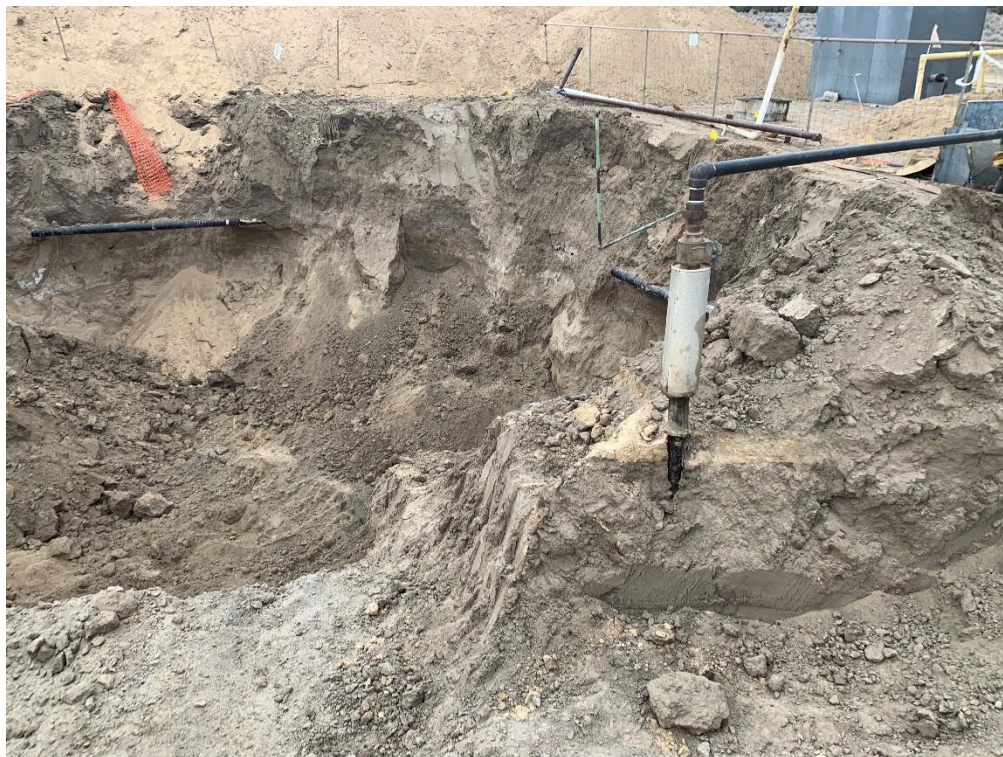
Photo 1: Excavation in progress. View is to the southwest.

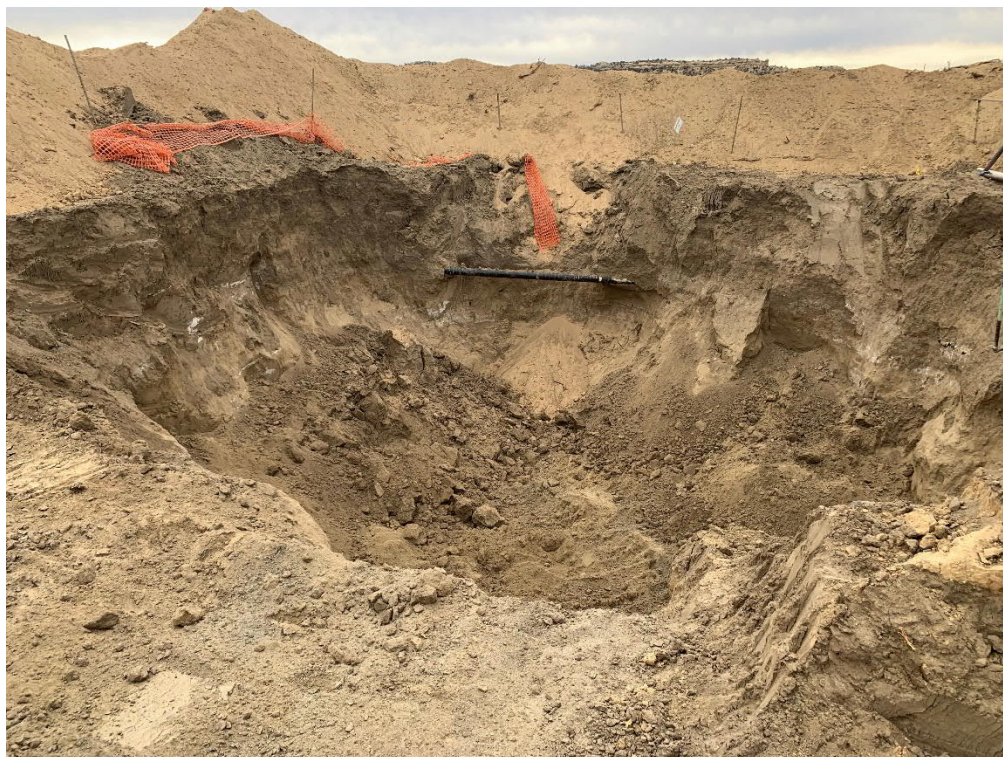
Photo 2: Excavation in progress. View is to the southeast.

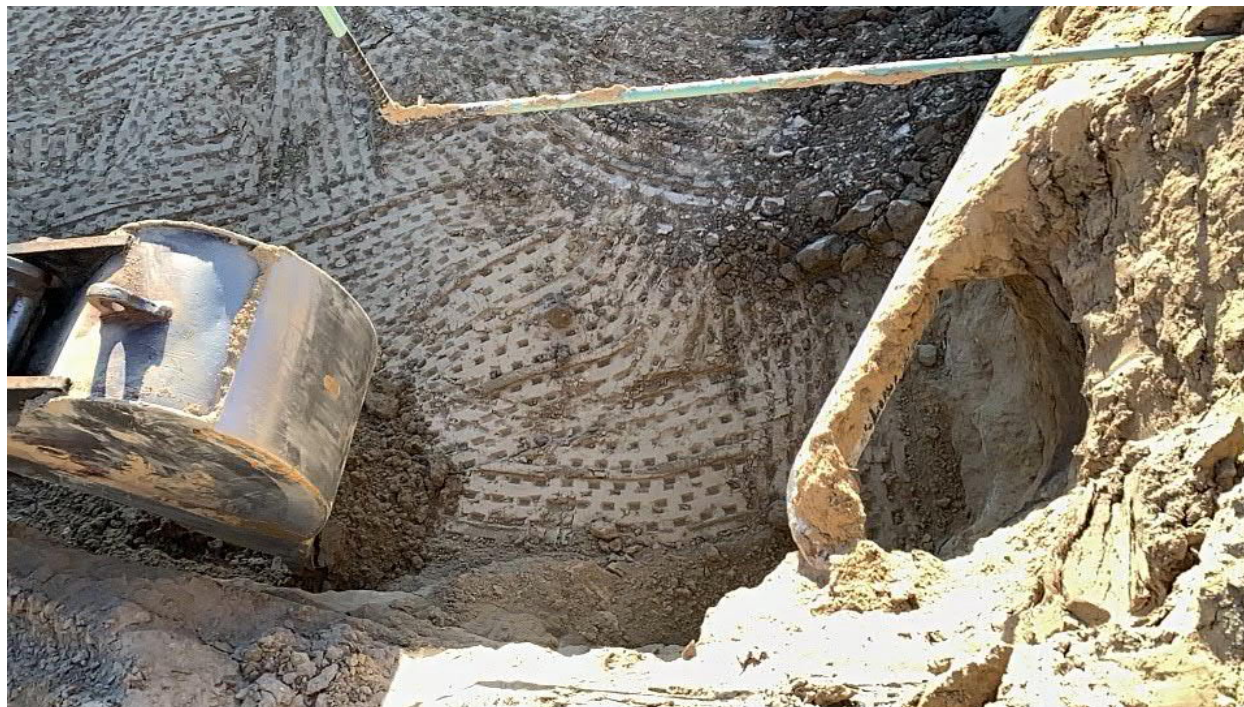
Photo 4: Northwest corner of excavation.

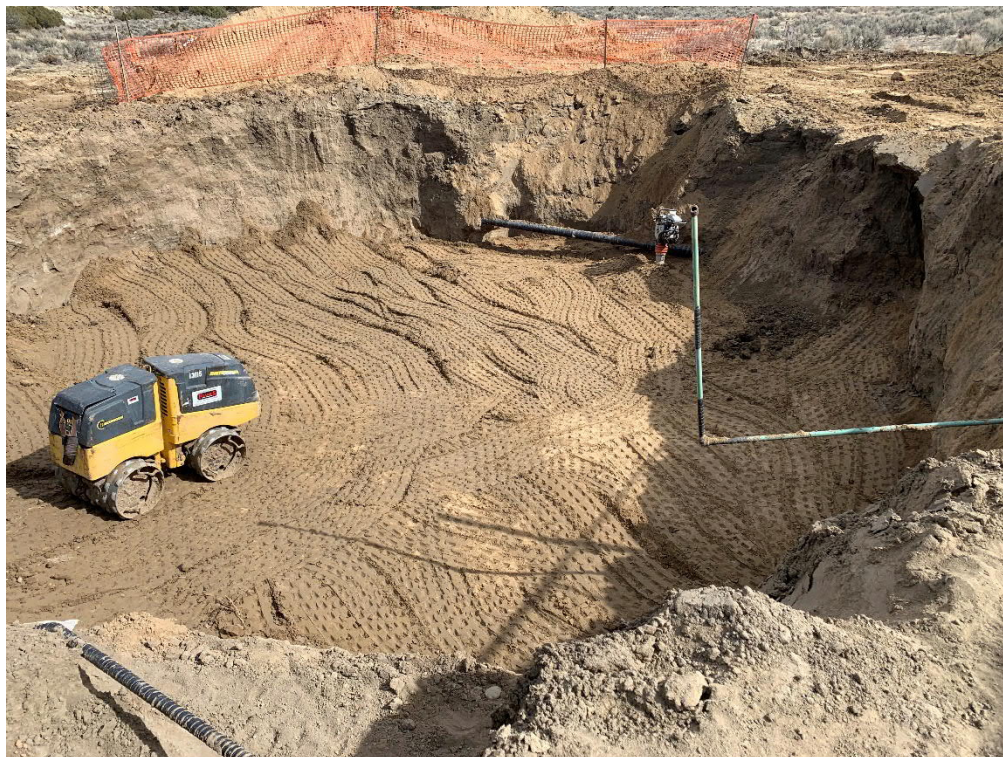
Photo 5: Excavation. View is to the south.

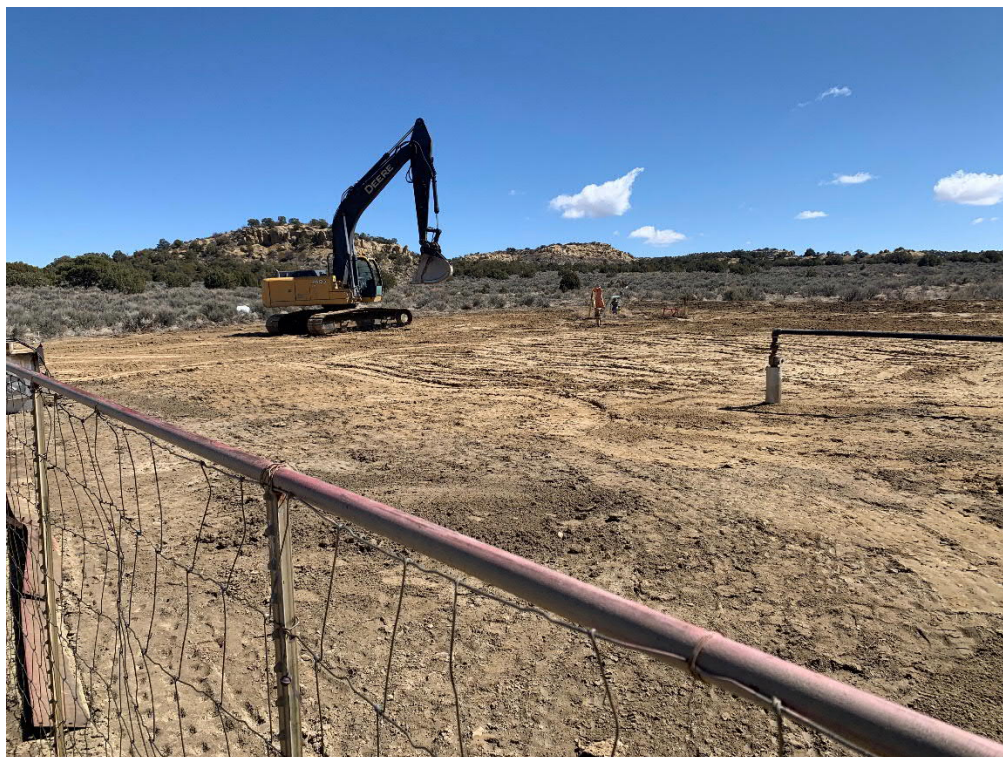
Photo 6: Backfilled excavation, April 2021.
