**Spill Closure Report:** Cotton Draw Unit #153  
Unit B, Section 3, Township 25 South, Range 31 East  
County: Eddy  
API: 30-015-38535  
Tracking Number: NAB1524750307

**Prepared For:** Devon Energy Production Company  
6488 Seven Rivers Highway  
Artesia, New Mexico 88210

2019 Spill Assessment and Closure  
April 2020

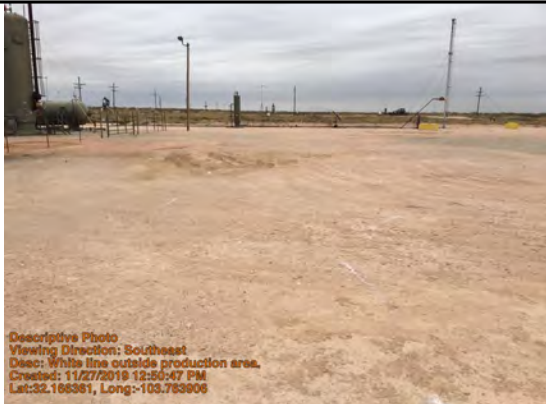
Descriptive Photo  
Viewing Direction: Southeast  
Desc: White line outside production area.  
Created: 11/27/2019 12:50:47 PM  
Lat:32.166361, Long:-103.763906

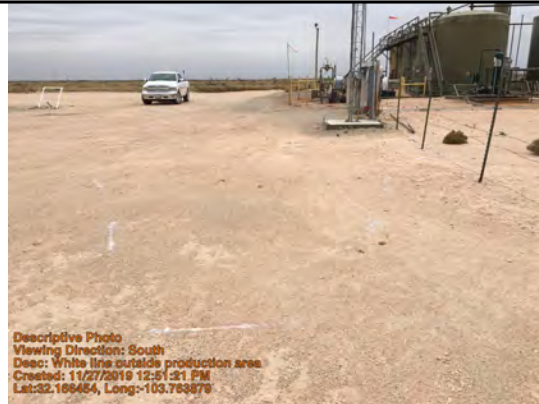
Descriptive Photo  
Viewing Direction: South  
Desc: White line outside production area  
Created: 11/27/2019 12:51:21 PM  
Lat:32.166454, Long:-103.763976

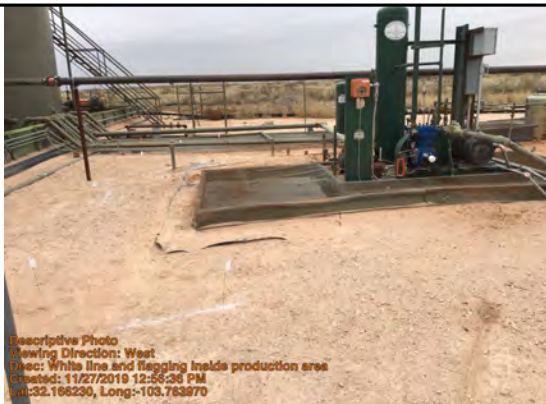
Descriptive Photo  
Viewing Direction: West  
Desc: White line and flagging inside production area  
Created: 11/27/2019 12:56:36 PM  
Lat:32.166230, Long:-103.763970

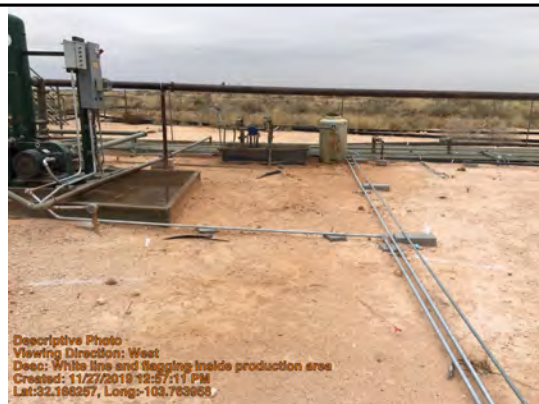
Descriptive Photo  
Viewing Direction: West  
Desc: White line and flagging inside production area  
Created: 11/27/2019 12:57:11 PM  
Lat:32.166257, Long:-103.763965

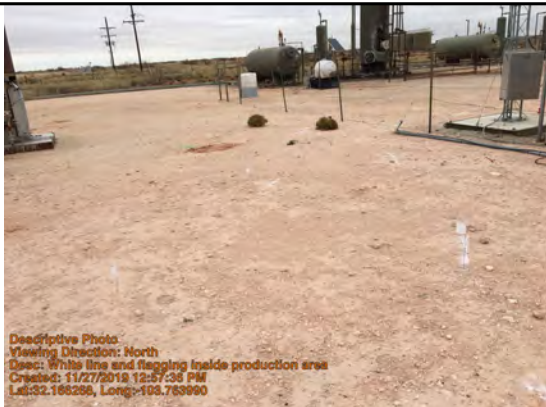
Viewing Direction: North

White line and flagging inside production area

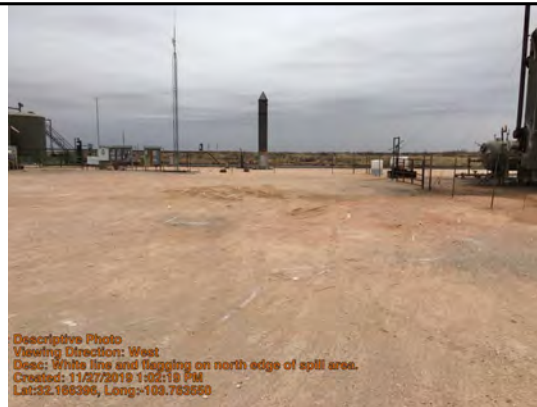
Viewing Direction: West

White line and flagging on north edge of spill area.

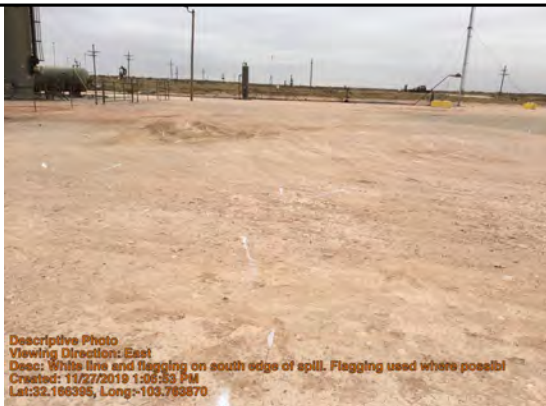
Viewing Direction: East

White line and flagging on south edge of spill. Flagging used where possible.

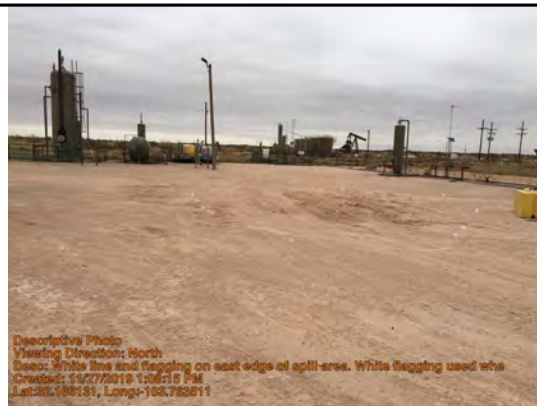
Viewing Direction: North

White line and flagging on east edge of spill area. White flagging used where possible.

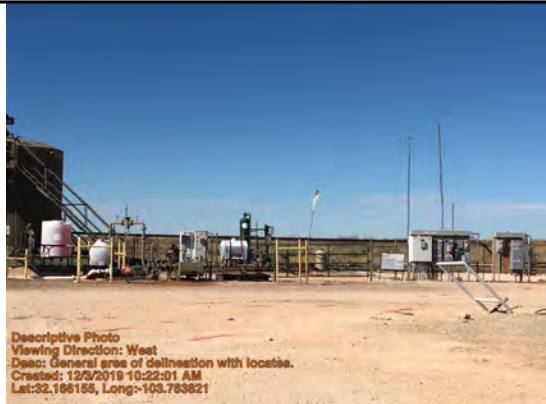
**Viewing Direction: West**

Descriptive Photo  
Viewing Direction: West  
Desc: General area of delineation with locates.  
Created: 12/3/2019 10:22:01 AM  
Lat:32.166155, Long:-103.763621

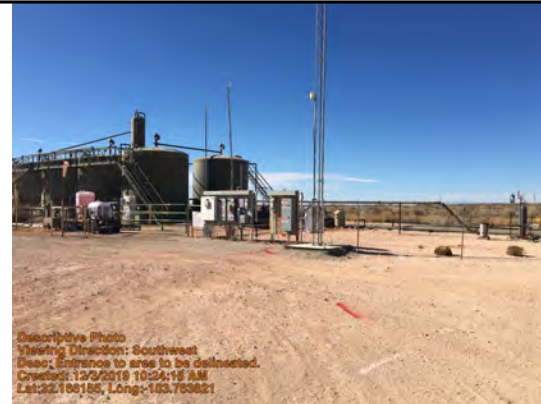
**Viewing Direction: Southwest**

Descriptive Photo  
Viewing Direction: Southwest  
Desc: Entrance to area to be delineated.  
Created: 12/3/2019 10:24:16 AM  
Lat:32.166155, Long:-103.763621

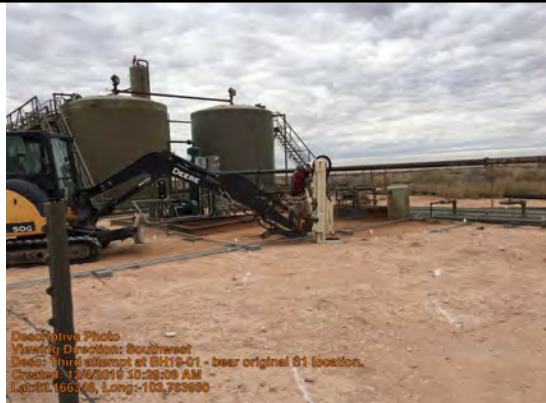
Viewing Direction: Southwest

Third attempt at BH19-01 - bear original S1 location.

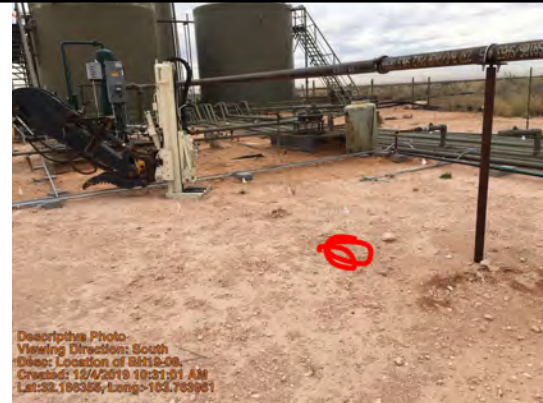
Viewing Direction: South

Location of BH19-06.

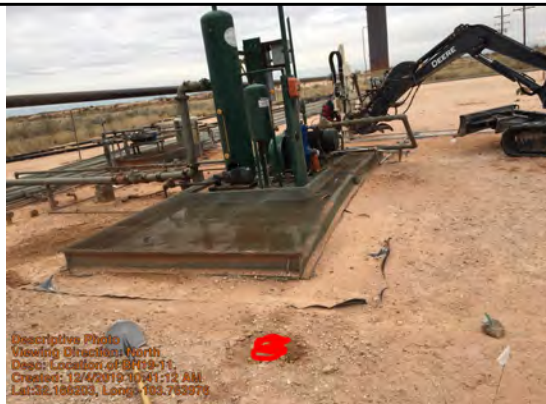
Viewing Direction: North

Location of BH19-11.

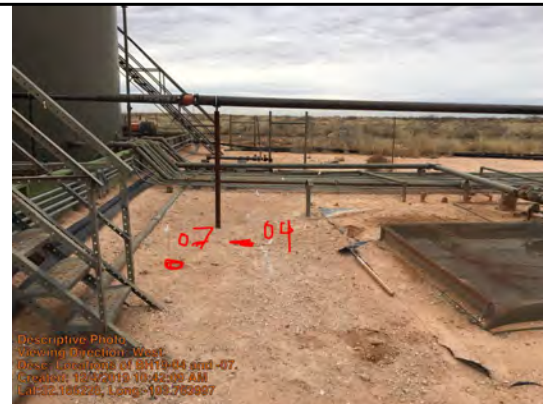
Viewing Direction: West

Locations of BH19-04 and -07.

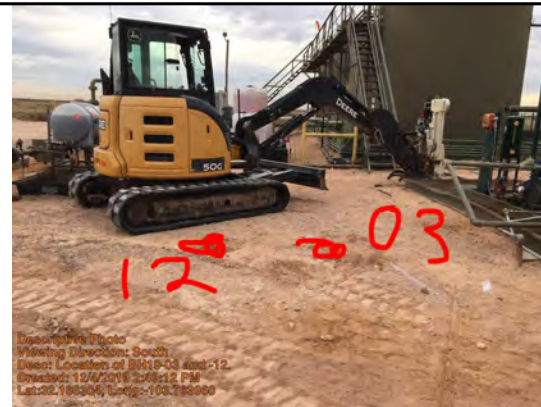
Viewing Direction: South

Location of BH19-03 and -12.

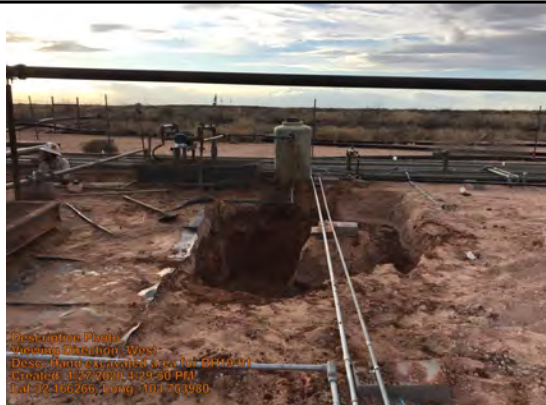
Viewing Direction: West

Hand excavated area for BH19-01

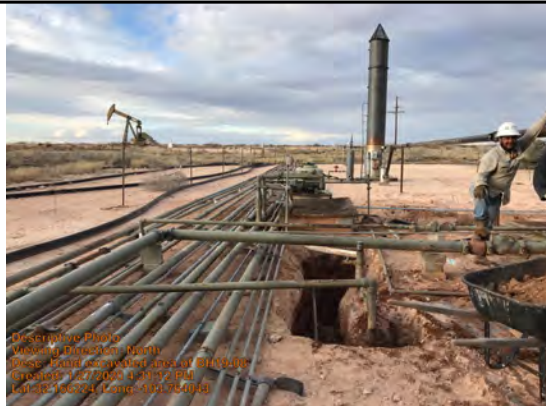
Viewing Direction: North

Hand excavated area of BH19-08

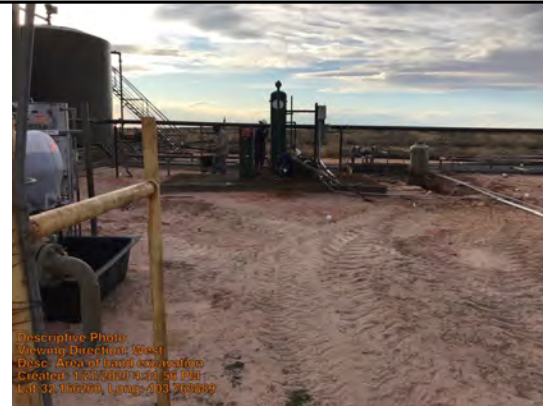
Viewing Direction: West

Area of hand excavation

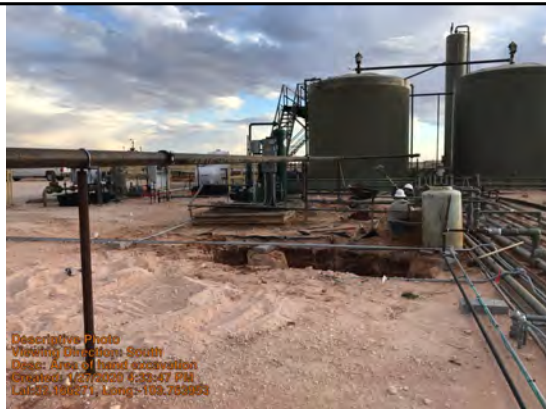
Viewing Direction: South

Area of hand excavation
