## Release Notification

# Release Closure Report

## Jicarilla 95-7B

API #30-039-26854

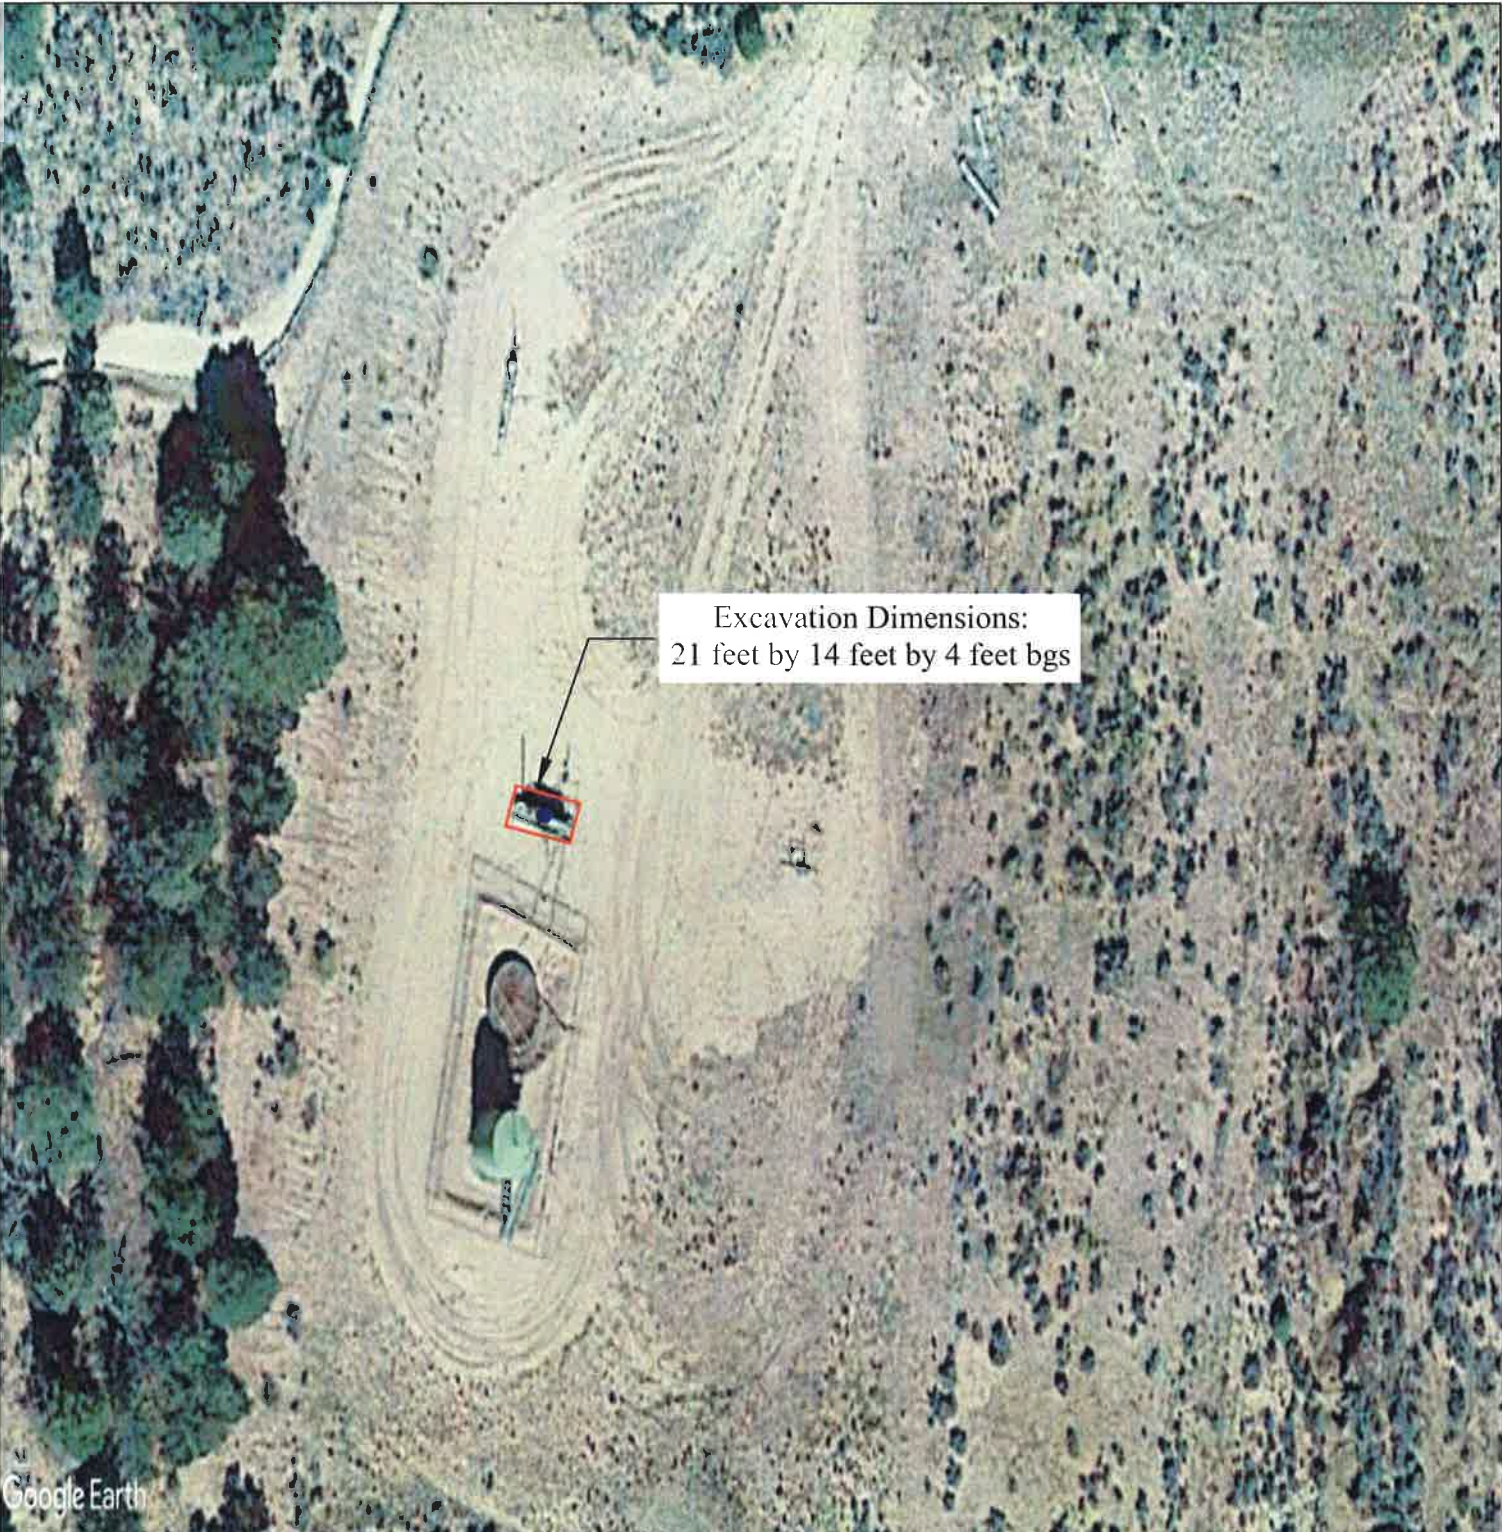
Figure 2, *Site Map*

Per direction from Keith Manwell, JOGA Environmental Specialist, Envirotech personnel collected a five-point composite sample from the excavation base on November 18, 2020. The sample was collected from approximately 4 feet below ground surface (bgs). The soil sample was placed into individual laboratory provided 4-ounce jars, capped head space free, and transported on ice to Envirotech Analytical Laboratory. The soil sample location is illustrated in **Figure 2, Site Map and Appendix C, Site Photography**.

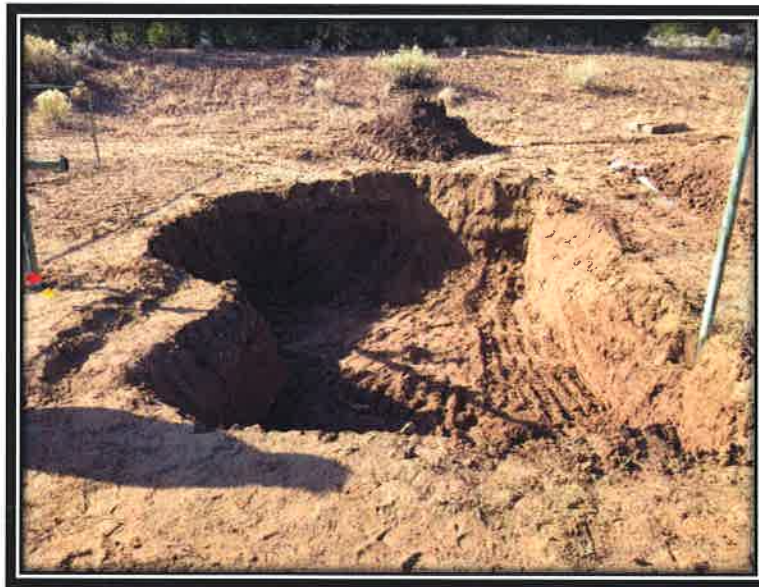
Picture 1: Excavation Base

The soil sample was analyzed per analytical methods referenced in 19.15.29.12 NMAC. The laboratory analytical results were below laboratory detection limits for all contaminants of concern. Analytical results are summarized below and in **Appendix D, Laboratory Analytical Report**.

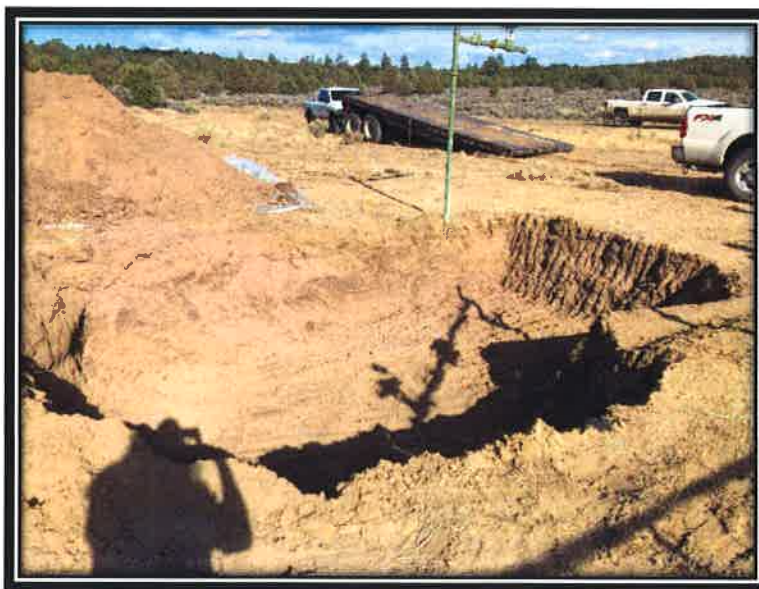
Picture 2: Excavation Base and Sidewalls

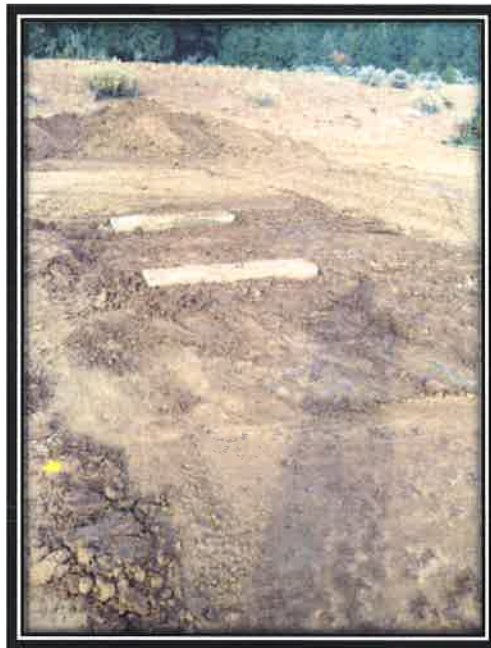
Picture 3: Backfill with New Footers

Logo's contractor completed the backfill of the subject excavation on December 2, 2020. The excavation was backfilled with non-waste containing, earthen material. The site was recontoured and graded to prevent ponding and erosion. New equipment was placed back into service within the former release site; therefore, reseeding was not necessary. Backfill photos are provided in **Appendix C**.

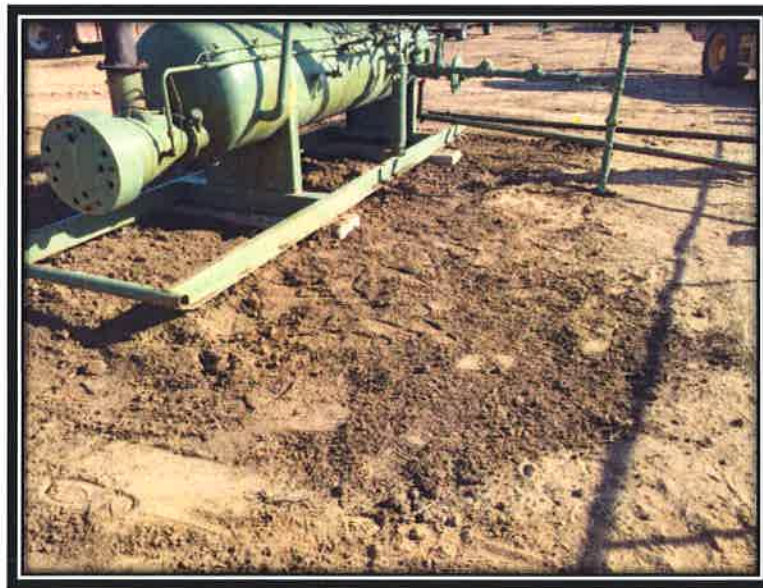
Picture 4: Equipment Placement
