Re: Site Assessment, Remediation, and Closure Report
Morris Boyd State Com #005H
API No. 30-015-44741
GPS: Latitude 32.640573 Longitude -104.458892
UL --N, Sec. 23, T19S, R25E
Eddy County, NM
NMOCD Ref. No. NAPP2105350868

Pima Environmental Services, LLC (Pima) has been contracted by Spur Energy Partners, LLC. (Spur) to perform a spill assessment, remediation, and submit this closure report for a crude oil release that occurred at the Morris Boyd State Com #005H (Morris). The initial C-141 was submitted on March 4th, 2021 (Appendix C). This incident was assigned Incident ID NAPP2105350868, by the New Mexico Oil Conservation Division (NMOCD).

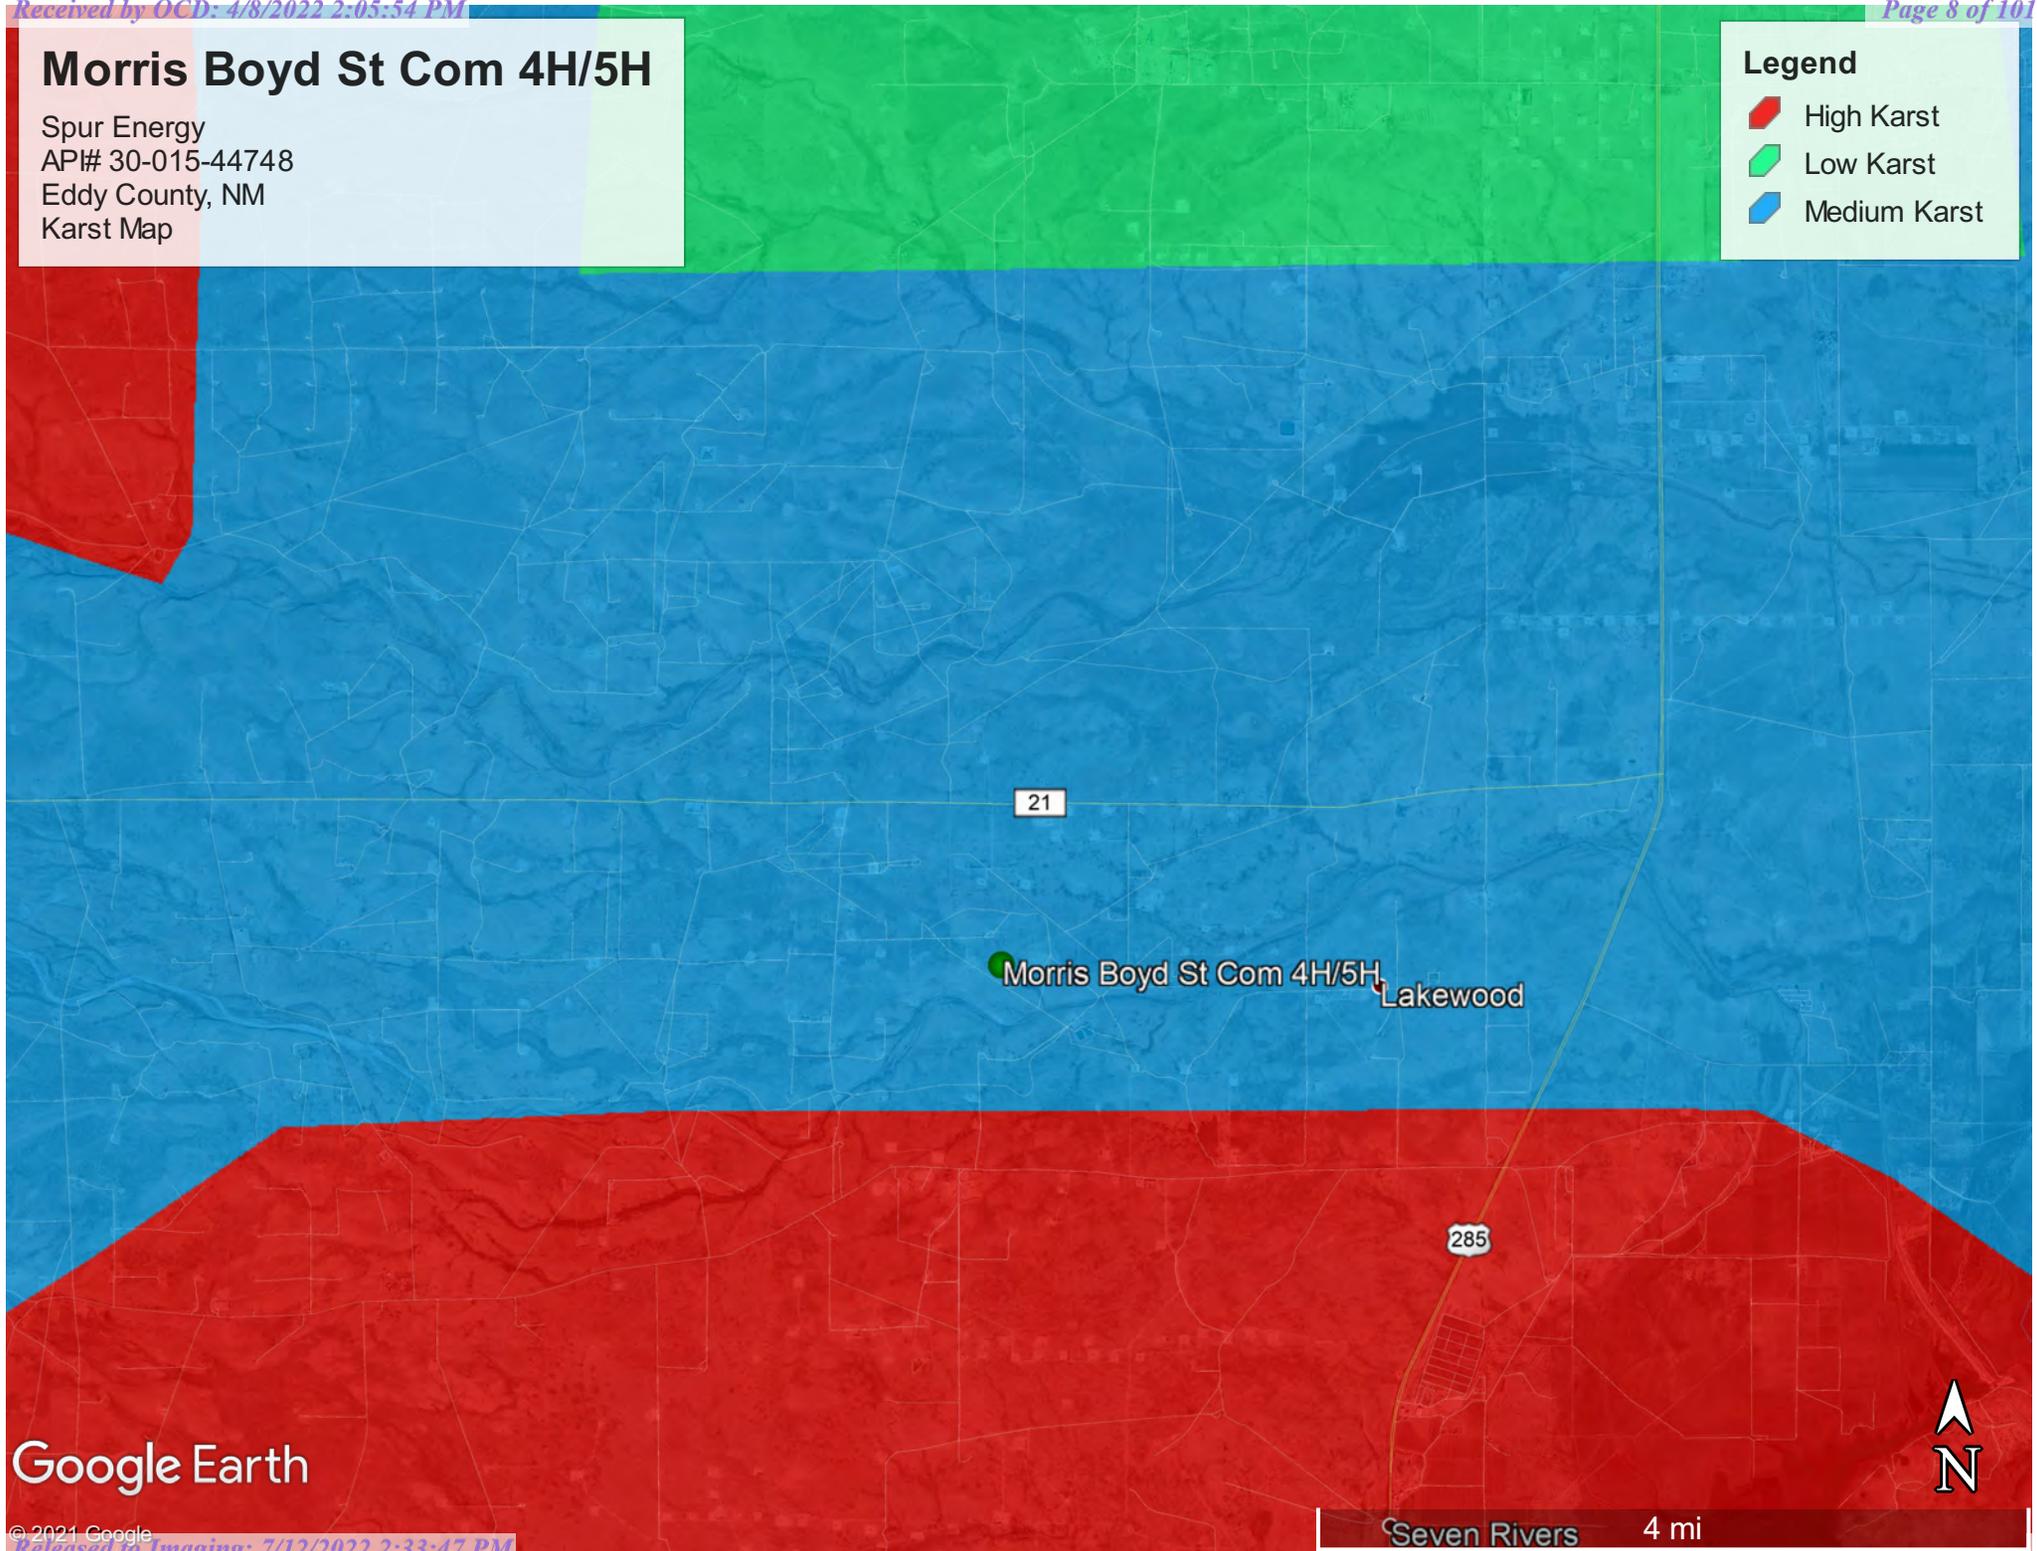
Per the New Mexico Bureau of Geology and Mineral Resources, the geology is made up of Piedmont alluvial deposits. Includes deposits of higher gradient tributaries bordering major stream valleys, alluvial veneers of the piedmont slope, and alluvial fans. May locally include uppermost Pliocene deposits. The soil in this area is made up of Pima silt loam, 0 to 1 percent slopes according to the United States Department of Agriculture Natural Resources Conservation Service soil survey (Appendix B). The drainage courses in this area are well drained. There is a medium potential for karst geology to be present around the Morris (Figure 3).

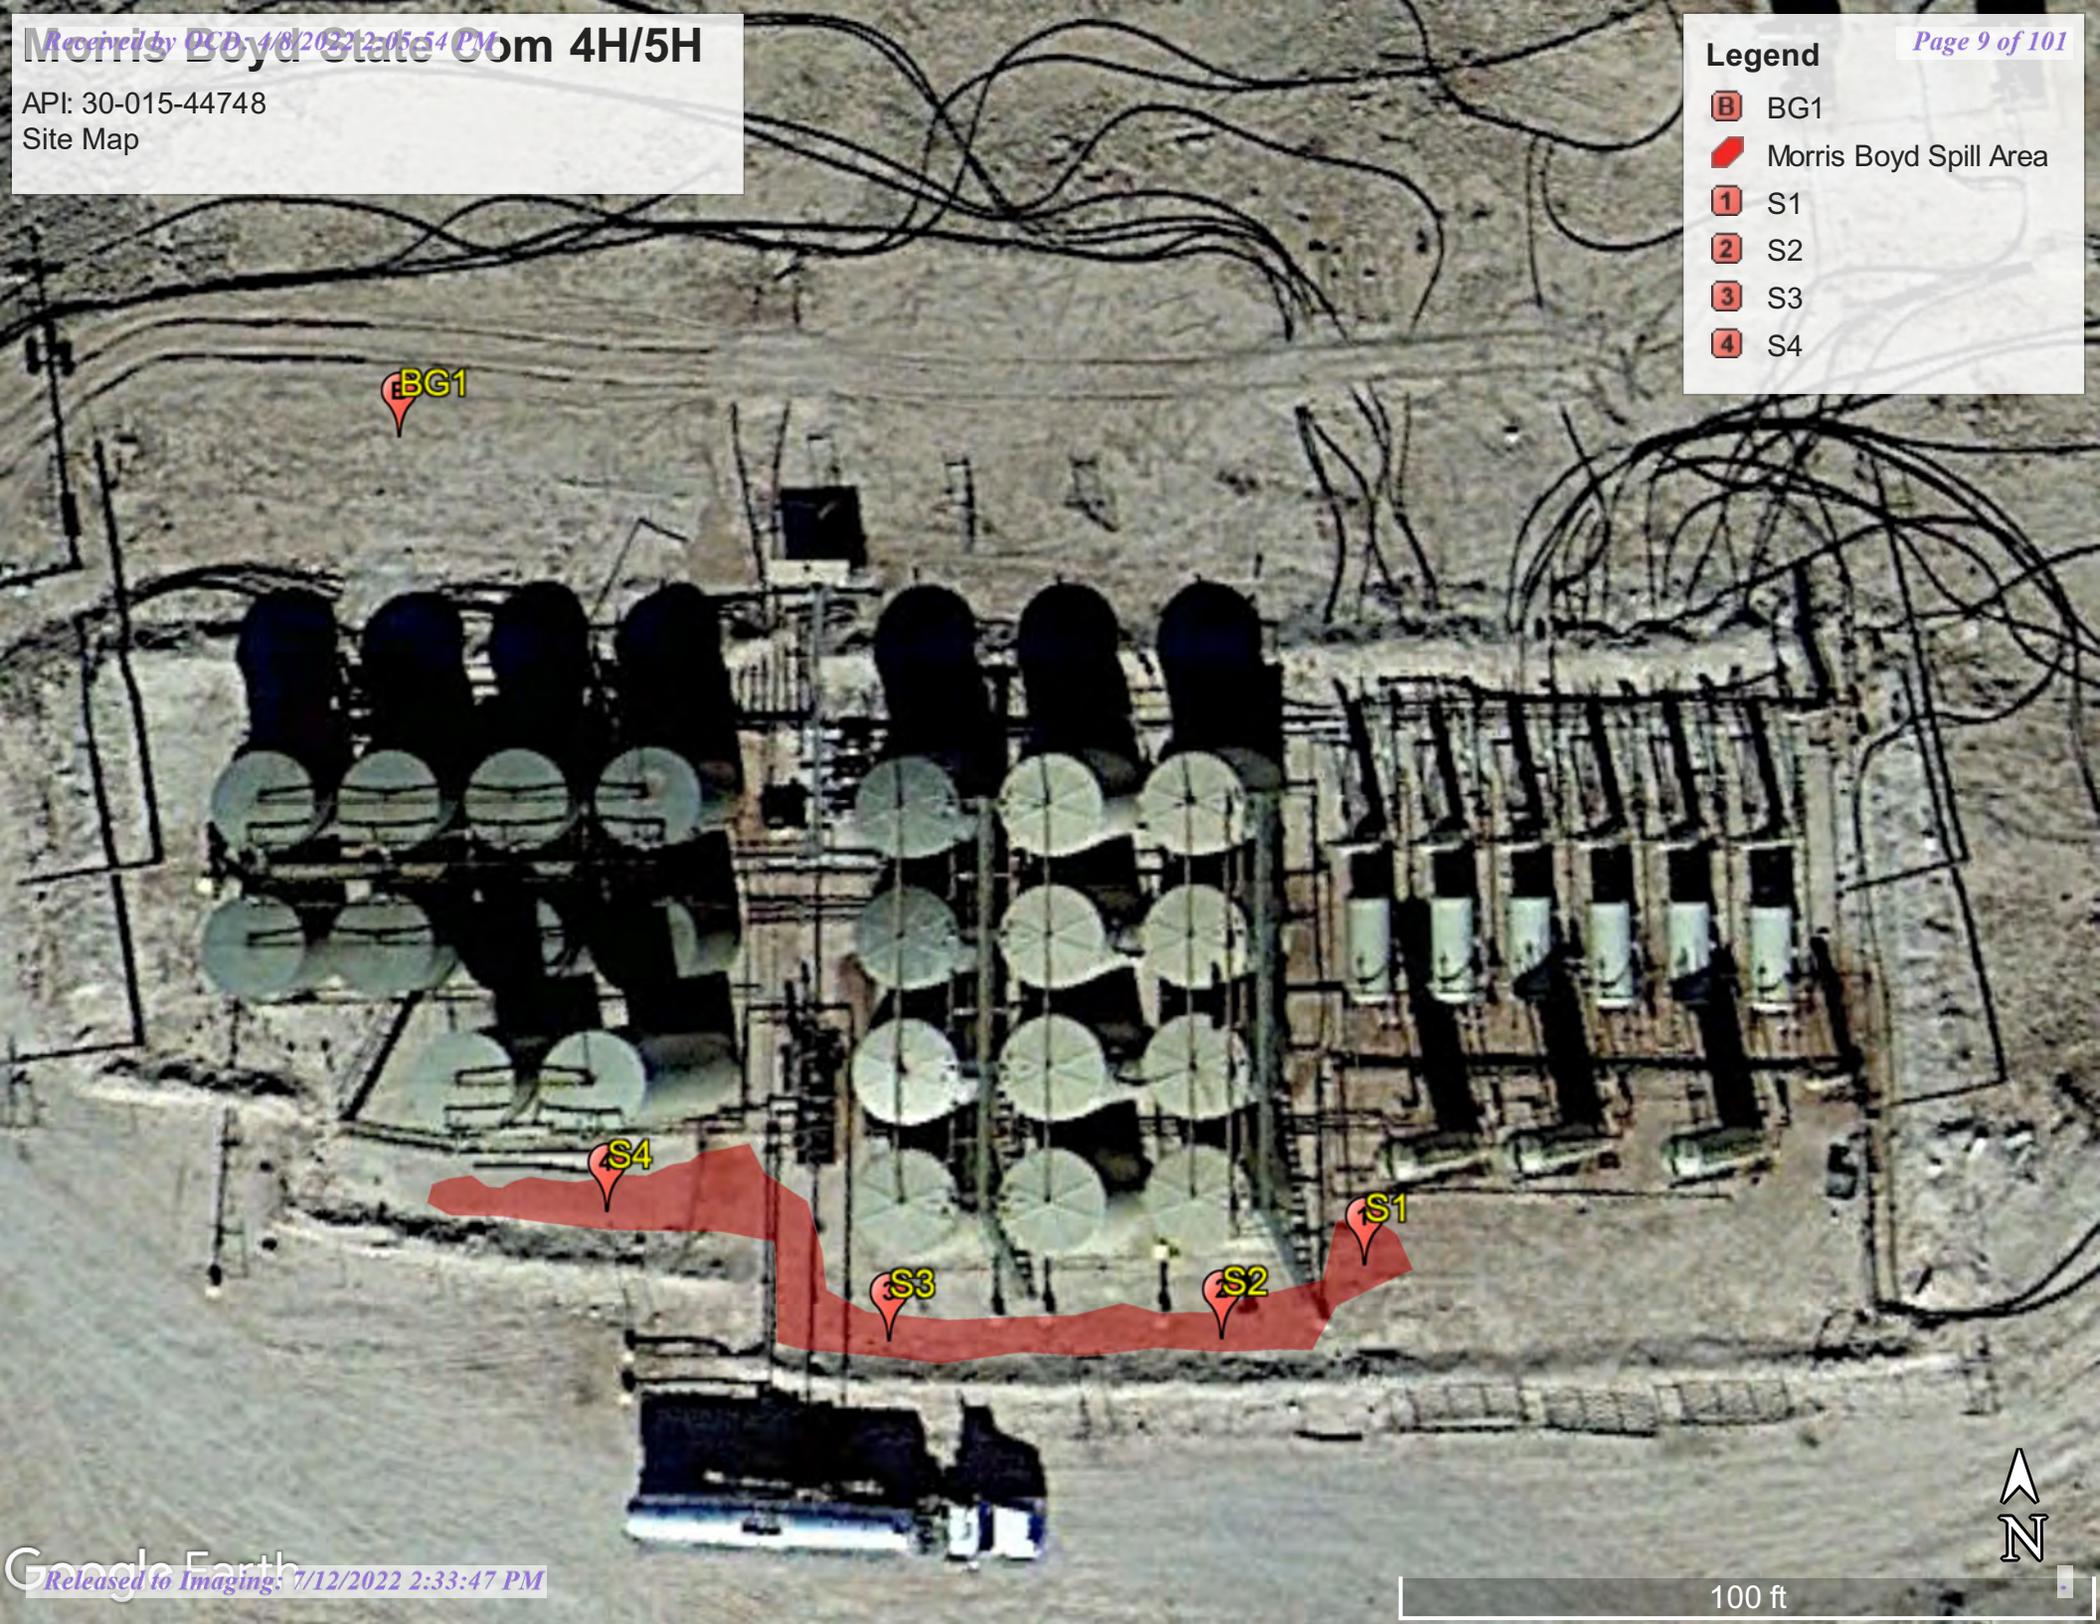
On June 7th, 2021, Pima Environmental mobilized personnel to the site to assess the area. We measured and took samples of the affected area. Laboratory results of this sampling event can be found in the following data table. A Site map can be found in Figure 4.

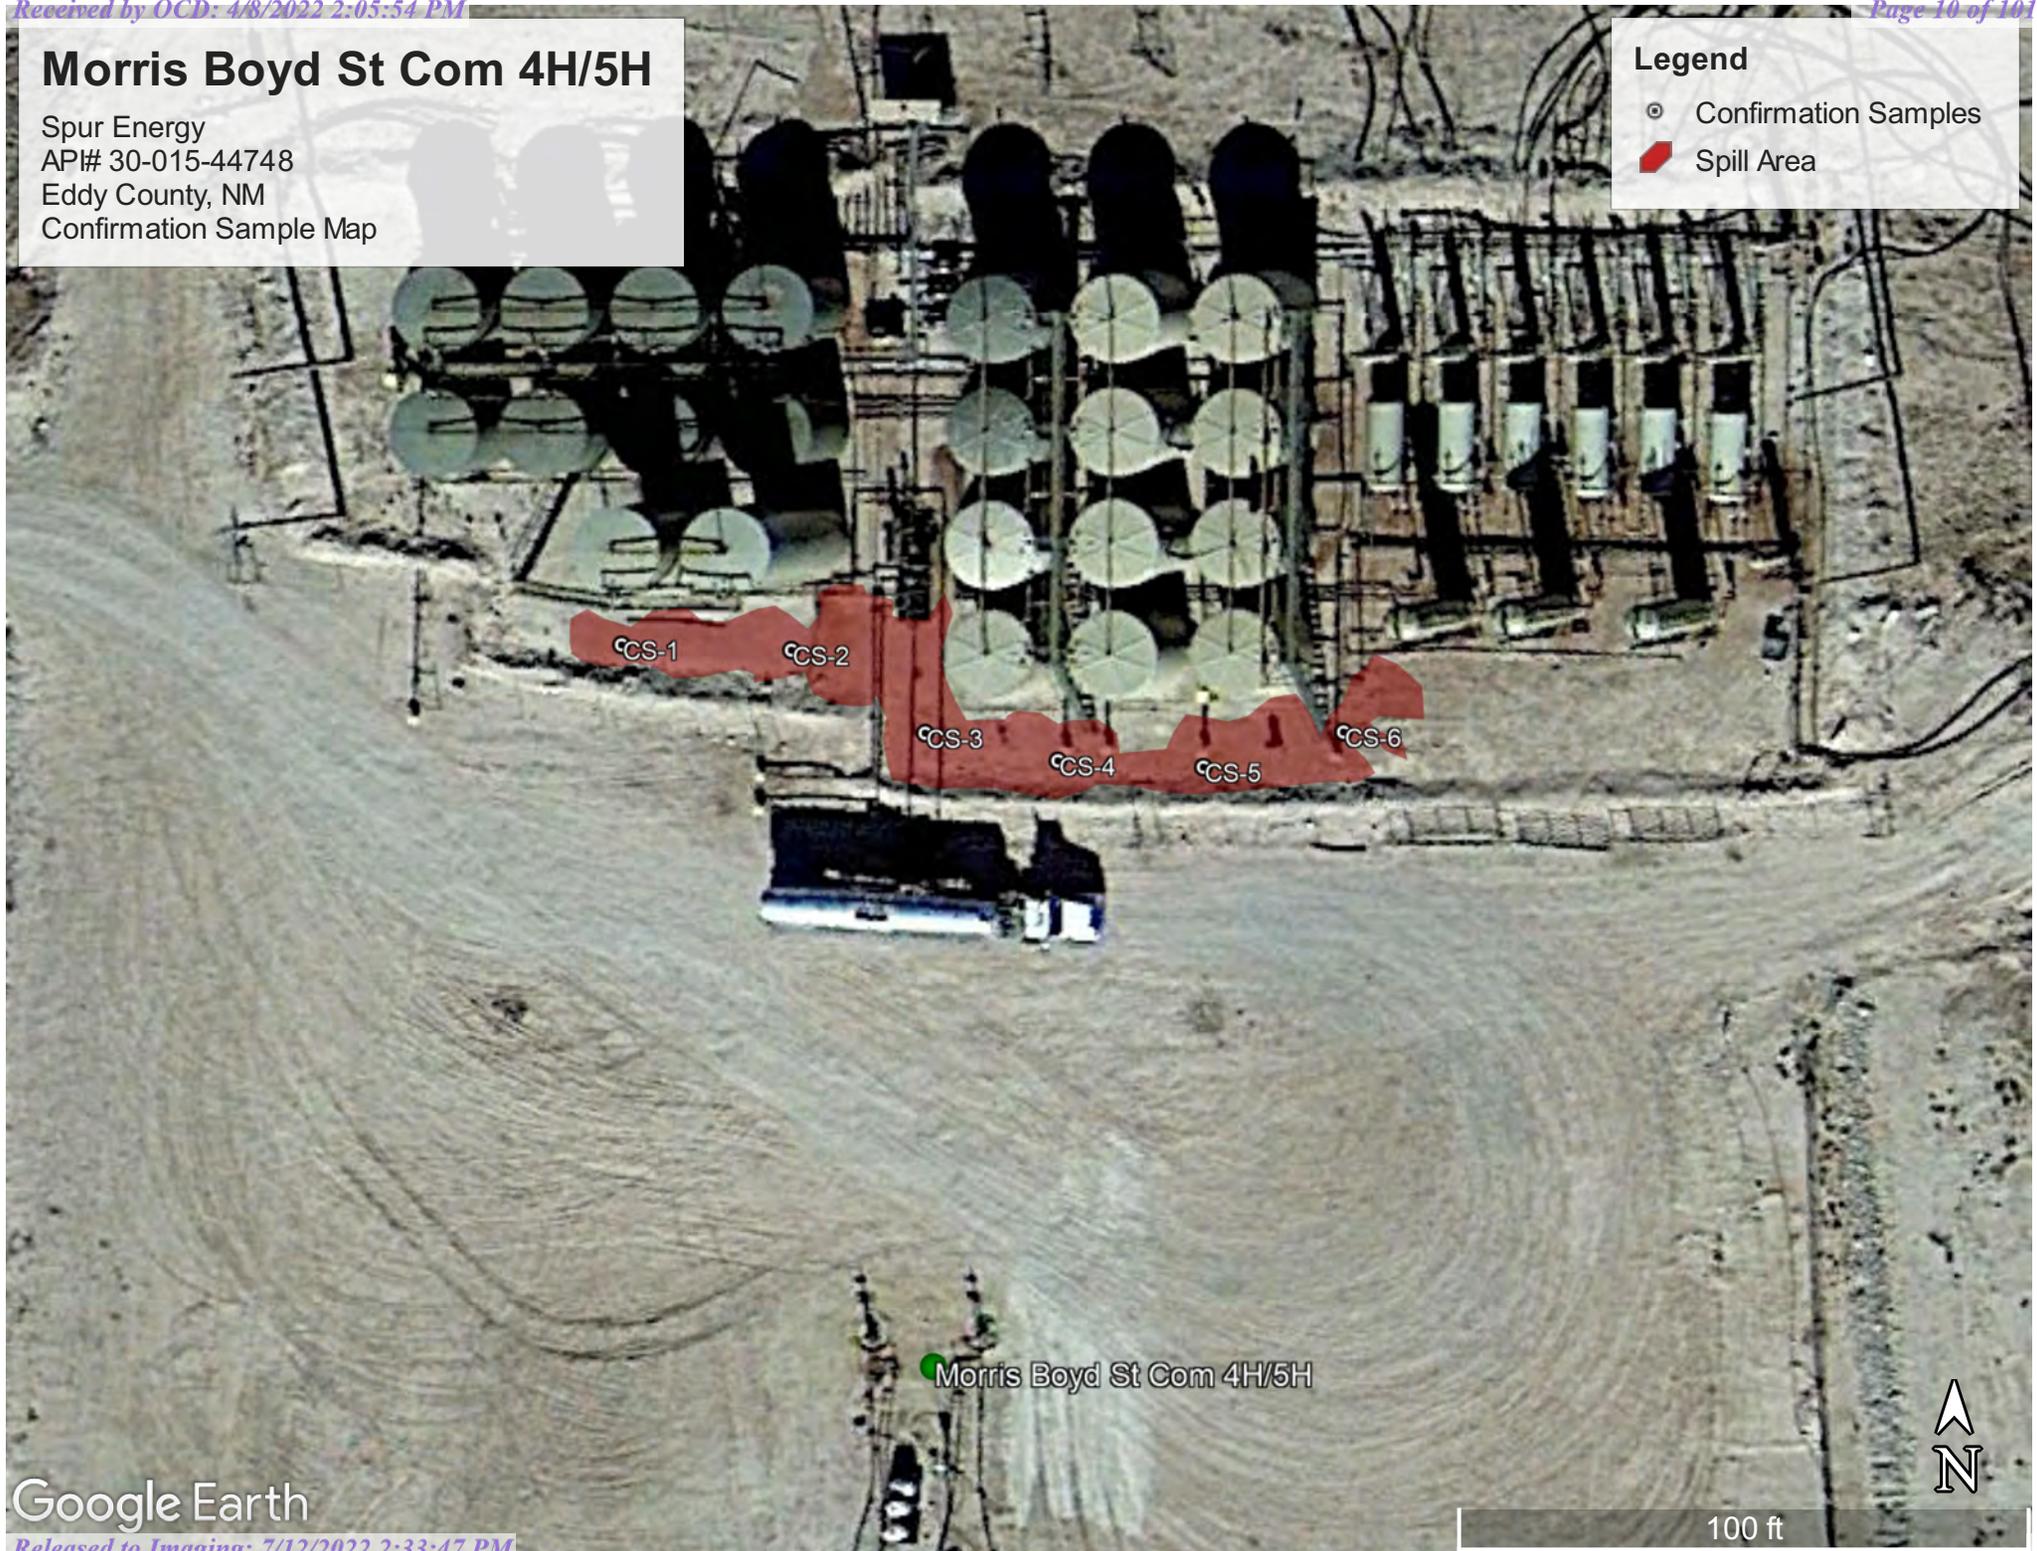
Based on the sample results, the bottom and sidewalls were below NMOCD Closure Criteria 19.15.29 NMAC. The contaminated material was transported to Lea Land, an NMOCD approved disposal site. The excavation was then backfilled with clean like material, machine compacted and contoured to match the surrounding terrain. See Appendix D for Photographic Documentation. A confirmation sample map can be found in Figure 5.

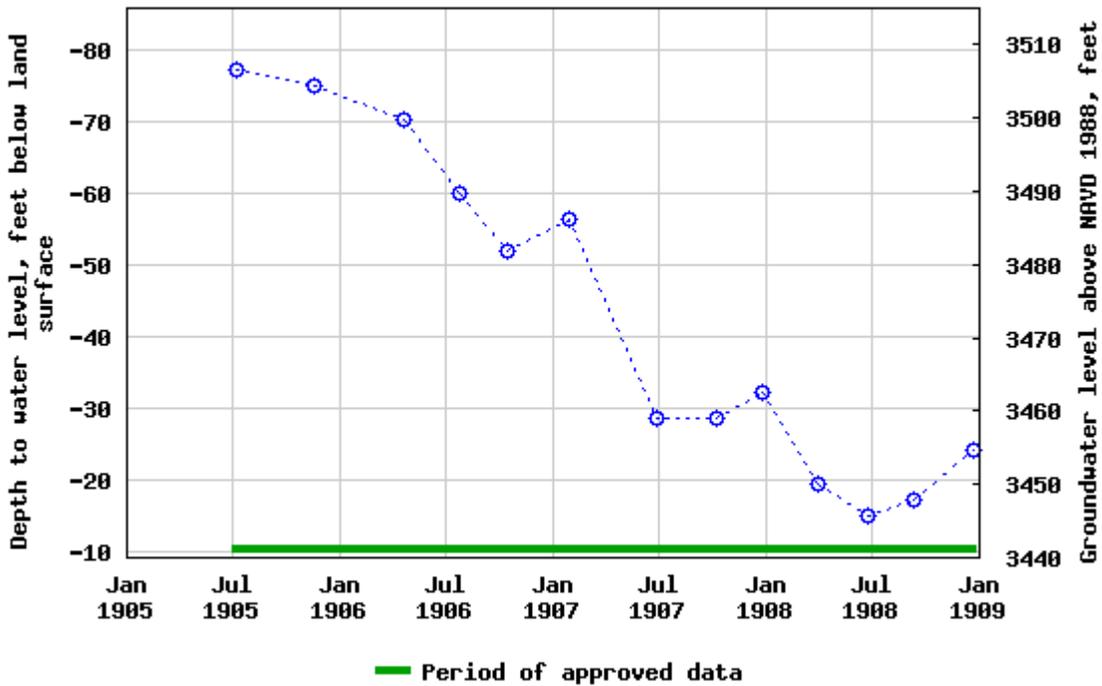
USGS 323809104274101 19S.25E.26.13130

According to the New Mexico Office of the State Engineer, depth to the nearest groundwater in this area is 60 feet below grade surface (BGS). According to the United States Geological Survey (USGS), the nearest groundwater is less than 50 feet BGS. The closest waterway is Brantley Lake located approximately 5.12 miles to the southeast of this location. See Appendix A for referenced water surveys.
