**Re: Closure Report  
Federal FC Com #2H Wellhead  
Incident Number NAPP2213936364  
Eddy County, New Mexico**

Ensolum, LLC (Ensolum) on behalf of EOG Resources, Inc. (EOG), has prepared this Closure Report to document site assessment, excavation, and soil sampling activities performed at the Federal FC Com #2H Wellhead (Site). The purpose of the site assessment, excavation, and soil sampling activities was to address unknown historical impacts to soil at the Site, which were discovered during the decommissioning process. Based on the excavation activities and analytical results from the soil sampling events, EOG is submitting this Closure Report, describing remediation that has occurred for closure of Incident Number NAPP2213936364.

EOG RESOURCES, INC.  
 FEDERAL FC COM #2H WELLHEAD  
 NAPP2213936364  
 Unit M, Sec 24 T20S R24E  
 Eddy County, New Mexico

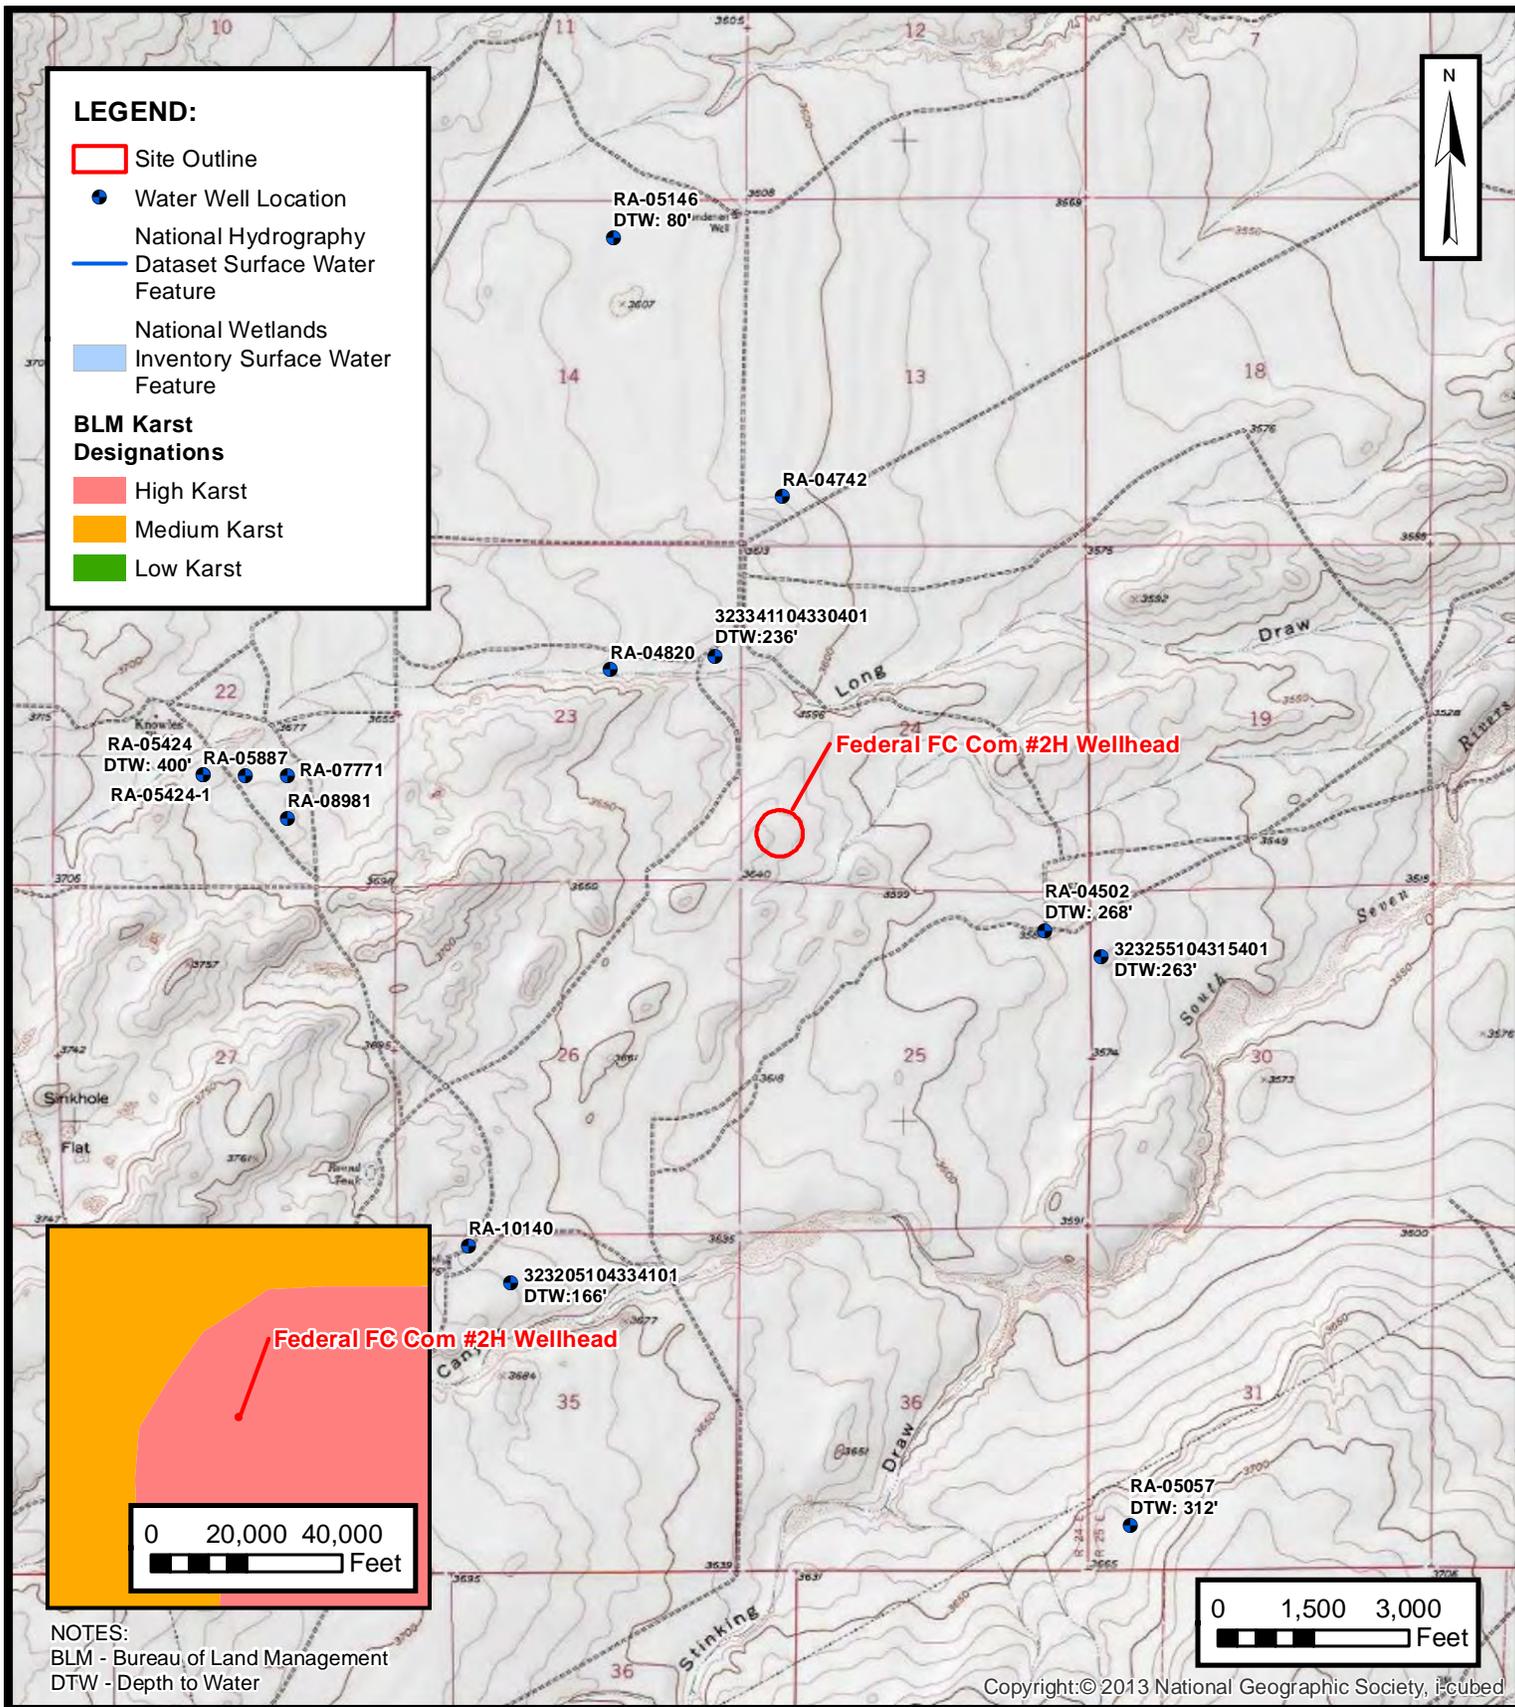
**FIGURE**  
**1**

The Site (Figure 1) is located in Unit M, Section 24, Township 20 South, Range 24 East, in Eddy County, New Mexico (32.5538864° N, 104.5482407°W) and is associated with oil and gas exploration and production operations on land under the stewardship of the Bureau of Land Management (BLM).

The closest continuously flowing or significant watercourse to the Site is a dry wash, located approximately 575 feet south of the Site. The Site is greater than 200 feet from a lakebed, sinkhole, or playa lake and greater than 300 feet from an occupied residence, school, hospital, institution, church, or wetland. The Site is greater than 1,000 feet to a freshwater well or spring and is not within a 100-year floodplain or overlying a subsurface mine. The Site is underlain by unstable geology (high potential karst designation area). Site receptors are identified on Figure 1.

**SITE RECEPTOR MAP**

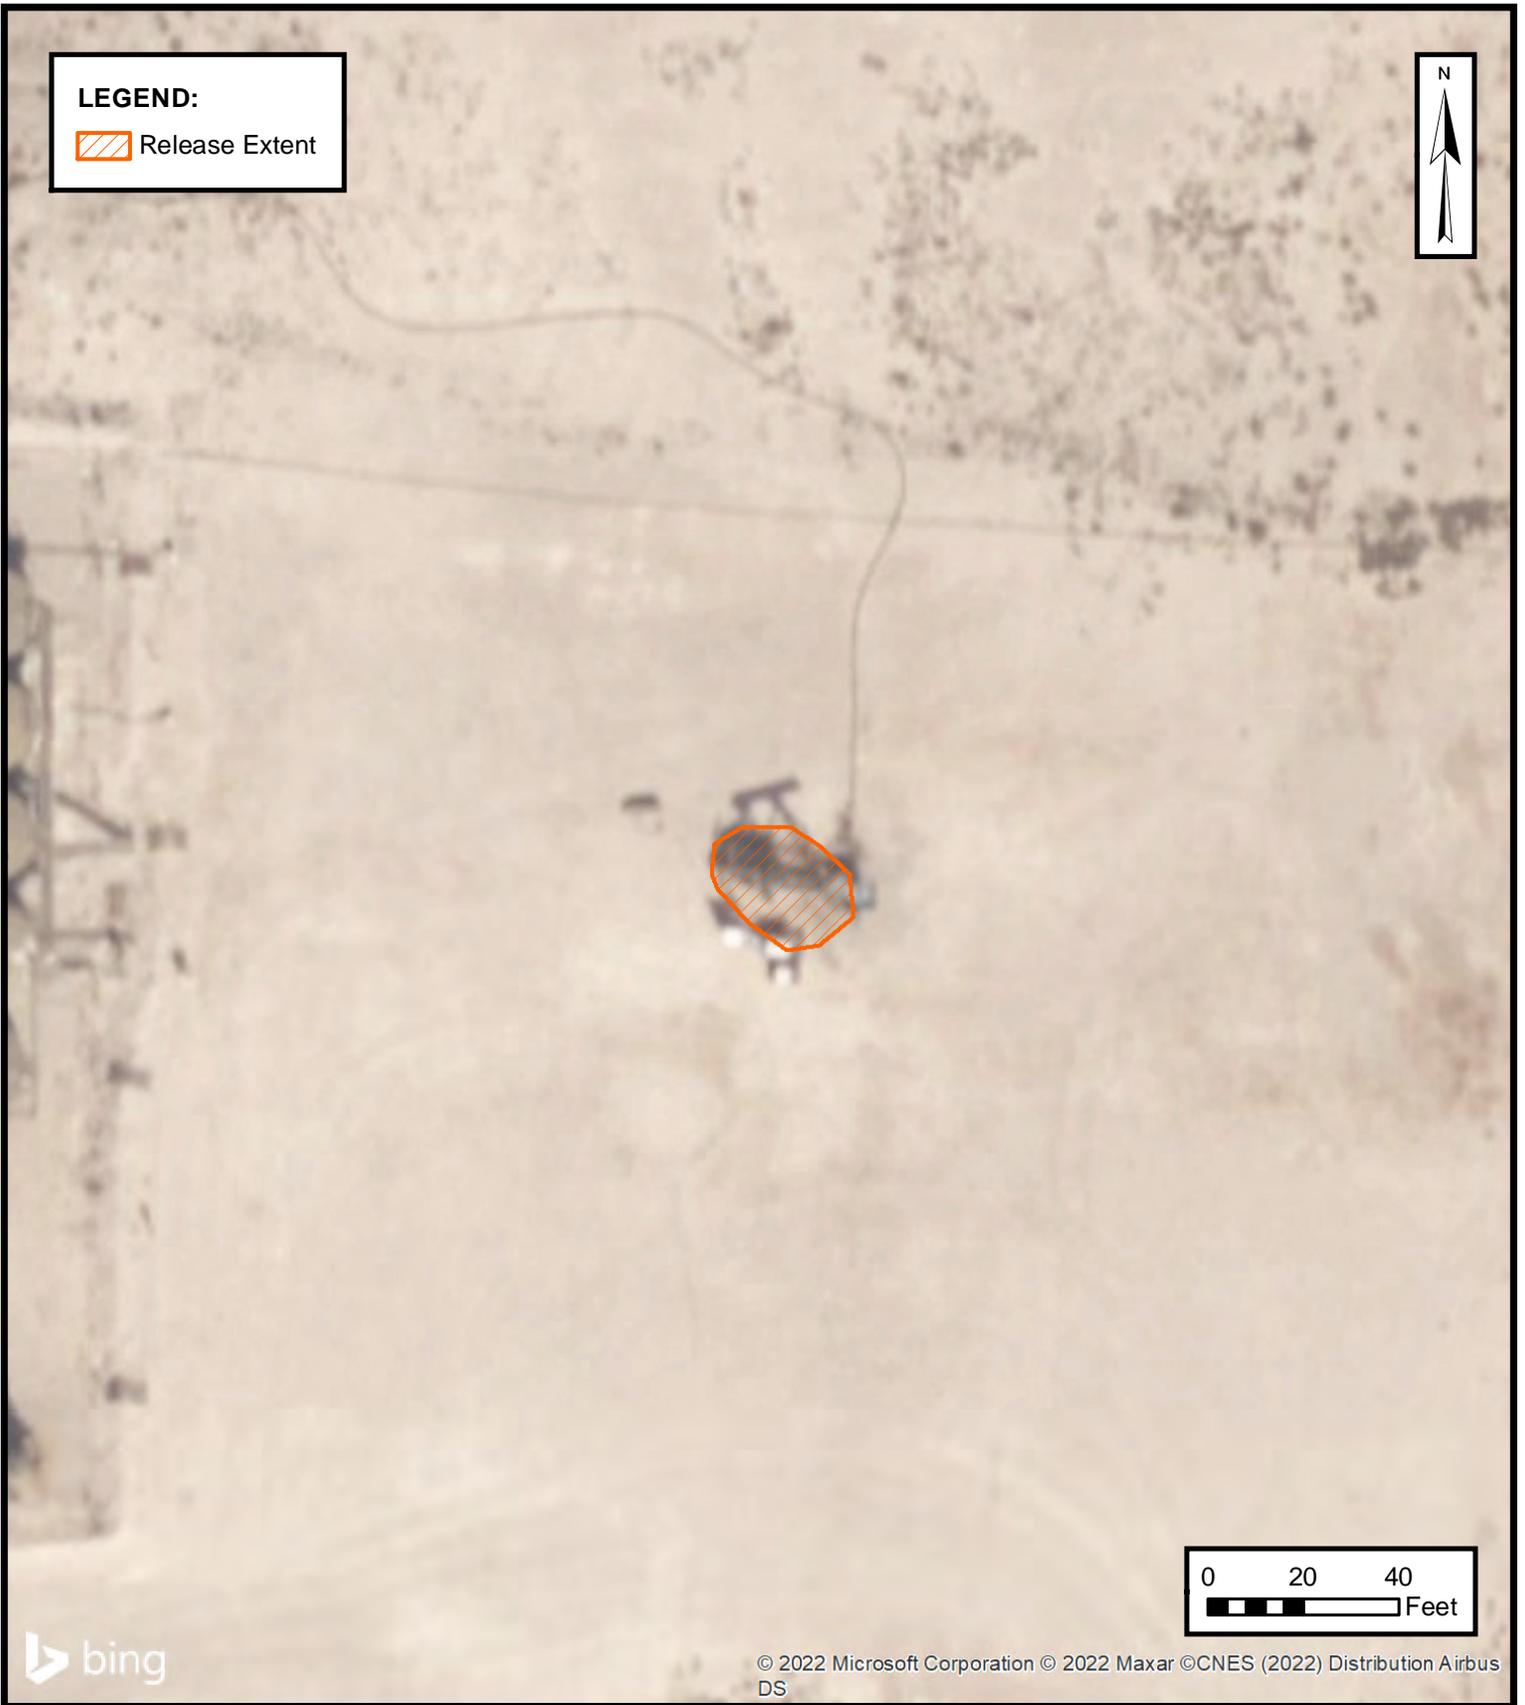
**FIGURE**  
**2**

On May 18, 2022, historical impacts were discovered during the decommissioning process of the Site. An unknown quantity of crude oil and produced water appears to have been released to the facility pad. No fluids were recovered. EOG reported the release to the NMOCD on a Release Notification Form C-141 (Form C-141) on May 19, 2022. The release was assigned Incident Number NAPP2213936364. The historical release extent was mapped utilizing a handheld Global Positioning System (GPS) unit and is depicted on Figure 2.

**RELEASE MAP**

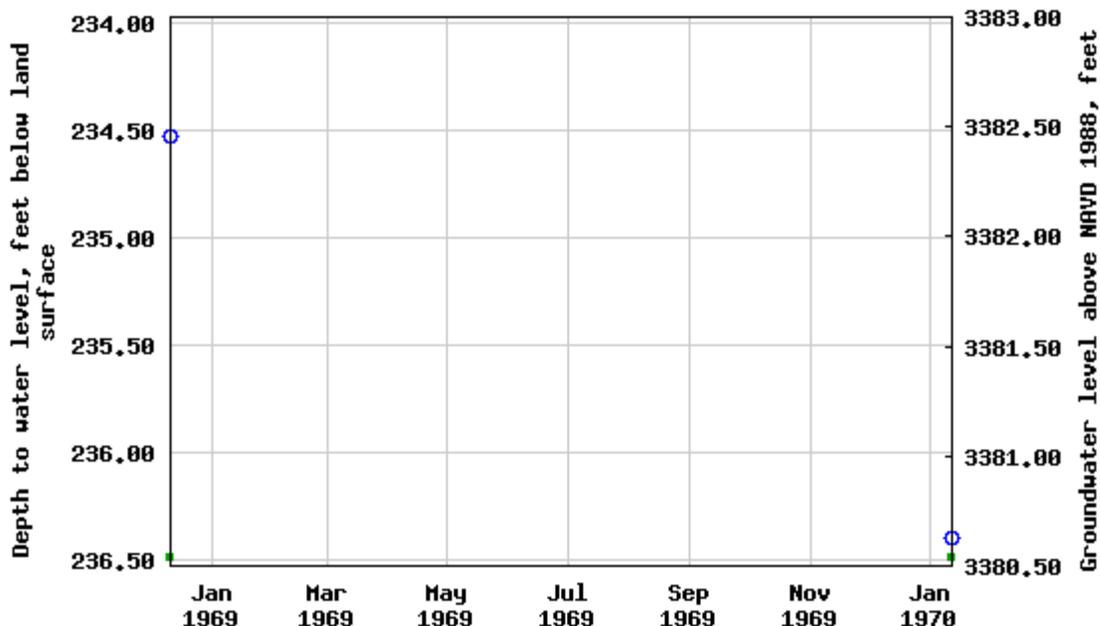
USGS 323341104330401 20S.24E.23.21444

— Period of approved data

Breaks in the plot represent a gap of at least one year between field measurements. [Download a presentation-quality graph](#)

Depth to groundwater at the Site is greater than 100 feet below ground surface (bgs) based on the nearest groundwater well data. The closest permitted groundwater well with depth to groundwater data is USGS well 323341104330401, located approximately 0.49 miles northwest of the Site. The

groundwater well has a reported depth to groundwater of 236 feet bgs and a total depth of 272 feet bgs. Ground surface elevation at the groundwater well location is 3,621 feet above mean sea level (amsl), which is approximately 19 feet lower in elevation than the Site. All wells used for depth to groundwater determination are presented on Figure 1. The referenced well records are included in Attachment 1.

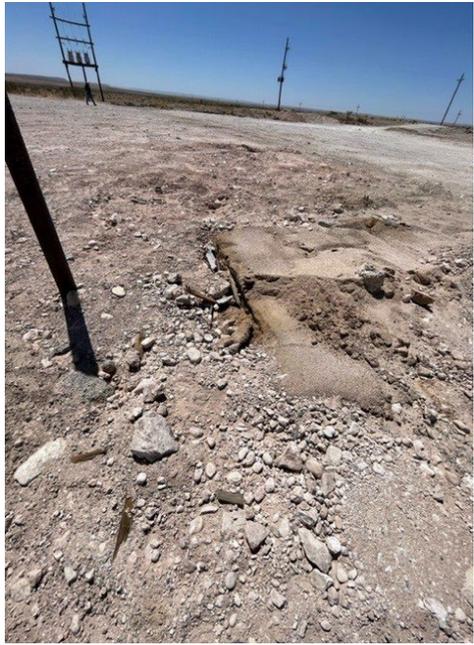
Photograph 1 Date: 20-Apr-22  
Description: View of staining observed during decommissioning facing east.

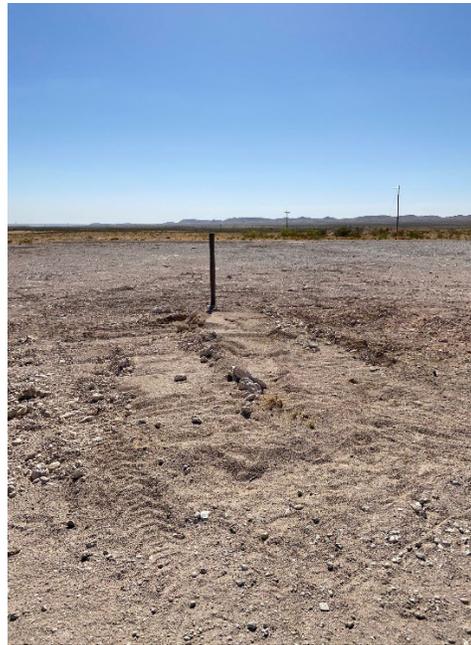
Photograph 2 Date: 28-Apr-22  
Description: View of staining observed during decommissioning facing north.

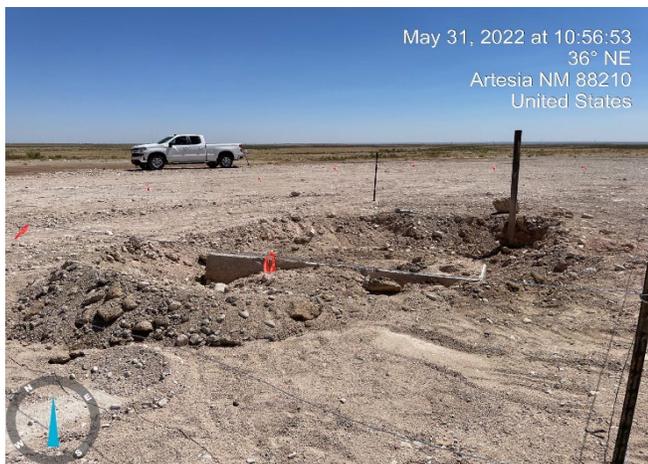
Photograph 3 Date: 31-May-22  
Description: View of excavaton facing northeast.

On May 31, 2022, Ensolum personnel were at the Site to oversee excavation activities. Impacted soil was excavated from the release area as indicated by visible staining and information provided on the Form C-141. Excavation activities were performed using track-mounted backhoe and transport vehicle. The excavation occurred on pad at the location of the decommissioned wellhead. To direct excavation activities, soil was screened for volatile aromatic hydrocarbons and chloride utilizing a PID and Hach® chloride QuanTab® test strips, respectively. The excavation was completed to a depth of 2 feet bgs. Photographic documentation of the excavation activities is included in Appendix B.

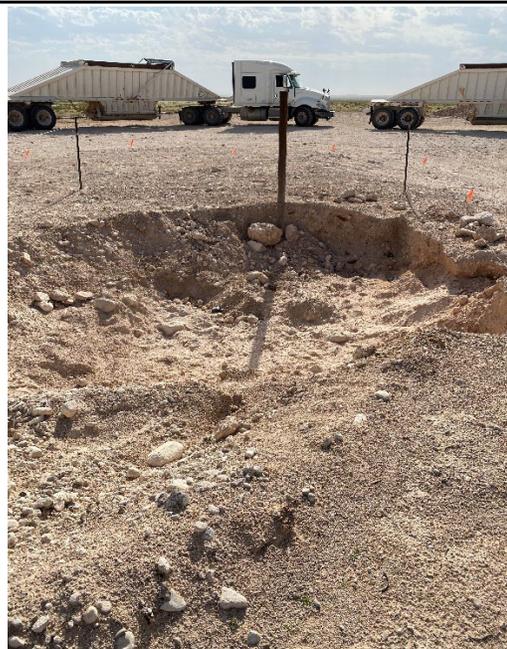
Photograph 4 Date: 22-Jun-22  
Description: View of final excavation facing north.

On June 22, 2022, Ensolum personnel returned to the Site to oversee further excavation activities. Additional impacted soil was excavated from the floor of the excavation. Composite floor soil samples FS01A and FS02A were collected from the floor of the excavation at a depth of 3 feet bgs. Composite sidewall sample SW02 was collected from the sidewall of the excavation from depths ranging from the ground surface to 3 feet bgs. The soil samples were collected, handled, and analyzed following the same

The excavation area measured approximately 390 square feet. A total of approximately 44 cubic yards of impacted soil was removed during the excavation activities. The impacted soil was transported and properly disposed of at the Lea Land Disposal Facility in Carlsbad, New Mexico.
