**Re: Site Assessment, Remediation, and Closure Report**  
**Dorami 33 Federal Com #2H**  
**API No. 30-015-46010**  
**GPS: Latitude 32.615075 Longitude -104.478445**  
**UL L, Sec. 34, T19S, R25E**  
**Eddy County, NM**  
**NMOCD Ref. No. NRM2007953992**

Pima Environmental Services, LLC. (Pima) has been contracted by Spur Energy Partners, LLC. (Spur) to perform a spill assessment, remediation, and submit this closure report for a produced water release that occurred at the Dorami 33 Federal Com #2H (Dorami). The initial C-141 was submitted on March 21, 2020 (Appendix C). This incident was assigned Incident ID NRM2007953992 by the New Mexico Oil Conservation Division (NMOCD).

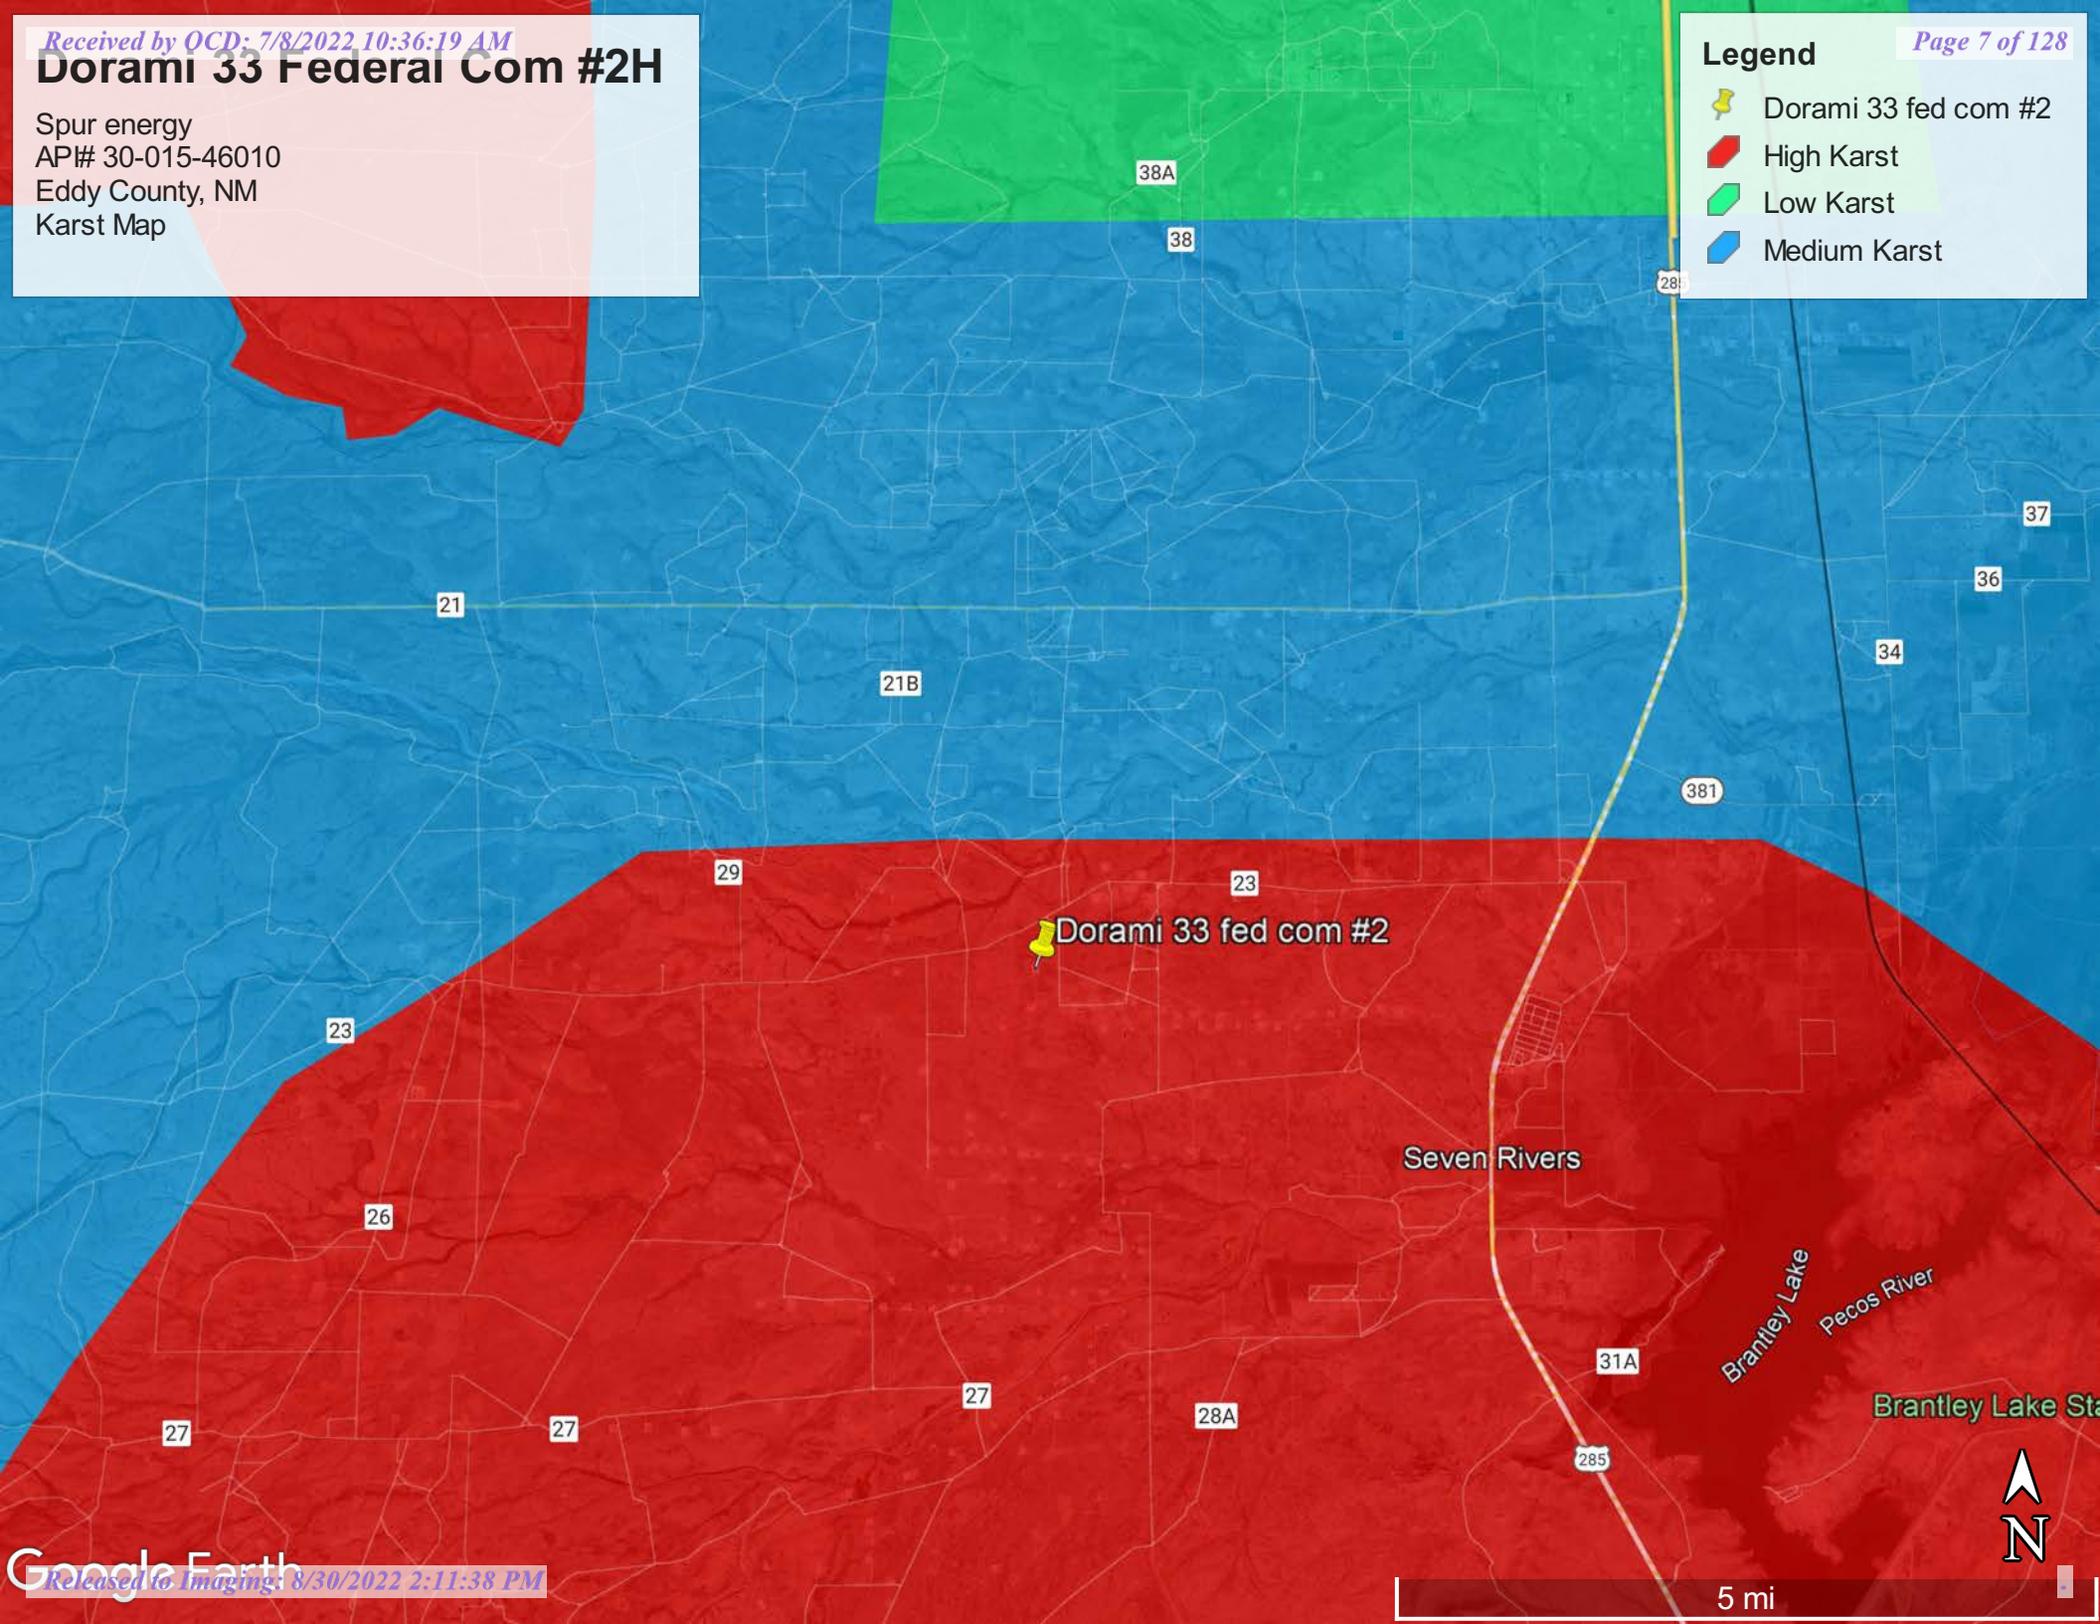
Spur energy  
AP# 30-015-46010  
Eddy County, NM  
Karst Map

Per the New Mexico Bureau of Geology and Mineral Resources, the geology is made up deposits of higher gradient tributaries bordering major stream valleys, alluvial veneers of the piedmont slope, and alluvial fans. May locally include uppermost Pliocene deposits. The soil in this area is made up of Reagan Upton association, 0 to 9 percent slopes according to the United States Department of Agriculture Natural Resources Conservation Service soil survey (Appendix B). The drainage courses in this area are well drained. There is a high potential for karst geology to be present around the Dorami (Figure 3).

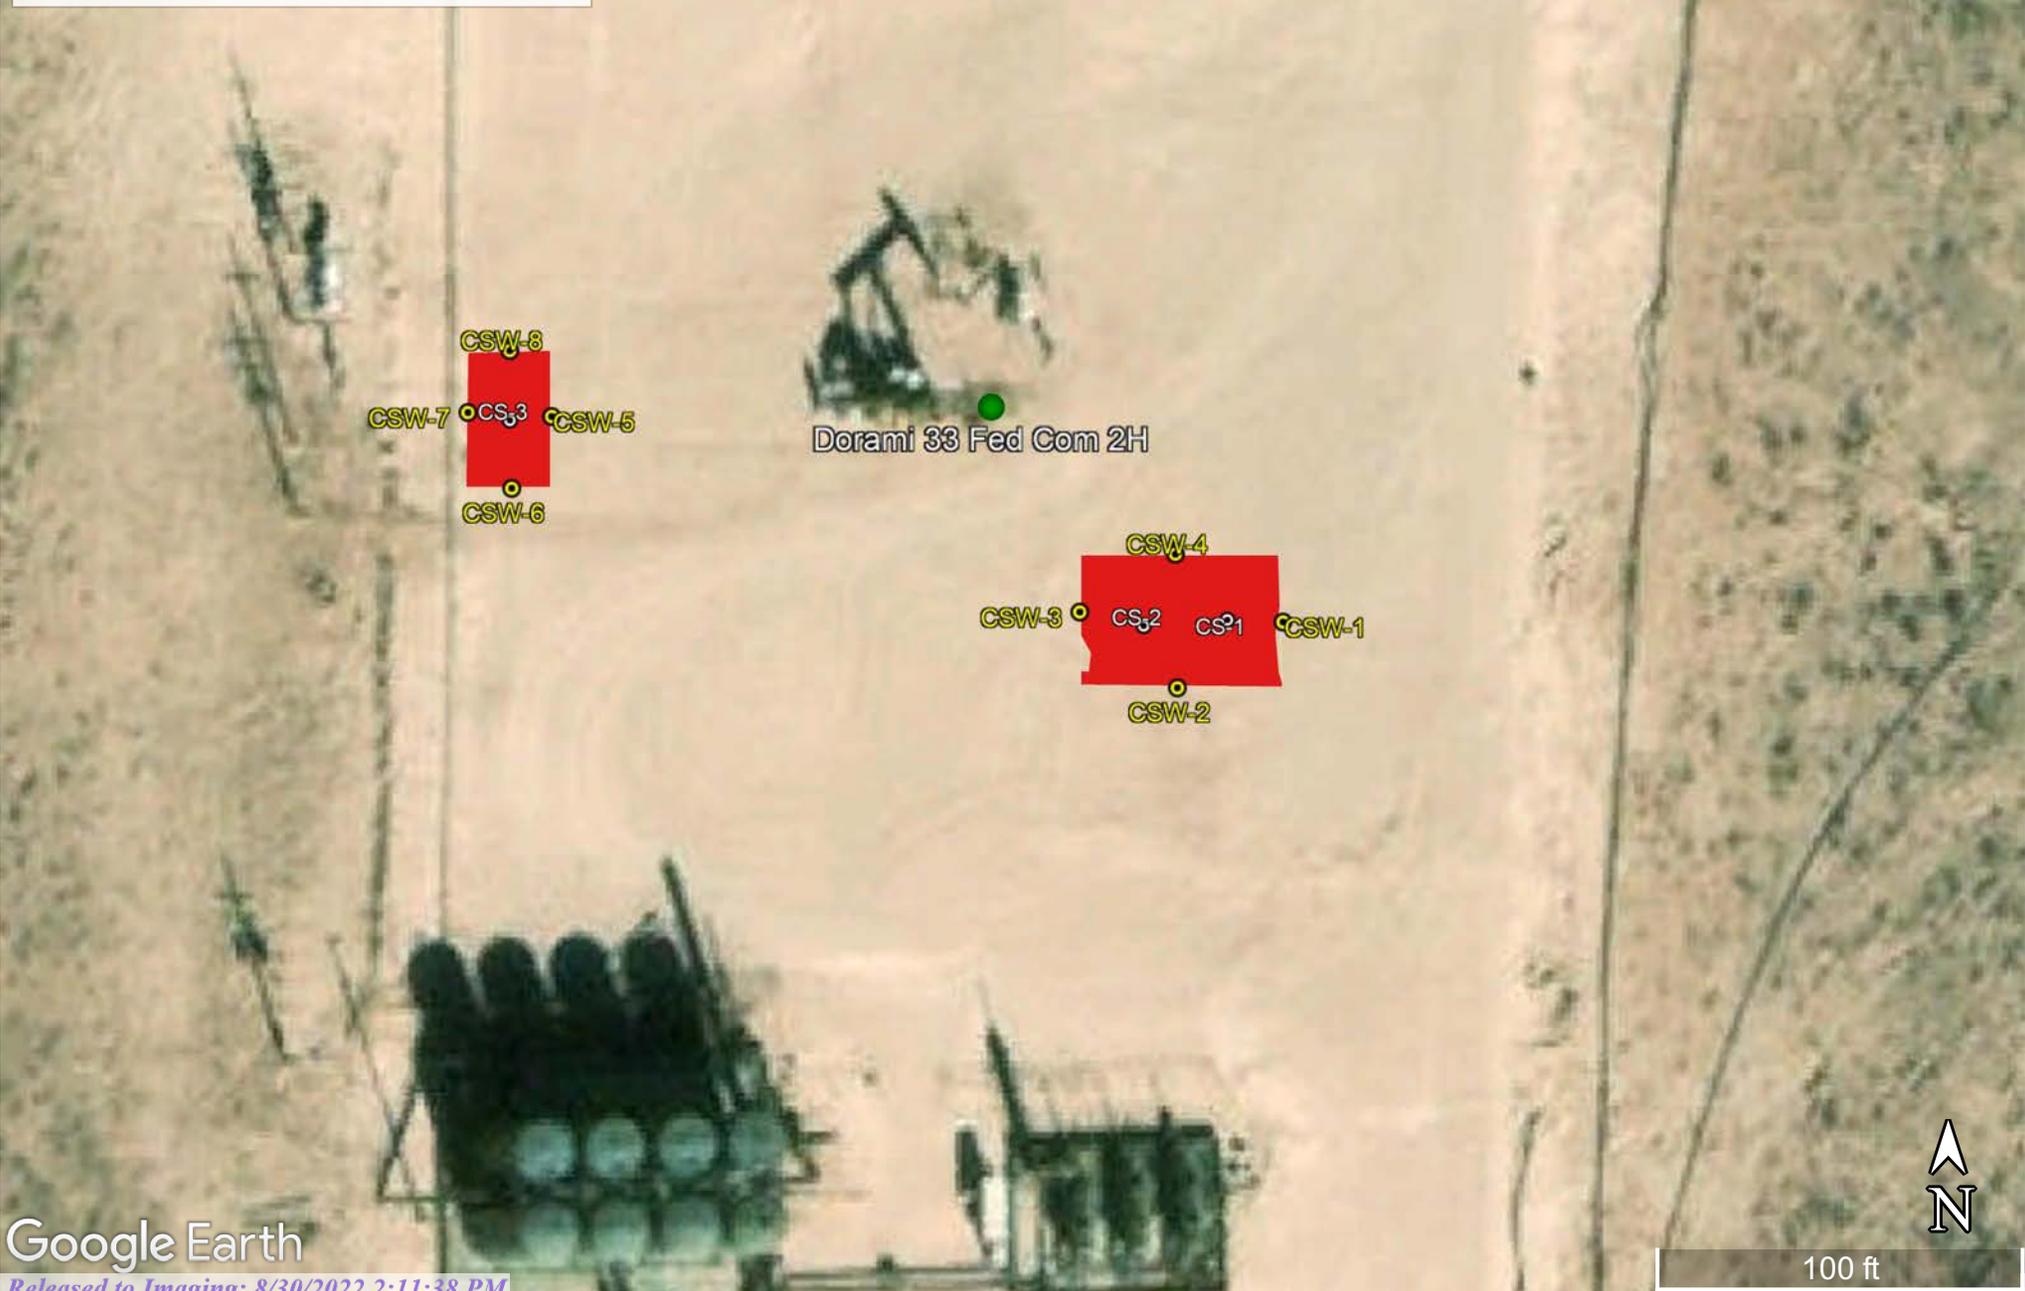
Spur Energy  
API #30-015-46010  
Eddy County, NM  
Confirmation Sample Map

On May 28, 2022, after sending a 48-hour notification (Appendix C), Pima collected confirmation samples of the excavated areas. Laboratory results of this sampling event can be found in the following data table. A confirmation sample map can be found in Figure 5.

- Composite Bottoms
- Composite Sidewalls
- Spill Areas

On June 7, 2022, Pima Environmental personnel returned to the site to further excavate the contaminated areas. We excavated 1 more foot of soil from all areas, extended the sidewalls another foot, and recollected confirmation samples. Laboratory results of these sampling events can be found in the following data table.

Based on the sample results, the bottom and sidewalls were below NMOCD Closure Criteria 19.15.29 NMAC. The contaminated material was transported to Lea Land, an NMOCD approved disposal site. The excavation was then backfilled with clean like material, machine compacted and contoured to match the surrounding terrain. See Appendix D for photographic documentation.

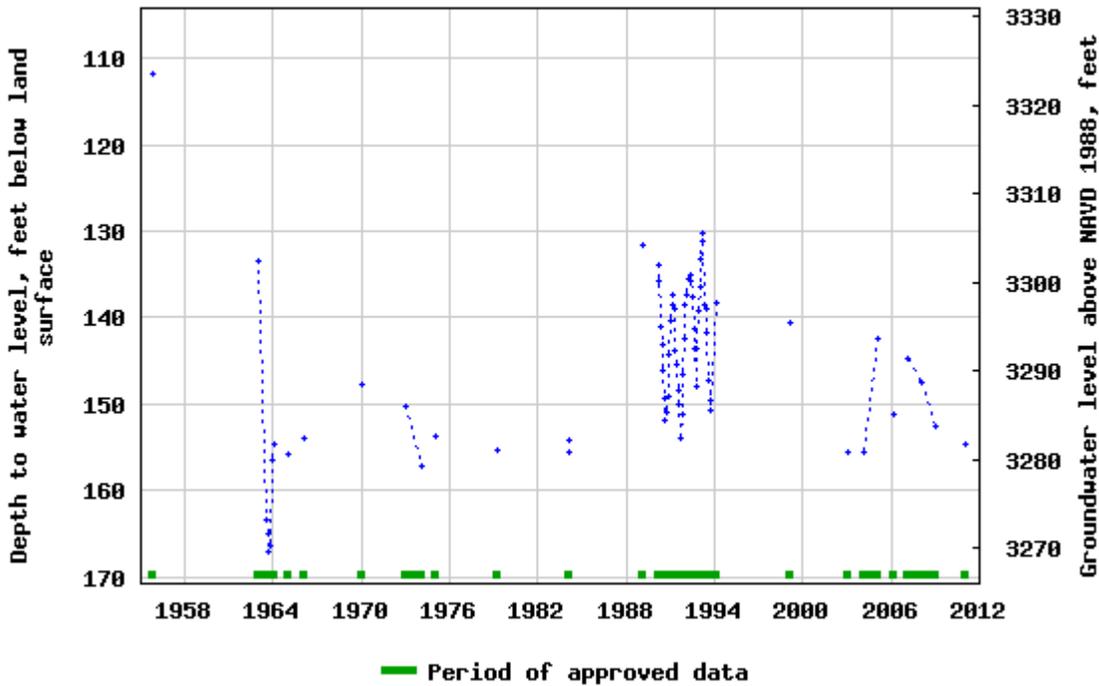
### USGS 323409104281401 20S.25E.15.34222

The depth of the well is 600 feet below land surface.

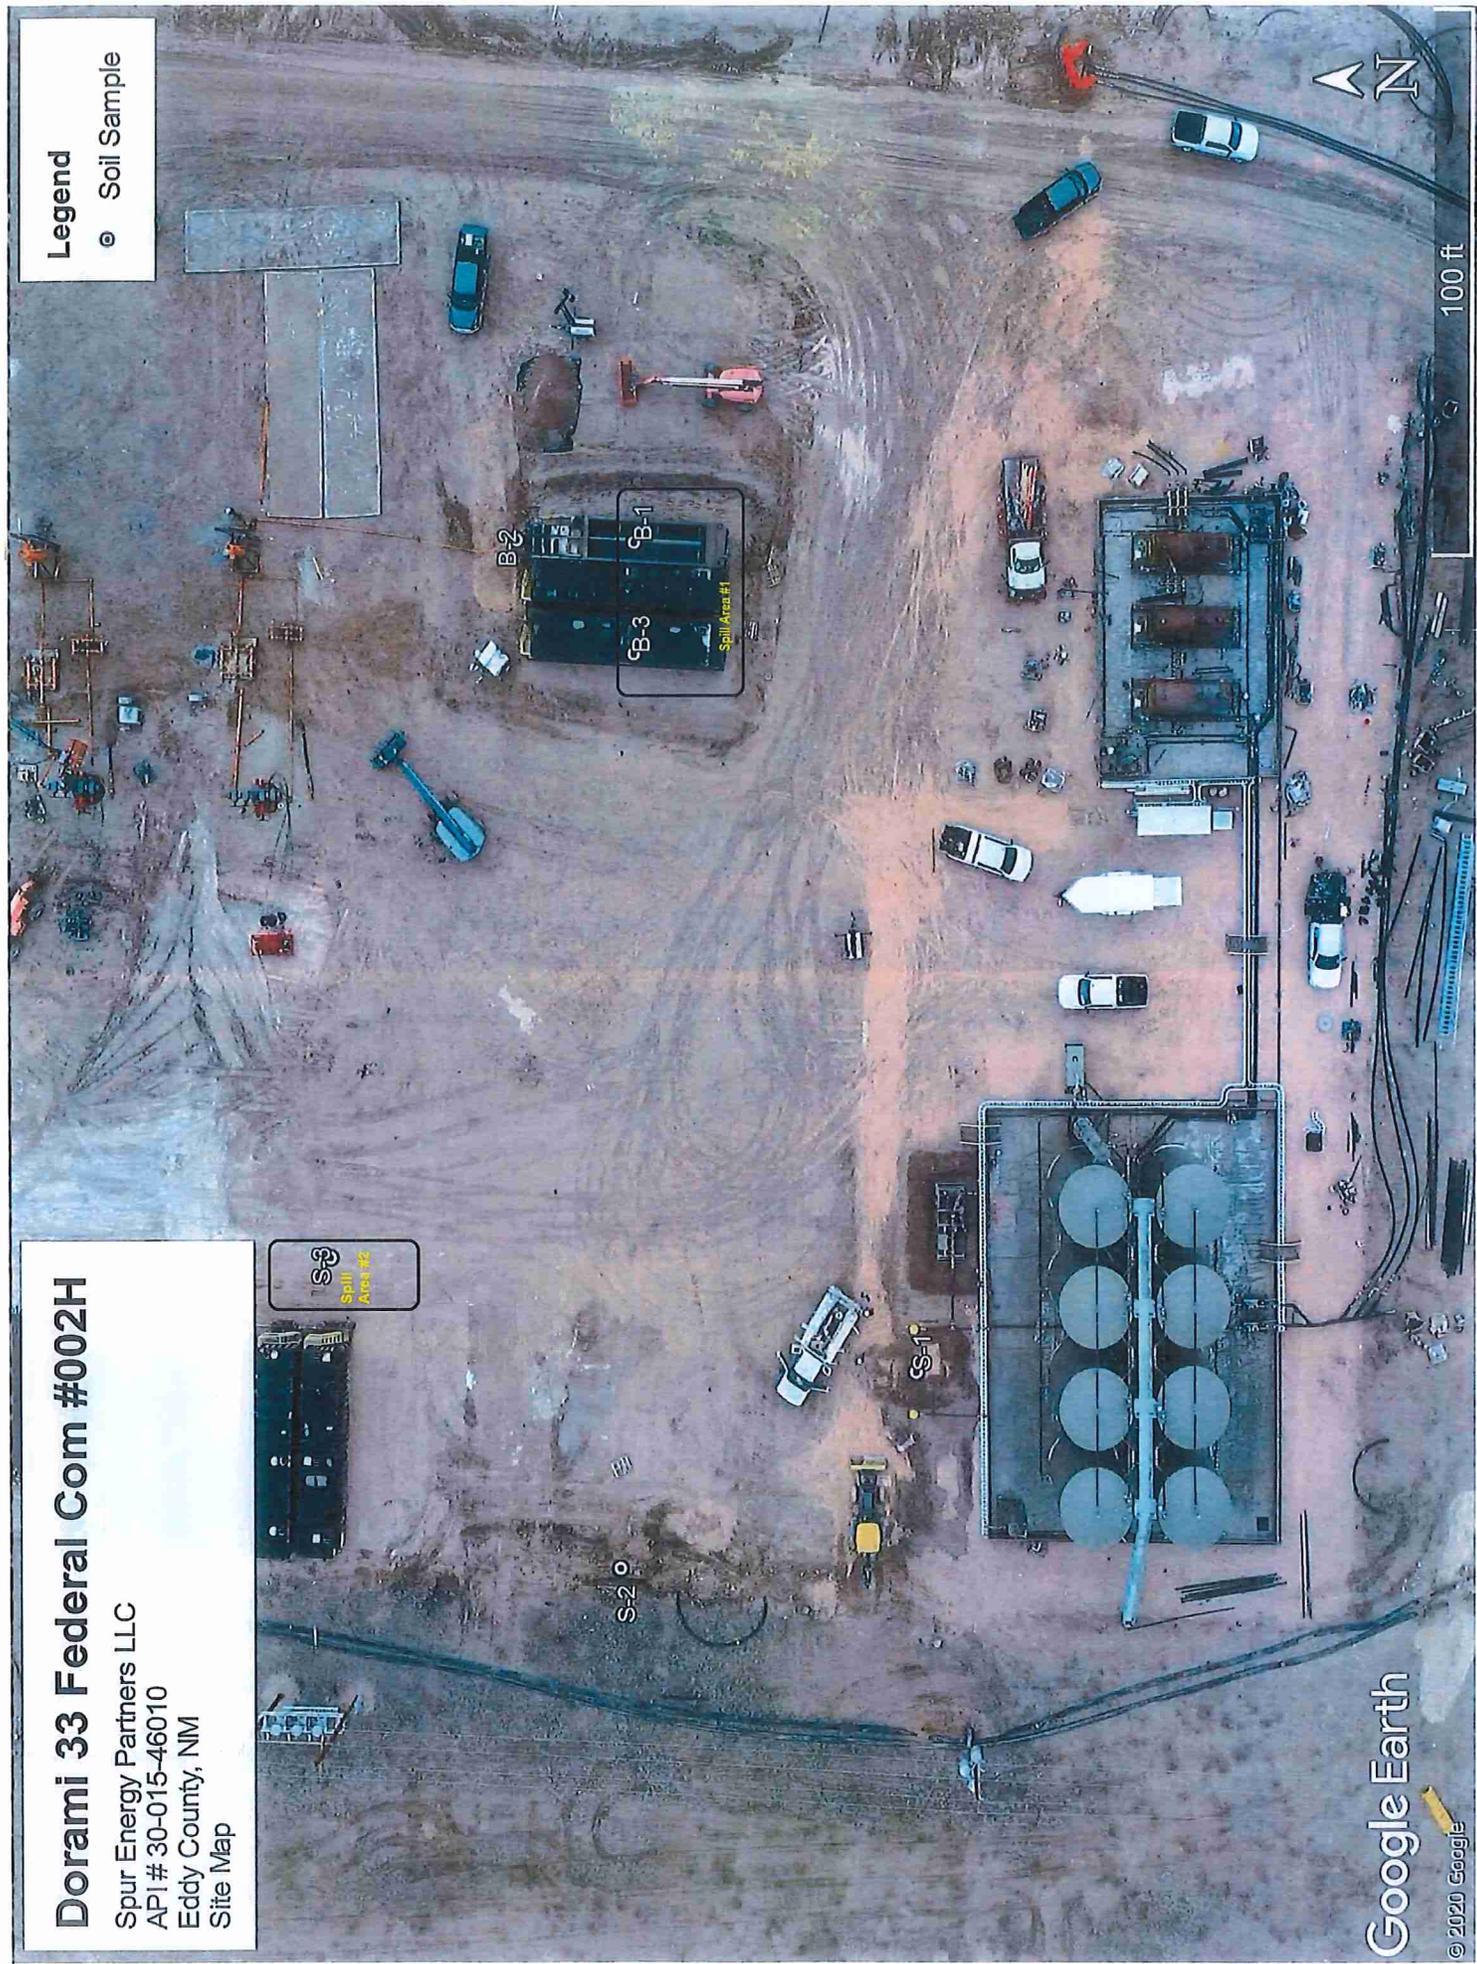
**Dorami 33 Federal Com #002H**  
 Spur Energy Partners LLC  
 API# 30-015-46010  
 Eddy County, NM  
 Site Map

On April 22, 2020, Talon personnel mobilized to begin site assessment and sampling activities. At the time of the initial site assessment, the field technician noticed staining and surface saturation at a secondary frac tank location on the west side of the pad area. Grab soil samples were collected with a hand auger to depths at which refusal was encountered in both areas. A Geoprobe (direct push rig technology) was utilized to advance samples to greater depths in order to achieve vertical delineation. Results from our initial sampling event are presented on the following data table. The complete laboratory report can be found in Appendix V.

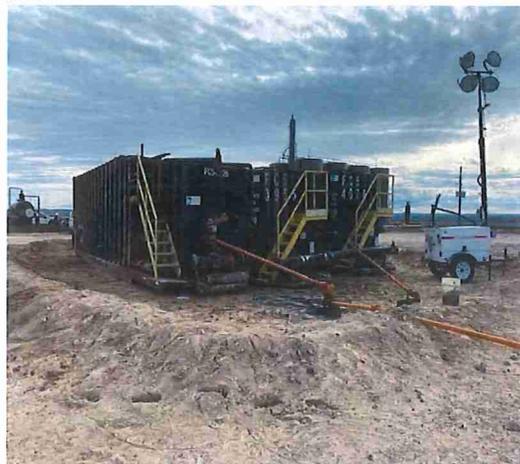
View of Overflowed Tank

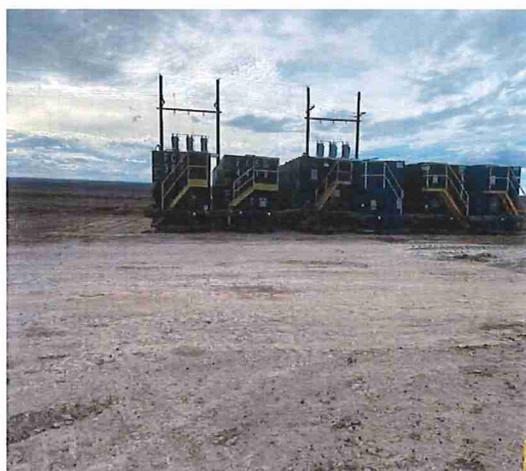
Impacted Area West Side

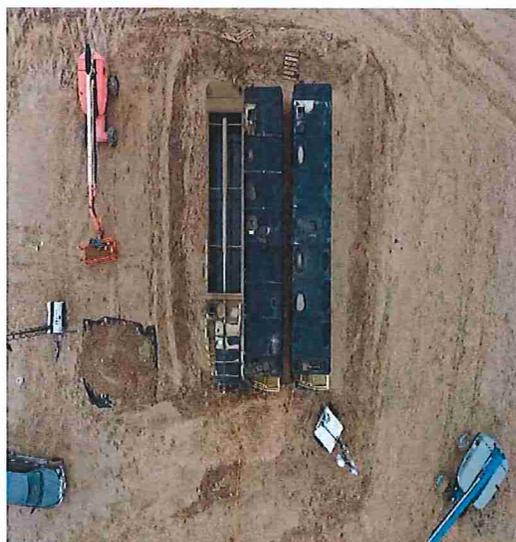
Aerial of Impact-Stockpile
