**Re: Closure Report - Revised  
ConocoPhillips (Heritage Concho)  
Phillips State #1 (Heater Treater Release)  
API # 30-025-30956  
Unit Letter O, Section 17, Township 21 South, Range 35 East  
Lea County, New Mexico  
Incident ID nOY1733235874  
1RP-4883**

Closure Report  
September 16, 2022

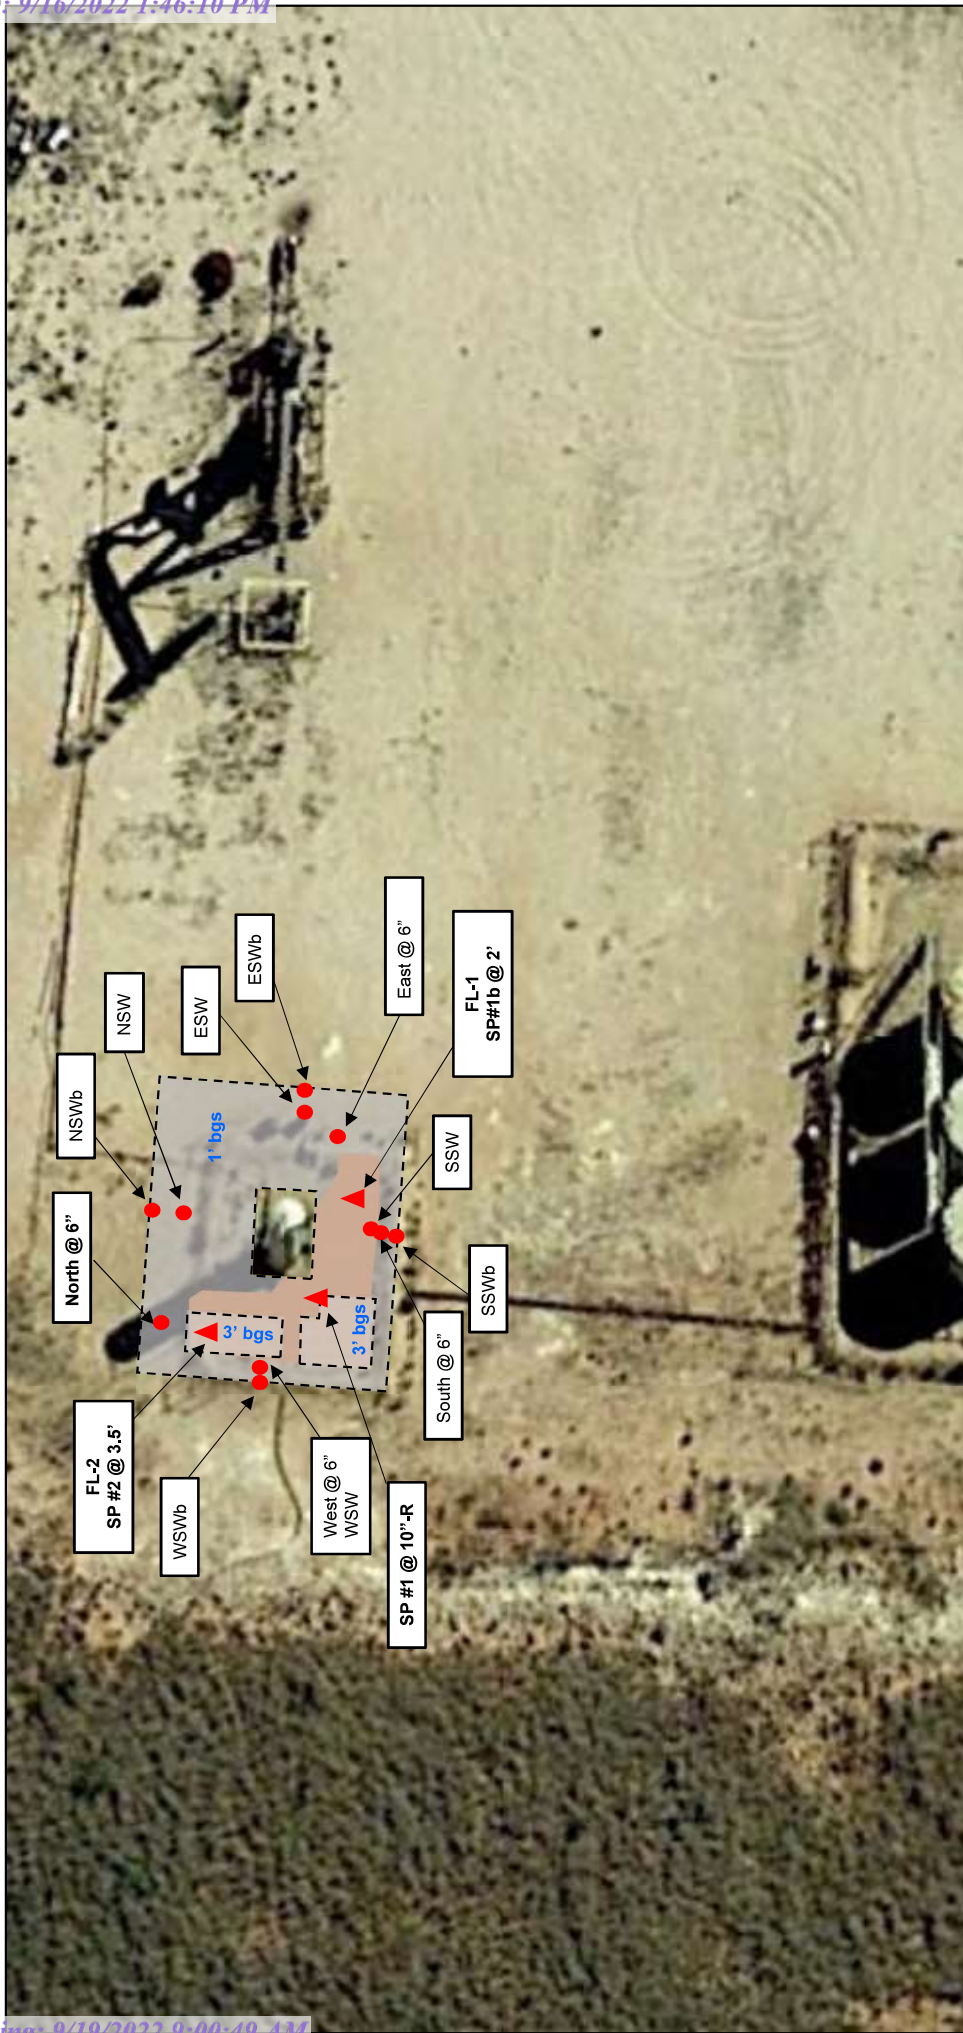
<b>LEGEND:</b>  ● Sidewall Sample Location ▲ Horizontal Sample Location --- Excavated Area ■ Affected Soil Remaining In-Situ	<b>Figure 2</b> Site & Sample Location Map COG Operating, LLC Phillips State #001  Lea County, New Mexico		Scale 1" = ~50'	
	Drafted by: BC	Checked by: JL		
	Draft: September 5, 2018			
	Lat. N 32.4744949 Long. W 103.3875351			
	UL "O", Sec. 17, T21S, R35E			
		TRC Proj. No.: 293168

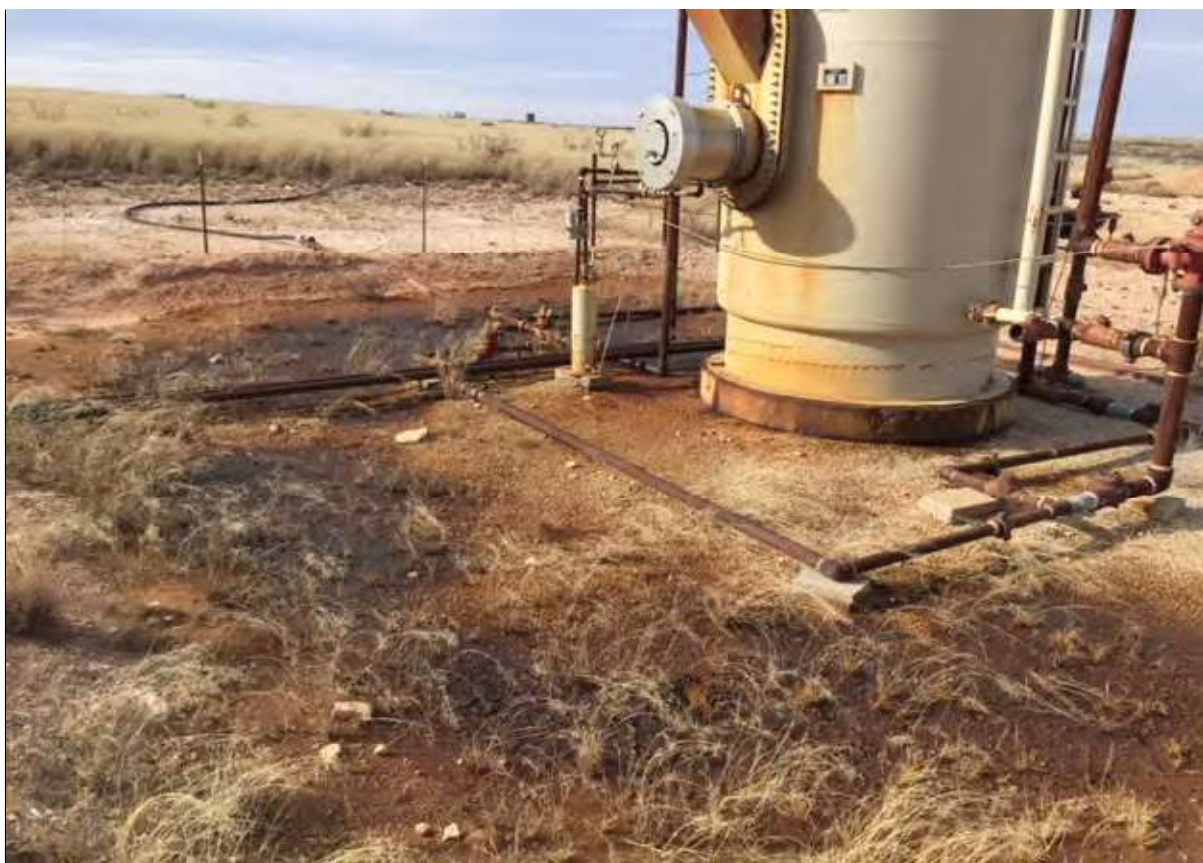
**Figure 1** - View of the affected area, facing northwest.

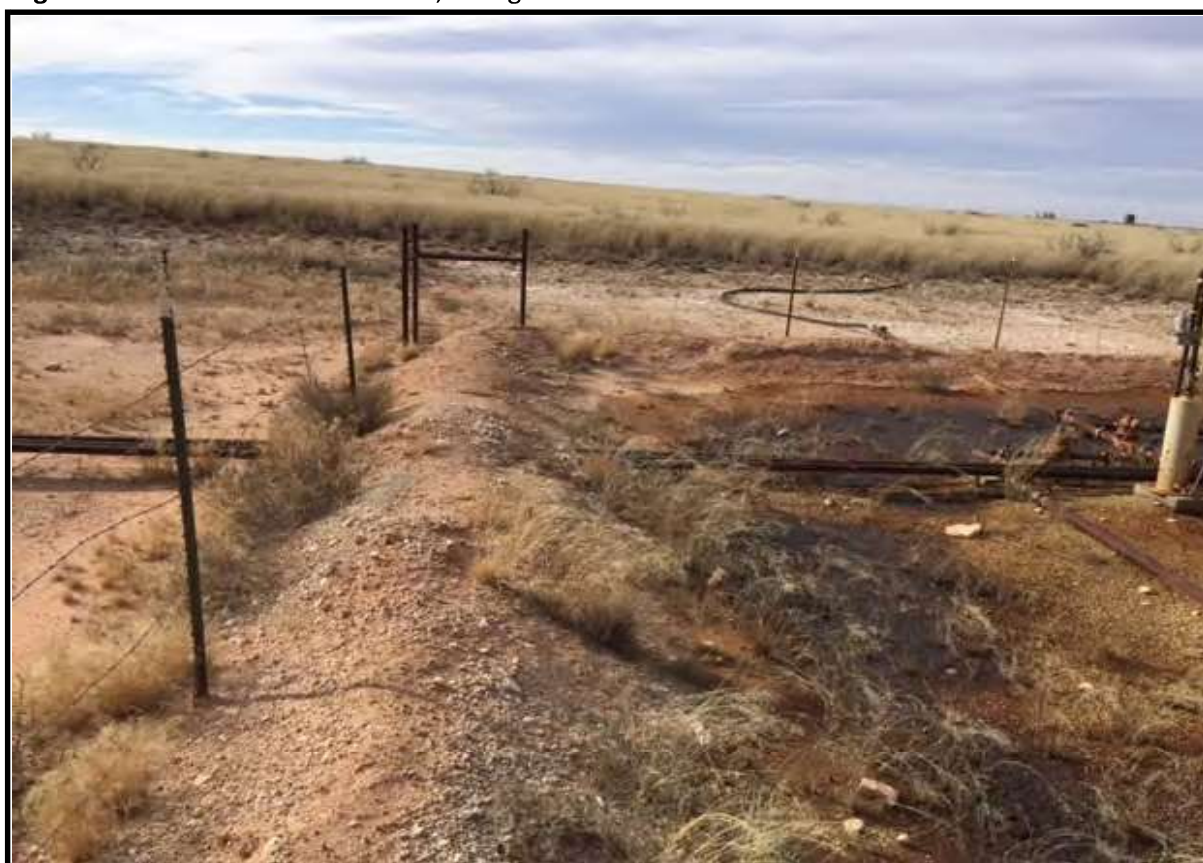
**Figure 2** - View of the affected area, facing west.

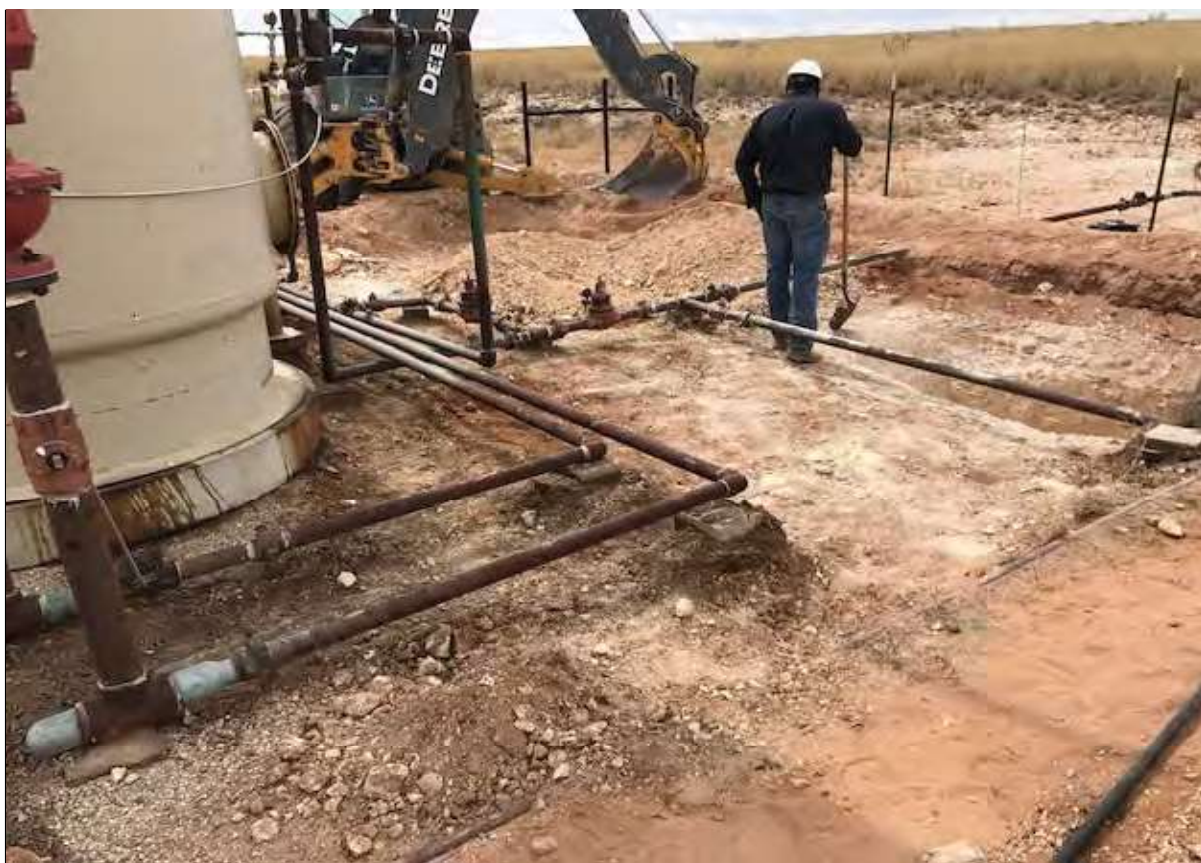
**Figure 3** - View of portion of the excavated area, facing southwest.

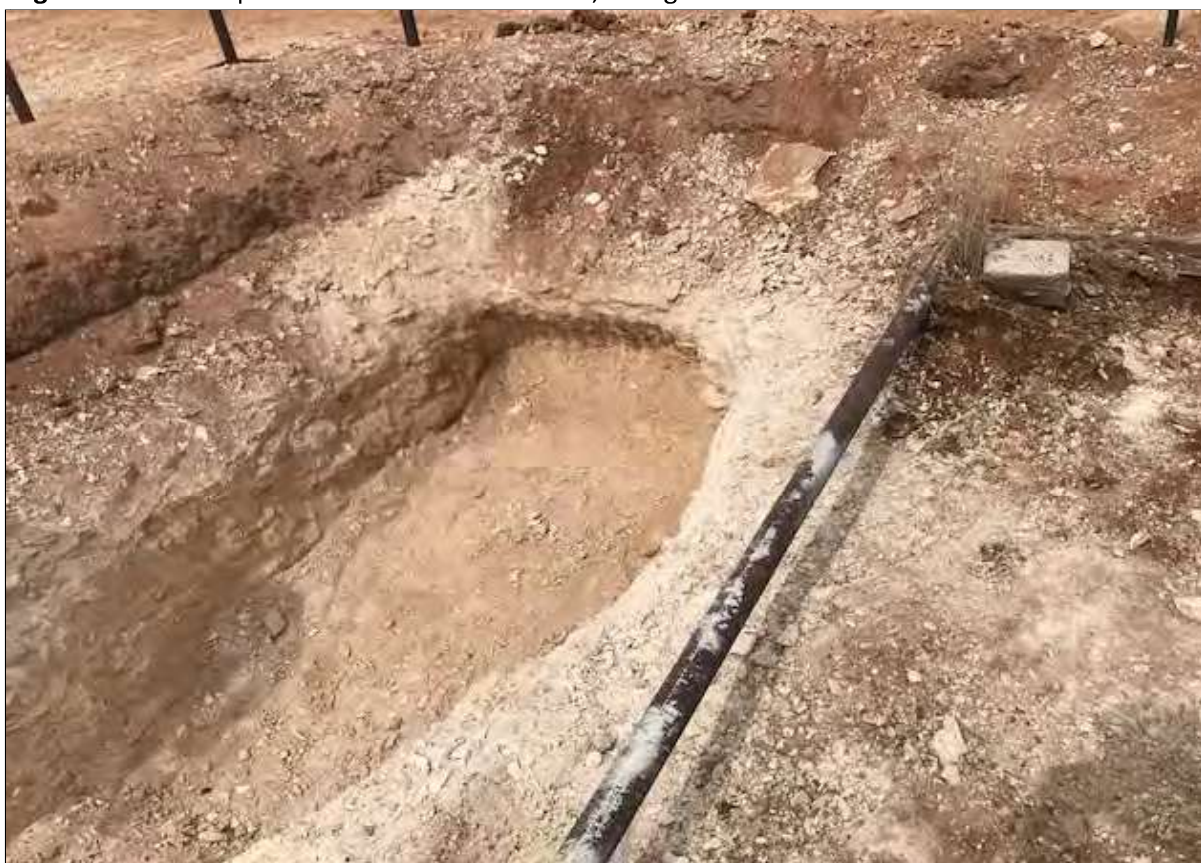
**Figure 4** - View of portion of the excavated area, facing north.

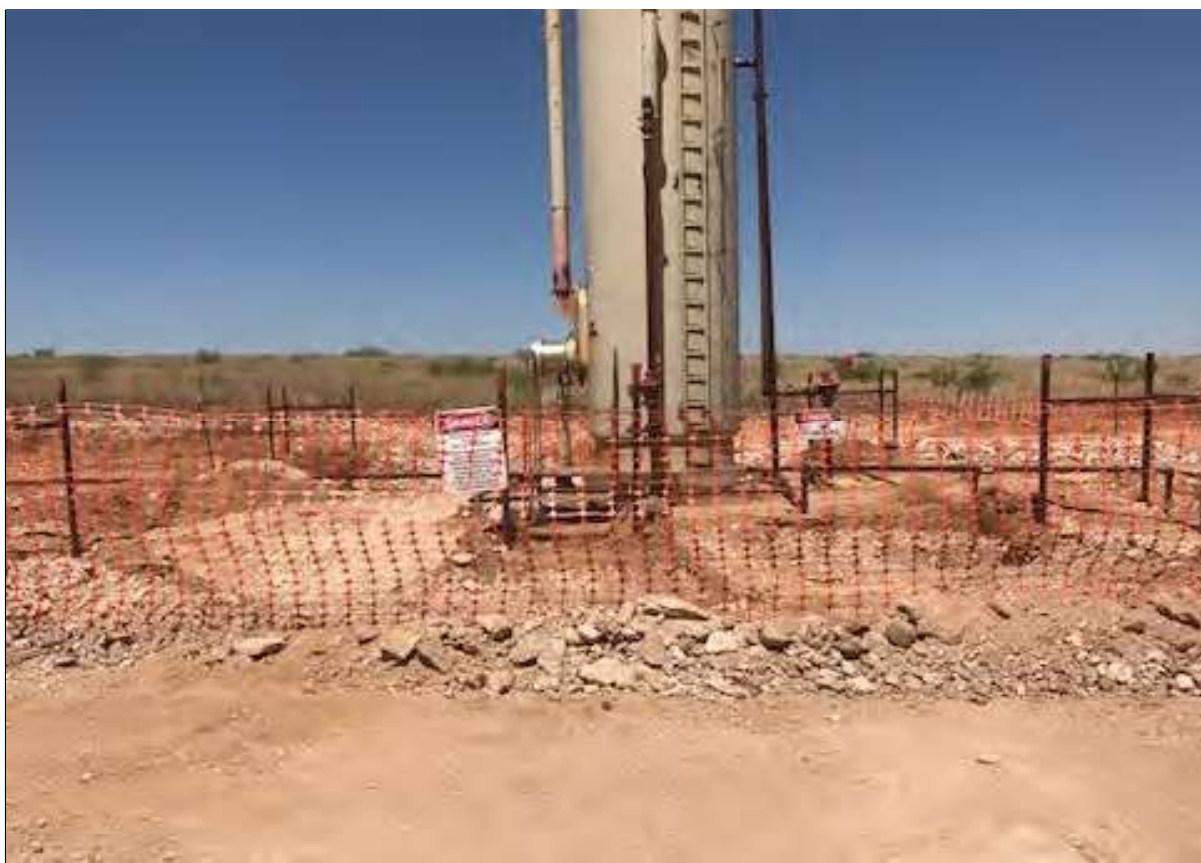
**Figure 5** - View of portion of the excavated area, facing west.

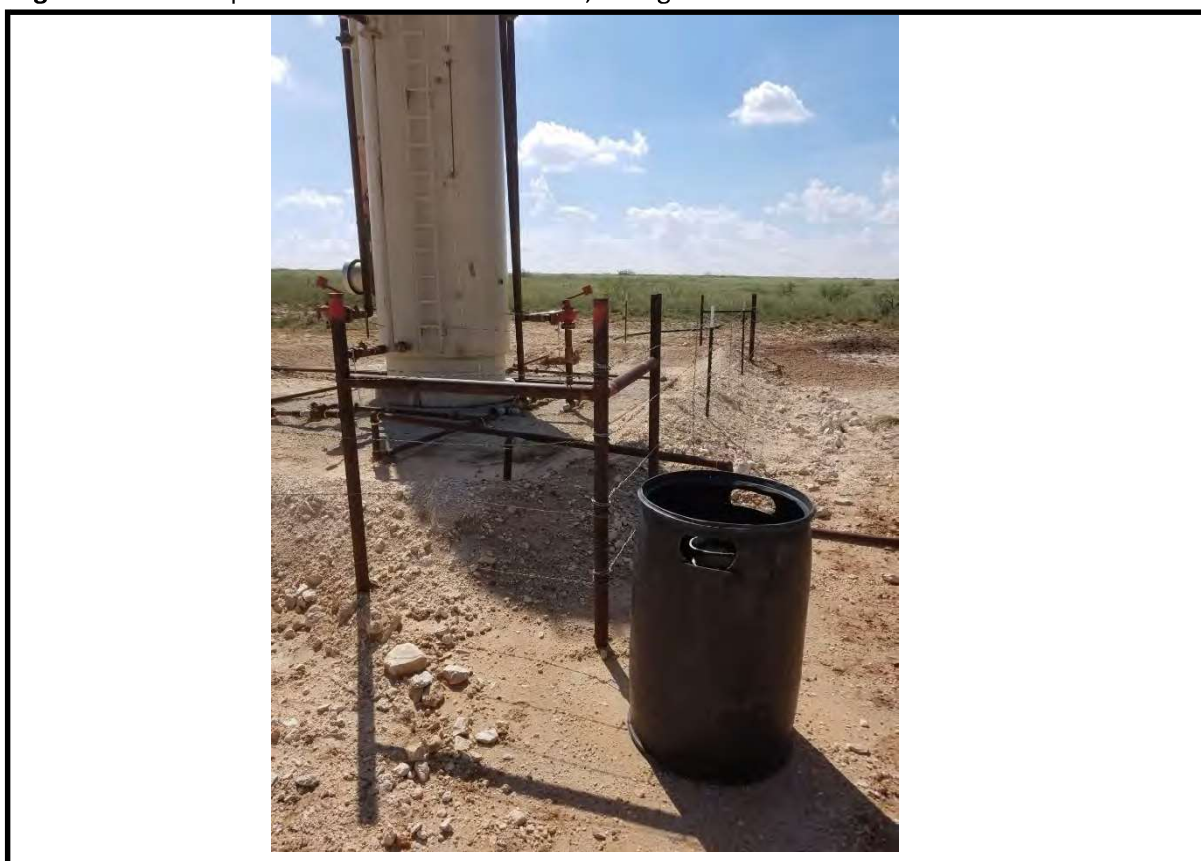
**Figure 6** - View of affected area after remediation activities, facing northwest.

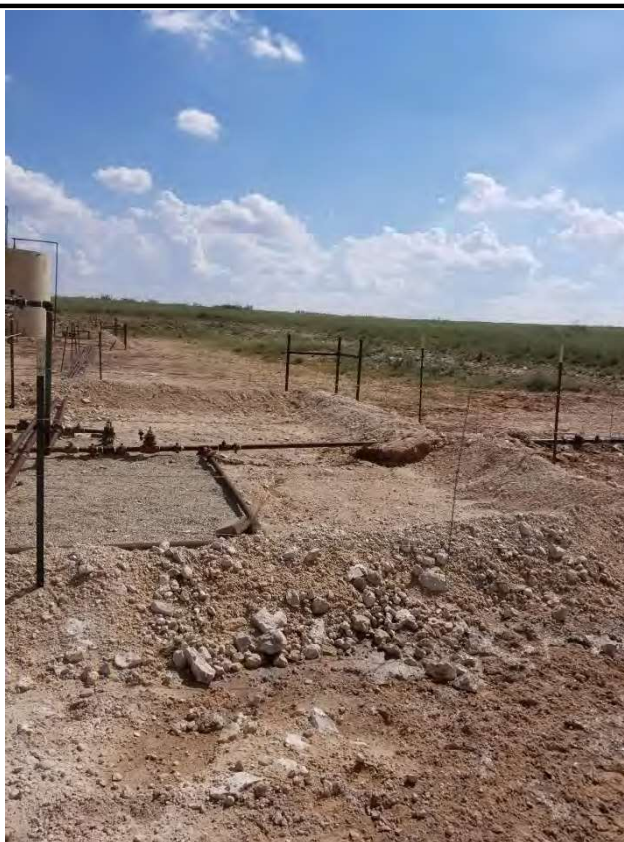
**Figure 7** - View of affected area after remediation activities, facing south.

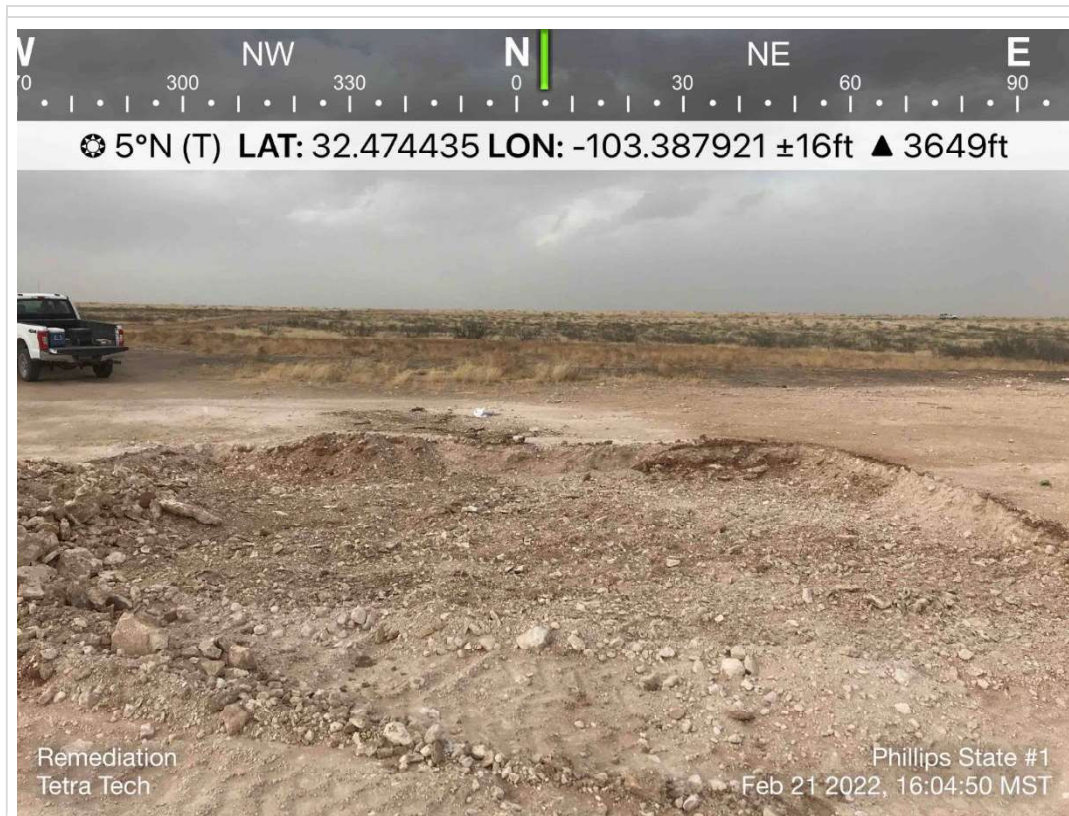
TETRA TECH, INC. PROJECT NO. 212C-MD-02601	DESCRIPTION	View north, excavated former heater treater release site prior to backfilling.	1
	SITE NAME	ConocoPhillips Phillips State #1 Remediation	2/21/2022

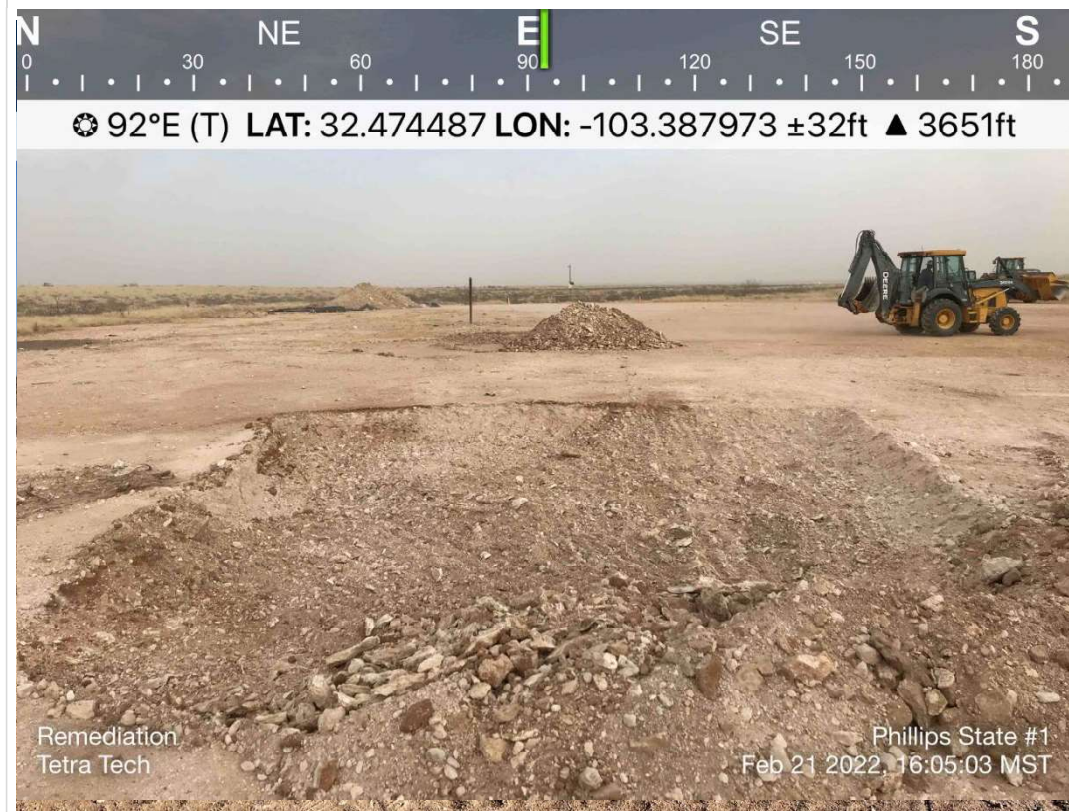
TETRA TECH, INC. PROJECT NO. 212C-MD-02601	DESCRIPTION	View east, excavated former heater treater release site prior to backfilling.	2
	SITE NAME	ConocoPhillips Phillips State #1 Remediation	2/21/2022

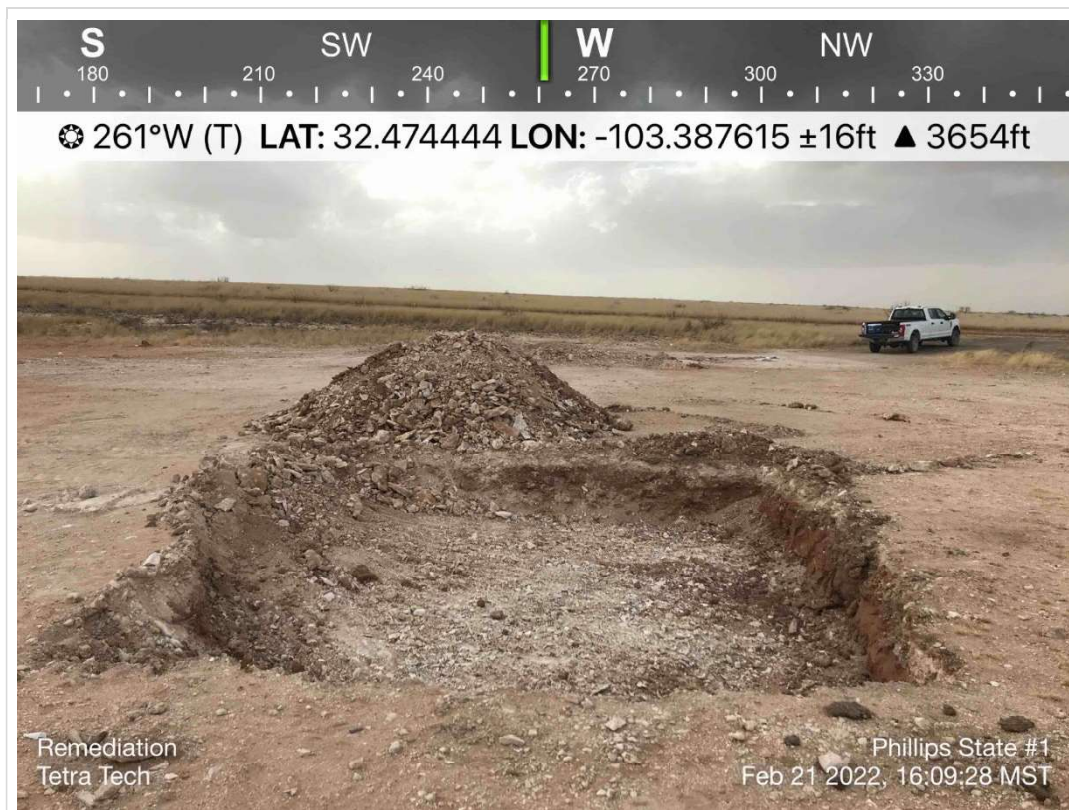
TETRA TECH, INC. PROJECT NO. 212C-MD-02601	DESCRIPTION	View west, excavated former heater treater release site prior to backfilling.	3
	SITE NAME	ConocoPhillips Phillips State #1 Remediation	2/21/2022

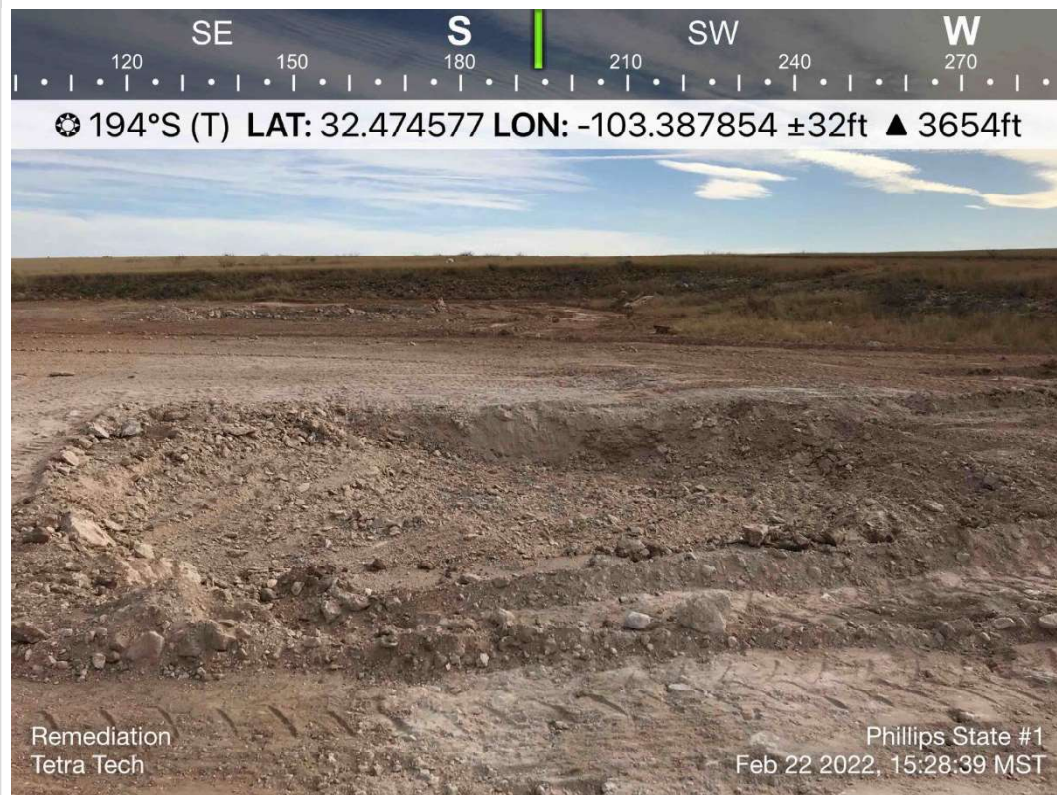
TETRA TECH, INC. PROJECT NO. 212C-MD-02601	DESCRIPTION	View south, excavated former heater treater release site prior to backfilling.	4
	SITE NAME	ConocoPhillips Phillips State #1 Remediation	2/22/2022

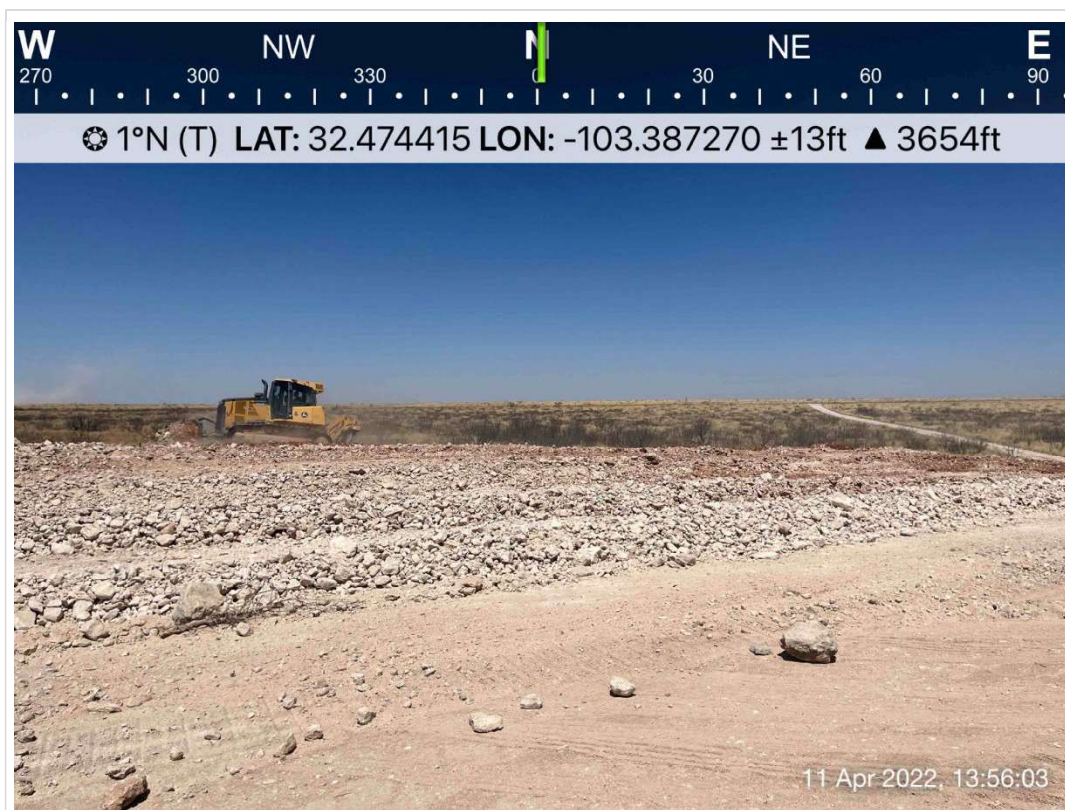
TETRA TECH, INC. PROJECT NO. 212C-MD-02601	DESCRIPTION	View north, ripping of caliche pad in progress.	5
	SITE NAME	ConocoPhillips Phillips State #1 Reclamation	4/11/2022

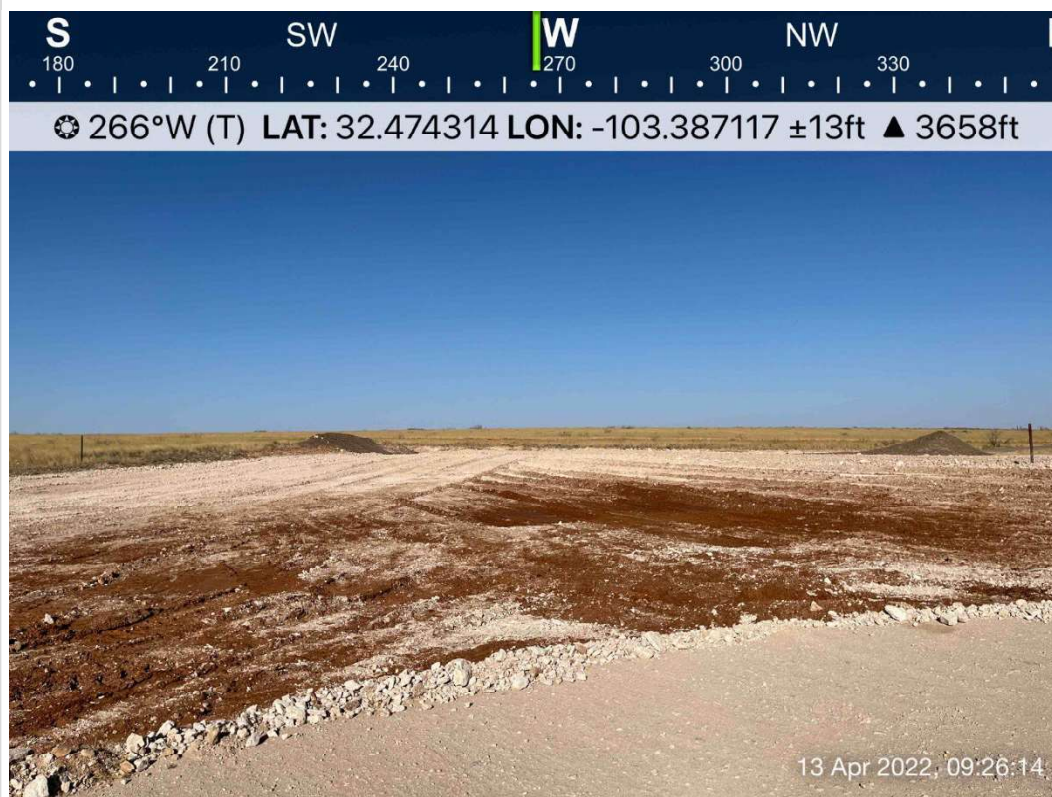
TETRA TECH, INC. PROJECT NO. 212C-MD-02601	DESCRIPTION	View west, imported material incorporated with ripped material.	6
	SITE NAME	ConocoPhillips Phillips State #1 Reclamation	4/13/2022

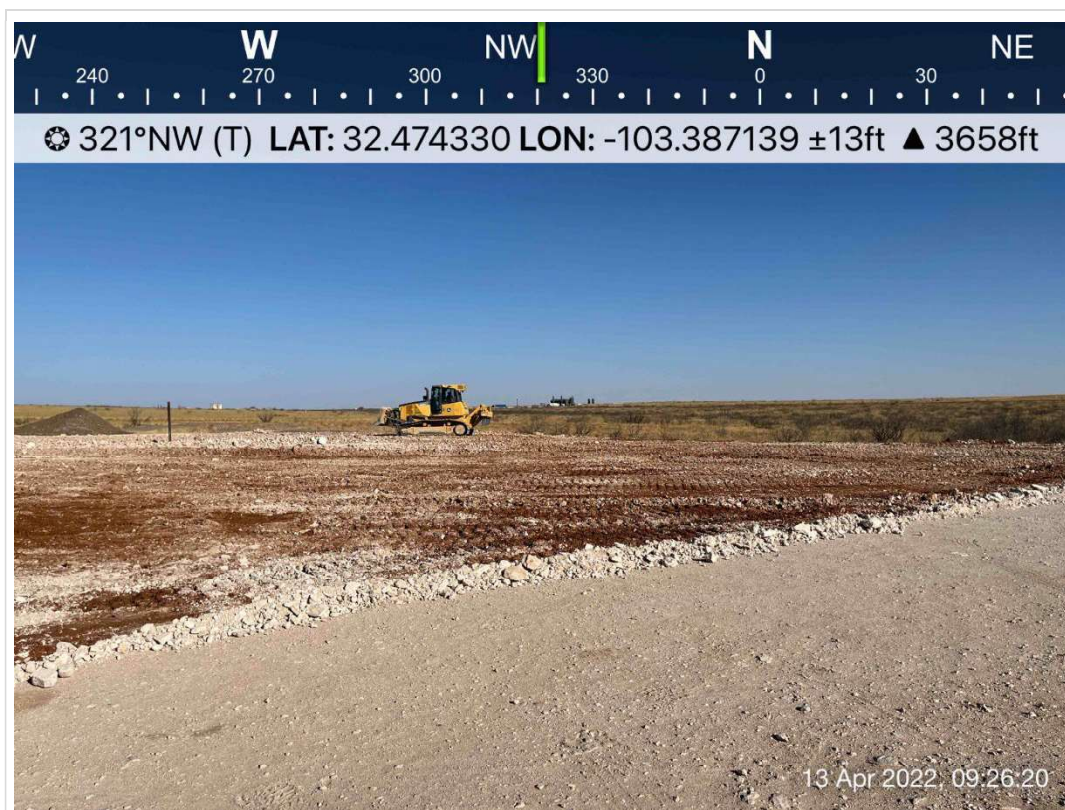
TETRA TECH, INC. PROJECT NO. 212C-MD-02601	DESCRIPTION	View northwest, imported material incorporated with ripped material.	7
	SITE NAME	ConocoPhillips Phillips State #1 Reclamation	4/13/2022

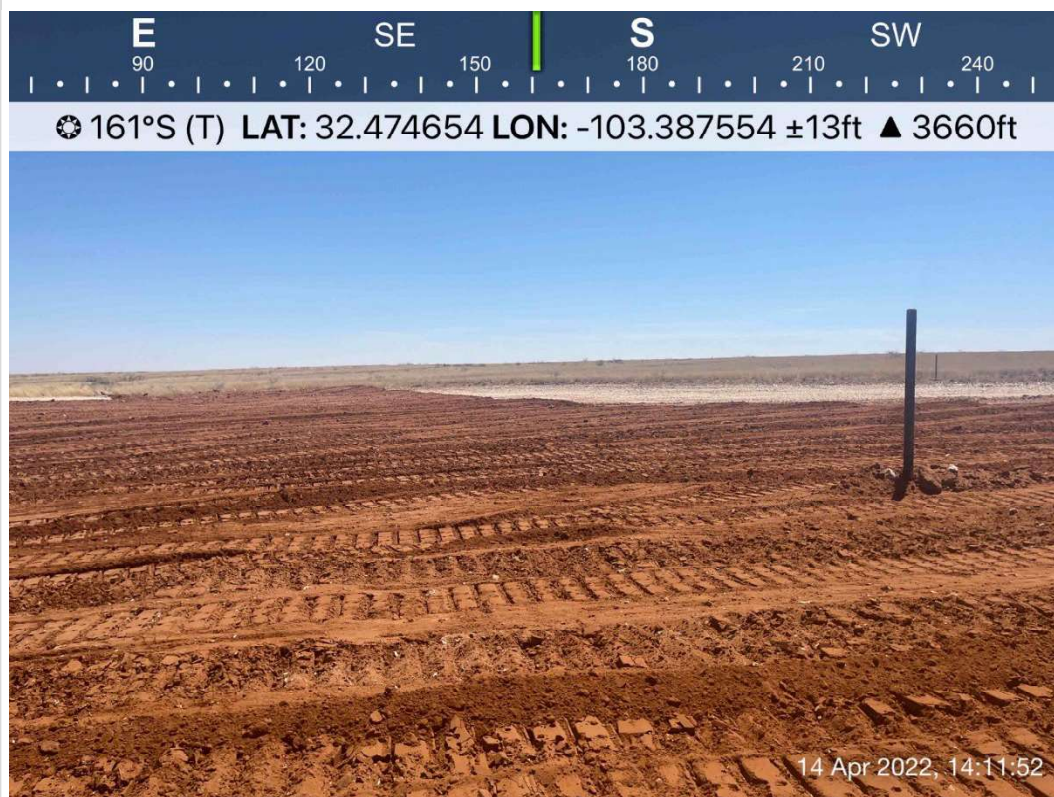
TETRA TECH, INC. PROJECT NO. 212C-MD-02601	DESCRIPTION	View south-southeast, pad surface ripped and imported material incorporated.	8
	SITE NAME	ConocoPhillips Phillips State #1 Reclamation	4/13/2022

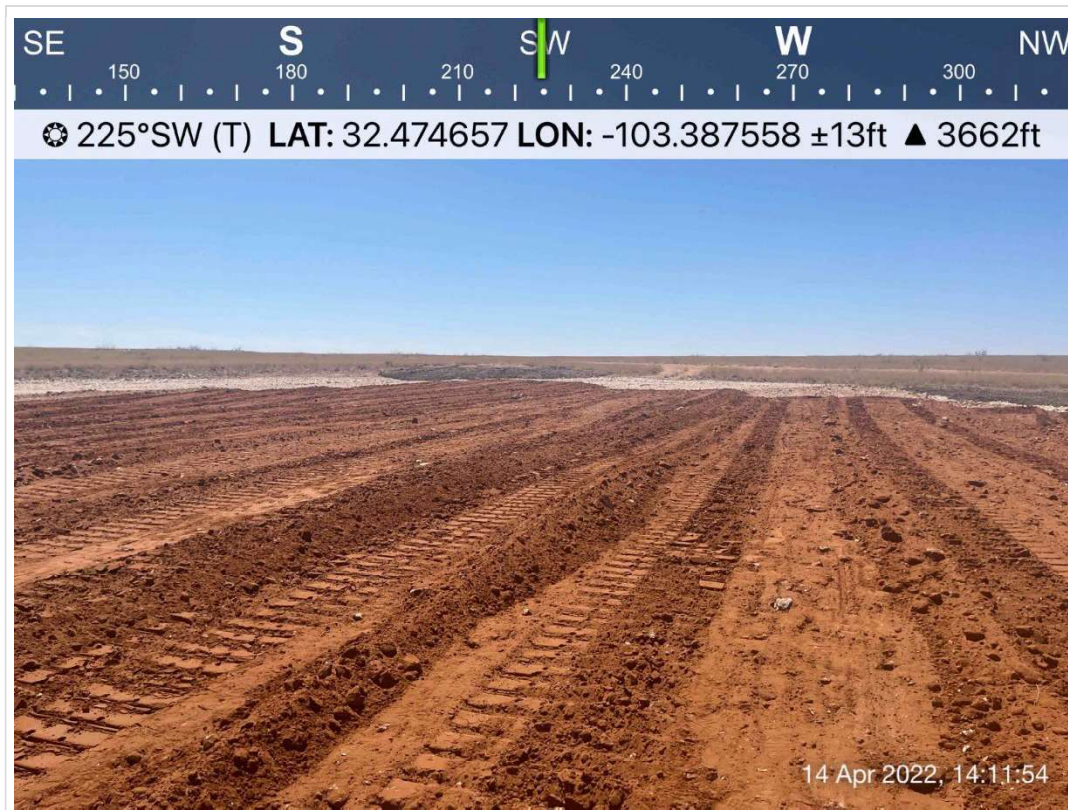
TETRA TECH, INC. PROJECT NO. 212C-MD-02601	DESCRIPTION	View southwest, pad surface ripped and imported material incorporated.	9
	SITE NAME	ConocoPhillips Phillips State #1 Reclamation	4/13/2022

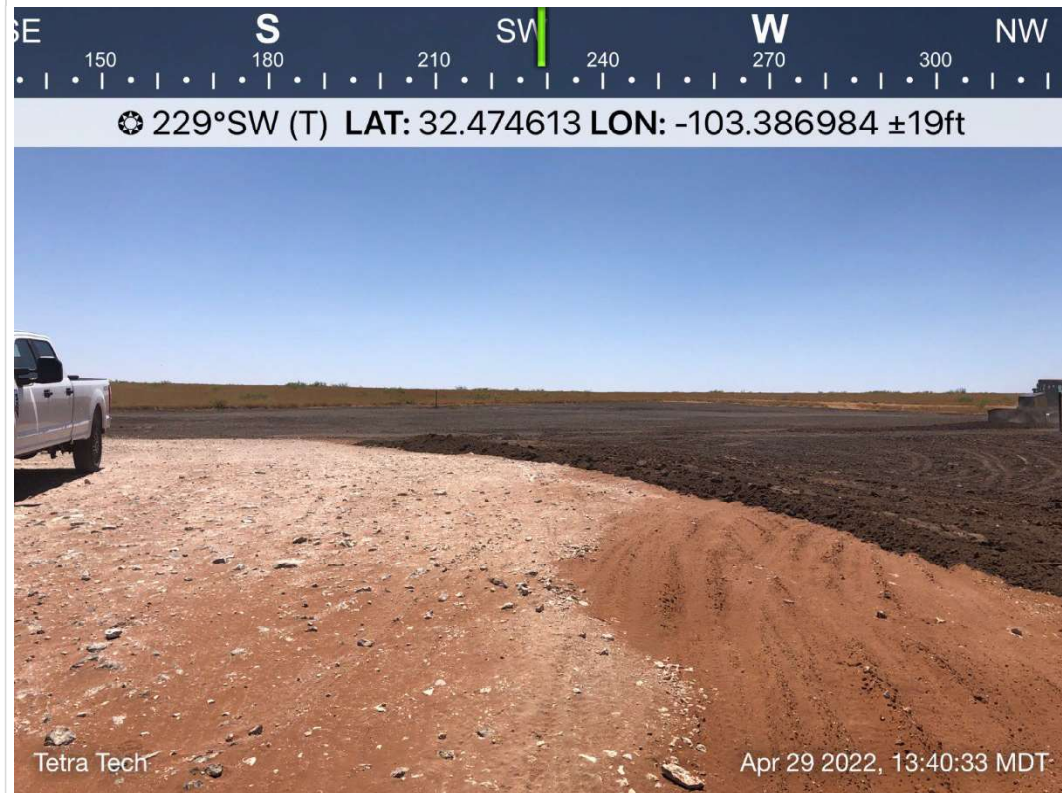
TETRA TECH, INC. PROJECT NO. 212C-MD-02601	DESCRIPTION	View southwest, incorporating more imported material to the ripped pad area.	10
	SITE NAME	ConocoPhillips Phillips State #1 Reclamation	4/29/2022

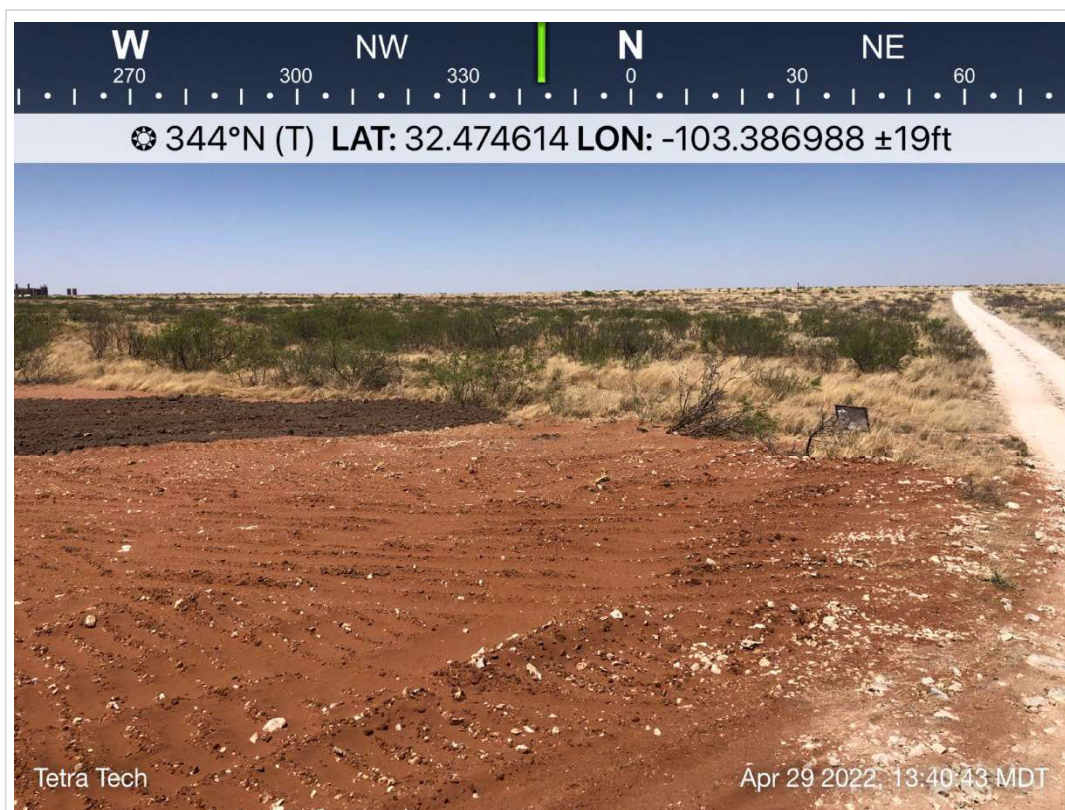
TETRA TECH, INC. PROJECT NO. 212C-MD-02601	DESCRIPTION	View north, ripped pad, pad boundary, and access road.	11
	SITE NAME	ConocoPhillips Phillips State #1 Reclamation	4/29/2022

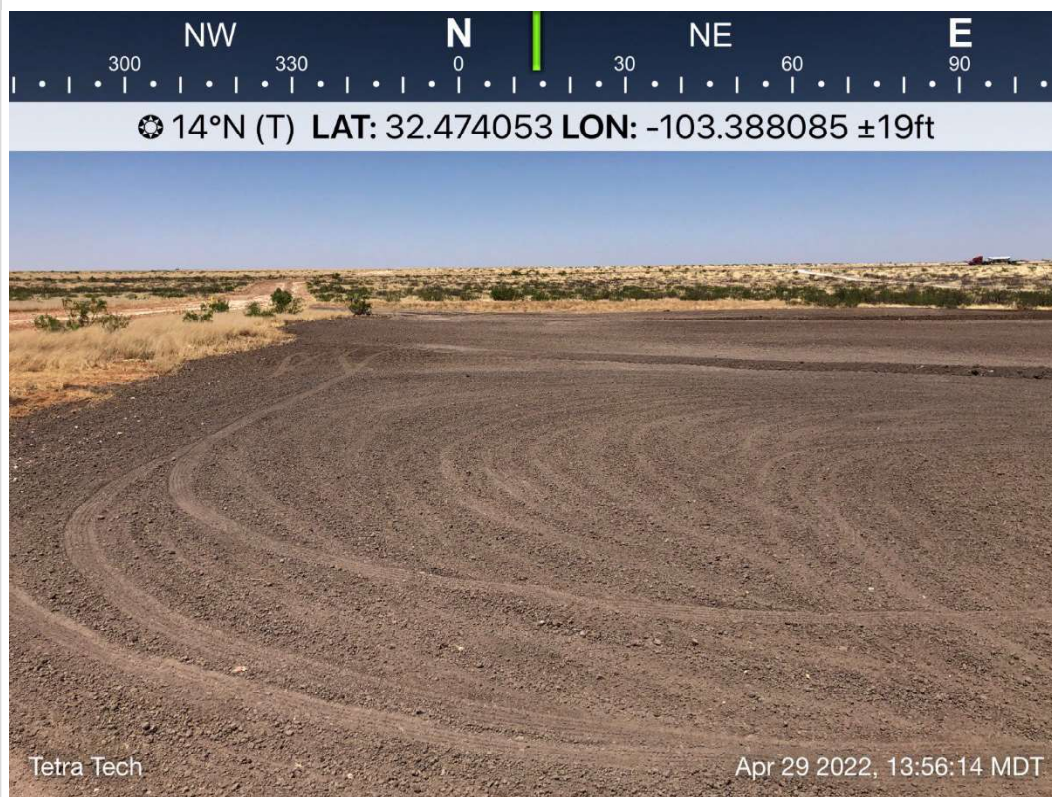
TETRA TECH, INC. PROJECT NO. 212C-MD-02601	DESCRIPTION	View north, western portion of pad prior to seeding.	12
	SITE NAME	ConocoPhillips Phillips State #1 Reclamation	4/29/2022

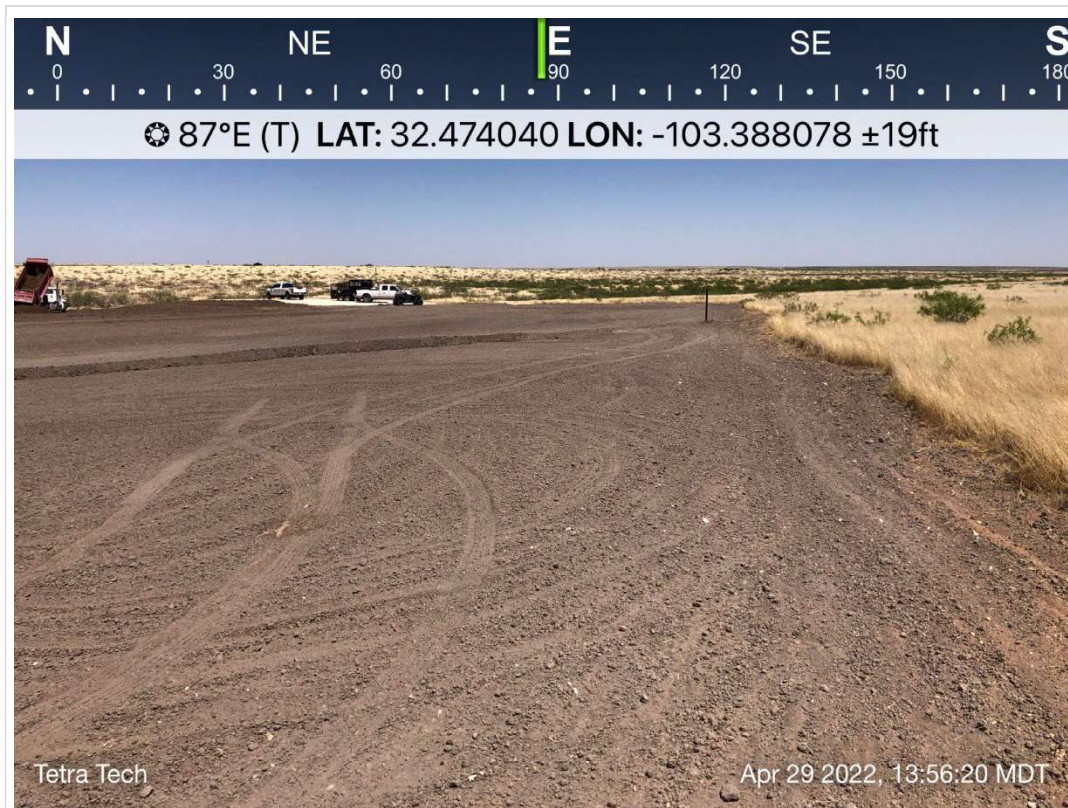
TETRA TECH, INC. PROJECT NO. 212C-MD-02601	DESCRIPTION	View east, southern section of pad prior to seeding.	13
	SITE NAME	ConocoPhillips Phillips State #1 Reclamation	4/29/2022

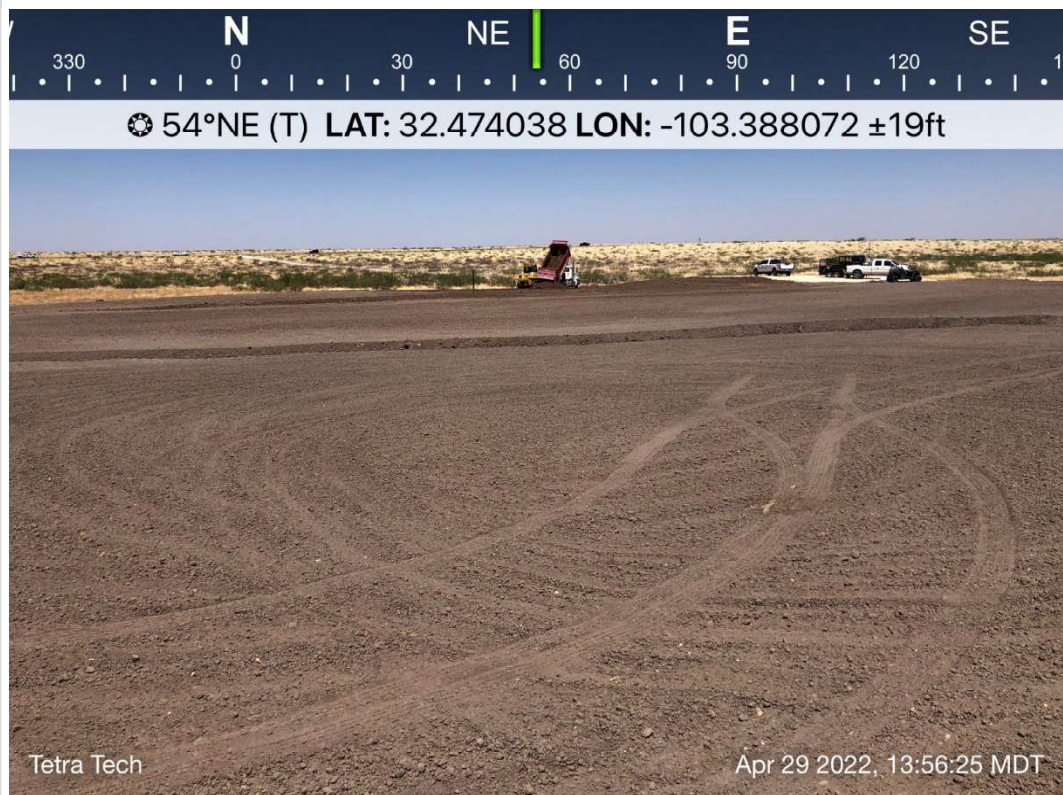
TETRA TECH, INC. PROJECT NO. 212C-MD-02601	DESCRIPTION	View northeast, central portion of pad prior to seeding.	14
	SITE NAME	ConocoPhillips Phillips State #1 Reclamation	4/29/2022

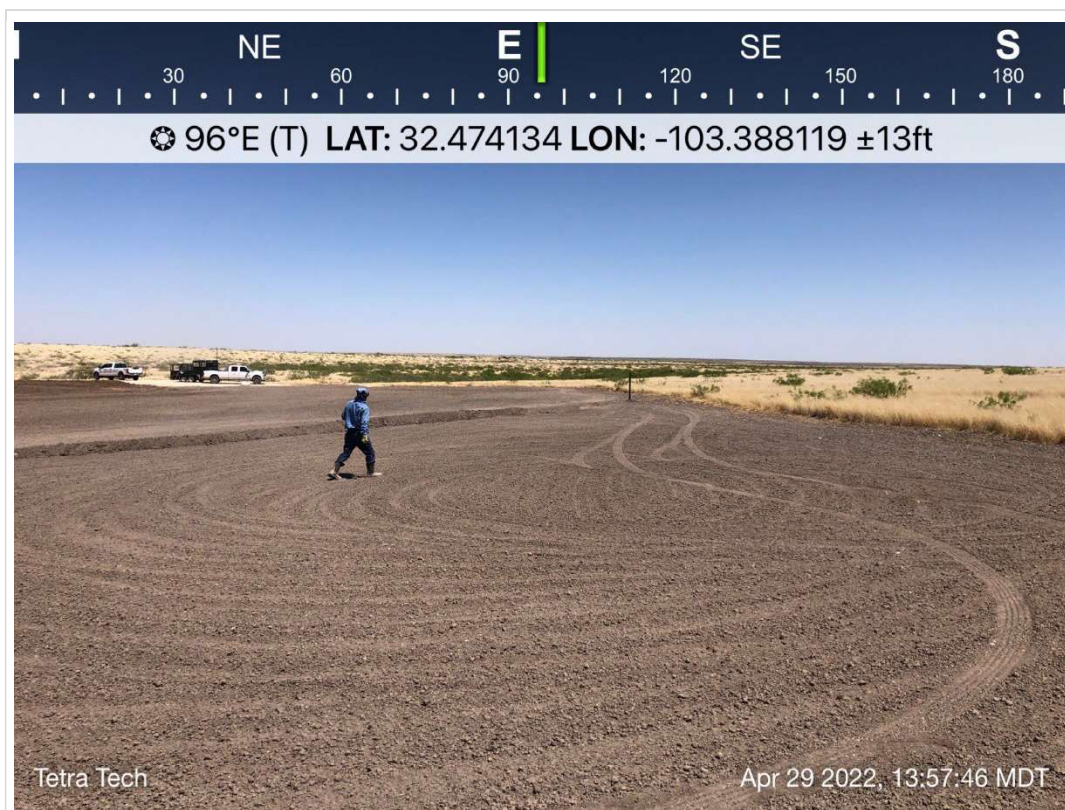
TETRA TECH, INC. PROJECT NO. 212C-MD-02601	DESCRIPTION	View east, seeding of reclaimed pad taking place.	15
	SITE NAME	ConocoPhillips Phillips State #1 Reclamation	4/29/2022
