**Re: Closure Report - Revised  
ConocoPhillips (Heritage Concho)  
Phillips State #1 (Heater Treater Release)  
API # 30-025-30956  
Unit Letter O, Section 17, Township 21 South, Range 35 East  
Lea County, New Mexico  
Incident ID nOY1733235874  
1RP-4883**

Closure Report  
September 16, 2022

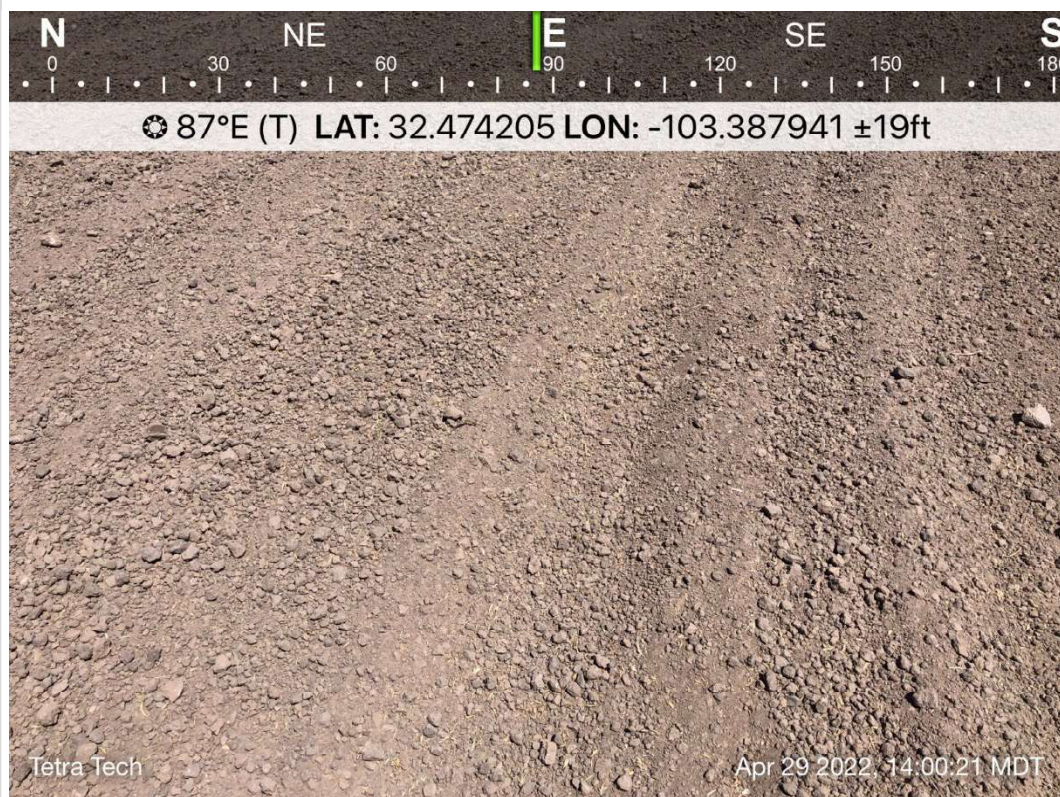
TETRA TECH, INC. PROJECT NO. 212C-MD-02601	DESCRIPTION	View of ground surface post reclamation work.	16
	SITE NAME	ConocoPhillips Phillips State #1 Reclamation	4/29/2022

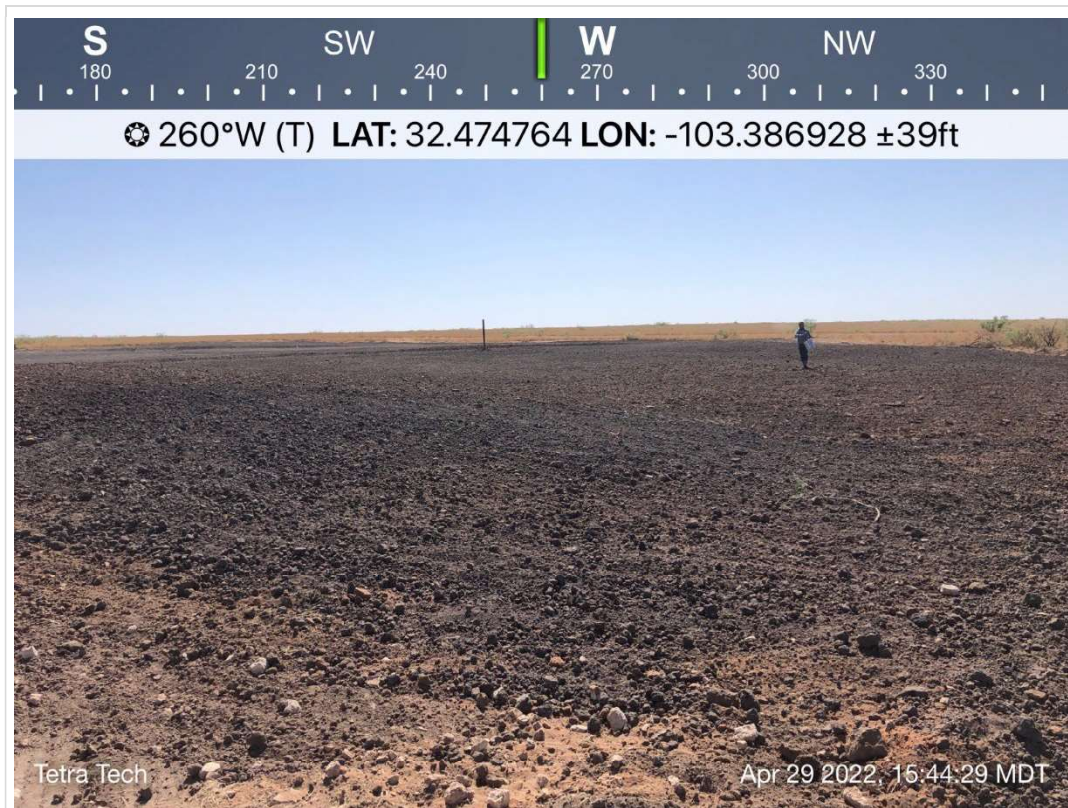
TETRA TECH, INC. PROJECT NO. 212C-MD-02601	DESCRIPTION	View west, continuing the seeding process.	17
	SITE NAME	ConocoPhillips Phillips State #1 Reclamation	4/29/2022

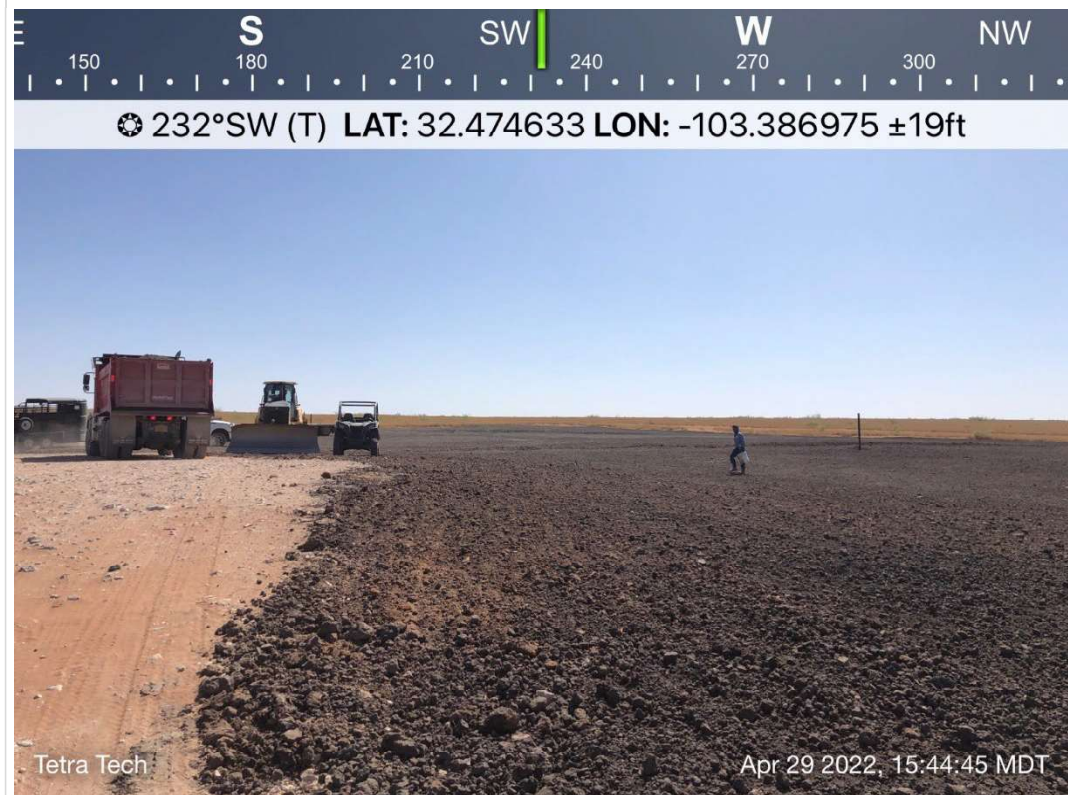
TETRA TECH, INC. PROJECT NO. 212C-MD-02601	DESCRIPTION	View southwest, seeding process taking place.	18
	SITE NAME	ConocoPhillips Phillips State #1 Reclamation	4/29/2022
