Release Notification

Site Name Vasaly 2 SWD	Site Type: Saltwater Disposal
Date Release Discovered: 6/2/2022	API# 30-045-29936

Executive Summary – Incident #nAPP2215935656

On June 2, 2022, approximately 17 bbls of produced water was released from a corroded section of pipeline during a water transfer at the Vasaly 2 SWD facility. Operations isolated the corroded section and removed remaining pipeline fluids. Standing fluids and impacted soil were removed via hydrovac and transported offsite for disposal. The corroded portion of pipeline was replaced and put back into service. The release occurred on pad at the Vasaly Saltwater Disposal facility.

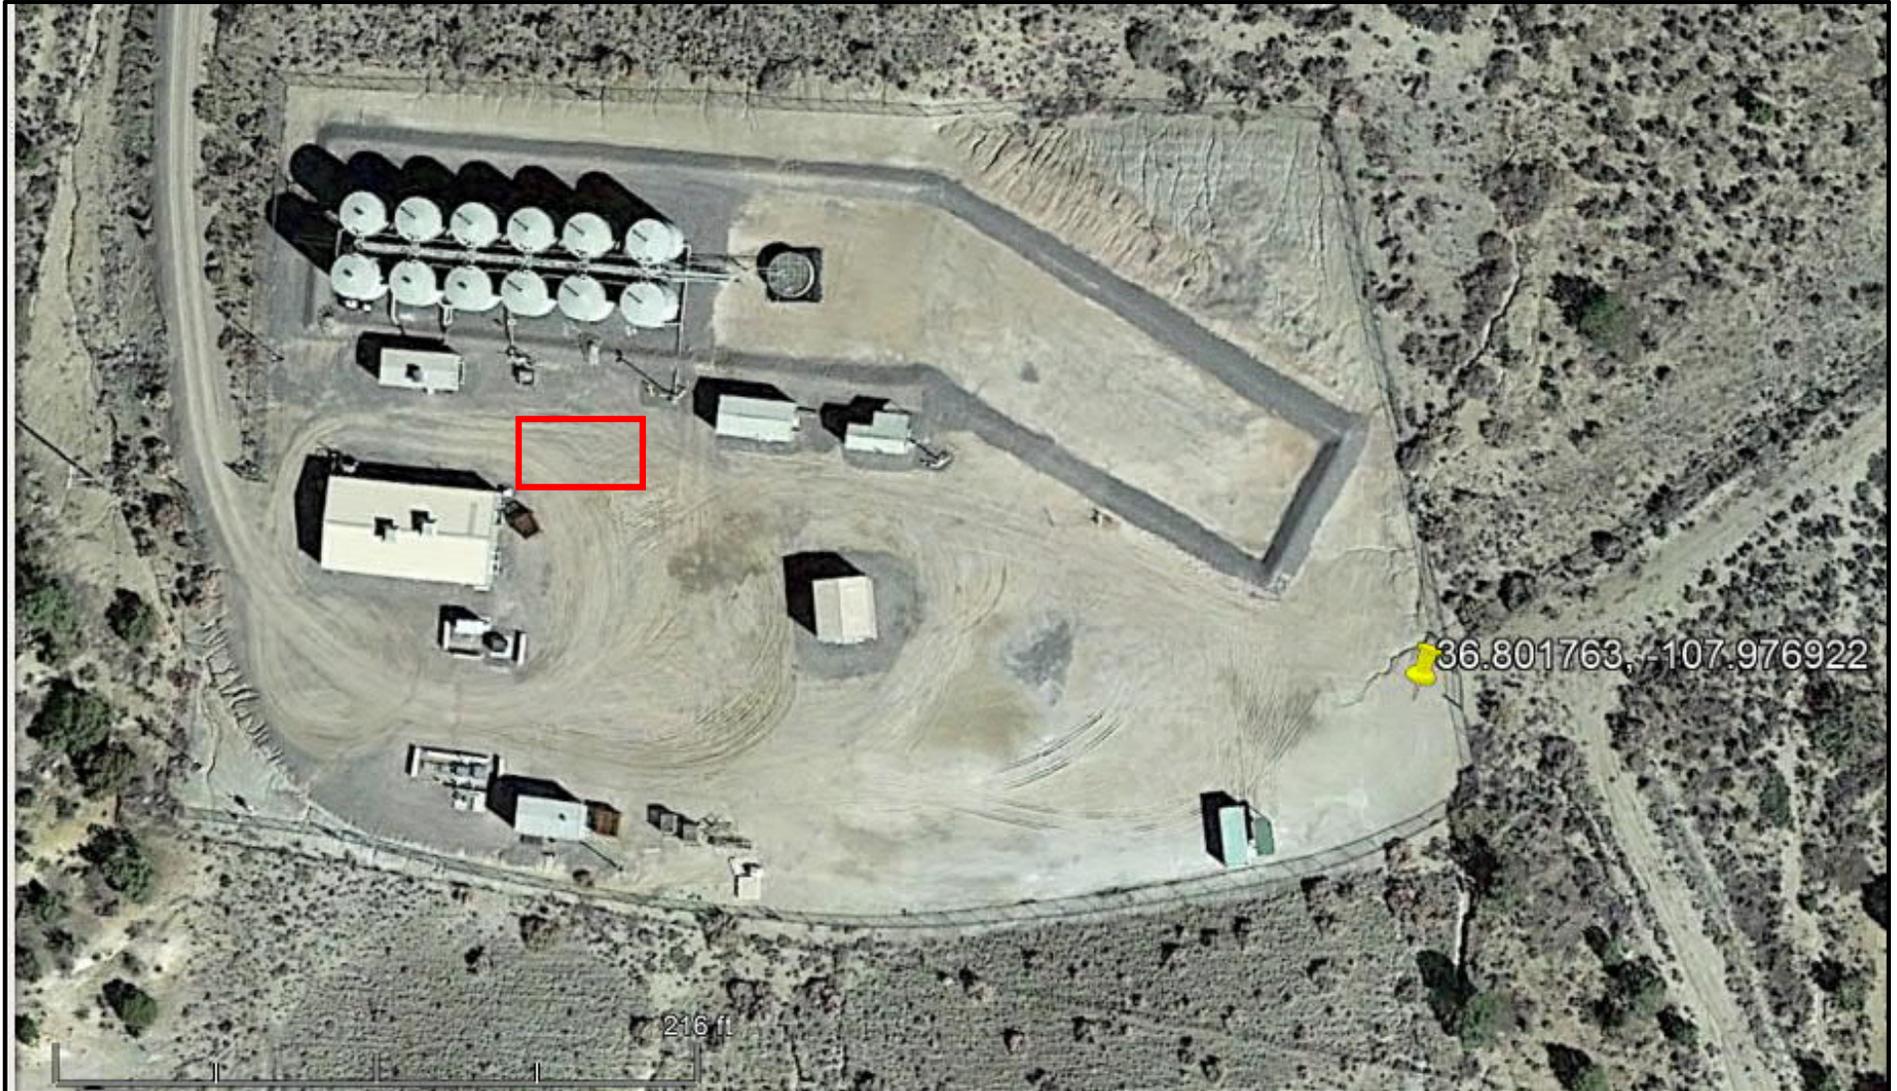
Scaled Site Map

Lat: 36.801763
Long: -107.976922

Vasaly 2 SWD
API: 30-045-29936

Release Area

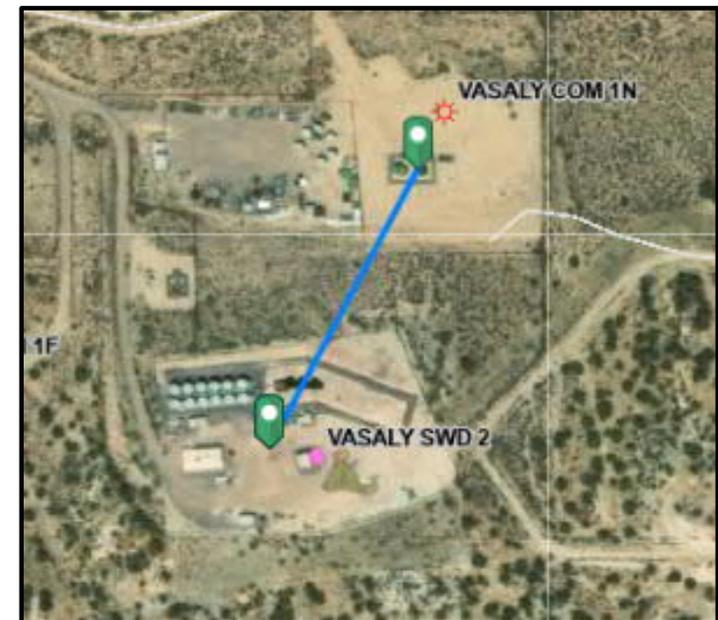
BGT Siting Criteria for Vasaly Com 1N – 470' north of the Vasaly 2 SWD

Estimated depth to groundwater is greater than 100'.

The Vasaly Com 1N is not located in an unstable area. The location is not over a mine and is not on the side of a hill as indicated on the Mines, Mills and Quarries Map and Topographic Map. The location of the excavated pit material will not be located within 300' of any continuously flowing watercourse or 200' from any other watercourse as indicated on the Topographic Map. The location is not within a 100-year floodplain area as indicated on the FEMA Map. The Cathodic well data from the Fuller 1 has an elevation of 5789' and groundwater depth of 80'. The subject well has an elevation of 5835' which is greater than the Fuller 1, therefore the groundwater depth is greater than 126'. There are no iWATERS data points located in the area as indicated on the TOPO Map. The hydro geologic analysis indicates the groundwater depth and the Nacimiento formation will create a stable area for this new location.

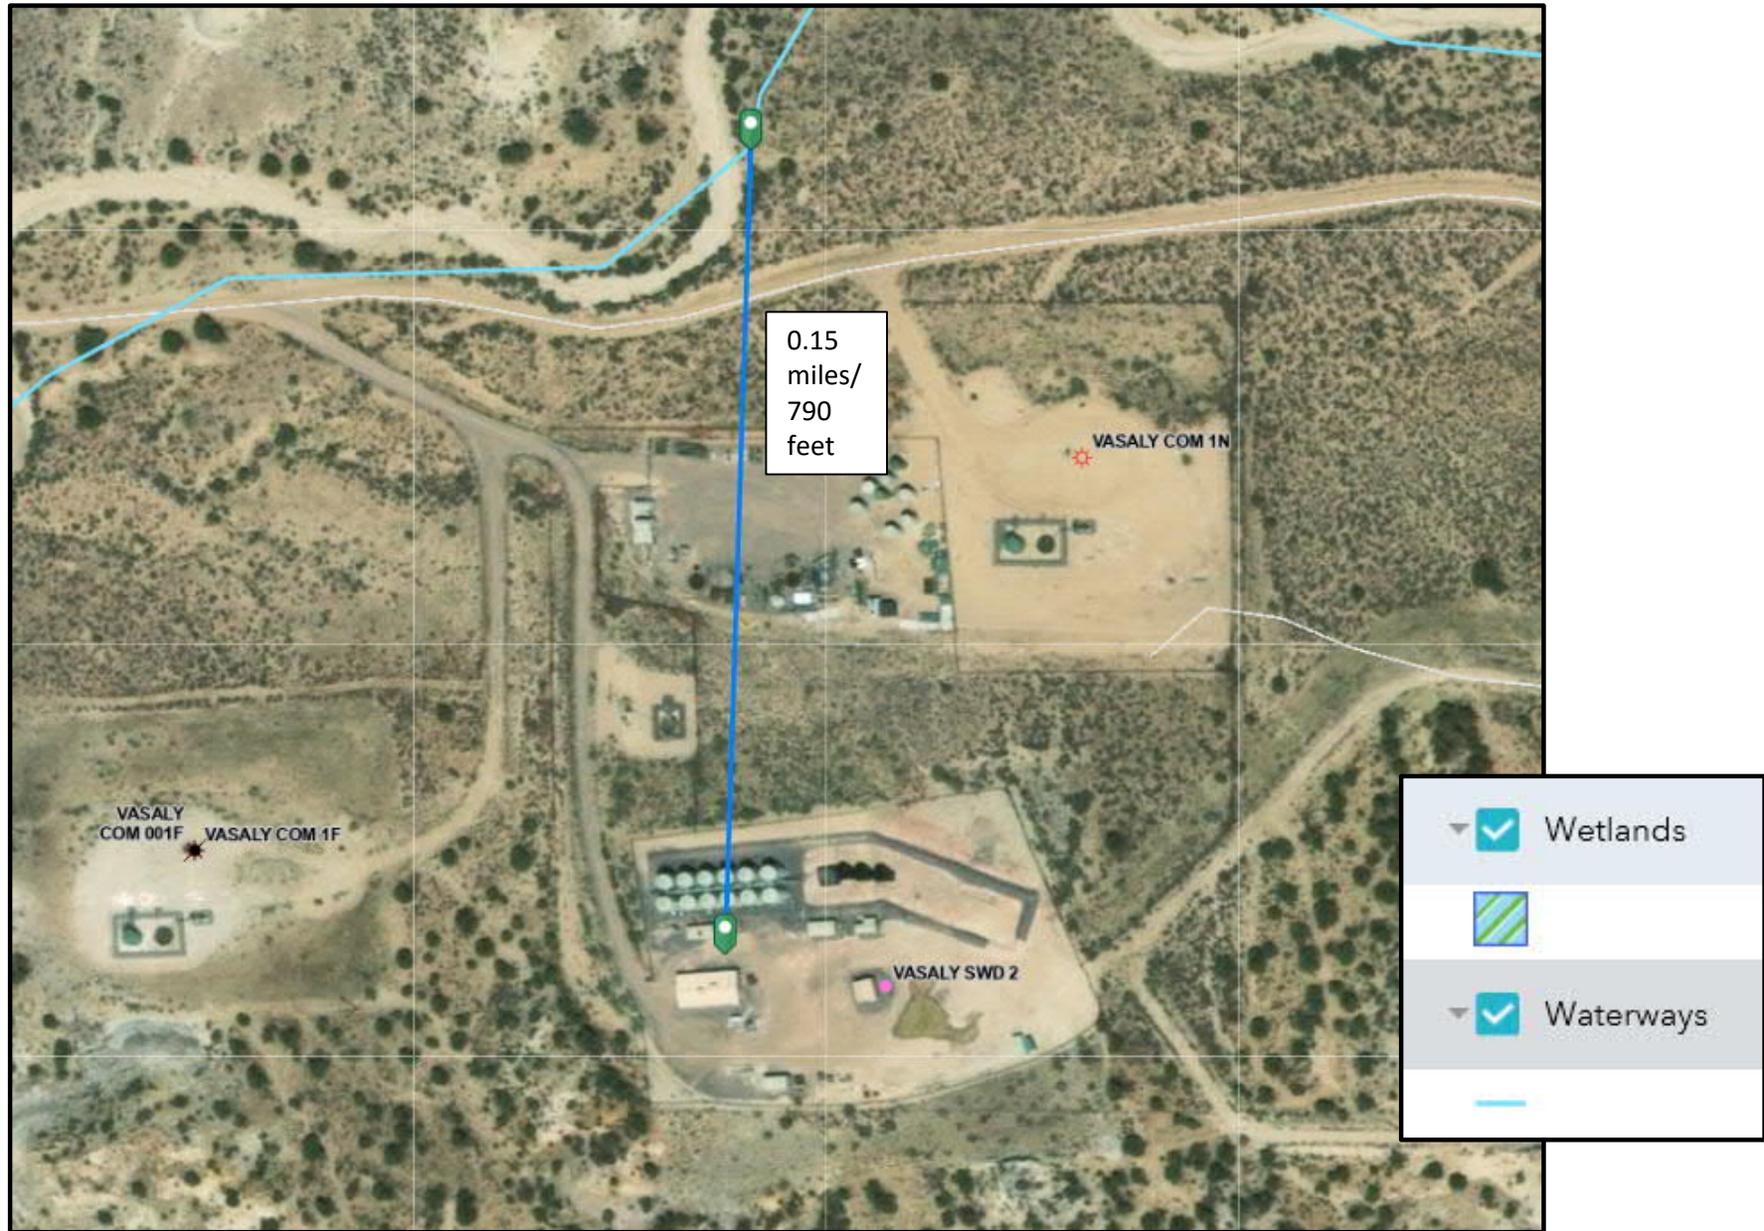
Determination of water sources and significant watercourses within 1/2 mile of the lateral extent of the release

Note 1: Release point is not shown to be within 300 ft of any continuously flowing watercourse or any other significant water course.

Note 2: The lateral extents of the release point are not shown to be within 300 feet of a mapped wetland.

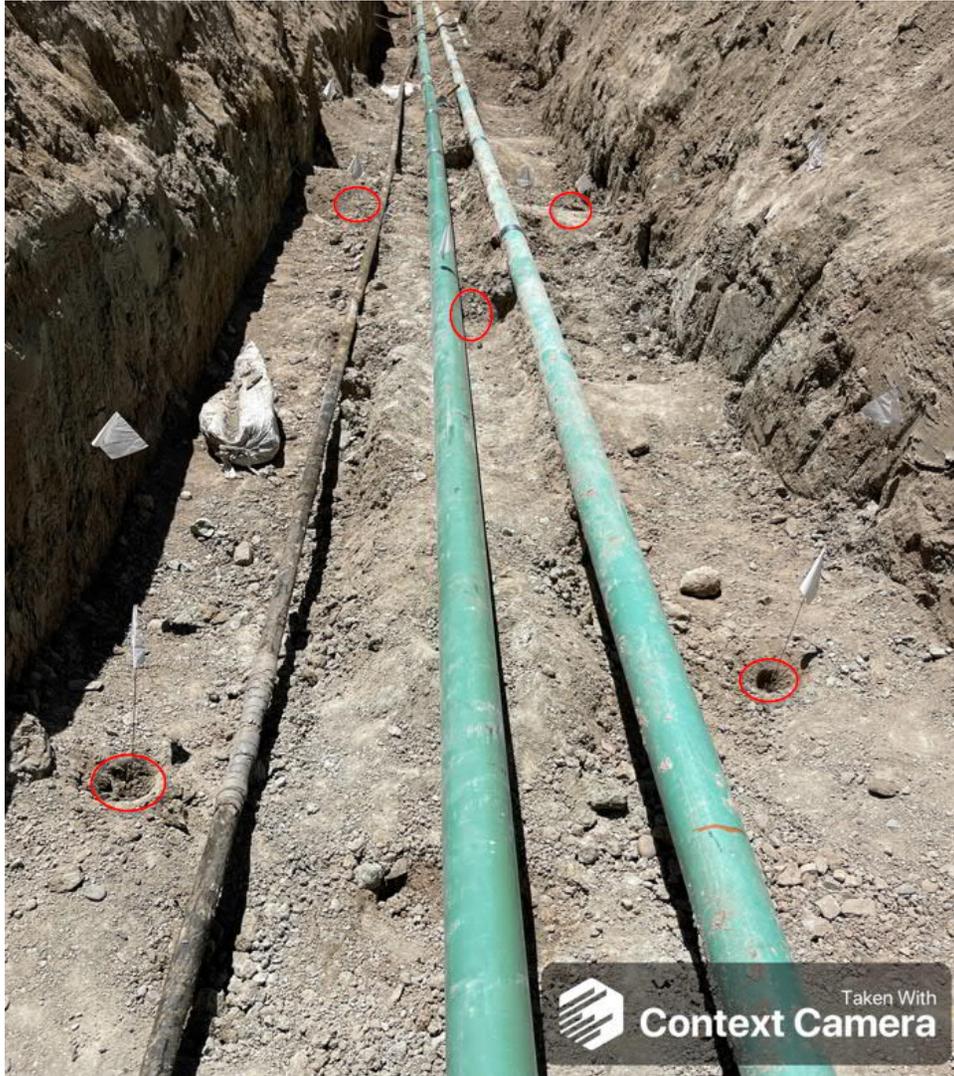
Base Sample Locations

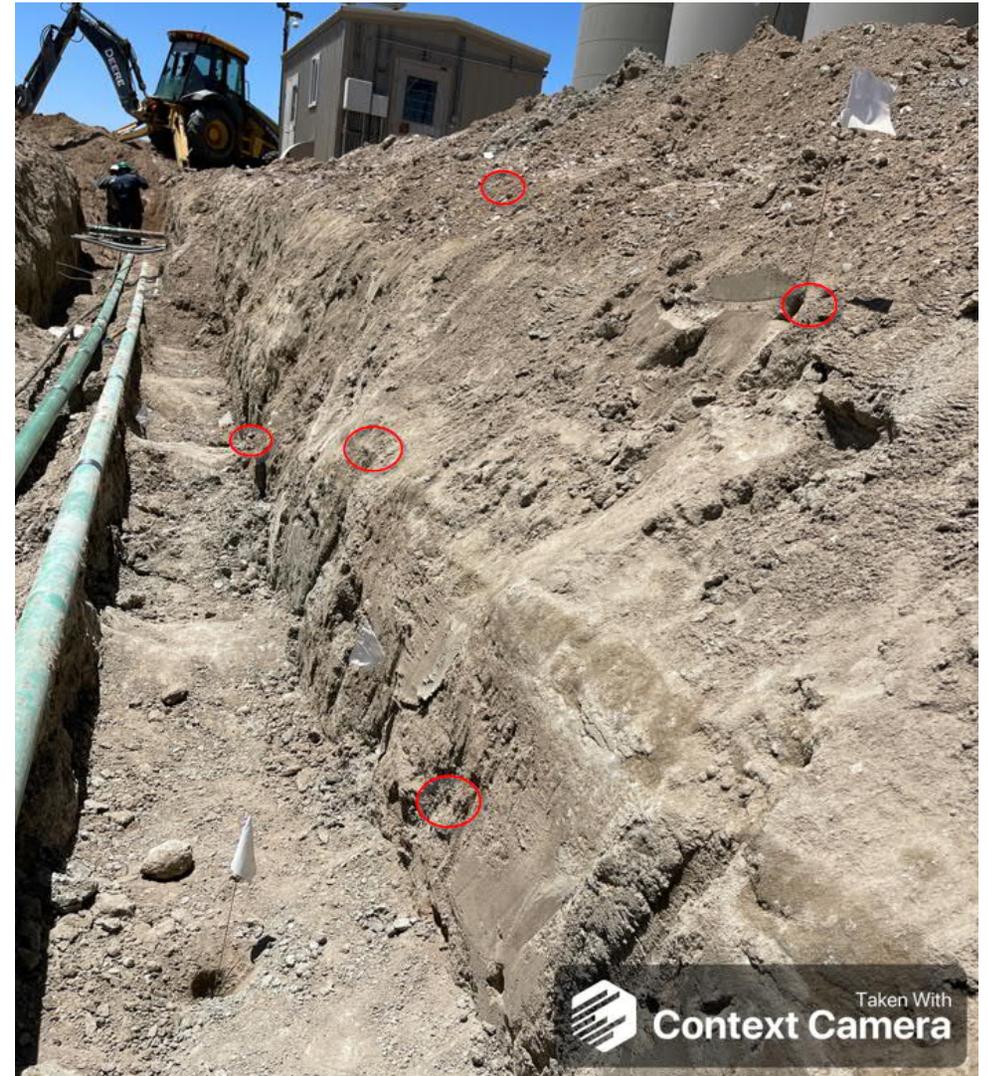
North Wall Sample Locations

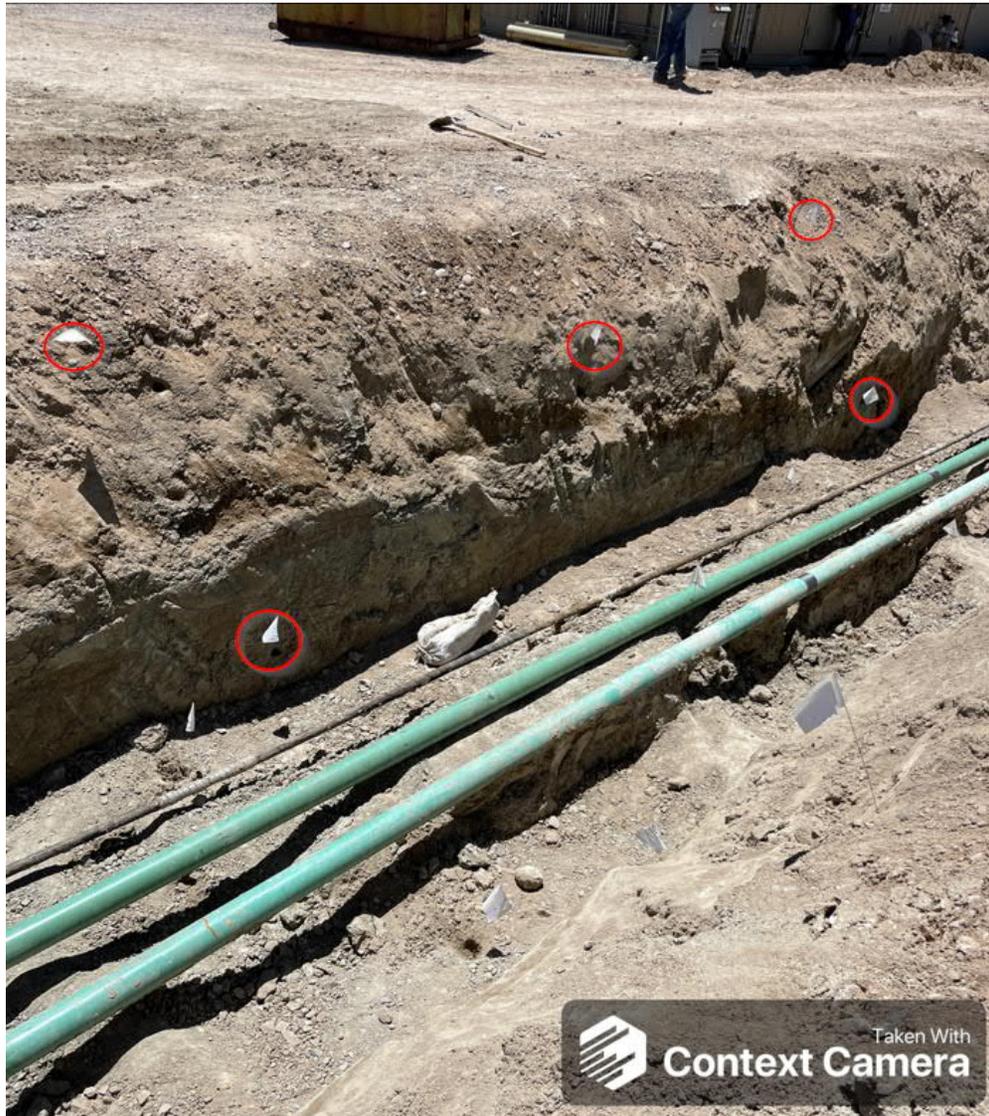
South Wall Sample Locations

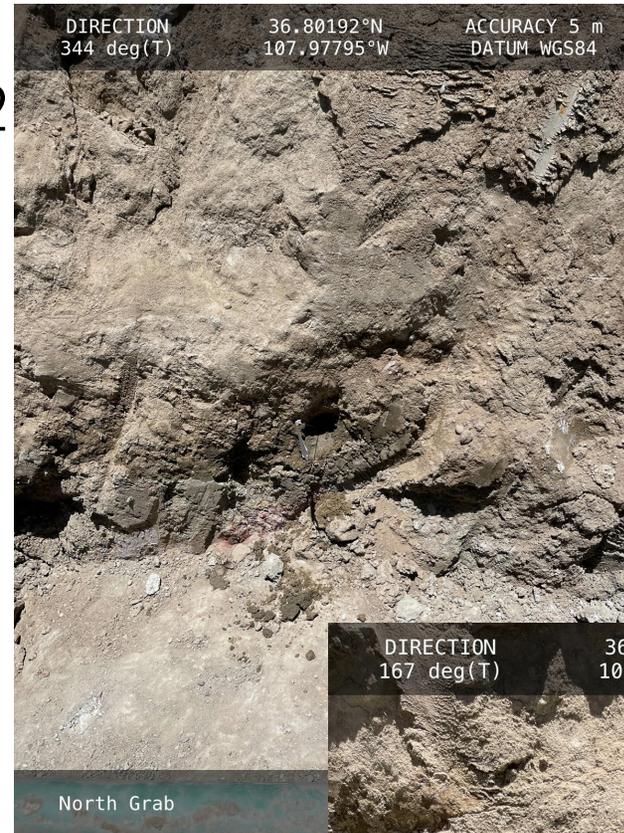
In the process of inspecting and repairing the pipeline, Hilcorp removed soil from the impacted area. Three 5-point composite samples and two grab samples were collected on June 10, 2022. Analytical results from this sampling event were below NMOCD action criteria noted in NMAC 19.15.29 Table 1. Sample results are included.
