Vertex Project #: 20E-00141-002

Spill Closure Report: Gaucho Unit 6H
Unit P, Section 17, Township 22 South, Range 34 East
County: Lea
API: 30-025-34789
Incident Tracking Number: NOY1727243107

2020 Spill Assessment and Closure
December 2020

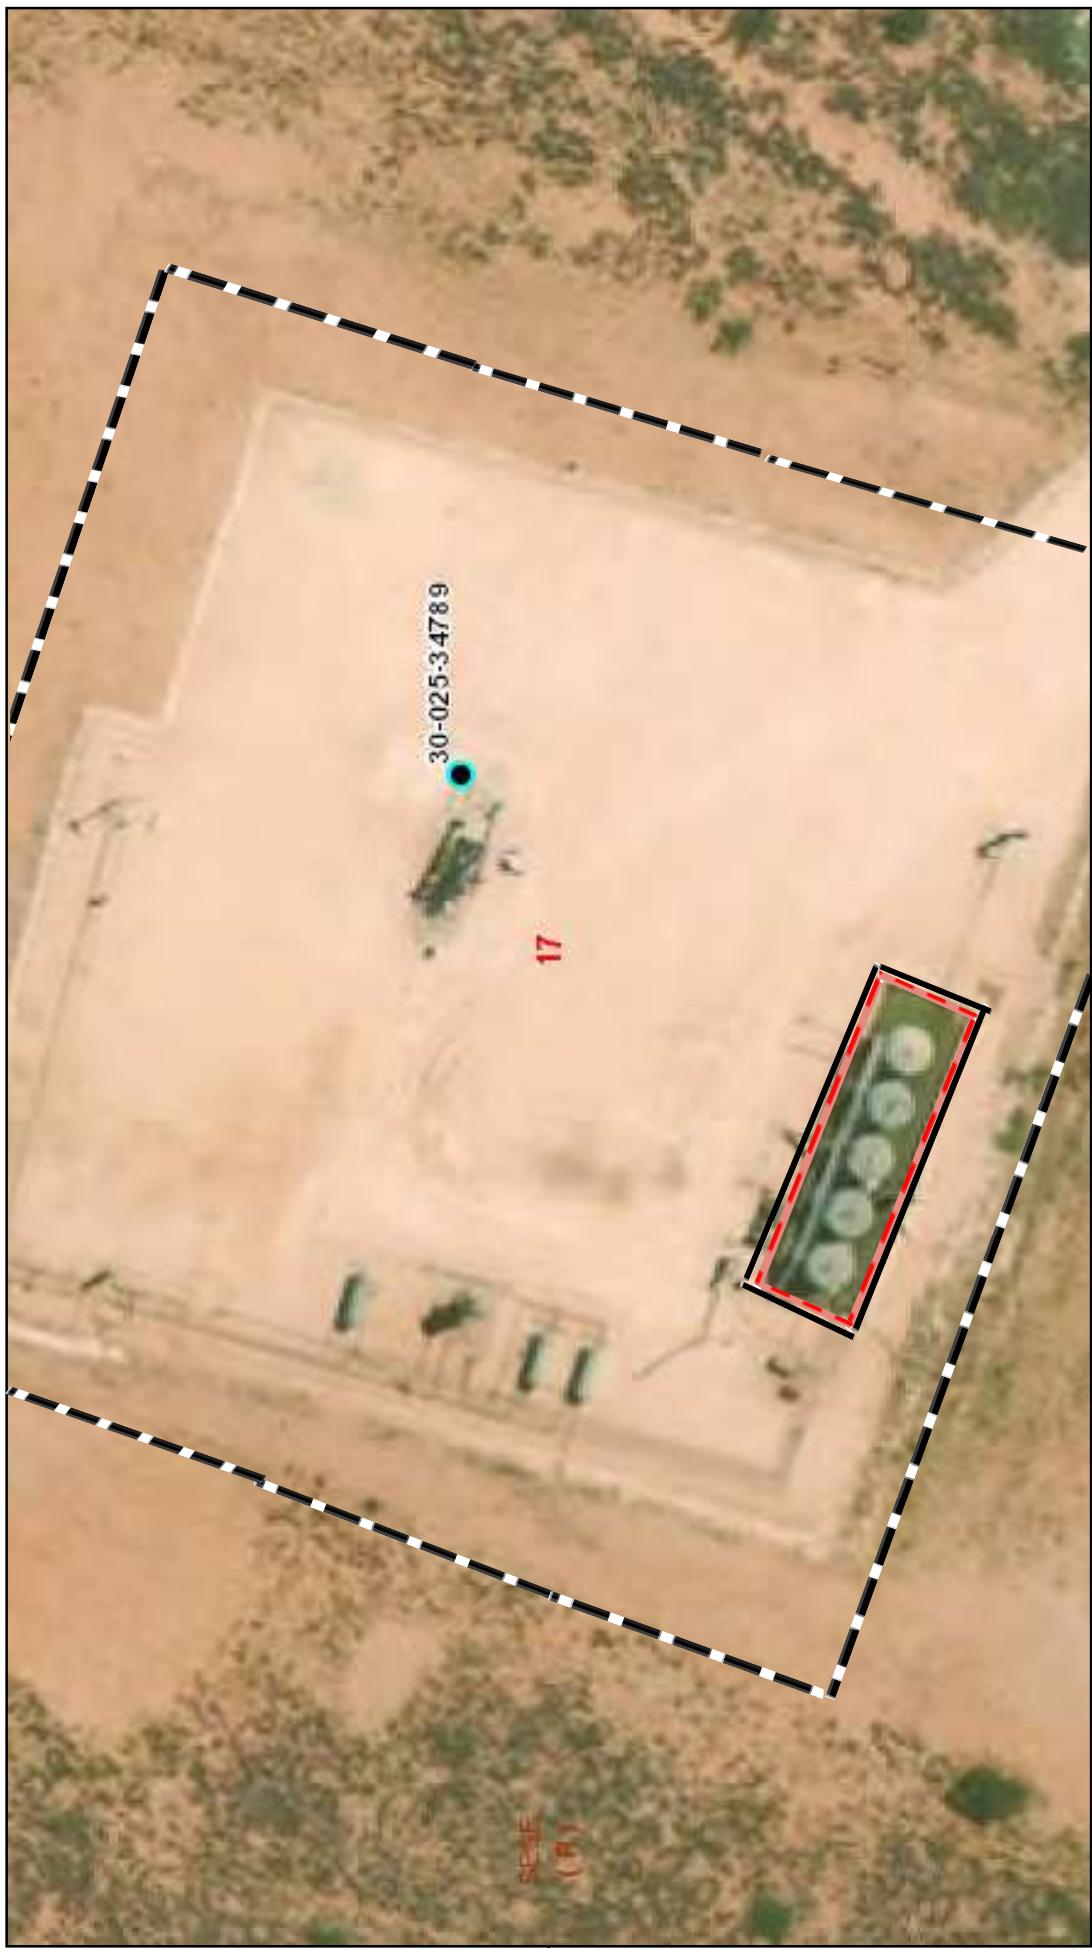
FIGURE:
1

Approximate Lease Boundary
 Approximate Spill Extent (~ 3,280 sq. ft.)

Site Schematic
Gaucho Unit #006

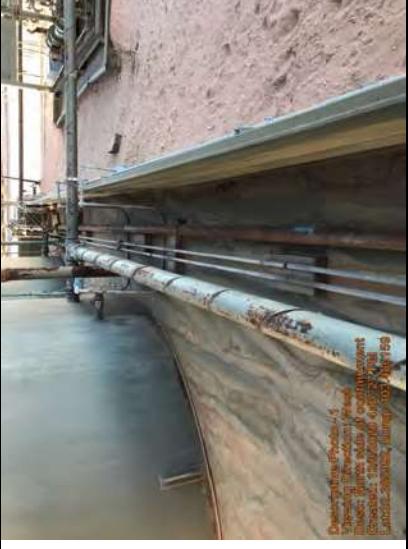
Client:	Devon Energy Corporation	Inspection Date:	12/9/2020		
Site Location Name:	Gaucho Unit 006	Report Run Date:	12/15/2020 10:30 PM		
Client Contact Name:	Amanda Davis	API #:	30-025-34789		
Client Contact Phone #:	(575) 748-0176	Project Owner:			
Unique Project ID		Project Manager:			
Project Reference #		Summary of Times			
Arrived at Site	12/9/2020 4:03 PM				
Departed Site	12/9/2020 4:10 PM				
Field Notes					
16:05	Arrive on site.	Complete safety paperwork. Conduct liner inspection.			
16:10	Liner is in good condition.	No tears or punctures.			
Next Steps & Recommendations					
1

<p>Viewing Direction: West</p>

<p>Description Photo -1: Viewing Direction: West Date: 12/15/2020 1:10:30 PM Lat: 33.948595 Long: -113.465159</p>	<p>Viewing Direction: North</p>

Vertex recommends no remediation action to address the release at Gaucho. The secondary containment liner appeared to be intact and had the ability to contain the release in question, as shown in the inspection photographs included with the DFR (Attachment 5). There are no anticipated risks to human, ecological or hydrological receptors associated with the release site.

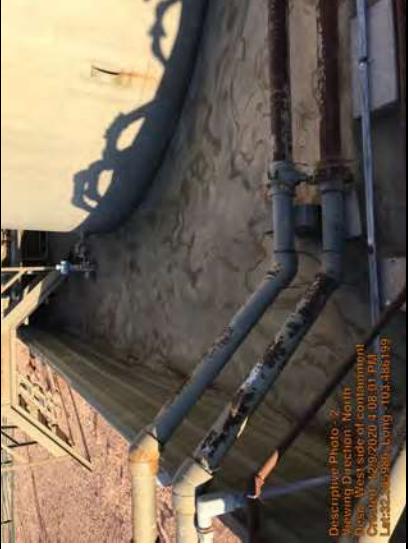
<p>Description Photo -2: Viewing Direction: North Date: 12/15/2020 1:09:30 PM Lat: 33.948595 Long: -113.465159</p>	<p>West side of containment</p>
<p>Viewing Direction: East</p>

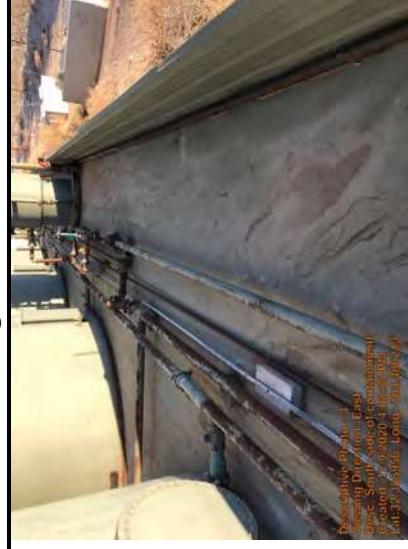
<p>Description Photo -3: Viewing Direction: East Date: 12/15/2020 1:10:30 PM Lat: 33.948595 Long: -113.465159</p>	<p>Viewing Direction: East</p>

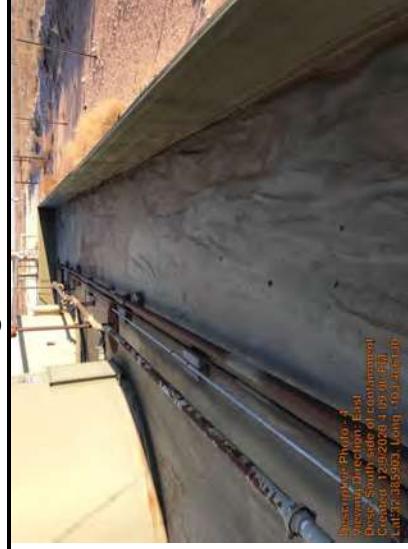
<p>Description Photo -4: Viewing Direction: East Date: 12/15/2020 1:09:30 PM Lat: 33.948595 Long: -113.465159</p>	<p>South side of containment</p>
<p>North side of containment</p>	<p>South side of containment</p>	<p>South side of containment</p>

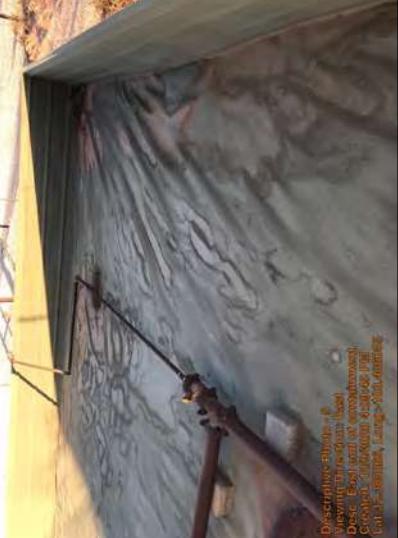
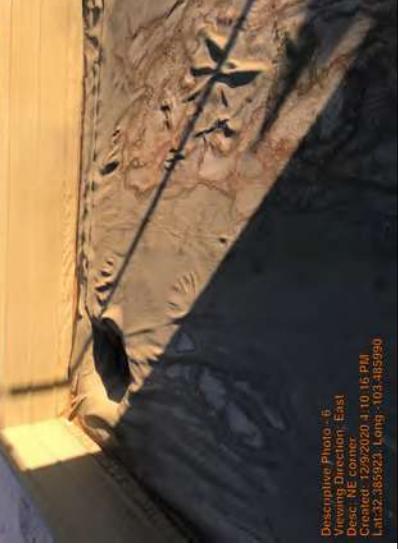
<p>East end of containment</p>	<p>NE corner</p> <p>Descriptive Photo 6 Viewing Direction: East View NE corner Described: 12/29/2020 4:10:16 PM Lat32.385923, Long -103.485990</p>
