Release Notification and Corrective Action

Remediation and Closure Report

Arabian 30 19 Federal Com #001H Trionyx Frac Pond
Lea County, NM
API# 30-025-43176, NOY1732133962 (1RP-4867)

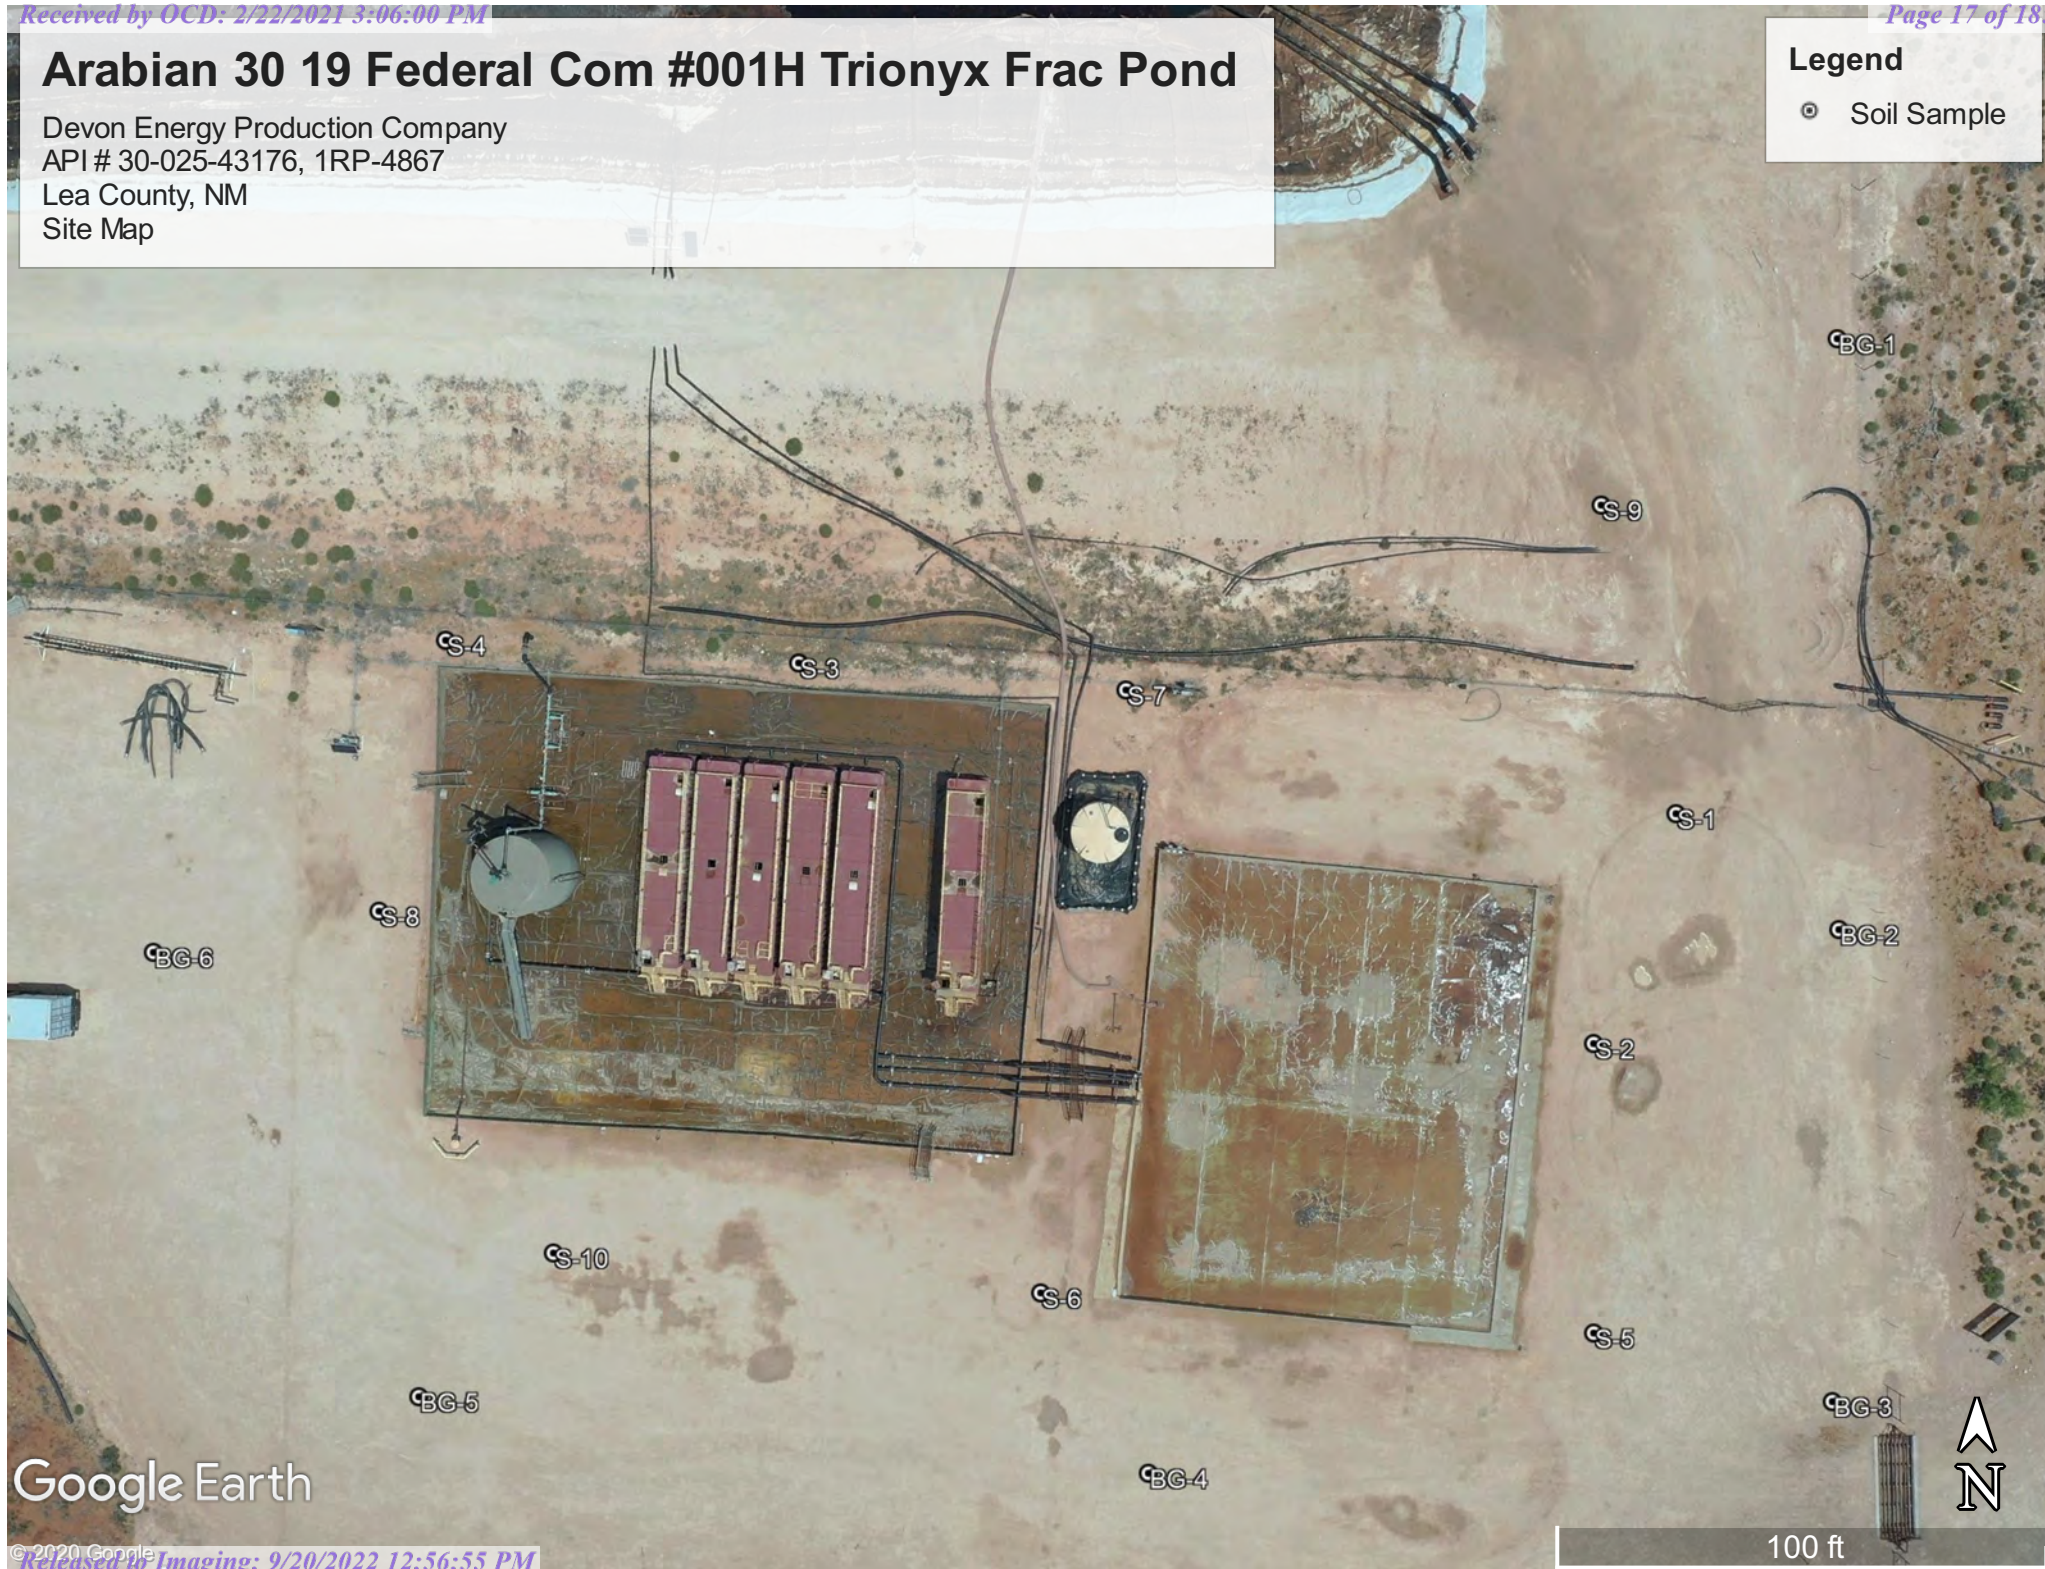
Arabian 30 19 Federal Com #001H Trionyx Frac Pond

On October 24, 2017, air pressure in a layflat line caused it to come out of the frac pond and spill approximately 50 barrels (bbls) of produced water onto the pad area. A vacuum truck recovered 40 bbls of fluid. The initial C-141 detailing this incident is attached in [Appendix III](#). A site map illustrating the affected area is presented in [Appendix I](#).
