Release Notification and Corrective Action

Name of Company Devon Energy Production Co LP (6137)	Contact Stephen Richards, Devon Completions Foreman
Address PO BOX 250, Artesia, NM 88211	Telephone No. (575) 252-3717
Facility Name: Trionyx Frac Pond (Completing wells on the Arabian 30-19 Fed Com 1H)	Facility Type Oil

Trionyx Pond Spill 10.24.17

Arabian 30 19 Federal Com #001H Release

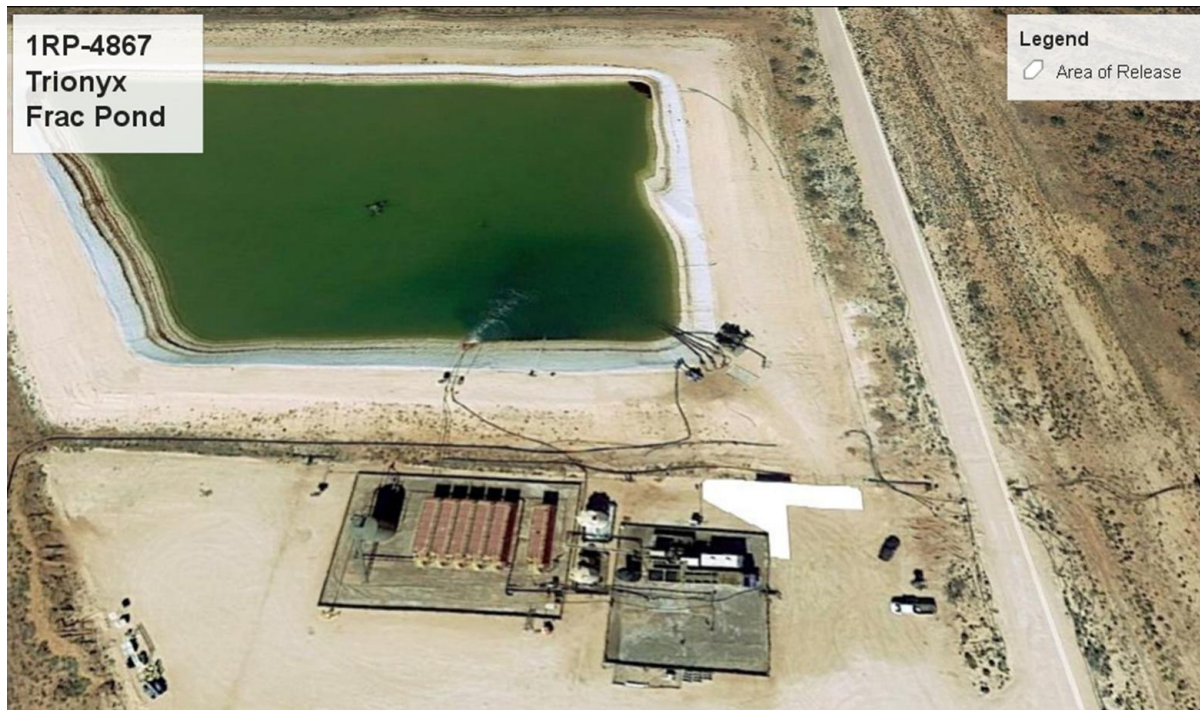
Figure 2: Area of Release at Trionyx Frac Pond – 50 bbls with 40 bbls recovered.

On October 24, 2017 at 2:14 PM MST, TETRA, under contract to Devon was pigging a line from the Arabian 30-19 Fed Com 1H to the Trionyx pond. TETRA had completed the line from the location to the booster pump. After rigging up to pig from the booster pump to the Trionyx pond, air in the line caused the line to come out of the pond and fluid was released to the ground. TETRA then shut down operations and notified Devon. Approximately 50bbls of produced water ran off the side of the pond onto the Trionyx facility. A vacuum truck was dispatched and recovered 40 bbls of treated produced water. The release affected approximately 25,000 square feet running south from the release point. The location of the release area is shown in Figure 2.
