Re: Junior AWW State #4H
30-015-36421
I-17-16S-28E
Eddy County, NM
2RP-4612
nAB1804435837

Junior AWW State #4H
Closure Report
#nAB1804435837

Junior AWW State #4H

Closure Report

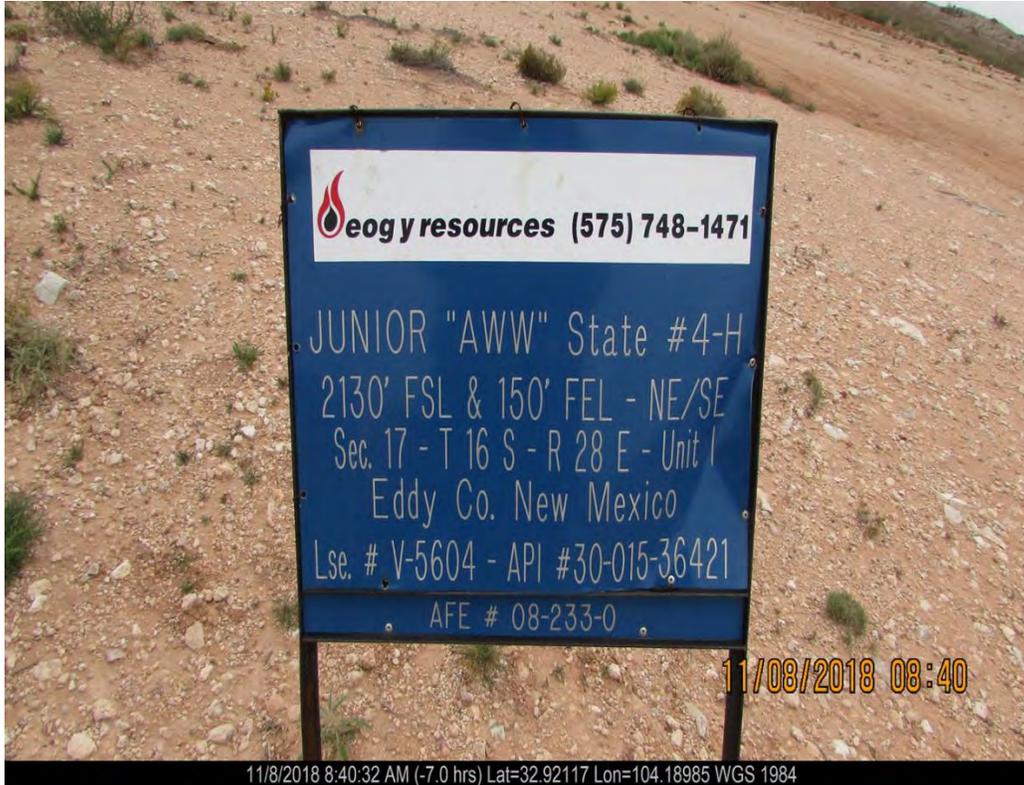
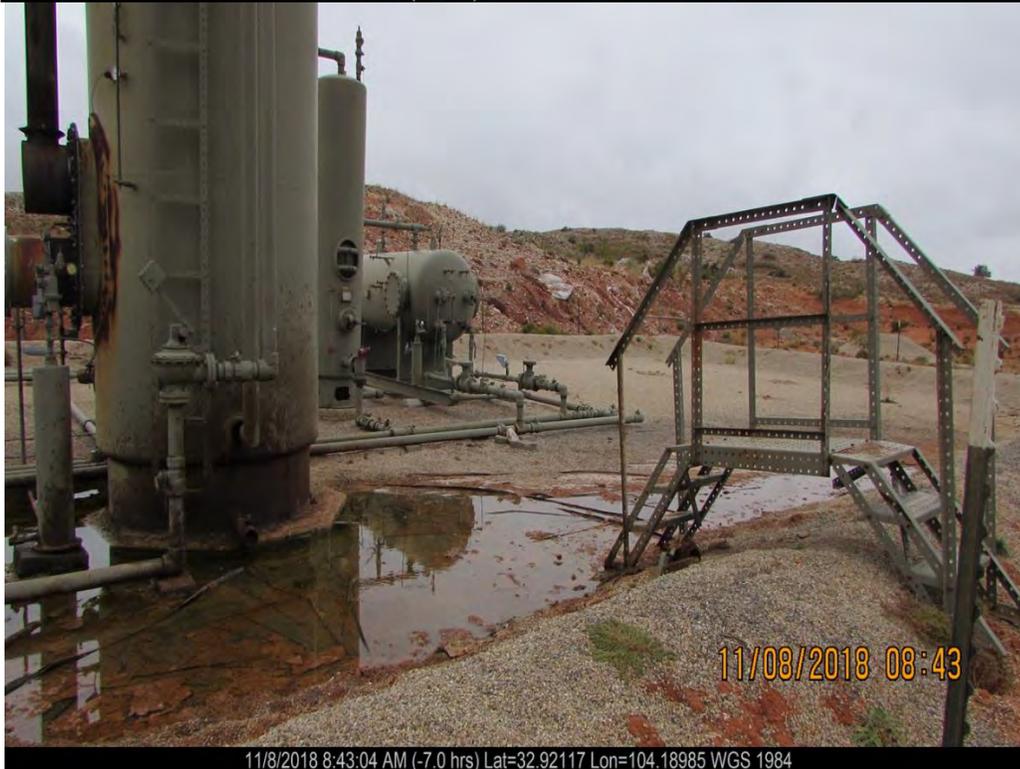
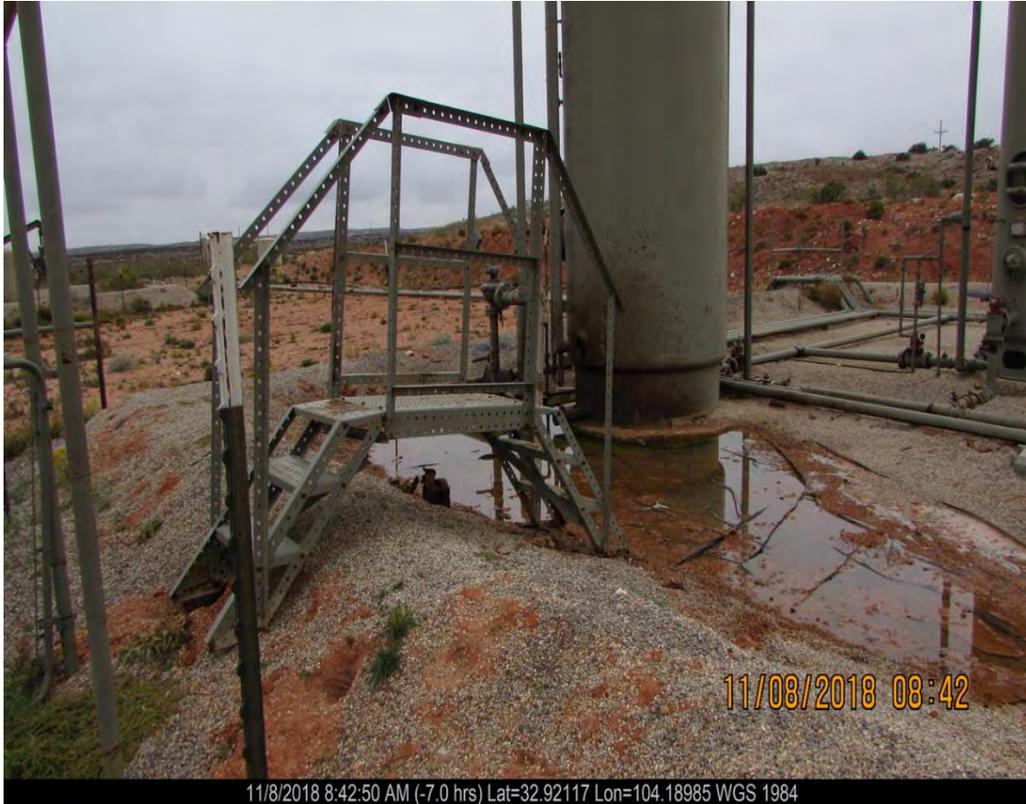
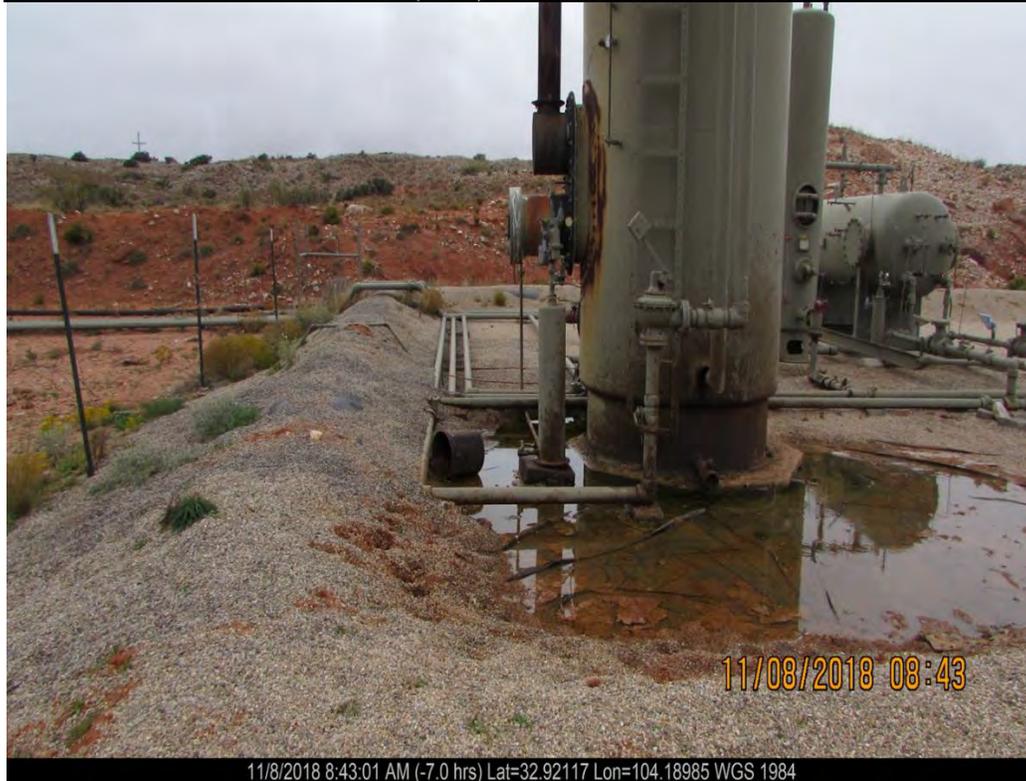
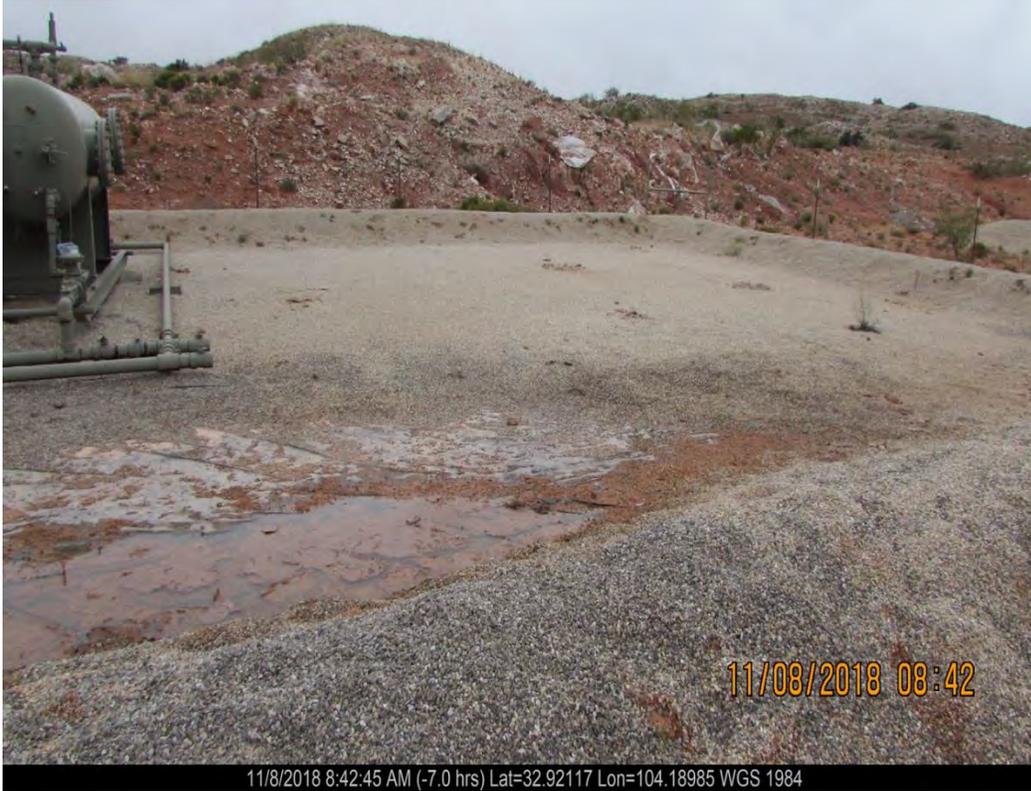
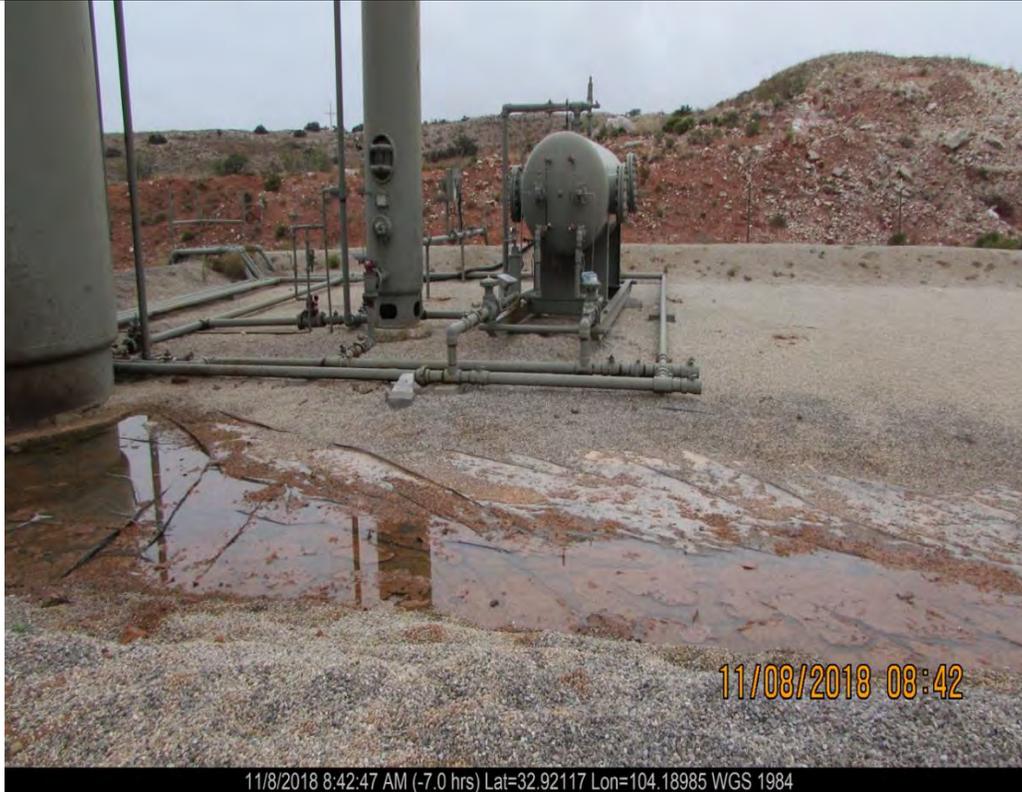
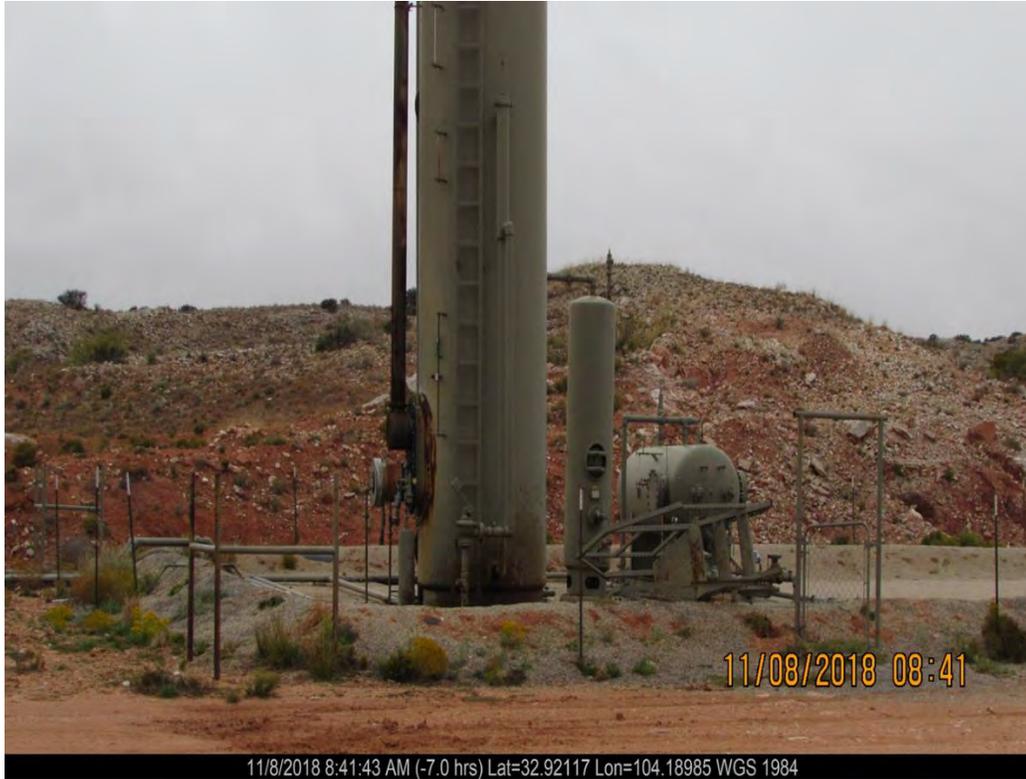
Liner Inspection Photographs

Based on the approval of the Characterization Plan by NMOCD on May 14, 2018, EOG submitted a notice to NMOCD District II to perform a liner inspection at the release site on November 8, 2018. Prior to the scheduling of the inspection, all gravel within the impacted area of the containment had been removed to provide visual access to the liner for inspection. With the liner exposed, the inspection of the liner was completed on November 8, 2018, and documented with photographs. The inspection confirmed no integrity issues with the liner at the time of the release, finding no defects or other failures which would have allowed the release to breach the lined containment.

As evidenced by the photos included in the original Closure Report, and included with this report as well, a precipitation event occurred prior to the inspection date, but other than displaying the ability of the liner to retain fluids, it had no other adverse impacts on the visual inspection of the liner integrity.

Since the liner integrity was not compromised, no soil sampling was conducted beneath the liner. As stated in the approved Characterization Plan, soil sampling was only to occur if the liner integrity was to have already been compromised. However, without prior damage to the liner, there was no need to damage and create integrity issues to collect soil samples when the release could not have impacted the soil beneath the liner.

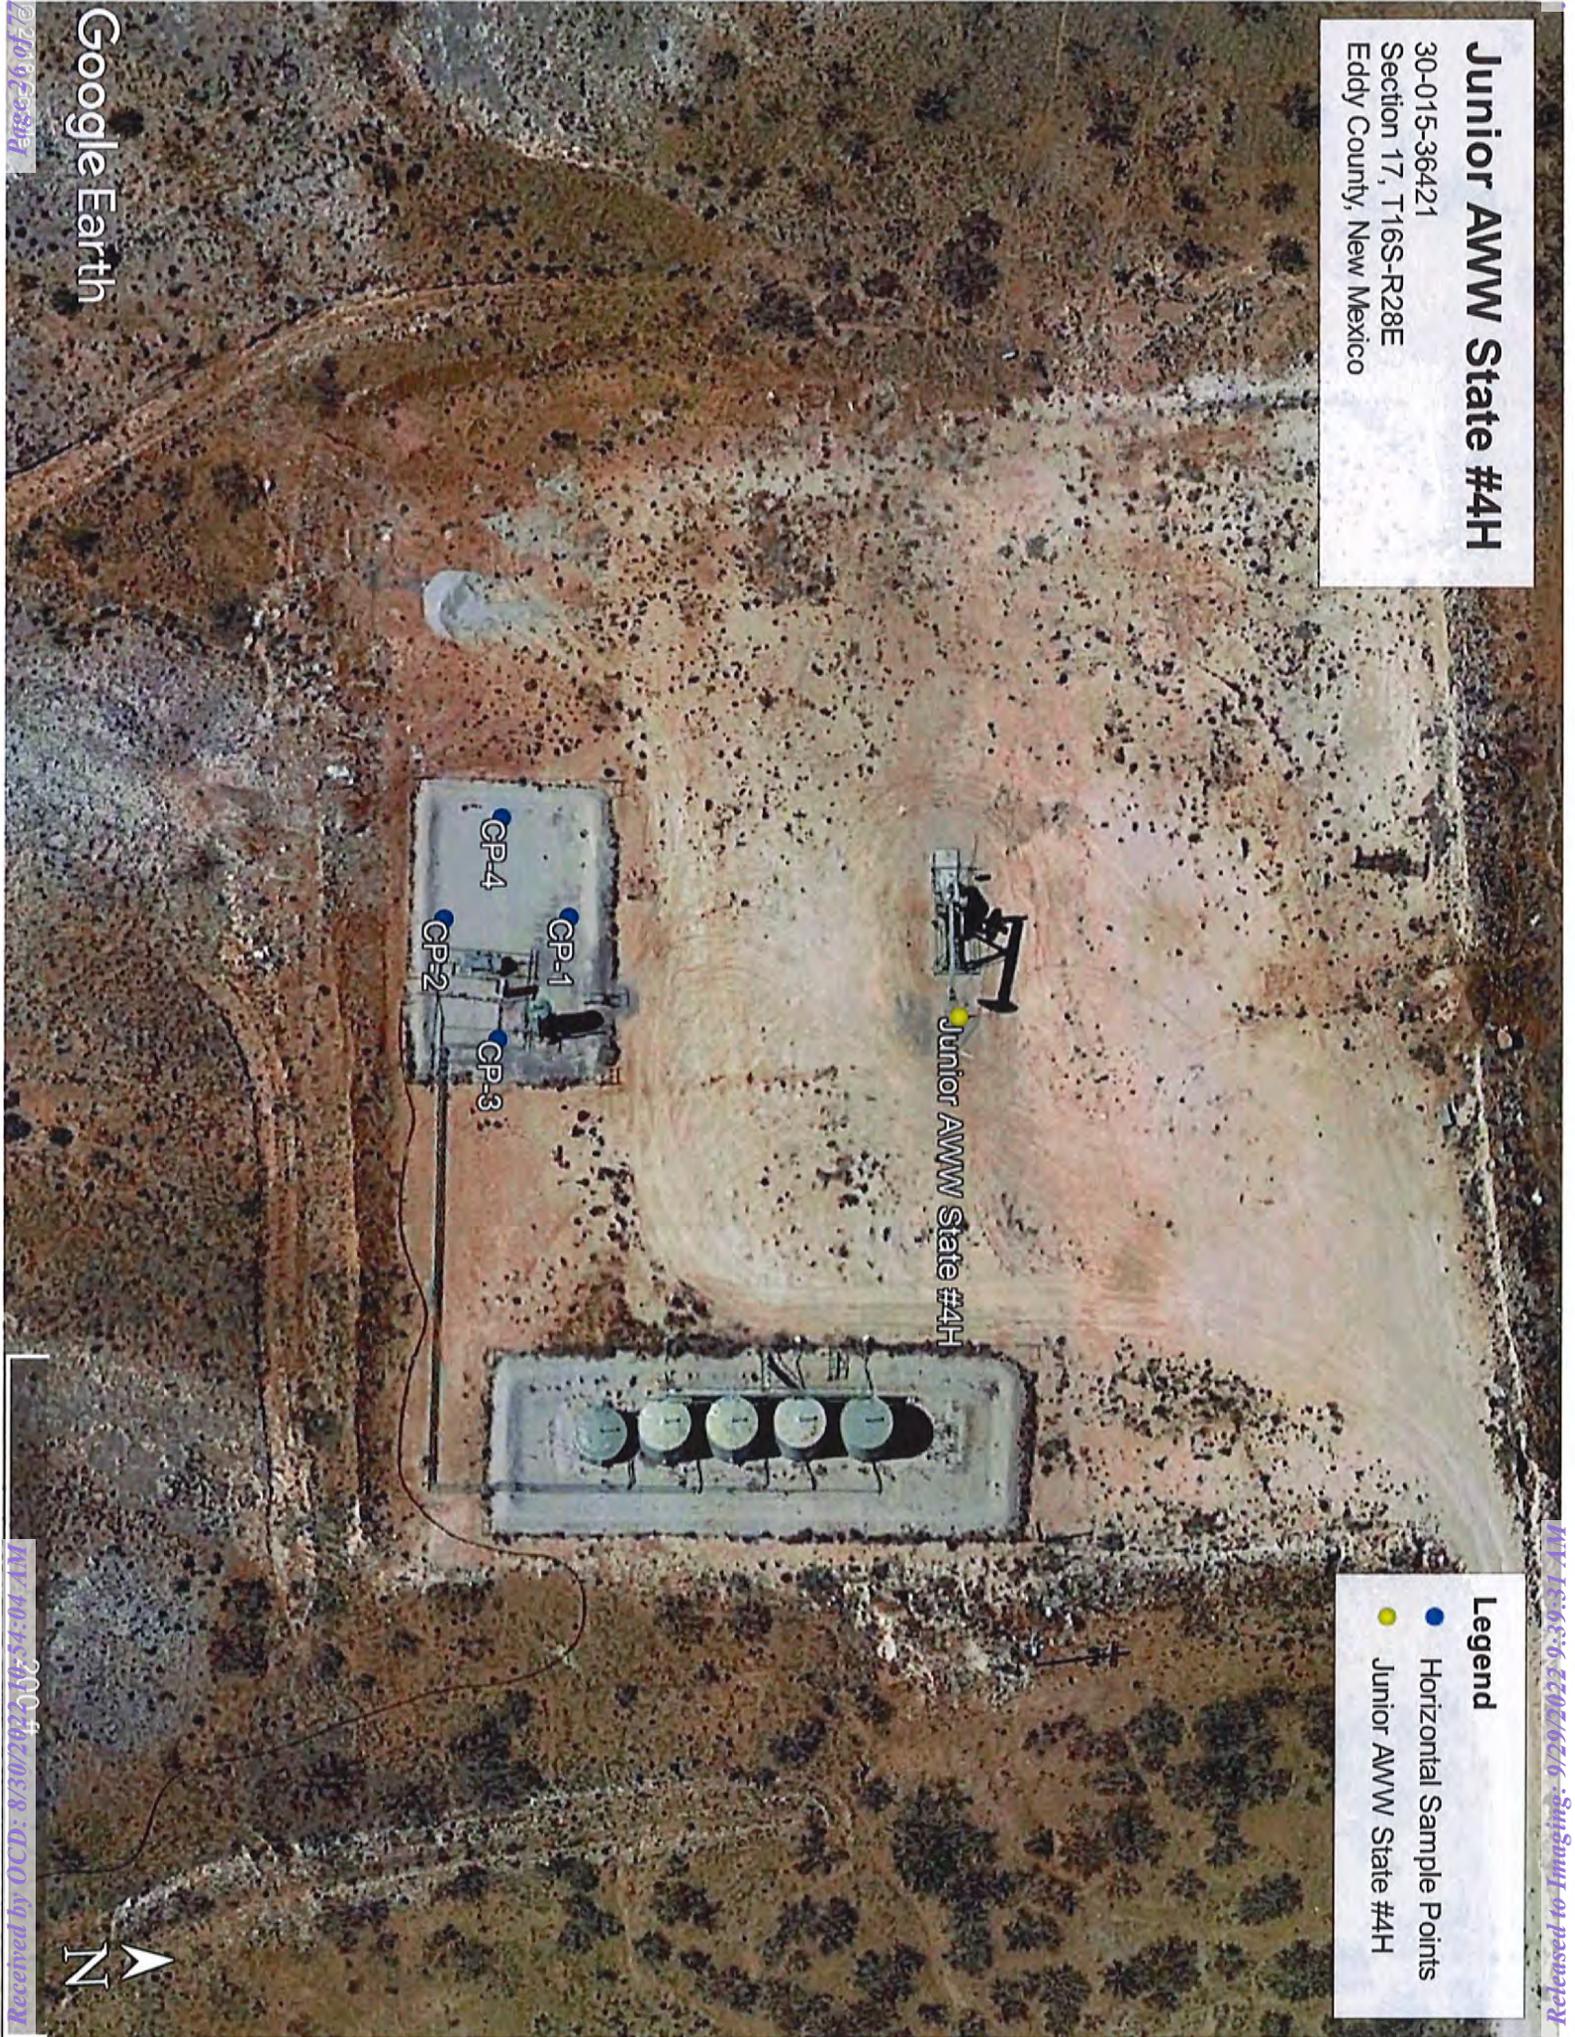
- Horizontal Sample Points
- Junior AWW State #4H

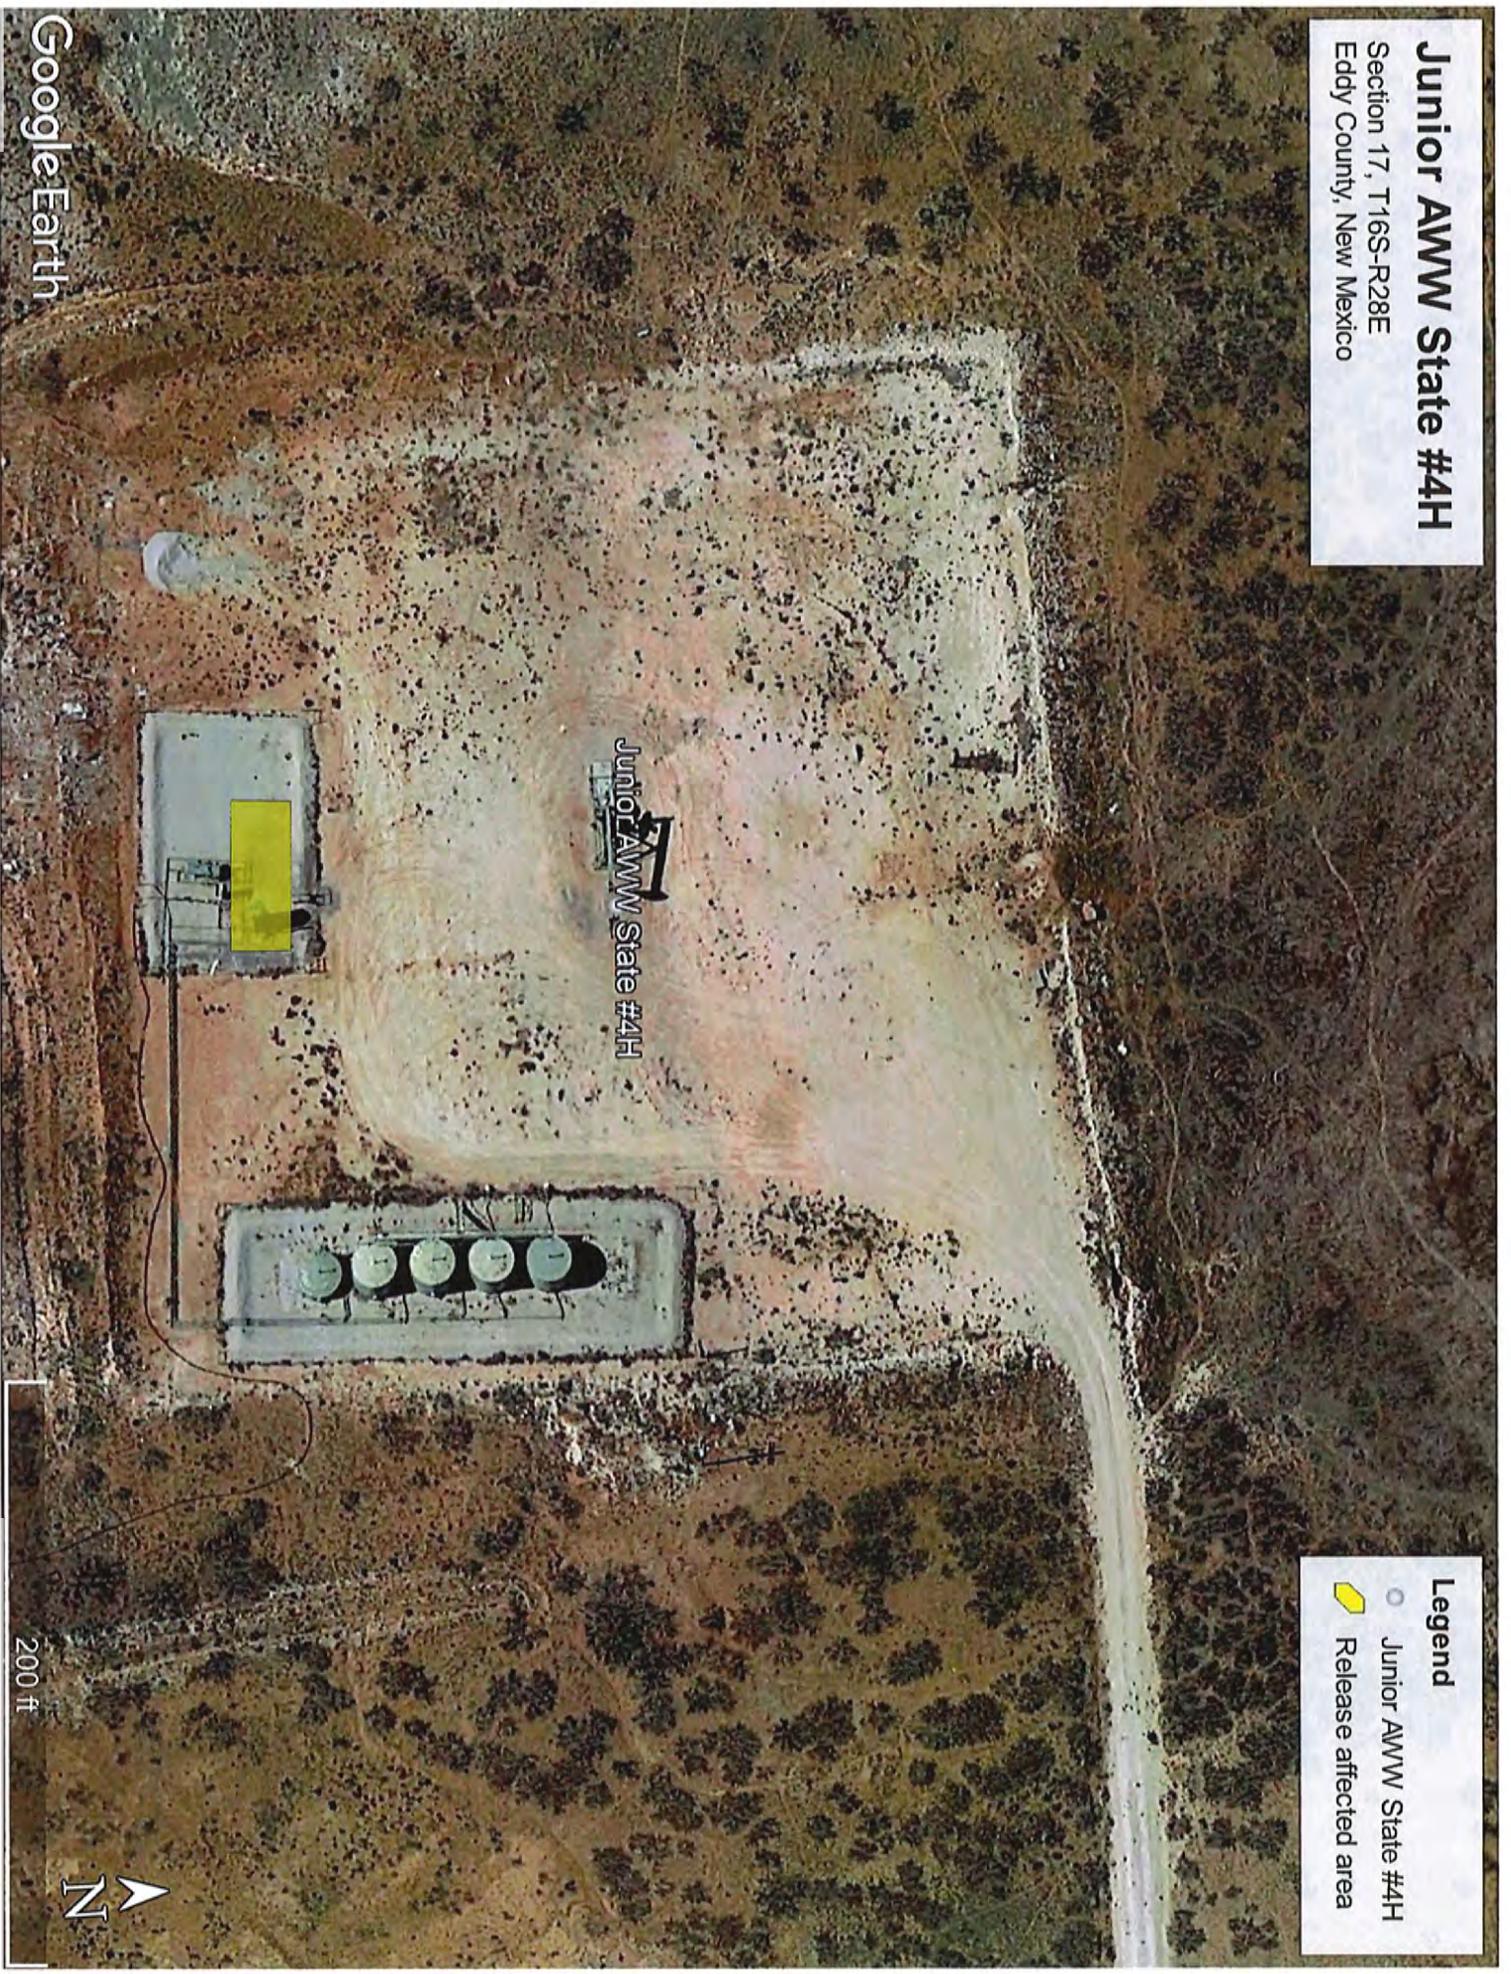
- Junior AWW State #4H
- Release affected area

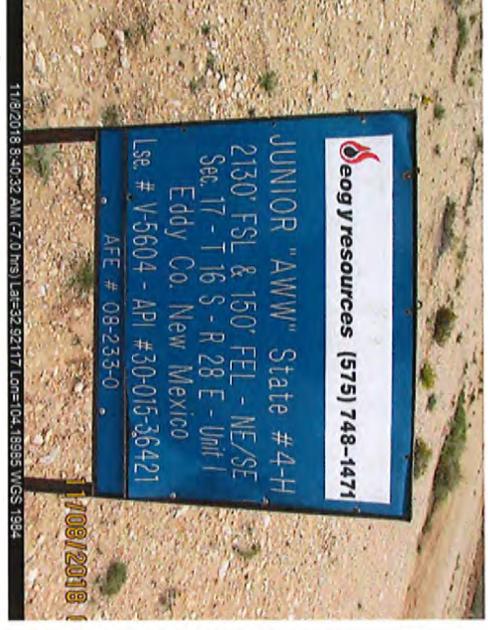
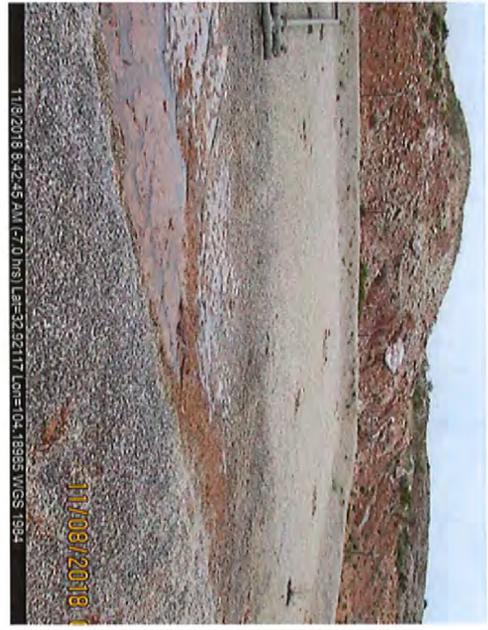
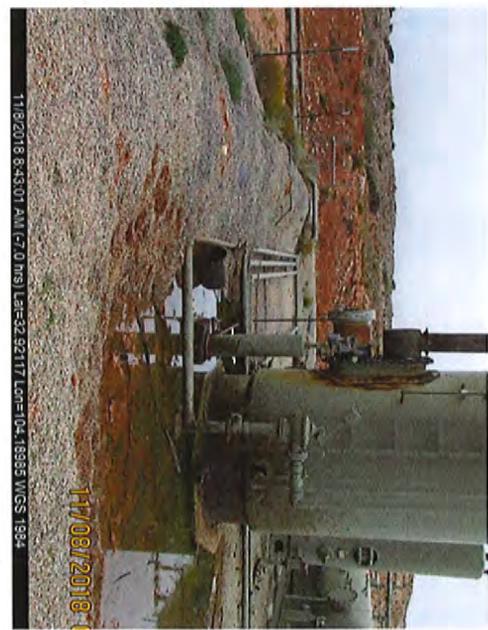
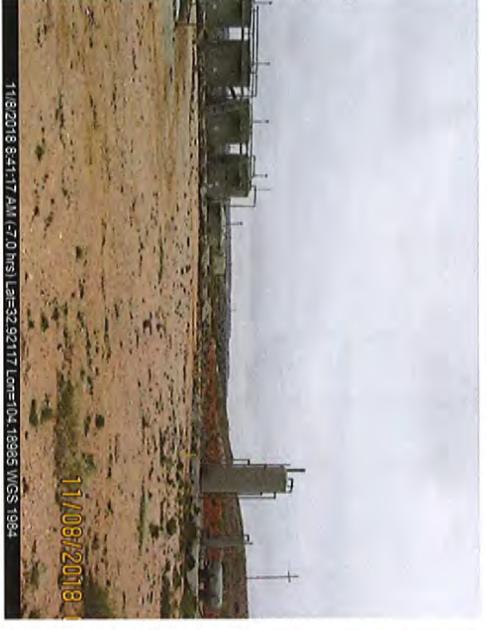
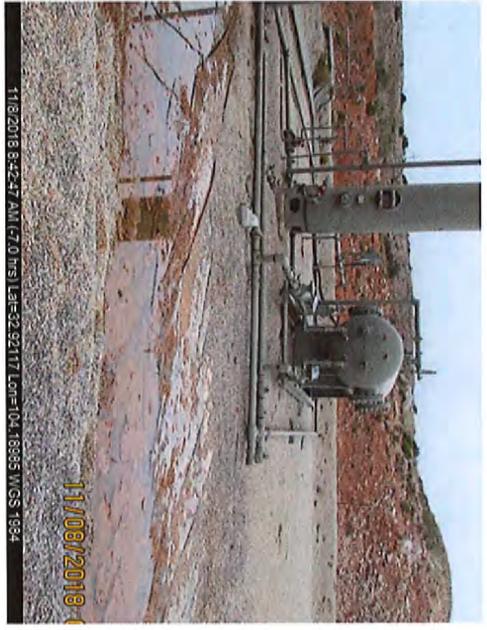
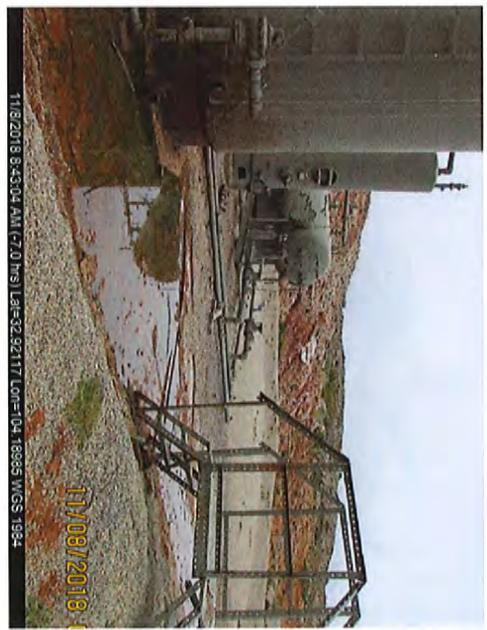
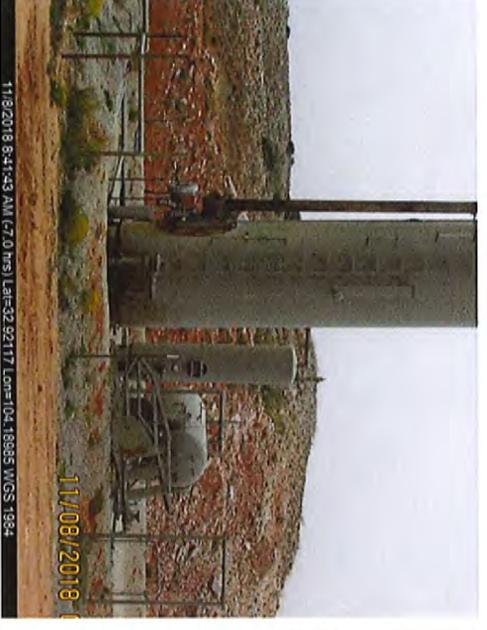
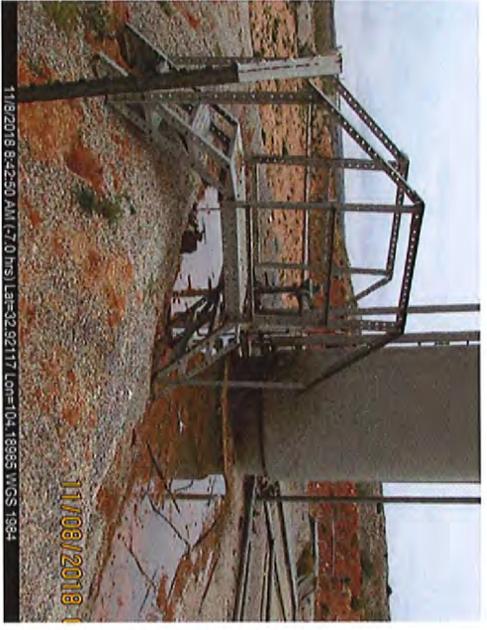
Figure 2

On February 12, 2018, EOG Y Resources, Inc. submitted to the NMOCD District I Office a Form C-141 for the release of 1 B/O and 5 B/PW with 1 B/O and 5 B/PW recovered. This release occurred when the weld on the bottom water leg of the heater rusted out on 1/25/2018. The affected area is approximately 20' X 50' (with in the bermed and lined heater/knockout containment which measures, 165' X 35'. This containment is located west of the battery) on the production pad/facility. A vacuum truck(s) was called, and recovered all of the oil and produced water. A roustabout crew was dispatched, the affected material (gravel) was removed and the affected area of the liner was exposed to inspect and demonstrate liner integrity.

EOG Y Resources, Inc. has visually inspected the liner where the release occurred and the liner remains intact and had the ability to contain the leak in question.
