**August 15, 2022**

**Re:** Remediation Work Plan  
**Lost Tank 4 Fed. #0009**  
**Off Louis Whitlock Rd**  
**32.42112° N, 103.78030° W**  
**Eddy County, New Mexico**  
**Incident ID: NAPP2219337009**  
 Ensolum Project No. 03B1417052

**TOPOGRAPHIC MAP**  
OXY USA INC.  
LOST TANK 4 FED. #0009  
Eddy County, New Mexico  
32.42112° N, 103.78030° W  
PROJECT NUMBER: 03B1417052

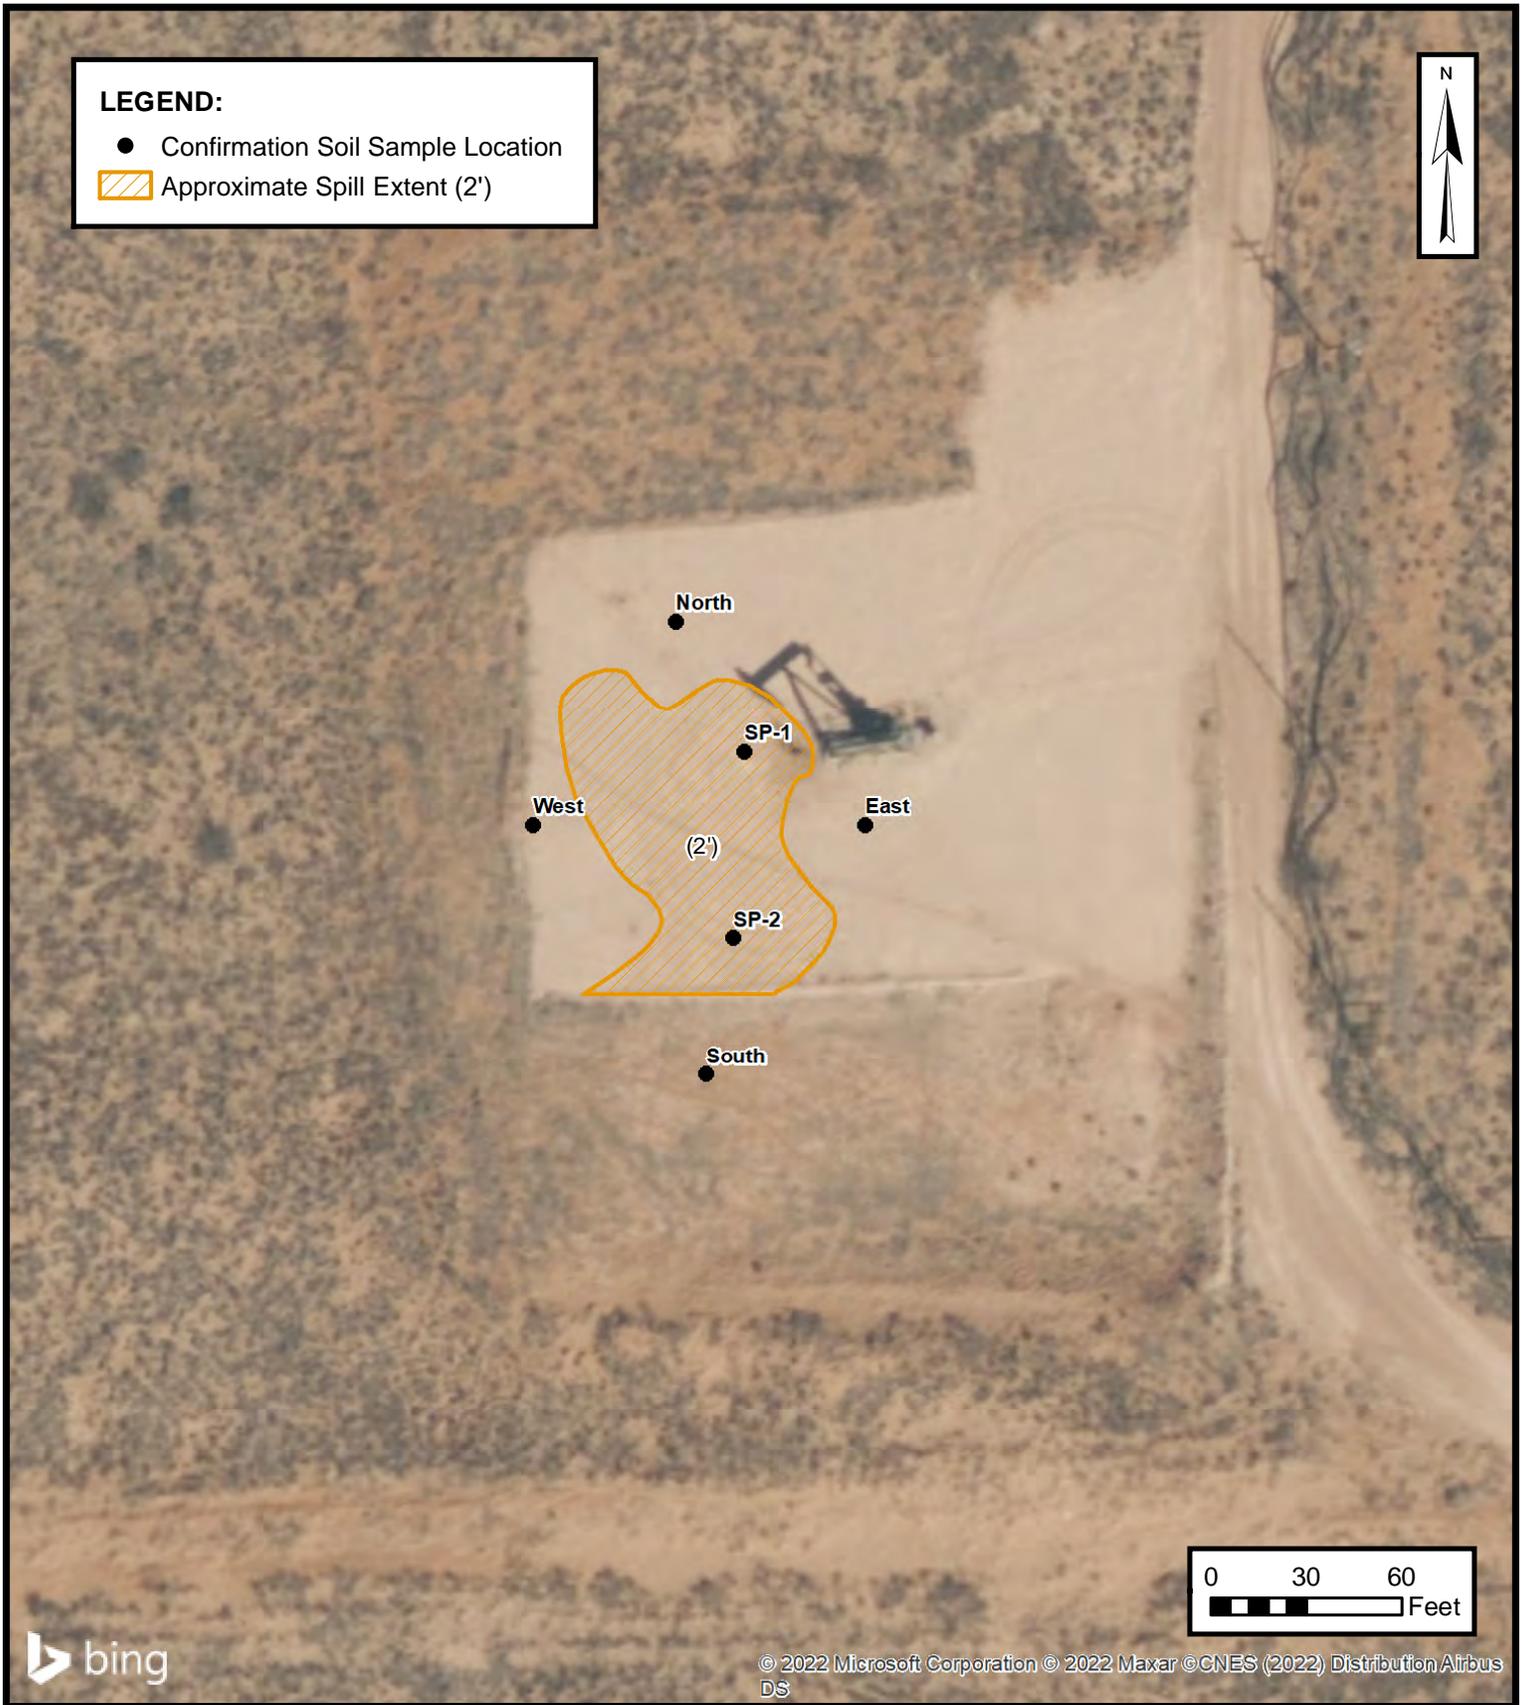
**3**

The Site Map indicating the overall area of the release, the composite pothole soil sample's locations, and the delineation composite soil sample's locations are included as **Figure 3** in **Attachment A**.

**SITE MAP**

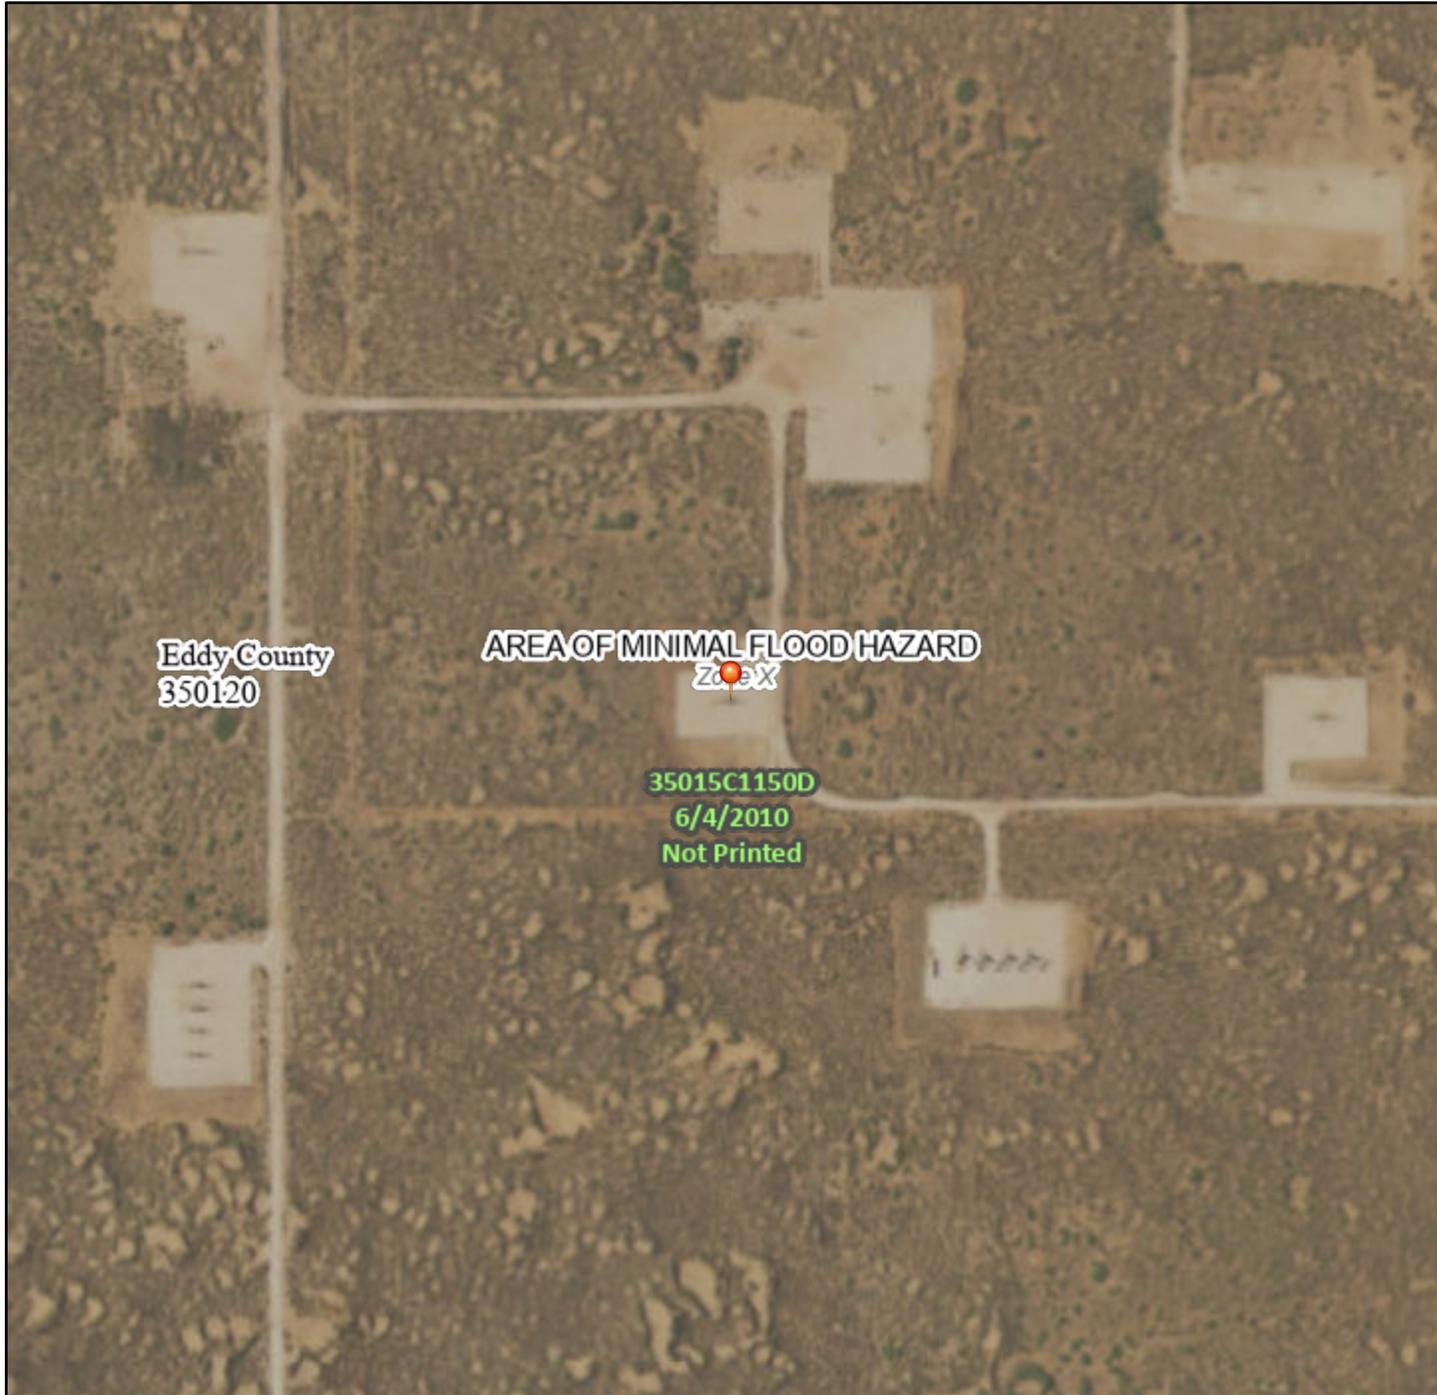
# National Flood Hazard Layer FIRMette

- Based on the Karst Occurrence Potential (.kmz) provided by the BLM, the Site is not located within an unstable area.
- The Site is not located within an area of flood hazard.

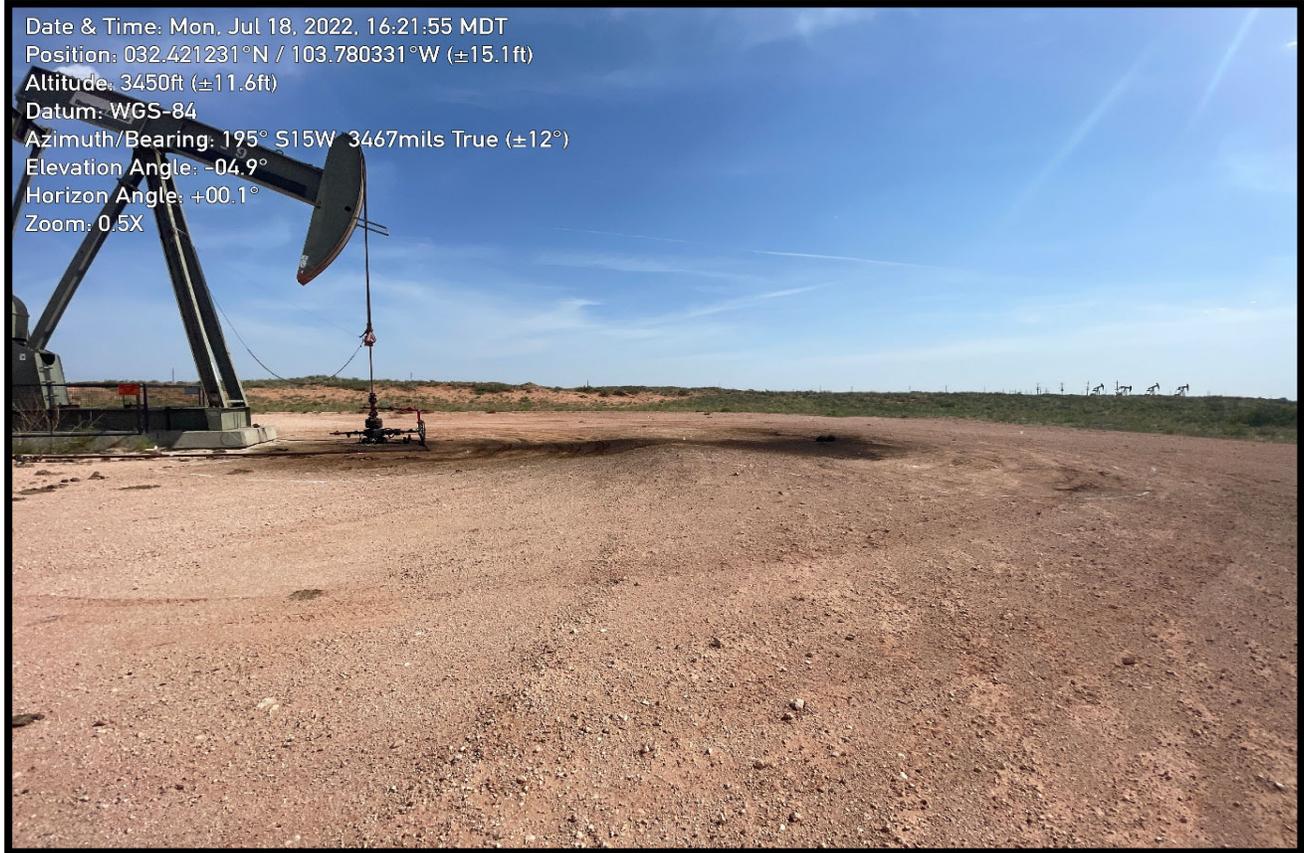
View of release point while marking for one call, facing south.

On July 4, 2022, a release of crude oil and produced water was reported from a packing failure from the stuffing box on a wellhead. Approximately three (3) barrels (bbls) of crude oil and approximately 12 bbls of produced water were released. No fluids were recovered. Oxy reported the release to the NMOCD and BLM through email notification on July 12, 2022. The release was assigned Incident Number NAPP2219337009.

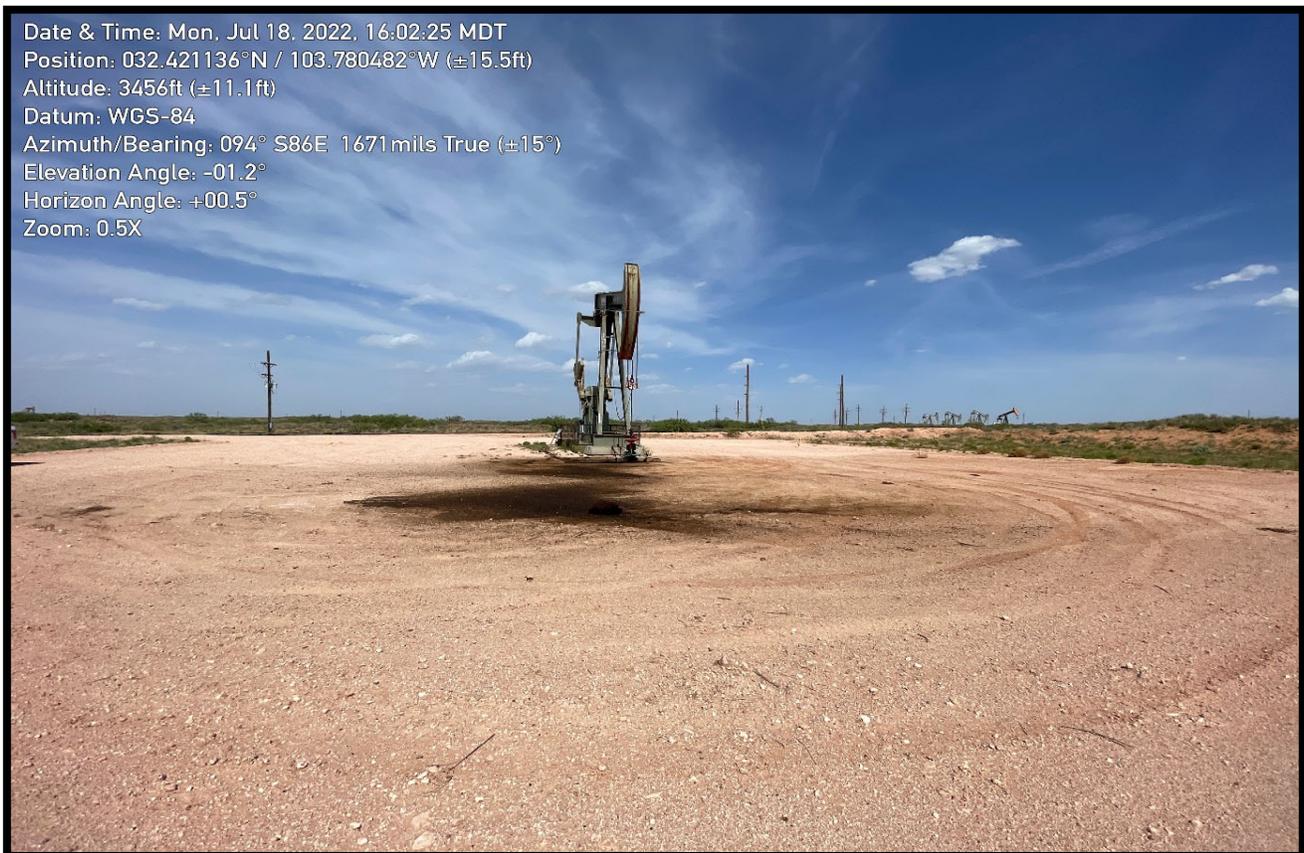
View of release area while marking for one call, facing east.

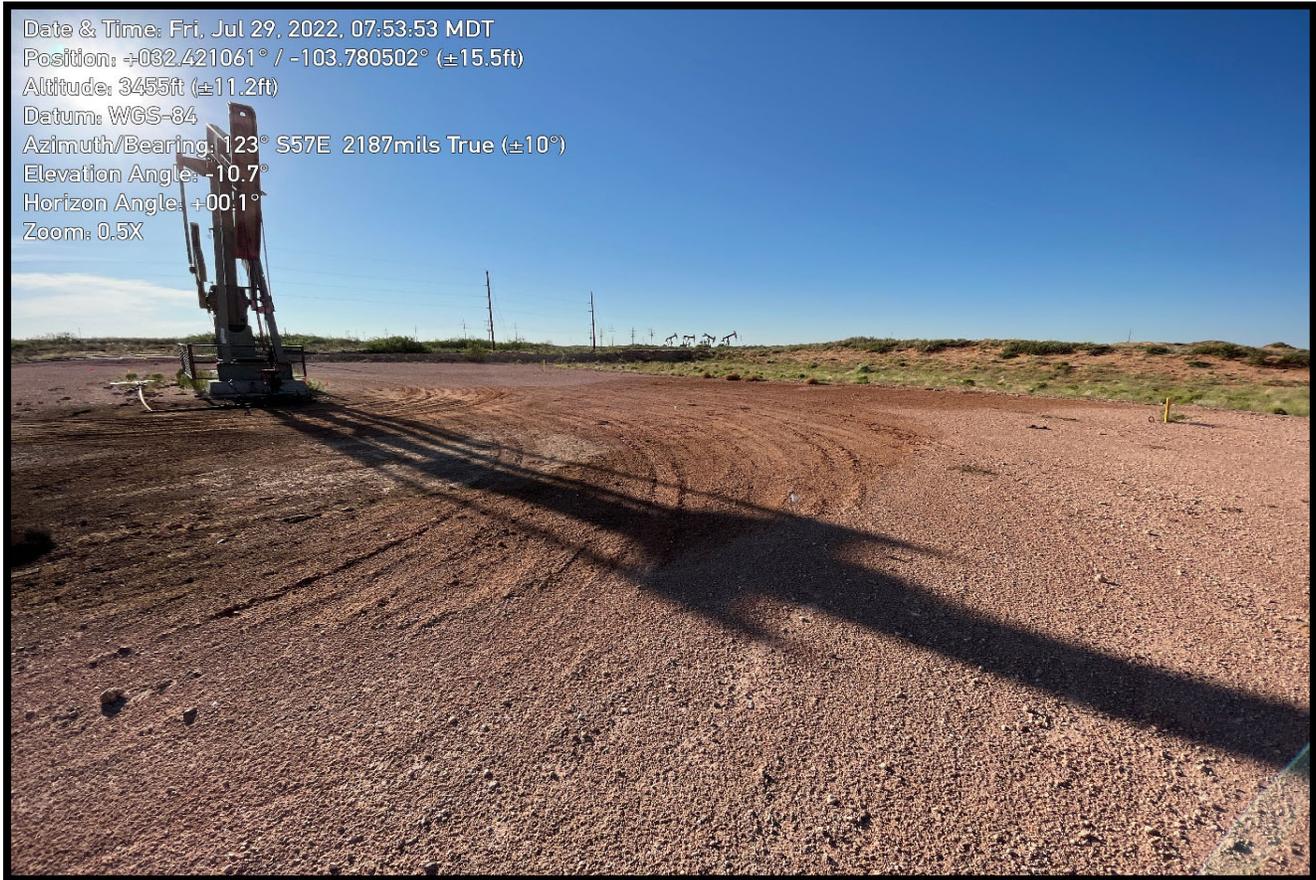
View of release area during initial soil sampling activities, facing southeast.

On July 29, 2022, Ensolum arrived on-Site and collected a total of six (6) composite pothole soil samples from two (2) locations (SP-1 and SP-2) at one-foot intervals down to a depth of three (3) feet below ground surface (bgs) within the release area. Additionally, four (4) delineation composite soil samples (North, East, South, and West) were collected from a depth of 0 – 0.5 feet bgs to determine the horizontal and vertical extent of the release.

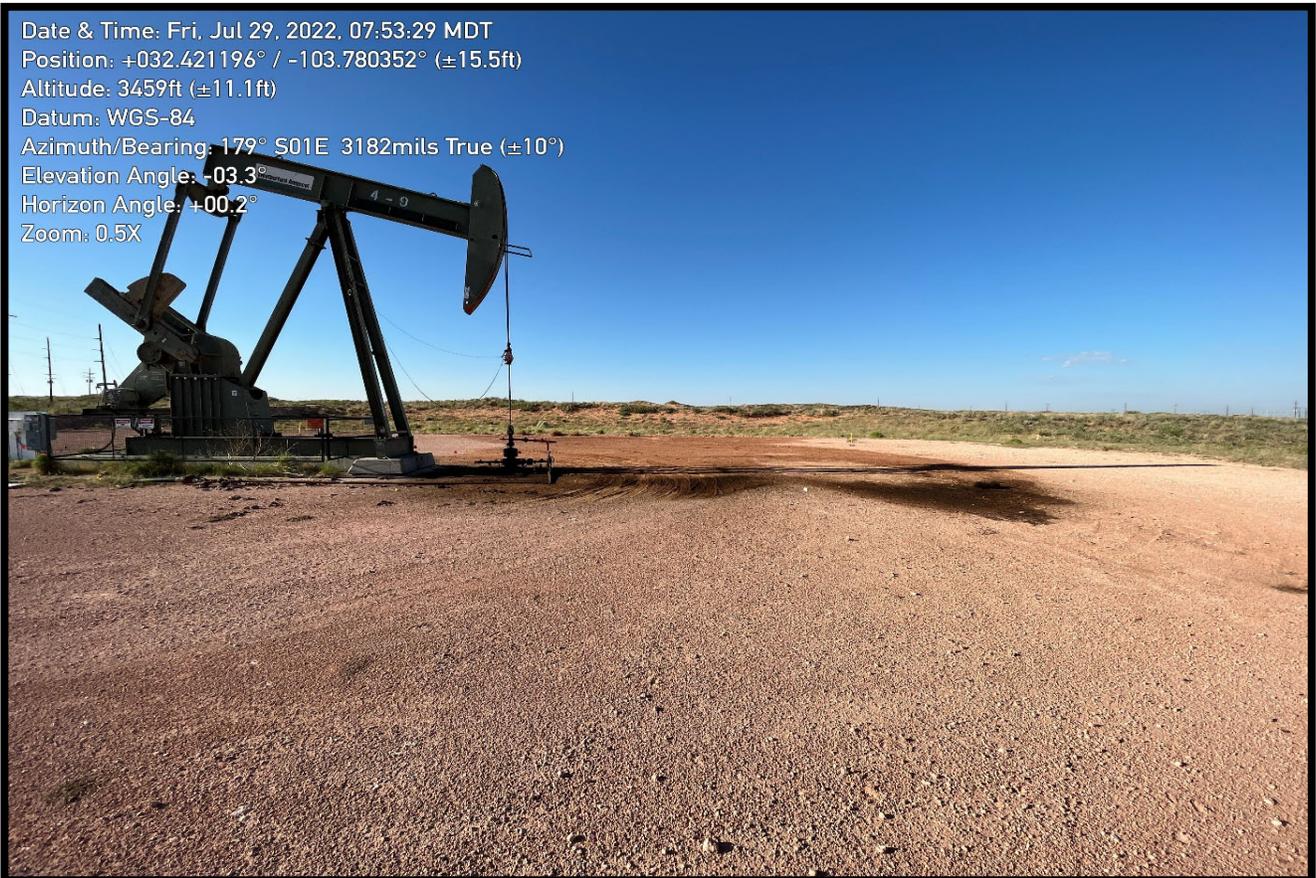
View of release area during initial soil sampling activities, facing south.
