Subject: **Exxon 8 Federal #001 Release
Unit Letter A, Section 8, Township 25 South, Range 29 East
Eddy County, New Mexico
Incident ID nAB1816358019
2RP-4802**

**Re: Release Characterization and Remediation Work Plan
ConocoPhillips
Heritage Concho
Exxon 8 Federal #001 Release
Unit Letter A, Section 8, Township 25 South, Range 29 East
Eddy County, New Mexico
2RP-4802
Incident ID NAB1816358019**

Photographic Documentation

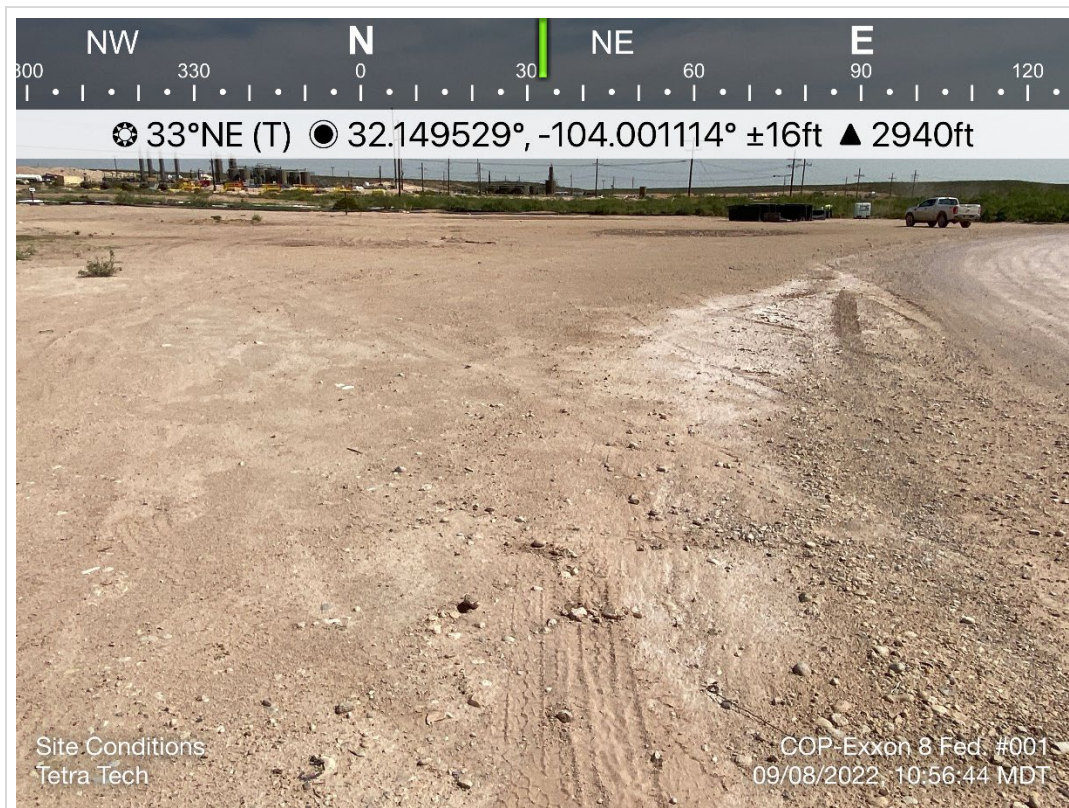
TETRA TECH, INC. PROJECT NO. 212C-MD-02832	DESCRIPTION	View northeast across pad with lease road to east.	1
	SITE NAME	EXXON 8 FEDERAL #001 Release	9/8/2022

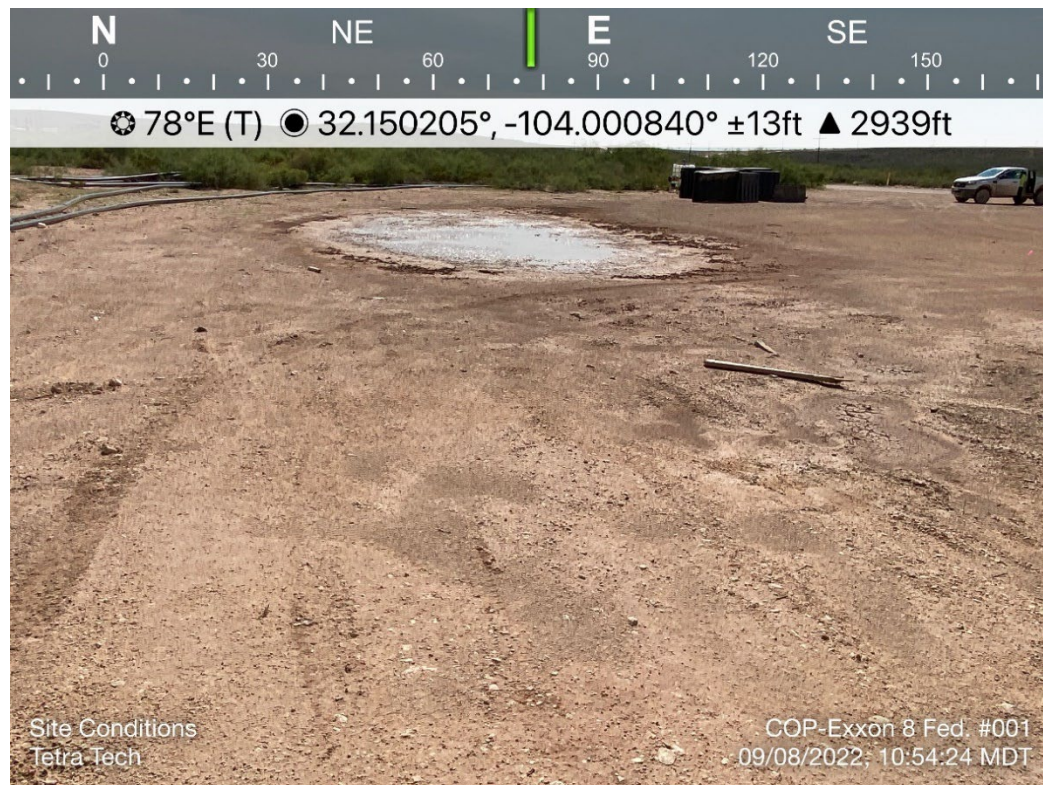
TETRA TECH, INC. PROJECT NO. 212C-MD-02832	DESCRIPTION	View east. Former tank battery located in north central area of pad. Ponded rainwater visible in background.	4
	SITE NAME	EXXON 8 FEDERAL #001 Release	9/8/2022

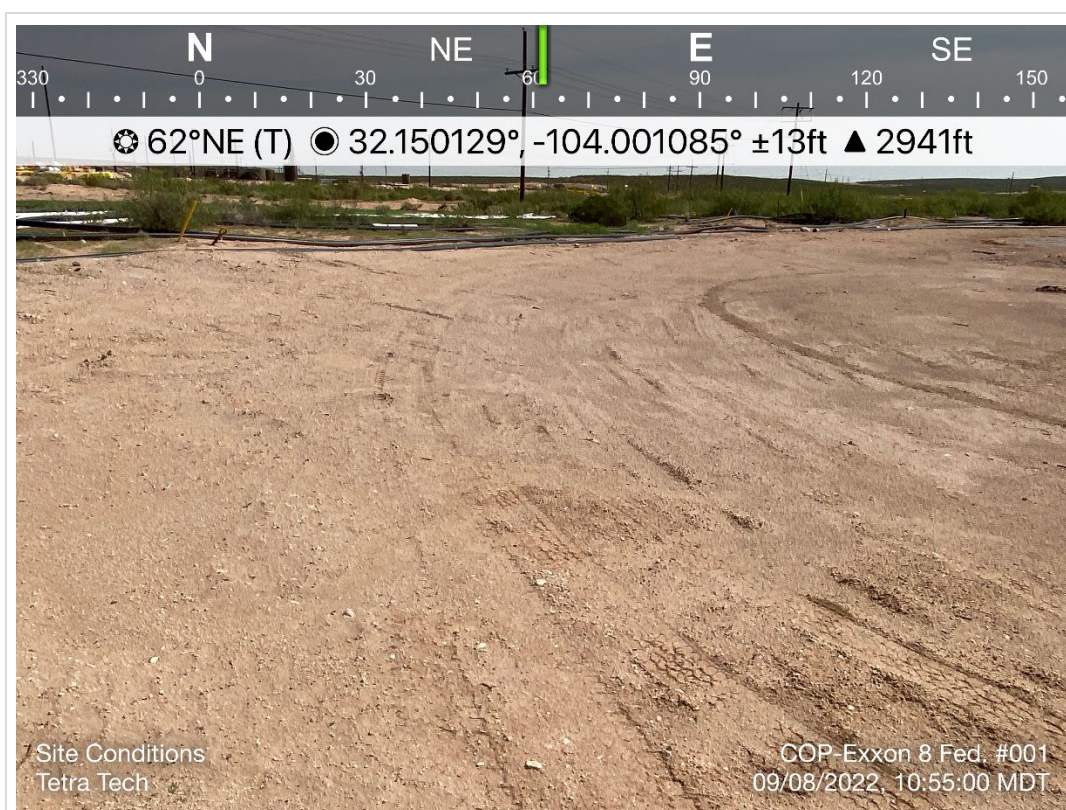
TETRA TECH, INC. PROJECT NO. 212C-MD-02832	DESCRIPTION	View northeast over pad area.	8
	SITE NAME	EXXON 8 FEDERAL #001 Release	9/8/2022

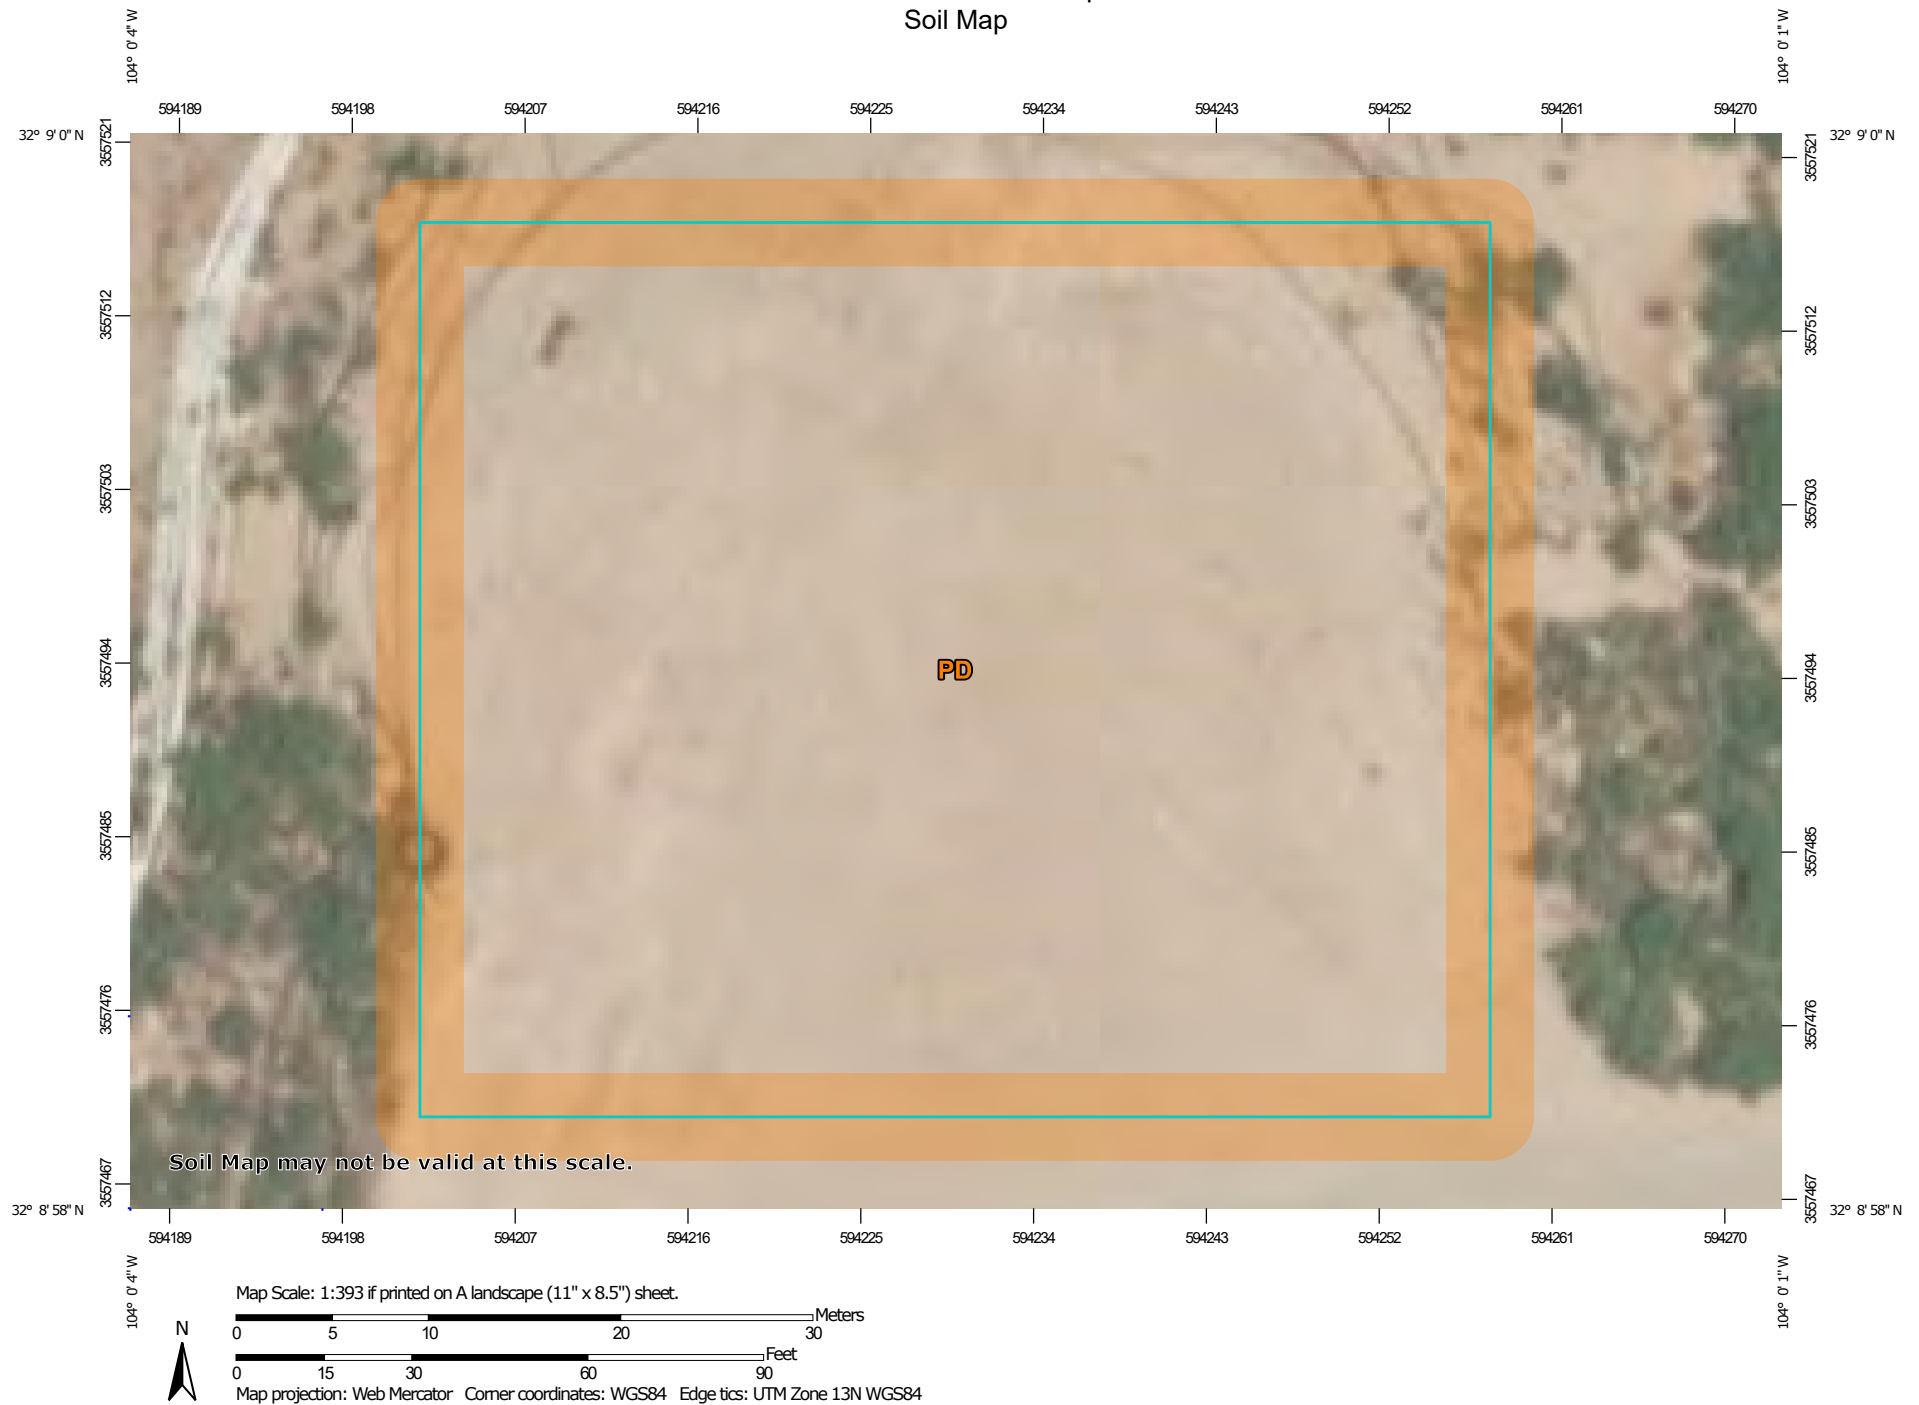
Custom Soil Resource Report
Soil Map

The soil map section includes the soil map for the defined area of interest, a list of soil map units on the map and extent of each map unit, and cartographic symbols displayed on the map. Also presented are various metadata about data used to produce the map, and a description of each soil map unit.
