**Re: Closure Report
ConocoPhillips
Heritage Concho
Miller B Federal #003 Flowline Release
Unit Letter A, Section 23, Township 17 South, Range 32 East
Lea County, New Mexico
Incident ID# nOY1704058292
1RP-4597**

Tetra Tech, Inc. (Tetra Tech) was contacted by ConocoPhillips to evaluate a Heritage Concho release and subsequent assessment activities performed at the Miller B Federal #003 Flowline Release site (API No. 30-025-31054). The release footprint is located in Public Land Survey System (PLSS) Unit Letter A, Section 23, Township 17 South, Range 32 East, in Lea County, New Mexico (Site). The approximate release point occurred at coordinates 32.8245583°, -103.7327499°, as shown on Figures 1 and 2.

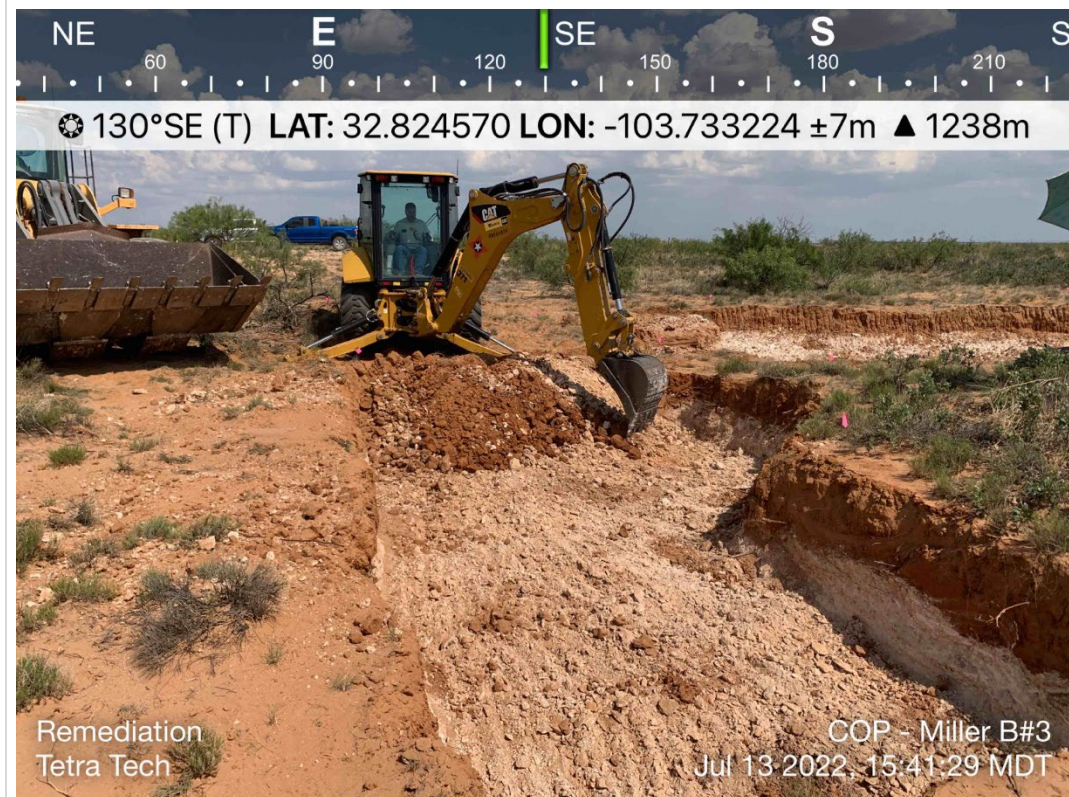
TETRA TECH, INC. PROJECT NO. 212C-MD-02672	DESCRIPTION	View southeast of Miller B Federal #003 excavation.	2
	SITE NAME	Miller B Federal #003 Flowline Release	7/13/2022

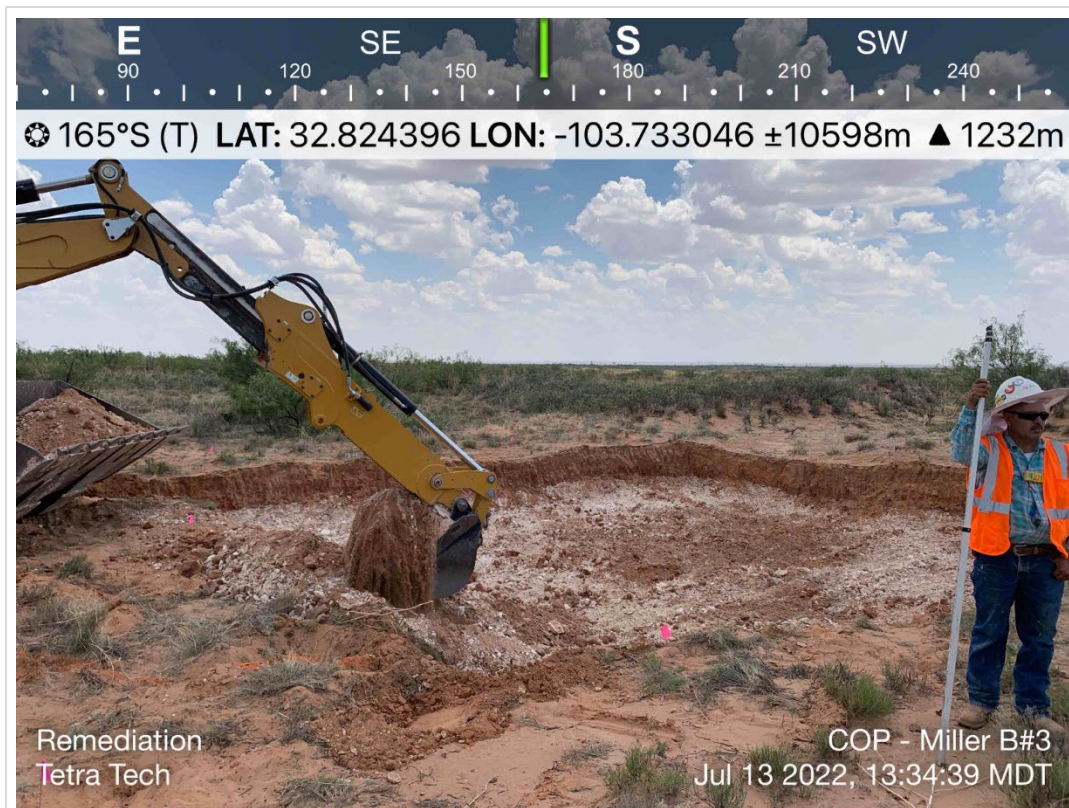
TETRA TECH, INC. PROJECT NO. 212C-MD-02672	DESCRIPTION	View south of Miller B Federal #003 excavation.	3
	SITE NAME	Miller B Federal #003 Flowline Release	7/13/2022

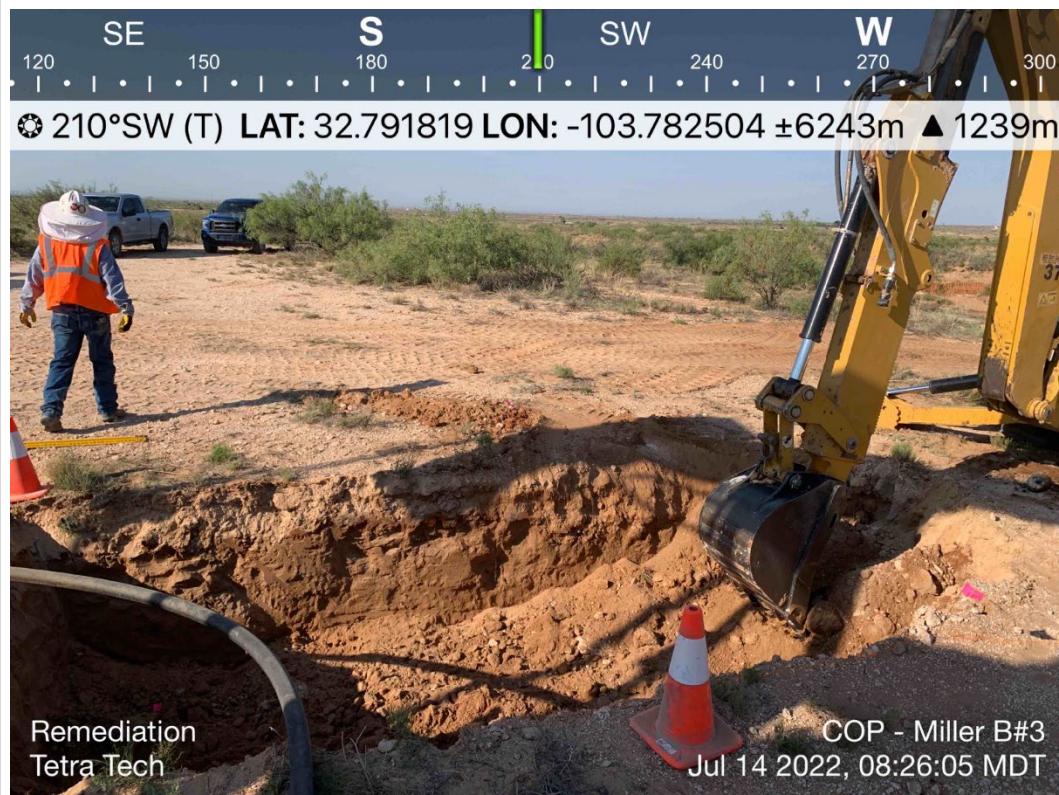
TETRA TECH, INC. PROJECT NO. 212C-MD-02672	DESCRIPTION	View south-southwest of Miller B Federal #003 excavation.	4
	SITE NAME	Miller B Federal #003 Flowline Release	7/14/2022

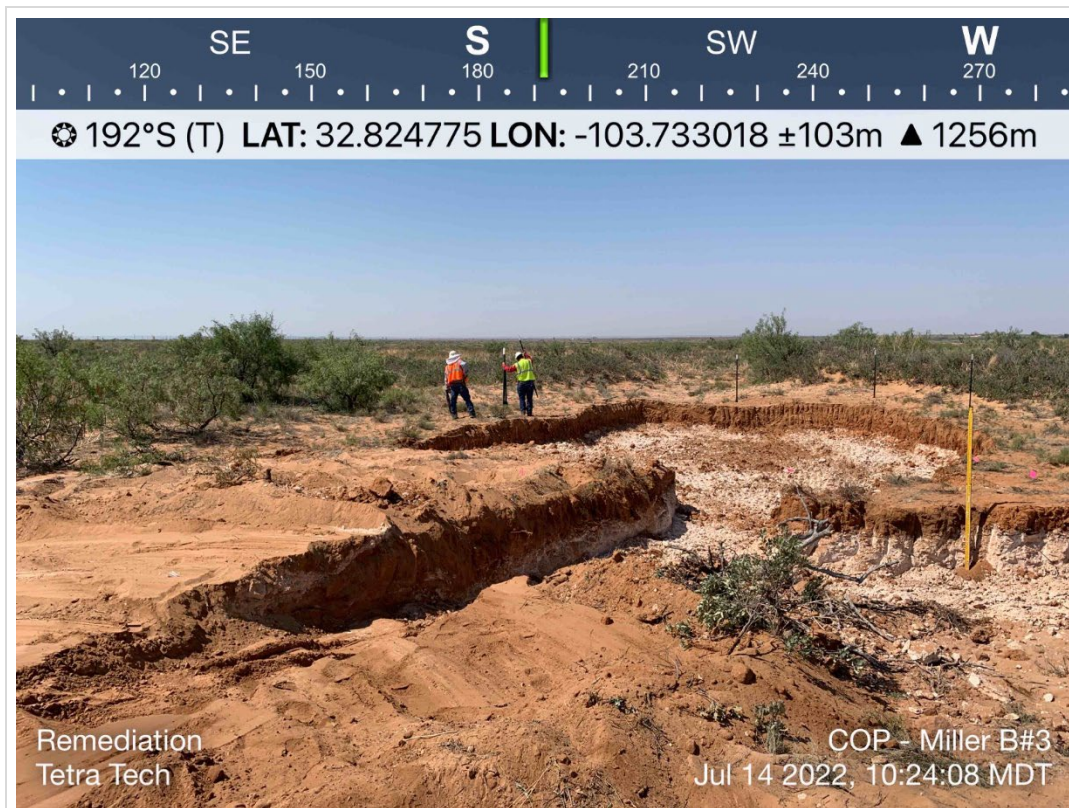
TETRA TECH, INC. PROJECT NO. 212C-MD-02672	DESCRIPTION	View south of Miller B Federal #003 excavation.	5
	SITE NAME	Miller B Federal #003 Flowline Release	7/14/2022

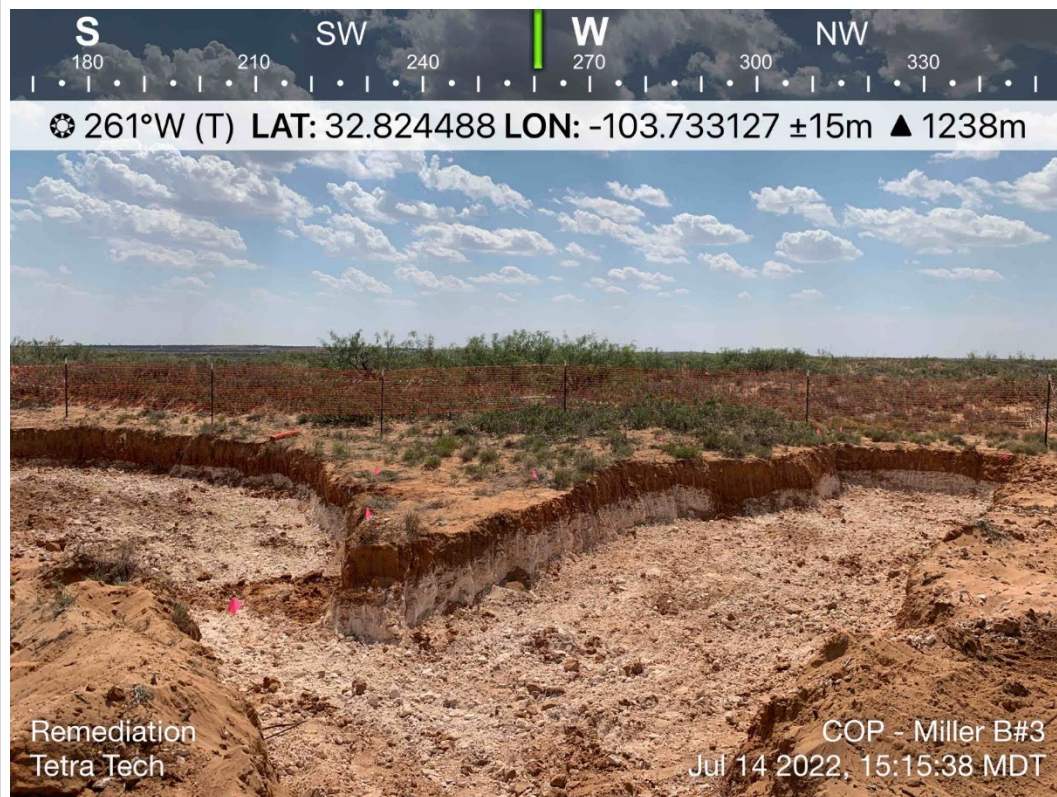
TETRA TECH, INC. PROJECT NO. 212C-MD-02672	DESCRIPTION	View west of Miller B Federal #003 excavation.	6
	SITE NAME	Miller B Federal #003 Flowline Release	7/14/2022

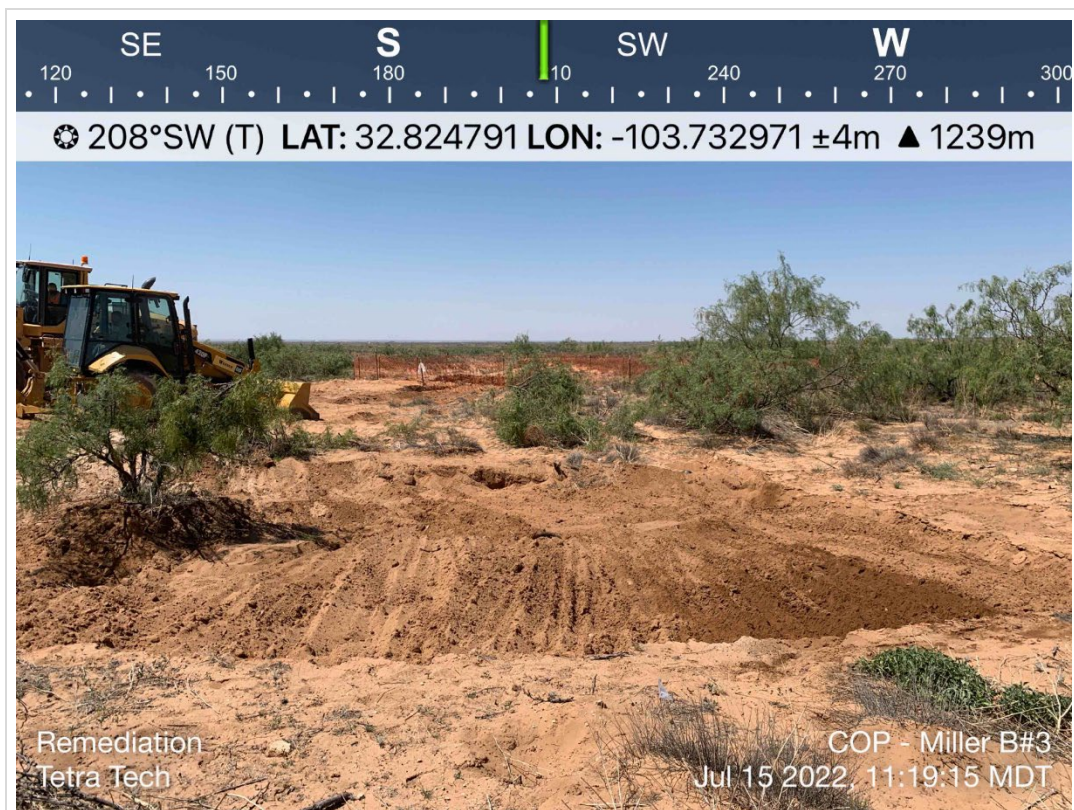
TETRA TECH, INC. PROJECT NO. 212C-MD-02672	DESCRIPTION	View southwest of scraped area over closed reserve pit.	7
	SITE NAME	Miller B Federal #003 Flowline Release	7/15/2022

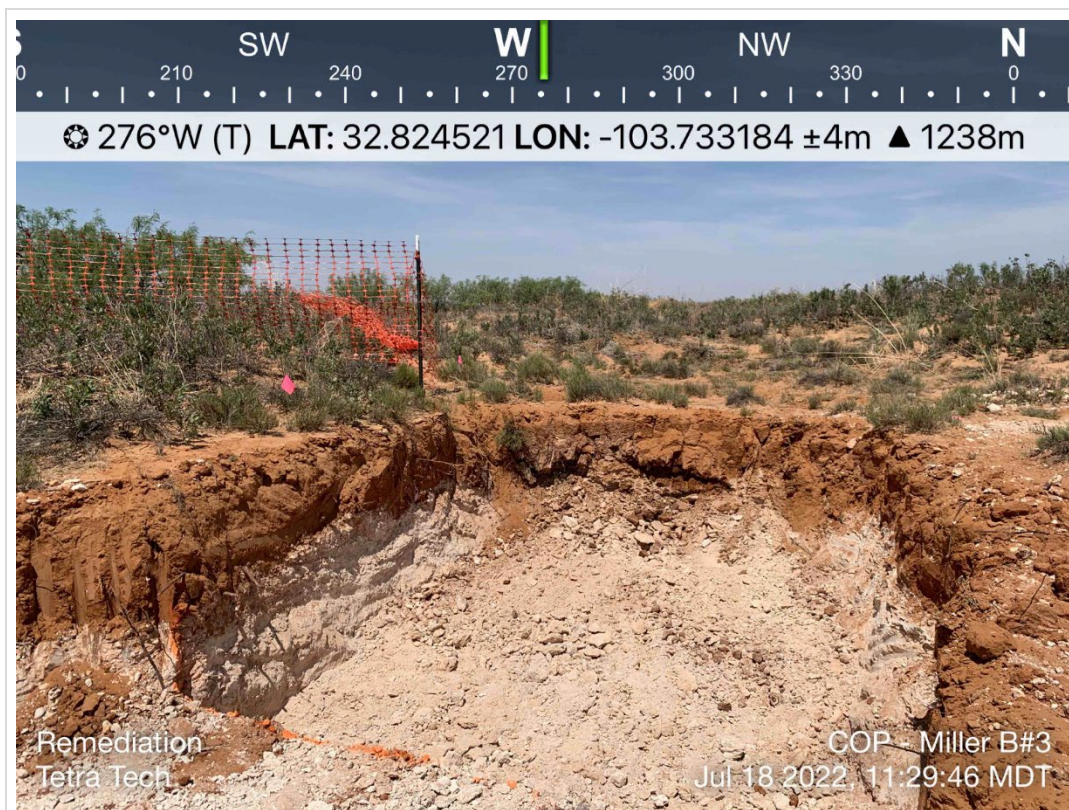
TETRA TECH, INC. PROJECT NO. 212C-MD-02672	DESCRIPTION	View west of WSW-3 expansion area.	9
	SITE NAME	Miller B Federal #003 Flowline Release	7/18/2022

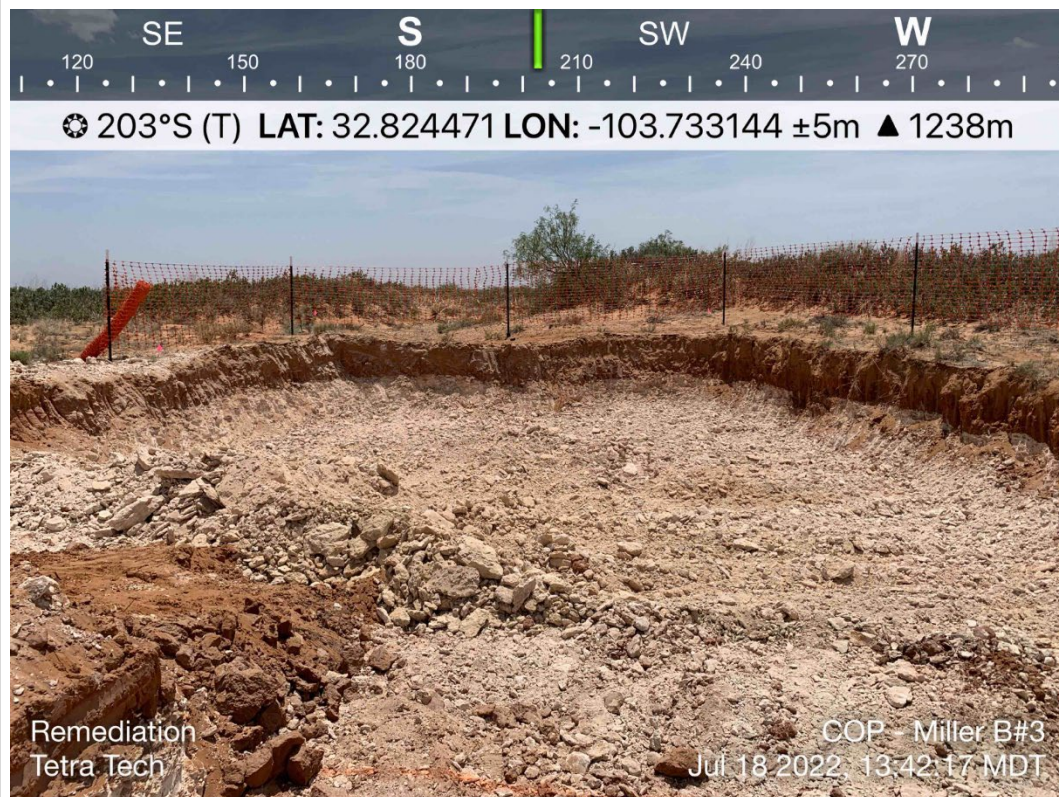
TETRA TECH, INC. PROJECT NO. 212C-MD-02672	DESCRIPTION	View south-southwest of deepened excavation in FS-4 and FS-5 area.	10
	SITE NAME	Miller B Federal #003 Flowline Release	7/18/2022
