| Incident ID | nAB1909834775 |

A lease operator pulled onto the location and discovered a leak under the pumping unit. Repairs were made. Approximately 7.9 bbls of produced water was released, with 2 bbls being recovered via vacuum truck. The total area of impact was estimated to be 4,423 square feet. According to documentation in the New Mexico Oil Conservation Division's (NMOCD) Imaging System, the well was plugged and abandoned in May 2019, and the location was subsequently reclaimed.

Based on laboratory analytical results and field activities conducted to date, Etech recommends Devon Energy provide copies of this *Remediation Summary & Soil Closure Request* to the appropriate agencies and request closure be granted to the Ore Ida 14 Federal 2 release site.

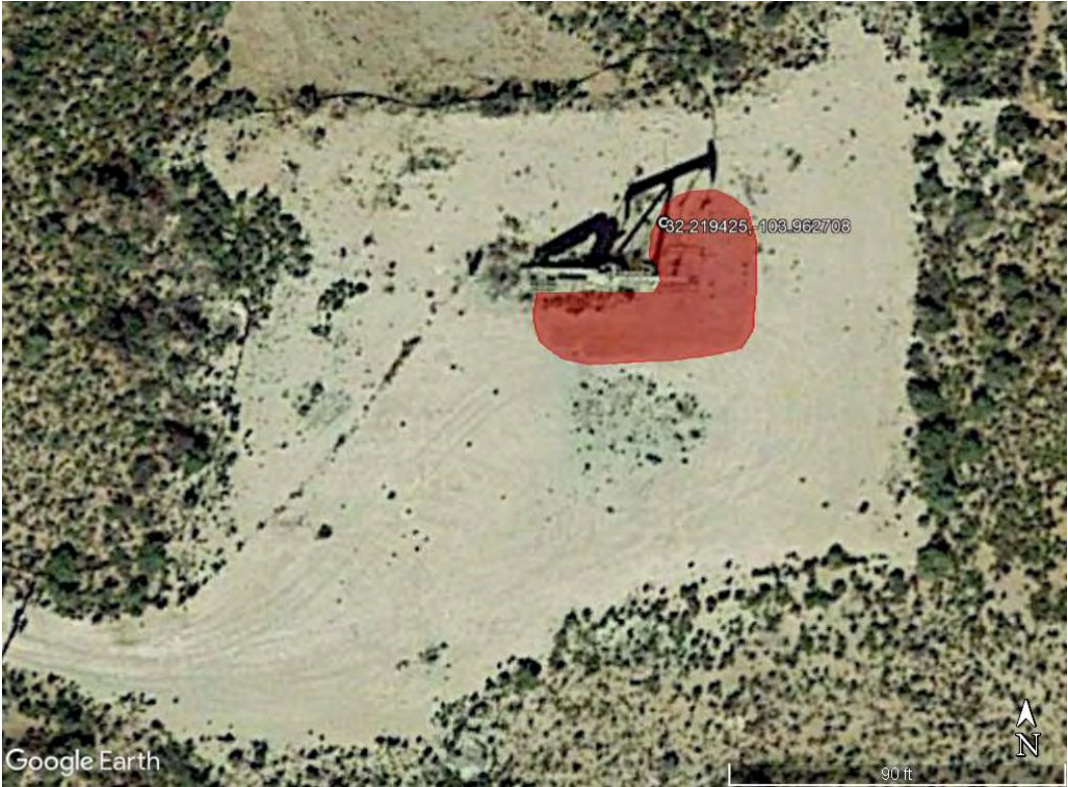
| Photo Number: 1 | |

| Photo Description: Inferred affected area (highlighted in red). | |

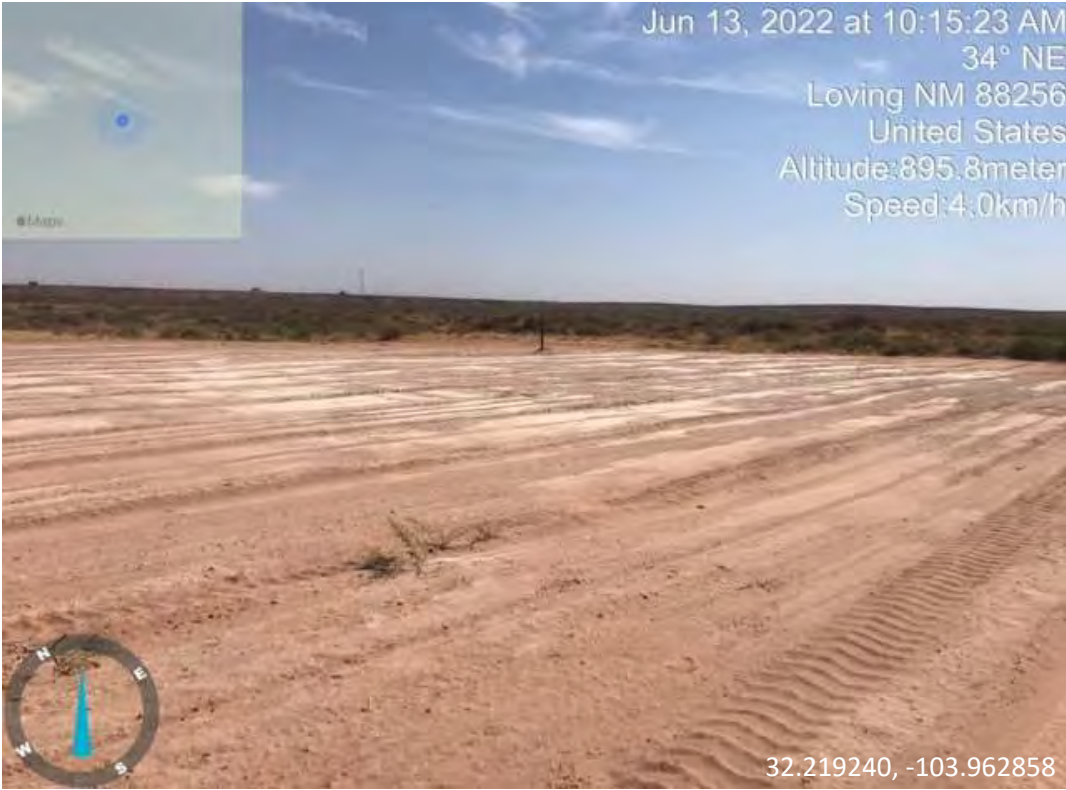
| Photo Number: 6 | |

| Photo Description: View of the remediated area after backfilling and regrading. | |

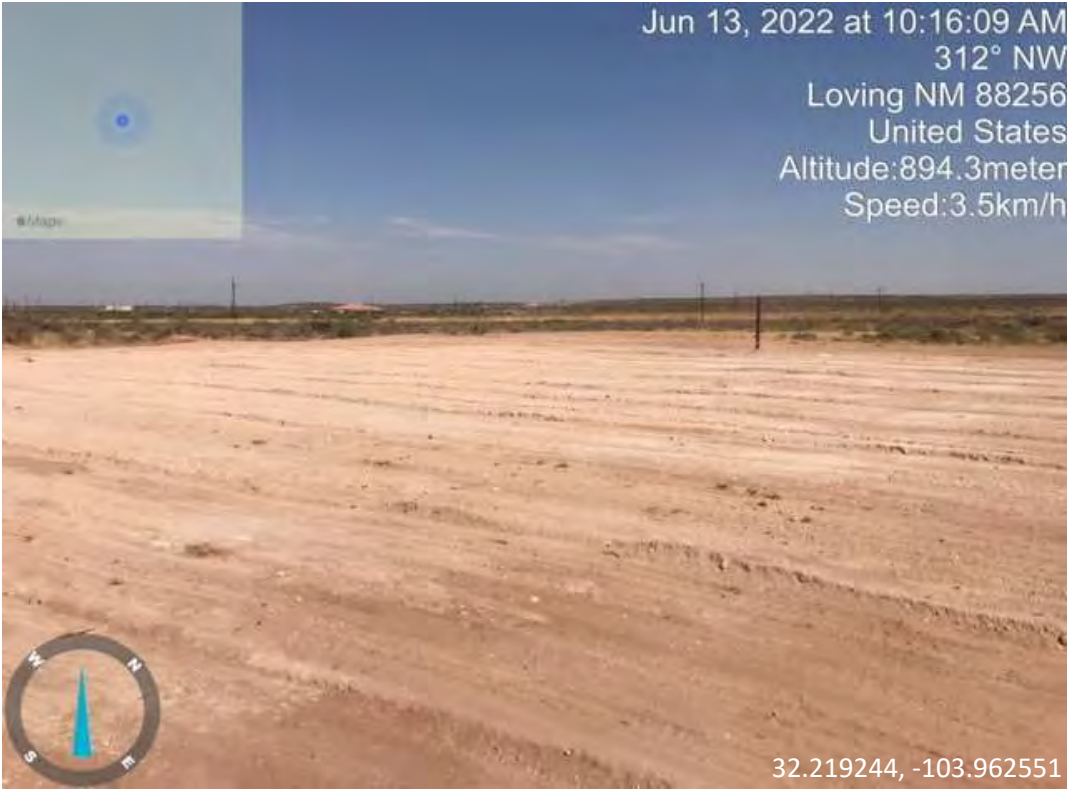
| Photo Number: 7 | |

| Photo Description: View of the remediated area after backfilling and regrading. | |

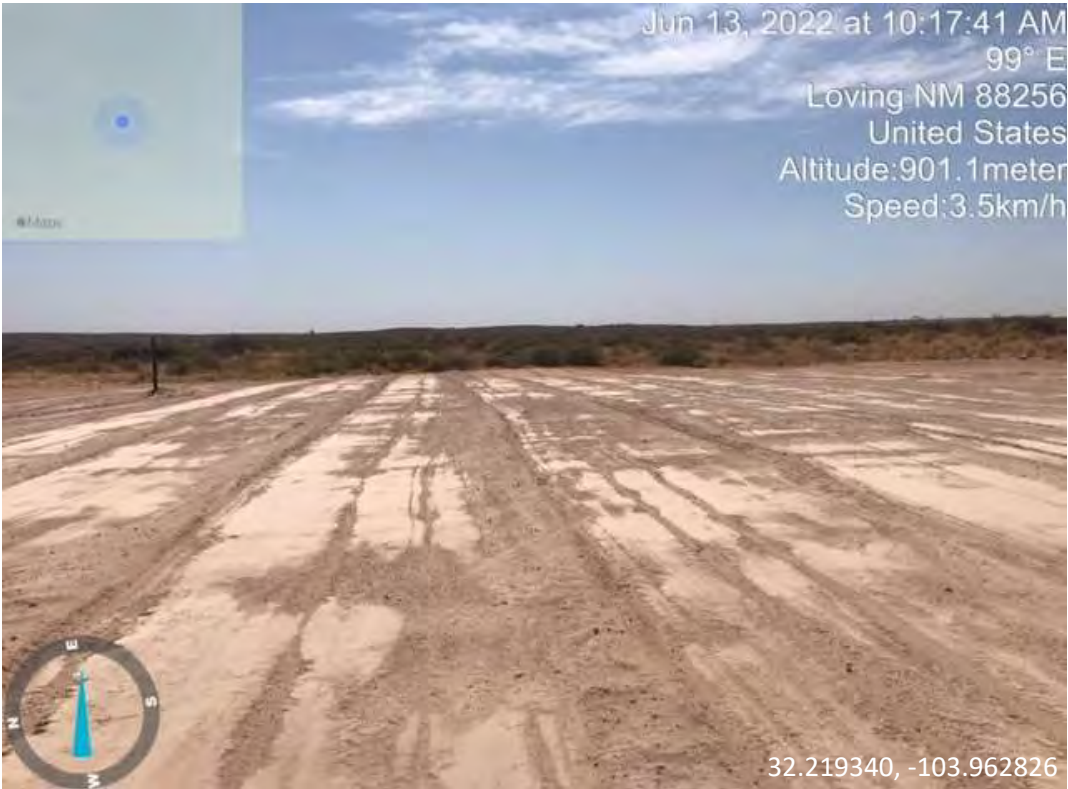
| Photo Number: 8 | |

| Photo Description: View of the remediated area after backfilling and regrading. | |

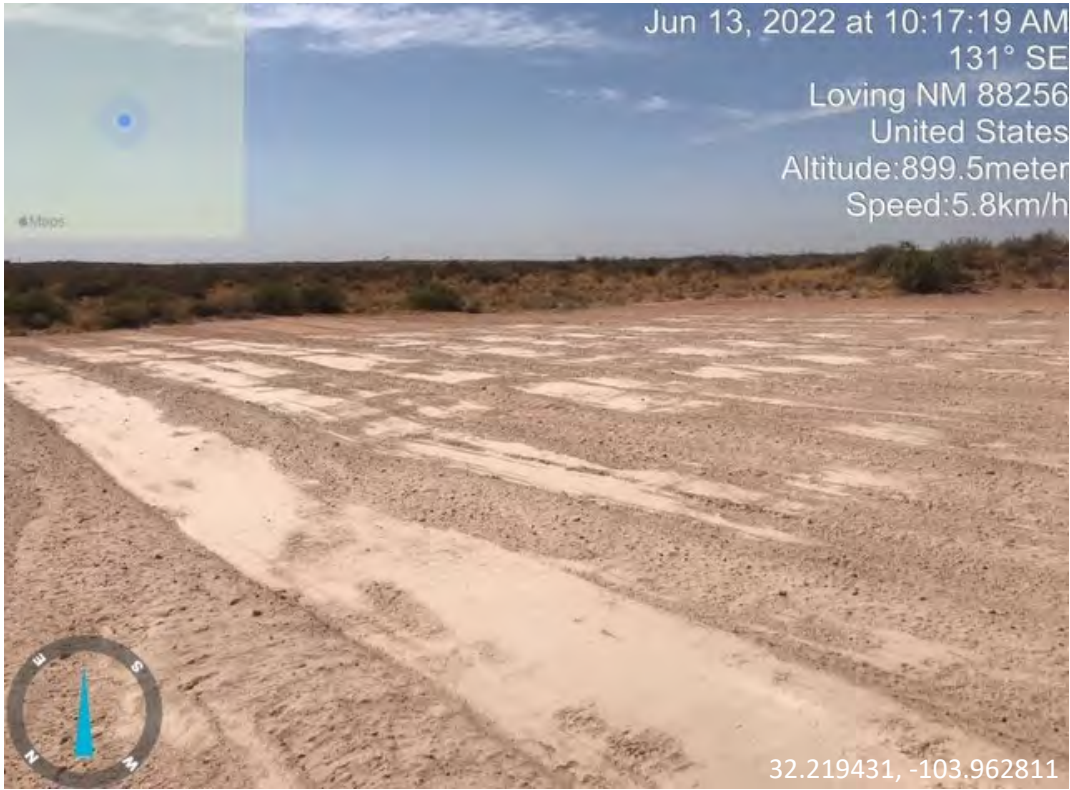
| Photo Number: 9 | |

| Photo Description: View of the remediated area after backfilling and regrading. | |

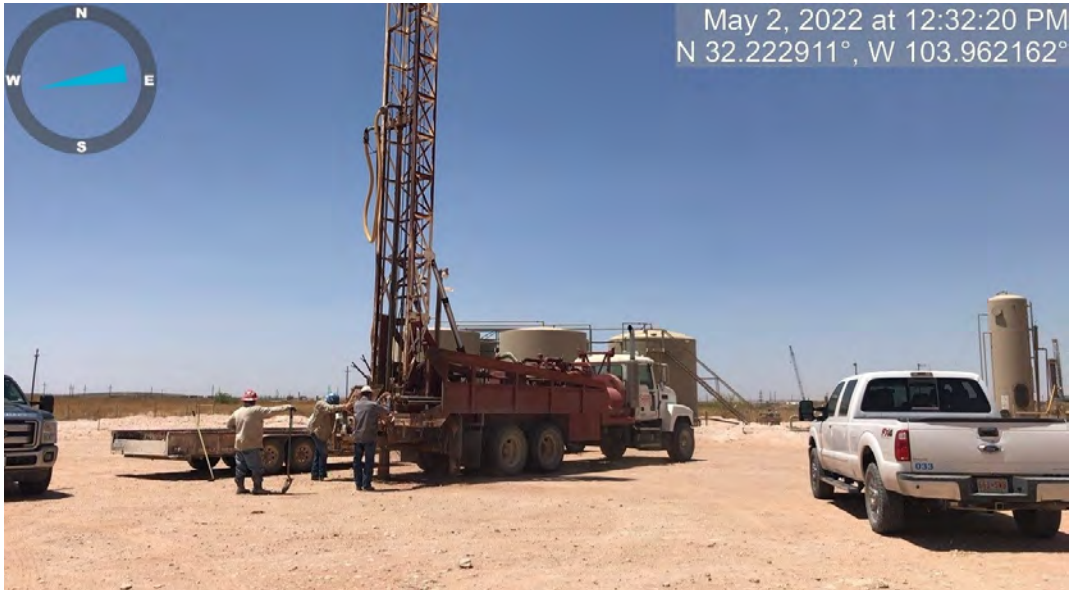
| Photo Number: 10 | |

| Photo Description: View of the advancement of temporary monitor well TMW-1. | |
