Final Closure Report

**Grizzly Operating, LLC
Horse Creek Com #2
Chaves County, New Mexico
Unit Letter "E", Section 11, Township 5 South, Range 24 East
Latitude 33.8888512 North, Longitude 104.3996964 West
NMOCD Incident # nAB1701252341**

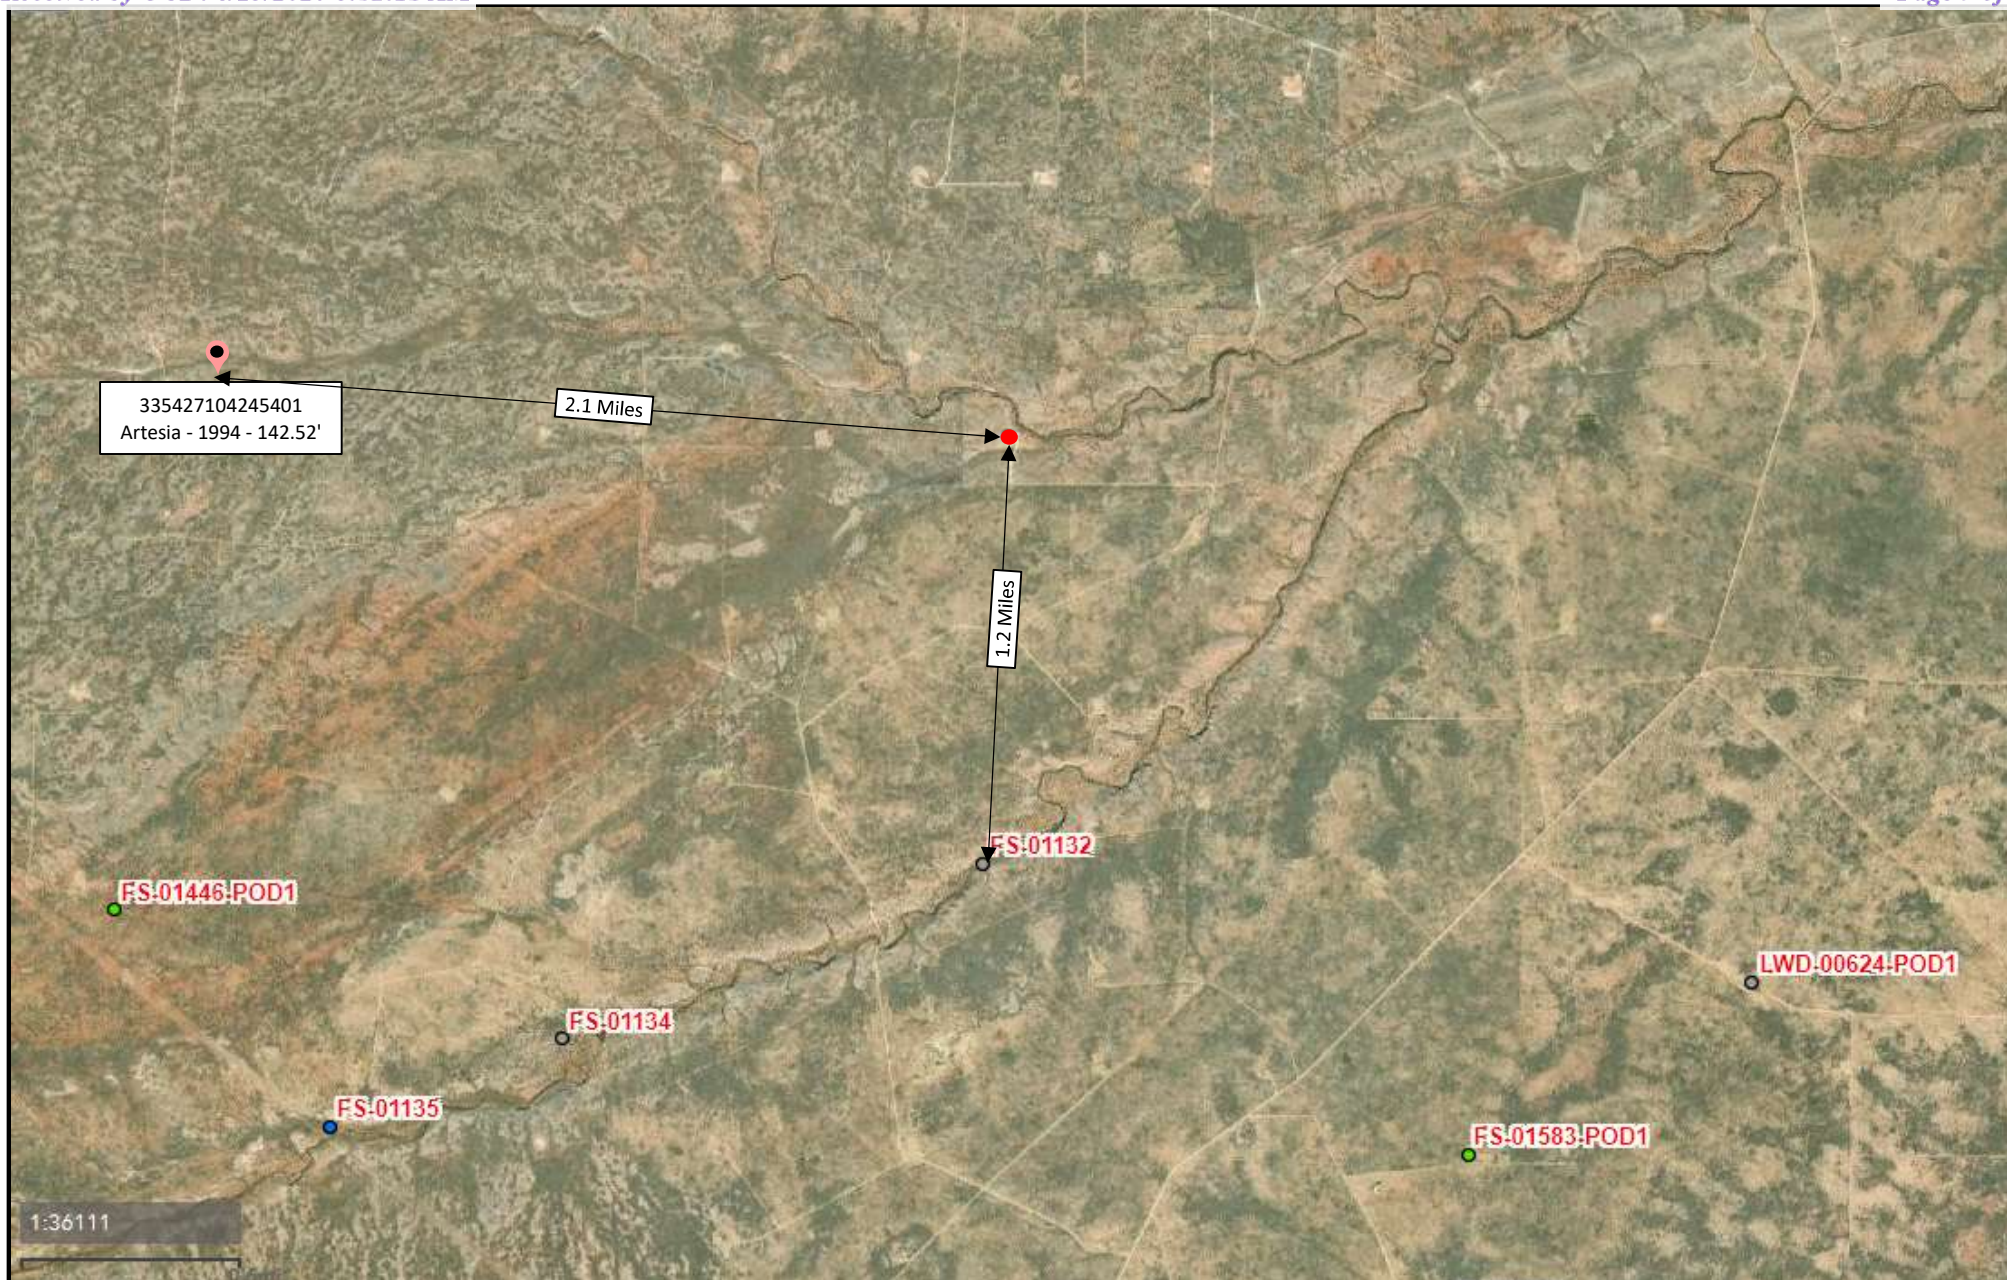
**Figure 2**

Water Well Proximity Map
 Grizzly Operating, LLC
 Horse Creek Com #2
 GPS: 33.8888512, -104.3996964
 Chaves County

A search of the New Mexico Office of the State Engineer (NMOSE) and United States Geological Survey (USGS) groundwater databases was completed to determine the horizontal distance to known water sources within a half mile radius of the release site. The search returned no wells located within a half mile radius of the release site. Also, no wells (domestic, agriculture or public) and no bodies of surface water exist within a 1,000-foot radius of the release site. The NMOSE database indicates average water depth is approximately 199 feet bgs within a 4,500-meter radius. However, as this is too great a distance to accurately determine depth to water for this location and the closest documented well to this location is 1,943 meters away and doesn't provide depth to groundwater, the Chaves county groundwater flowline map was utilized to determine an approximate depth to water of seventy-five to one hundred feet bgs. Depth to groundwater information is provided as Attachment II and the results are depicted on Figure 2.

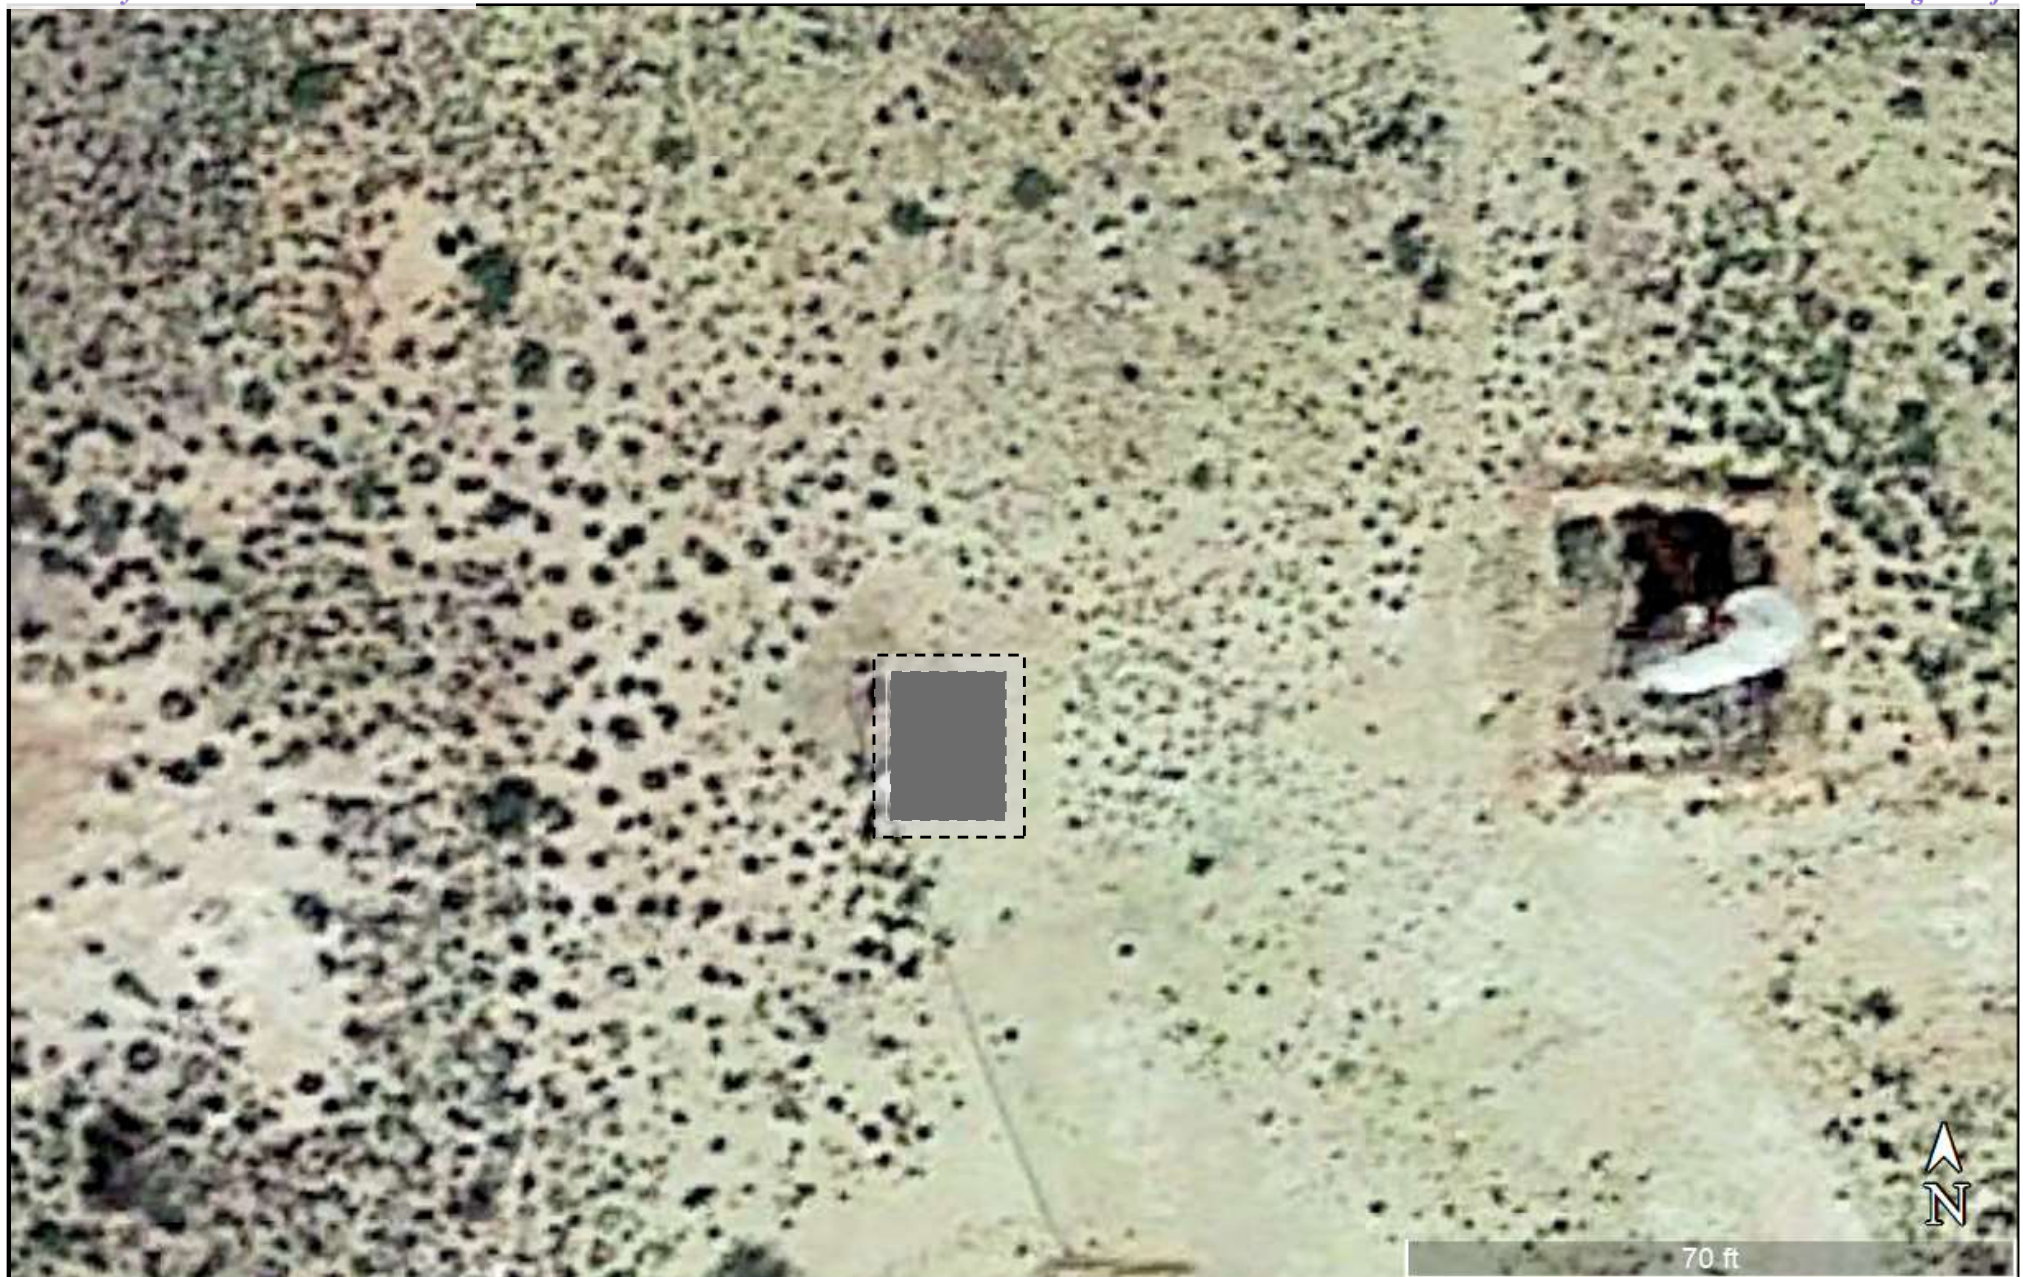
**Figure 3**

Excavation Area Map
Grizzly Operating, LLC
Horse Creek Com #2
GPS: 33.8888512, -104.3996964
Chaves County

Excavated three feet bgs and lined
-

Excavated seven feet bgs and lined

From November 16 – 18, 2017, remediation activities commenced on location. In accordance with the approved work plan, impacted soil around the edge of the existing excavation was excavated one foot laterally and three feet vertically. Excavated soil was then hauled to an NMOCD approved disposal facility. After excavation activities were complete, a 20-millimeter poly-ethylene liner was installed, at seven feet bgs, covering the deepest portion of the excavation and extended up the sidewalls to also cover the newly excavated area at three feet bgs.

An Excavation Area Map is provided as Figure 3, a Summary of Soil Sample Field and Laboratory Analytical Results is provided as Table 1, and Laboratory Analytical Reports are provided as Attachment III.

The final dimensions of the excavated area were approximately 20 ft. in length and 20 ft. in width and ranged from 3 ft. to 7 ft. in depth. During remediation activities approximately 40 cubic yards of impacted soil were hauled to an NMOCD approved disposal facility.

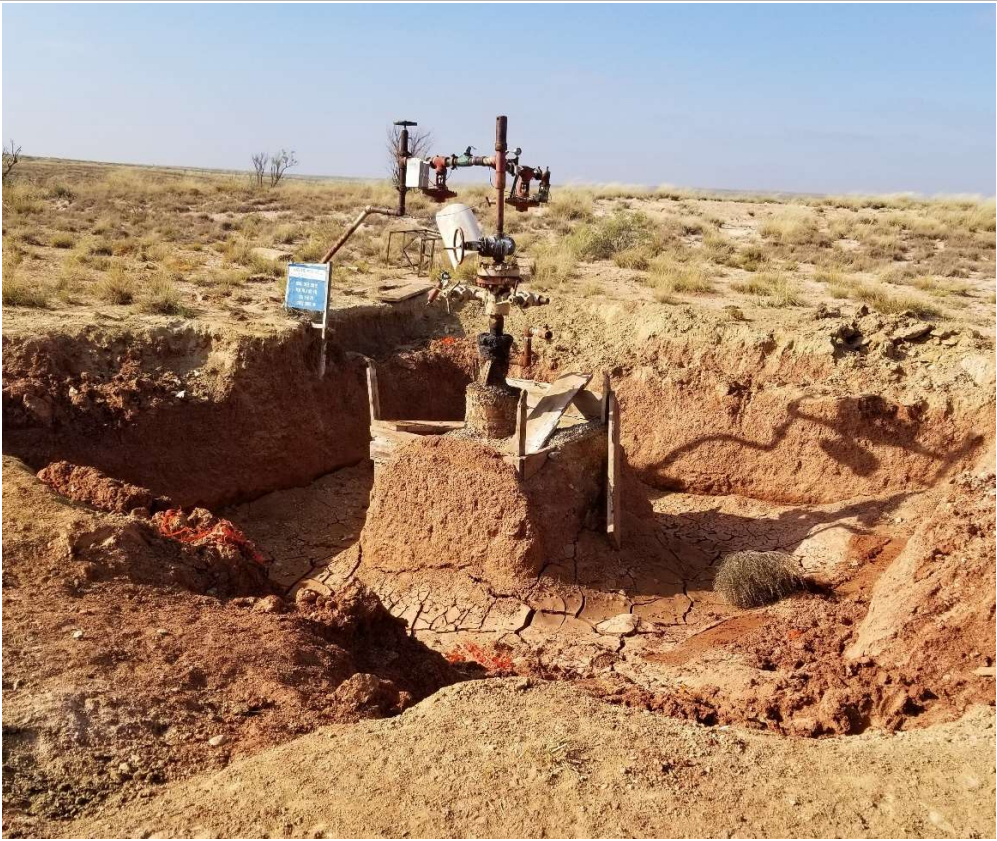
Photo 1

Direction Northwest	
Description Excavation prior to extending the sidewalls one foot laterally and three feet vertically.

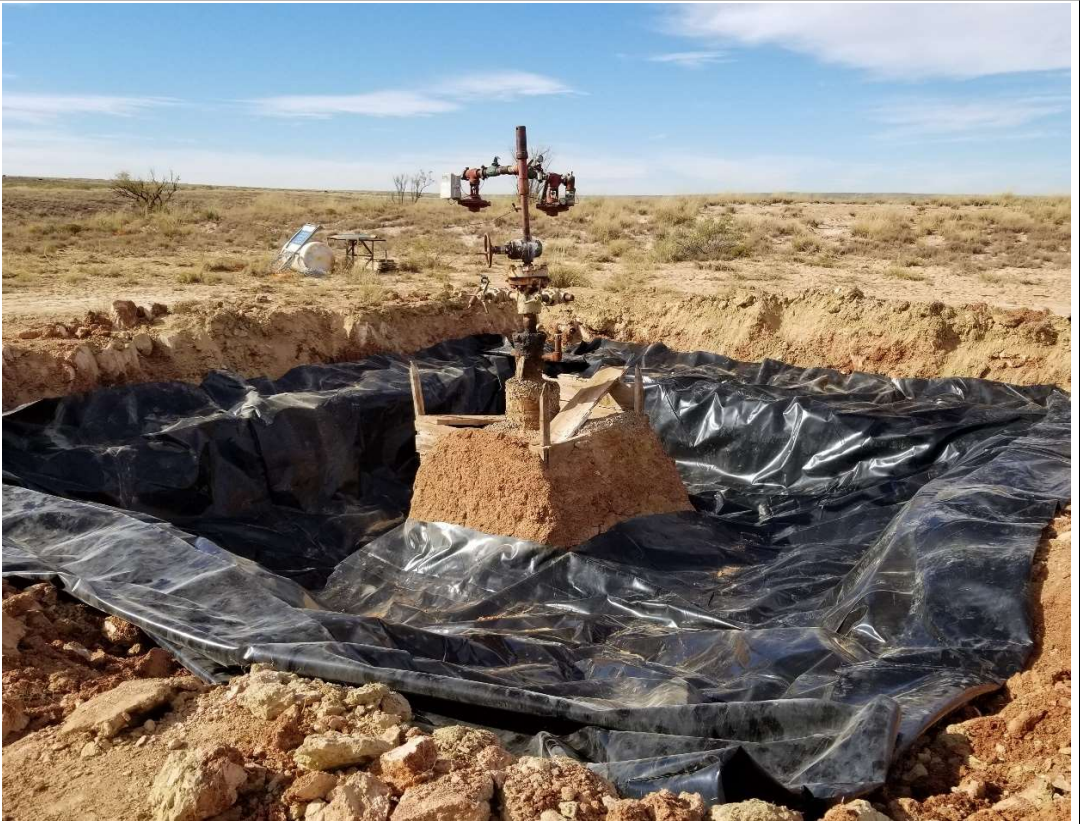
Photo 3

Direction Northwest	
Description Installation of liner at seven feet bgs and extended up the sidewalls to cover the newly excavated area at three feet bgs.

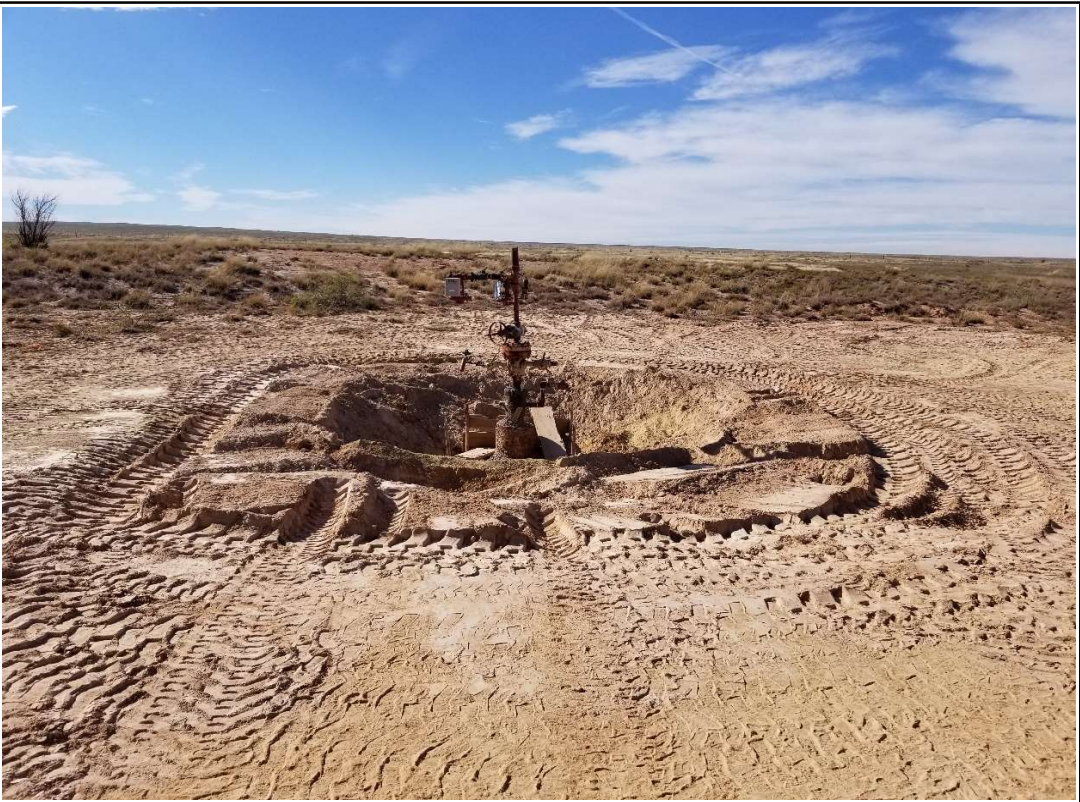
Photo 4

Direction North	
Description Backfilling after installation of liner.

After the liner was installed the excavation was backfilled with clean, non-impacted, like material and replaced to the near original relative positions. The areas were contoured to achieve erosion control and preserve surface water flow. And as the release occurred on an active well pad, no seeding will be required.
