RE: Conditional Approval of Soil Vapor Extraction (SVE) Remediation Method for Hare 014M
(API #: 30-045-33566; Incident #: NRM2028852747; Application ID: 68678)

To evaluate the design of an SVE system, WSP conducted a pilot test to determine the flow rate and applied vacuum required to influence the subsurface and cause volatilization of the petroleum hydrocarbons entrained in the soil. Pilot test data was also used to determine specific site design radius-of-influence (ROI) and radius-of-effect (ROE). Further information regarding the pilot test procedures and results are presented below.

SVE TEST RESULTS AND CONCLUSIONS

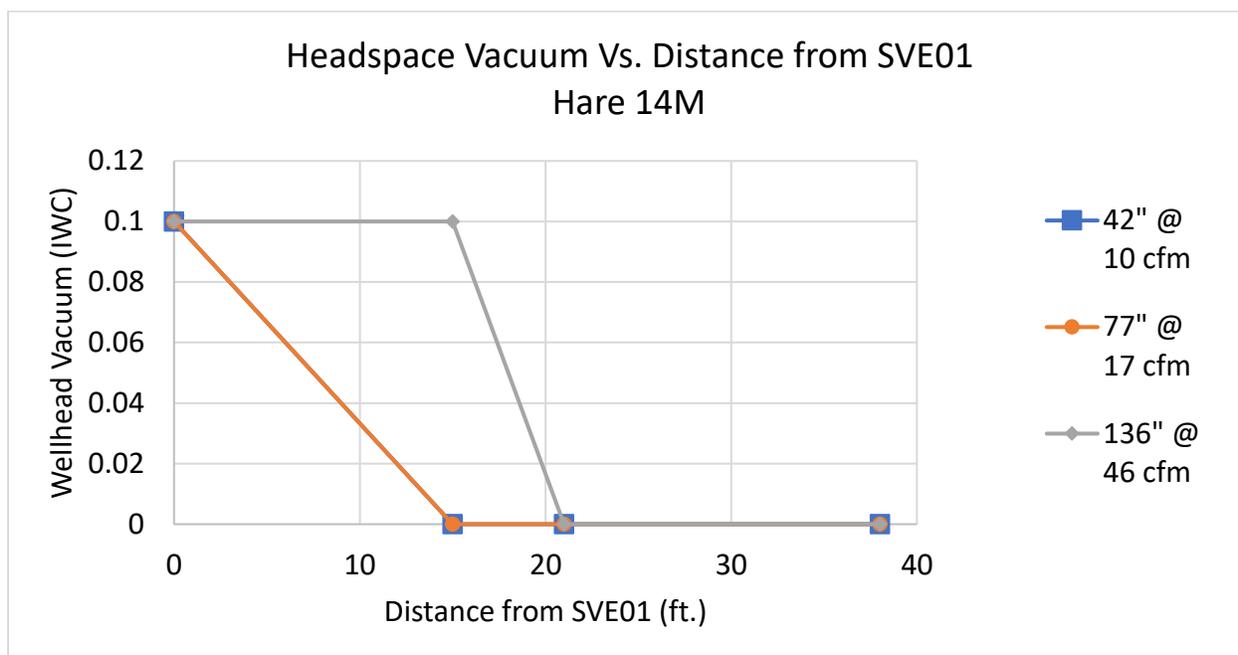
Pilot test data indicates that SVE is a viable technology to remediate the Site if equipment is sized correctly. The vacuum response from the pilot test well SVE01 and observation wells SVE02, SVE05, SVE07, and SVE09 is shown below. Observation wells ranged in distance of 0 feet to 38 feet from the SVE test well (SVE01). Vacuum influence was observed at SVE02 and SVE09 at a distance of 15 feet as shown on the figure below.

The above figure illustrates that vacuum influence was observed at a distance of 15 feet at 136 IWC at 46 standard cubic feet per minute (scfm). Vacuum response was not observed at 21 feet. Based on the vacuum observations a ROI of 15 to 20 feet can be assumed.

Additional calculations were performed to determine the ROE. These calculations are included in Enclosure C. To determine a ROE the annual pore volume exchange was calculated assuming an ROI of 20 feet at a flow rate of 46 scfm. The pore volumes calculated indicated an annual pore volume exchange of 3,207. The pore volume exchange meets literature values of at least 500 pore volume exchanges annually. To further verify that the ROE corresponds with the ROI, the pore velocity was calculated at the ROI of 20 feet. The calculated pore velocity was 88 feet per day (ft/day), which is above a recommended velocity of 3 ft/day. Current SVE research indicates that it is desirable to achieve pore-gas velocities throughout the treatment zone in excess of 0.001 cm/sec or ~3 ft/day (DiGiulo and Ravi, 1999).

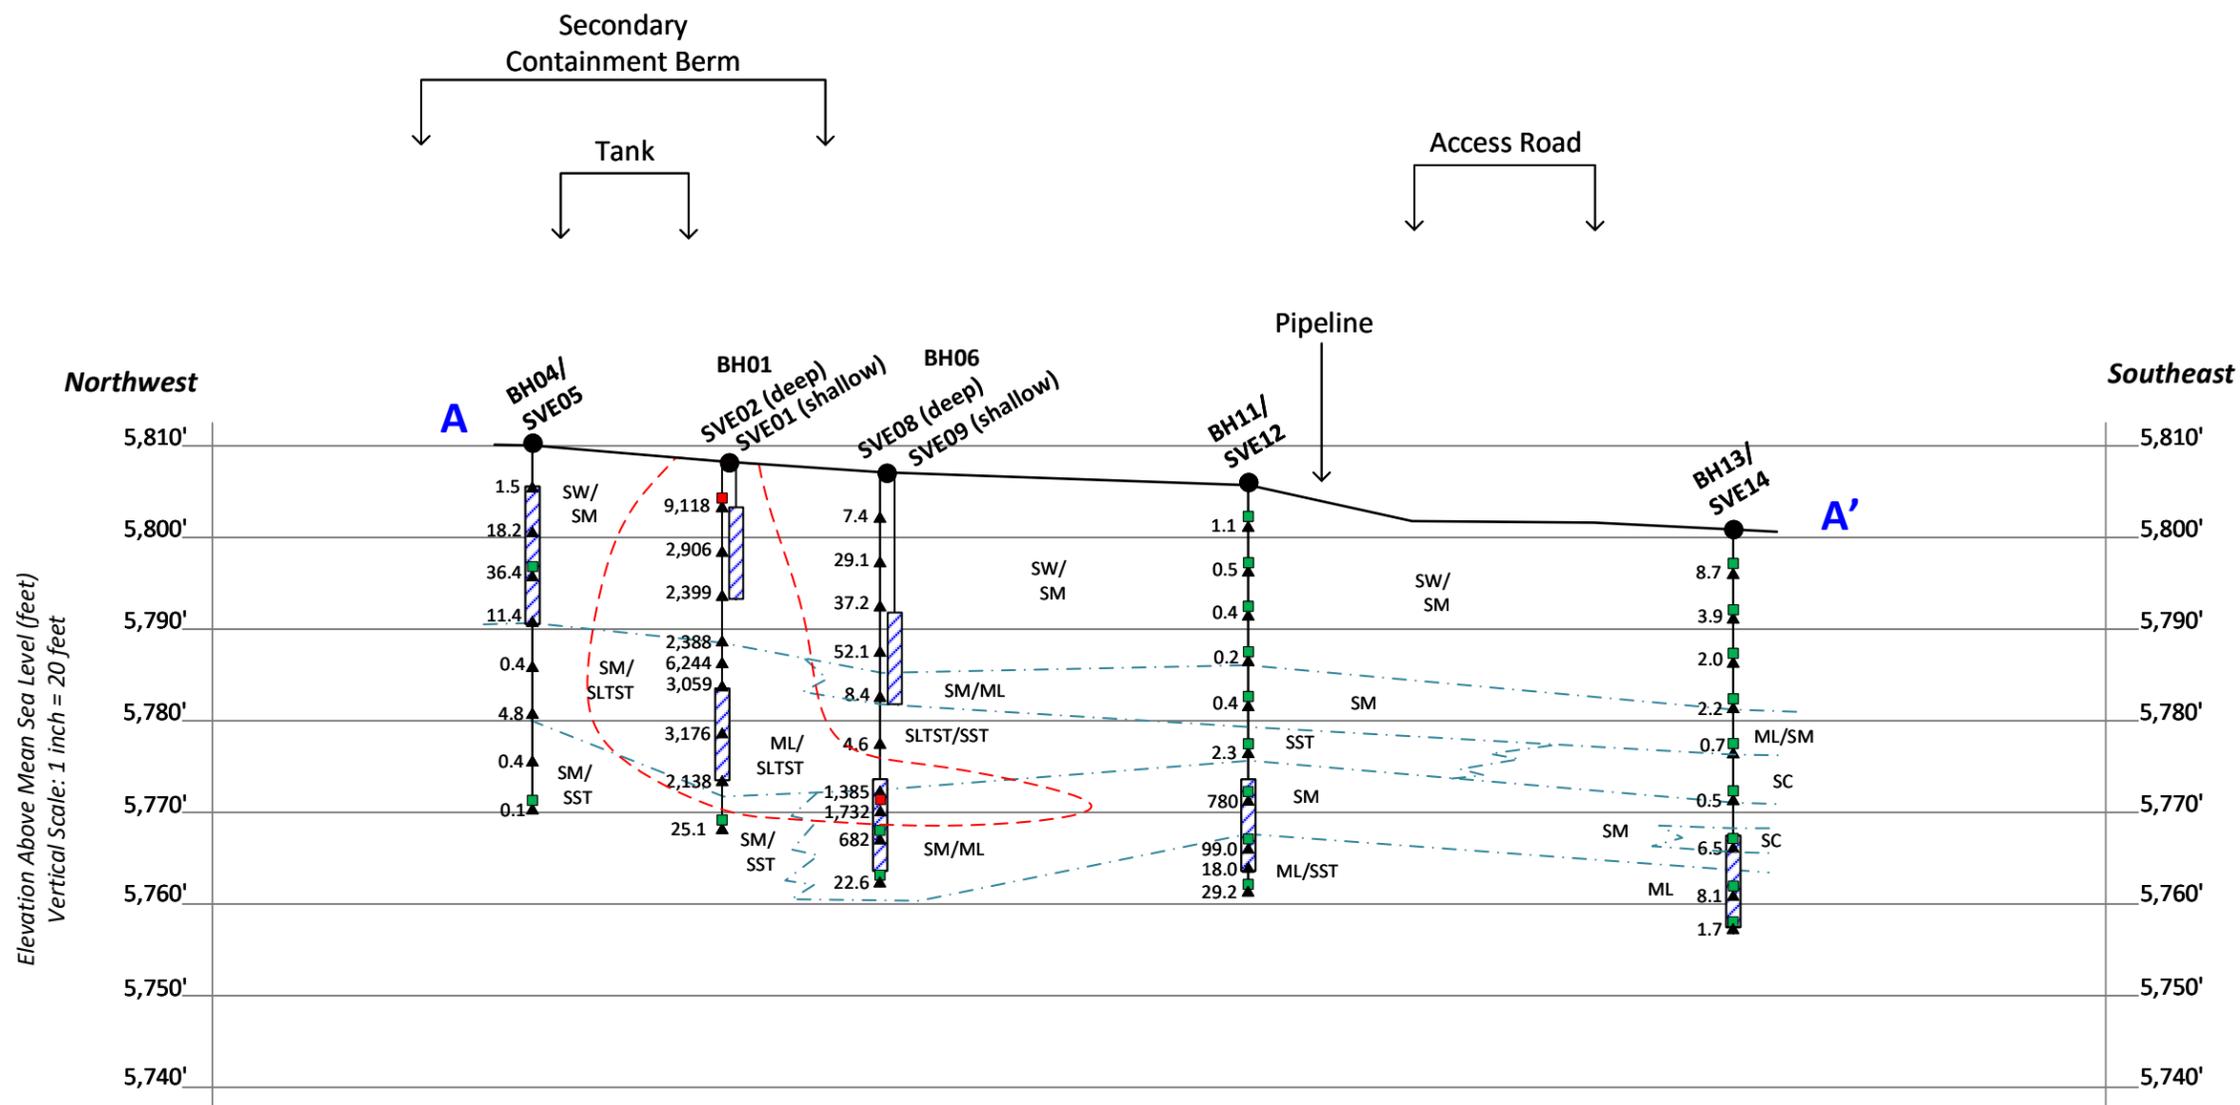
FIGURE 5A
 A TO A' CROSS SECTION
 HARE 14M
 LOT 4 SEC 10-T29N-R10W
 SAN JUAN COUNTY, NEW MEXICO
 HILCORP ENERGY COMPANY

- ML SILT
- SC CLAYEY SAND
- SLTST SILTSTONE
- SM SILTY SAND
- SW POORLY SORTED SAND
- SST SANDSTONE

Operation of wells SVE01, SVE02, SVE03, SVE08, and SVE09 is recommended to influence both the observed deep and shallow impacts. The other SVE wells are outside of the area of known impact and do not need to operate at this time. The cross sections provided as Figures 5A and 5B illustrate the vertical coverage of the SVE wells to influence the impact at depth. A full scale SVE system should be sized to supply a minimum of 136 IWC vacuum

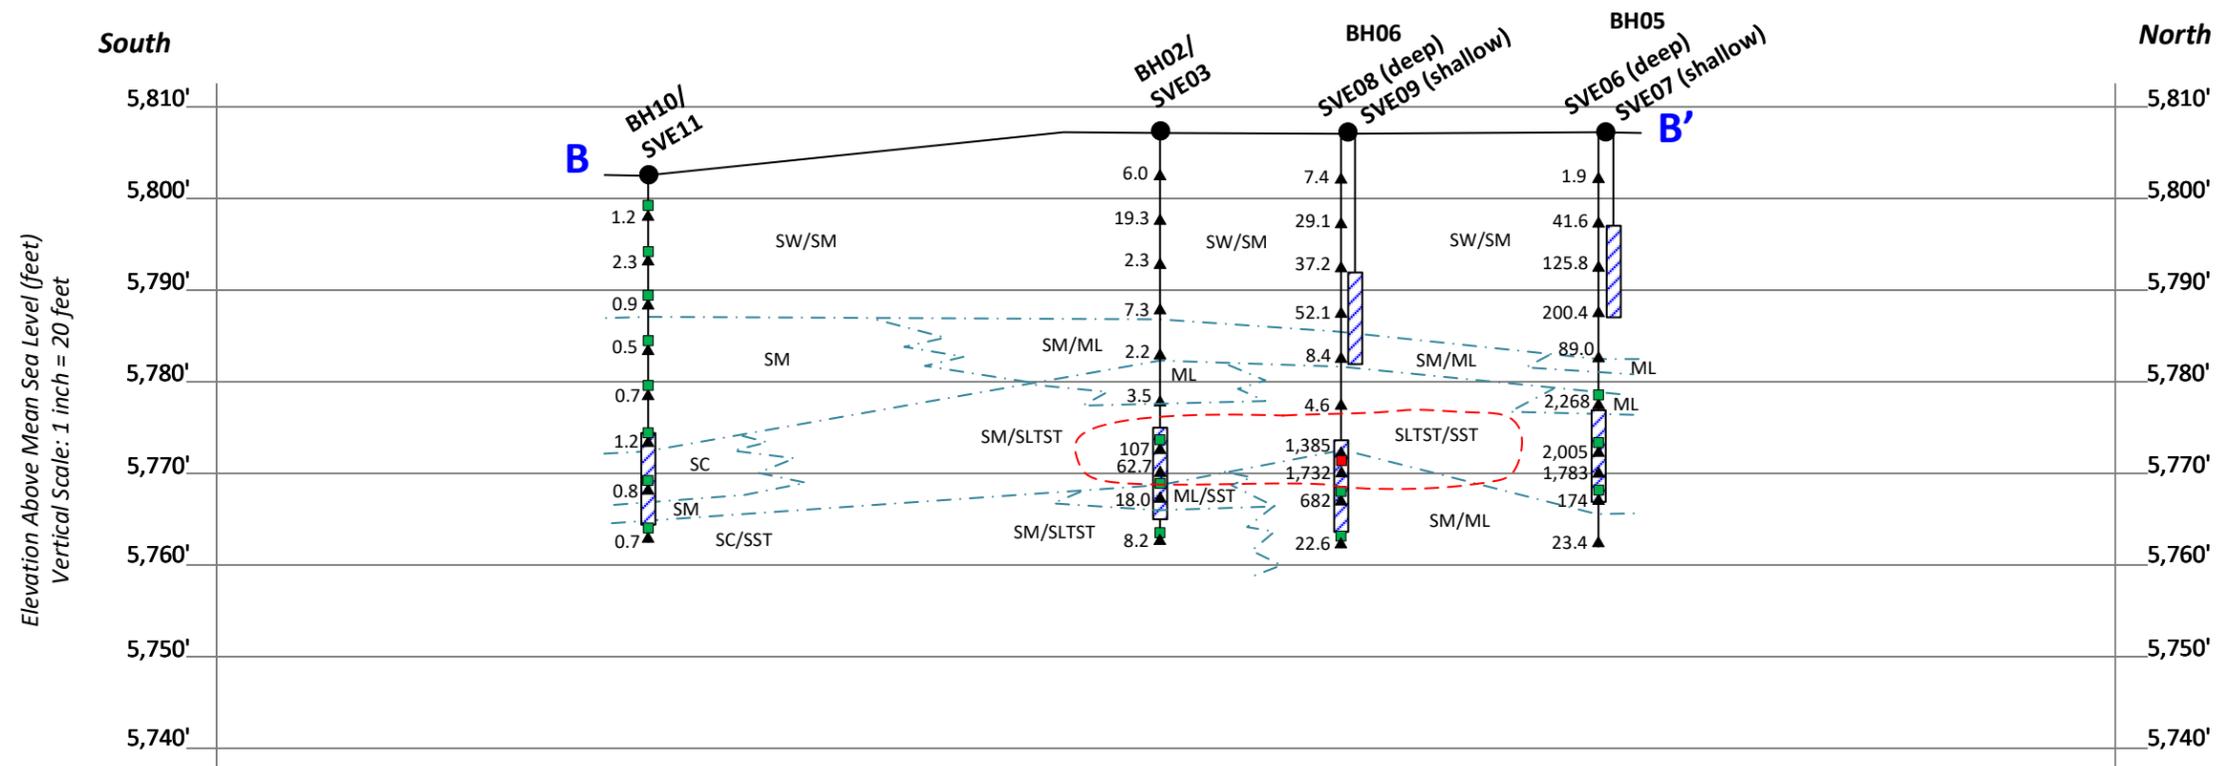
FIGURE 5B
B TO B' CROSS SECTION
HARE 14M
LOT 4 SEC 10-T29N-R10W
SAN JUAN COUNTY, NEW MEXICO
HILCORP ENERGY COMPANY

- ML SILT
- SC CLAYEY SAND
- SLTST SILTSTONE
- SM SILTY SAND
- SW POORLY SORTED SAND
- SST SANDSTONE

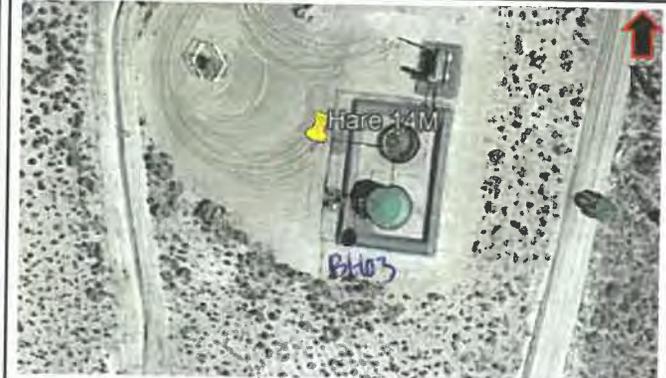
Casing Type: **Schedule 40 PVC 7.5-5.0'** Diameter: **2"** Length: **10'** Hole Diameter: **7"** Depth to Liquid: **—**

Screen Type: **Schedule 40 PVC 17.5-7.5'** Slot: **0.010"** Diameter: **2"** Length: **10'** Total Depth: **40'** Depth to Water: **—**

Gravel Pack: **10-20 Silica Sand 18-6.5'**

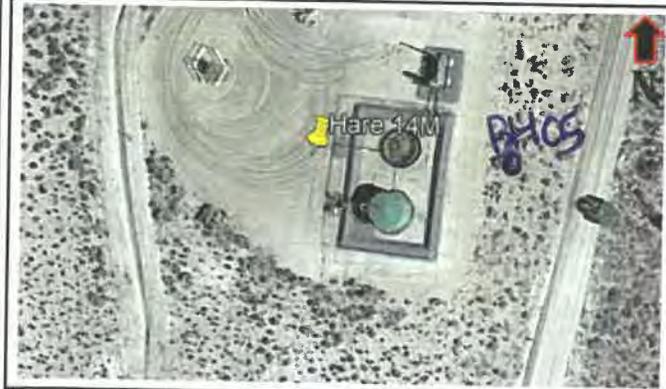
Elevation: 5,815	Detector: PID
Gravel Pack: 10-20 Silica Sand 40'-29' + 21'-9'	
Casing Type: Schedule 40 PVC 30'-S.U. 10'-S.U.	
Screen Type: Schedule 40 PVC 40'-30' + 20'-10' Slot 0.010"

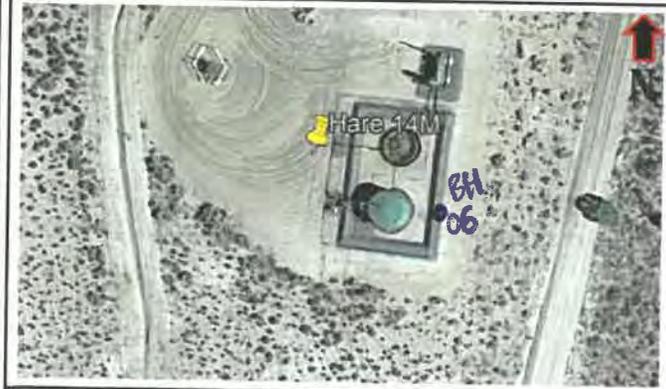
Boring/Well Number: **BH06** Project: **Hare 14M**
 Date: **8-19-20** Project Number: **017820017**
 Logged By: **Danny Burns** Drilled By: **MO-TE Drilling**

Elevation: **5.815** Detector: **PID**
 Gravel Pack: **10-20 Silica Sand 43'-32' + 26'-14'**
 Casing Type: **Schedule 40 PVC 33'-stickup + 15'-stickup**
 Screen Type: **Schedule 40 PVC 43'-33' Slot: 0.010" 25'-15'**

Drilling Method: **Hollow Stem/Air Rotary** Sampling Method: **Continuous**
 Seal: **Bentonite 32'-26' + 14'-12'** Grout: **Bentonite 12'-0'**
 Diameter: **2"** Length: **10'** Hole Diameter: **7"** Depth to Liquid: **—**
 Diameter: **2"** Length: **10'** Total Depth: **45'** Depth to Water: **—**
