**Re: Remediation Summary and Closure Report**  
**White Falcon 16 State #023H**  
**API No. 30-025-43699**  
**GPS: Latitude 32.13689 Longitude -103.377934**  
**UL "D", Sec. 16, T25S, R35E**  
**Lea County, NM**  
**NMOCD Ref. No. 1RP-4881**

TRC Environmental Corporation (TRC), on behalf of COG Operating, LLC (COG), has prepared this Remediation Summary and Closure Report for the Release Site known as the **White Falcon 16 State #023H**. Details of the release are summarized below:

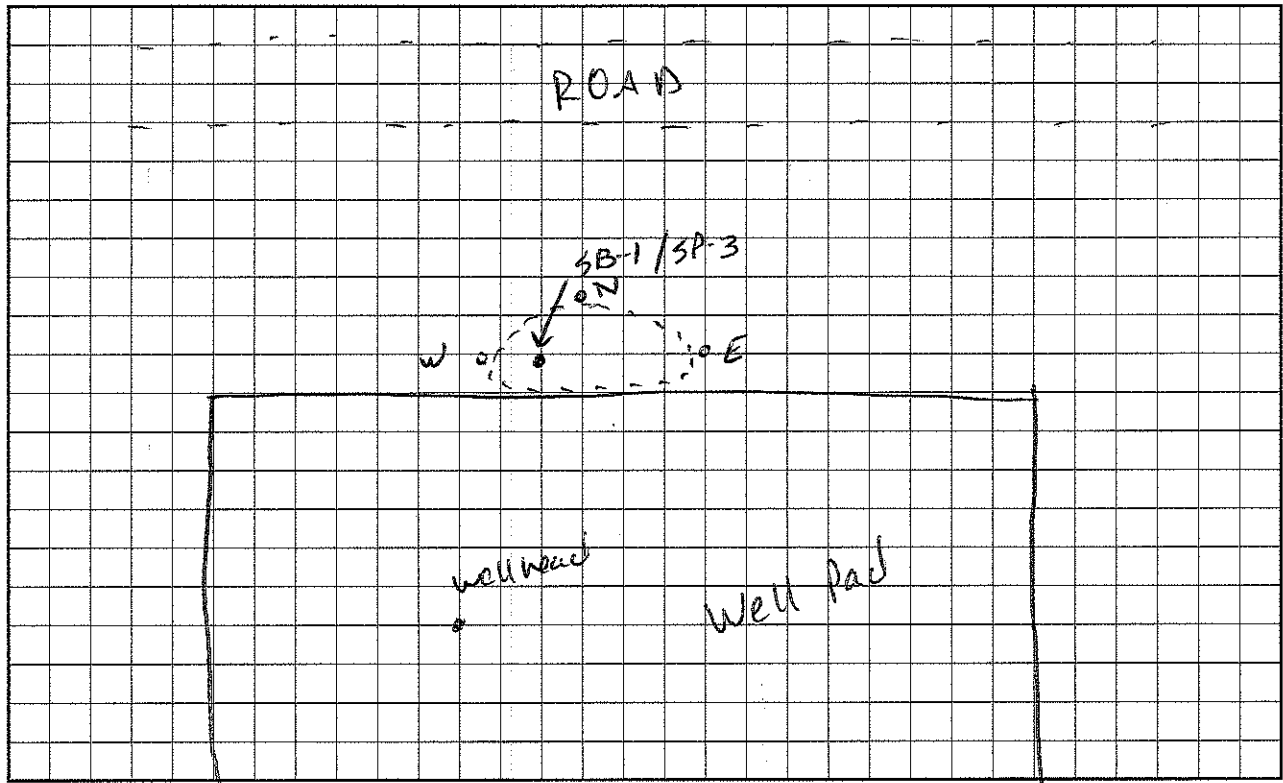
ID	CI-	Odor/PID
SB-106'	72,600	None
SB-108'	72,600	None
SB-1010'	260	None
SB-1012'	2120	None
GPS:

ID	CI-	Odor/PID
NP6"	2120	None
GPS:

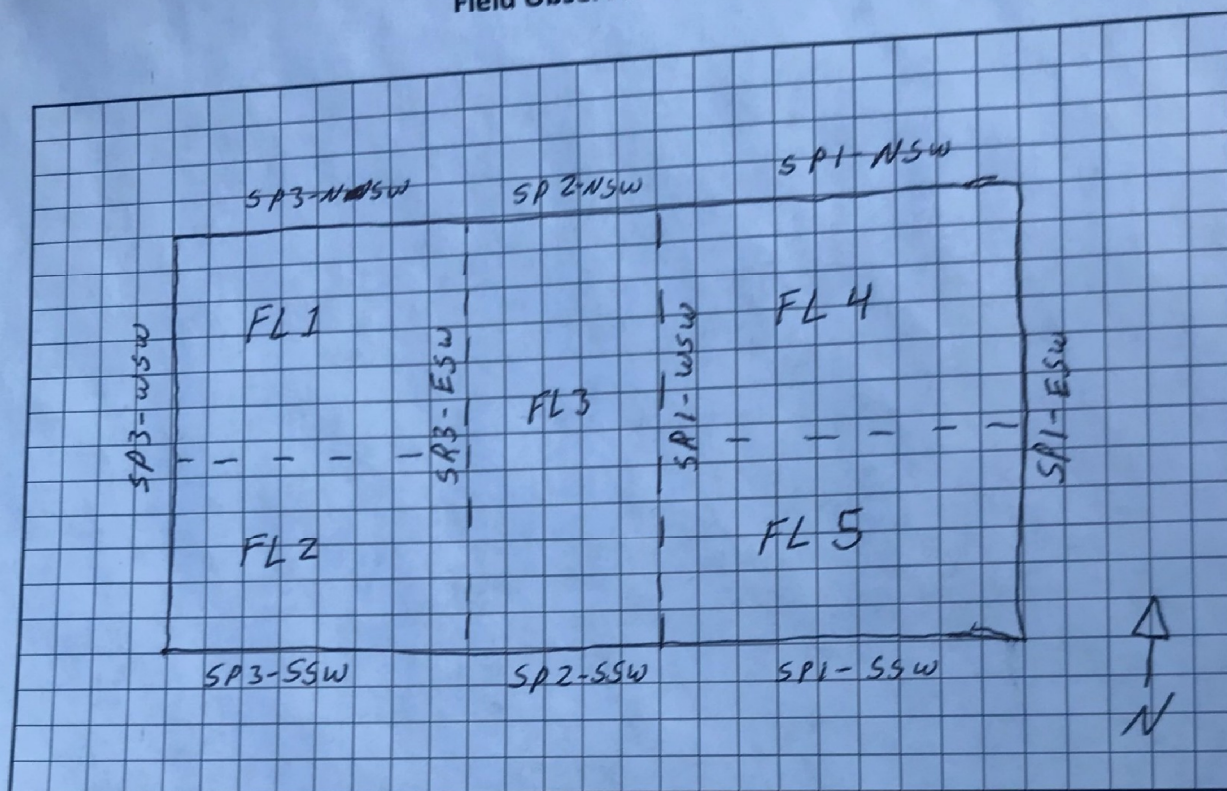
ID	CI-	Odor/PID
FL1	205	None
FL2	348	None
FL3	335	None
FL4	262	None
GPS:

ID	CI-	Odor/PID
<del>SP3-NSW</del>	<del>166</del>	<del>None</del>
SP1-NSW	166	None
SP1-SSW	379	None
SP1-ESW	212	None
GPS:

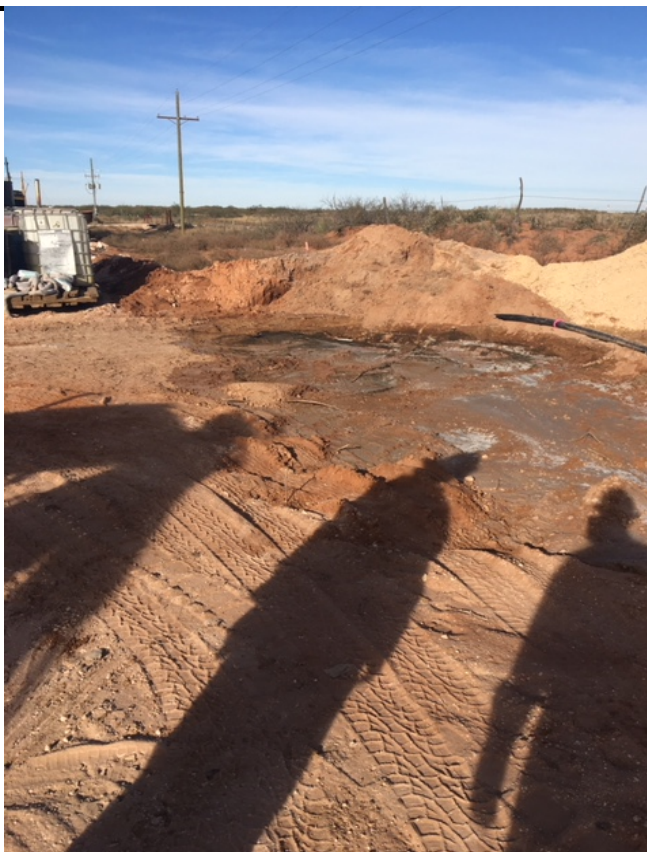
**Photo 1** - View of affected area prior to delineation activities, facing Northwest.

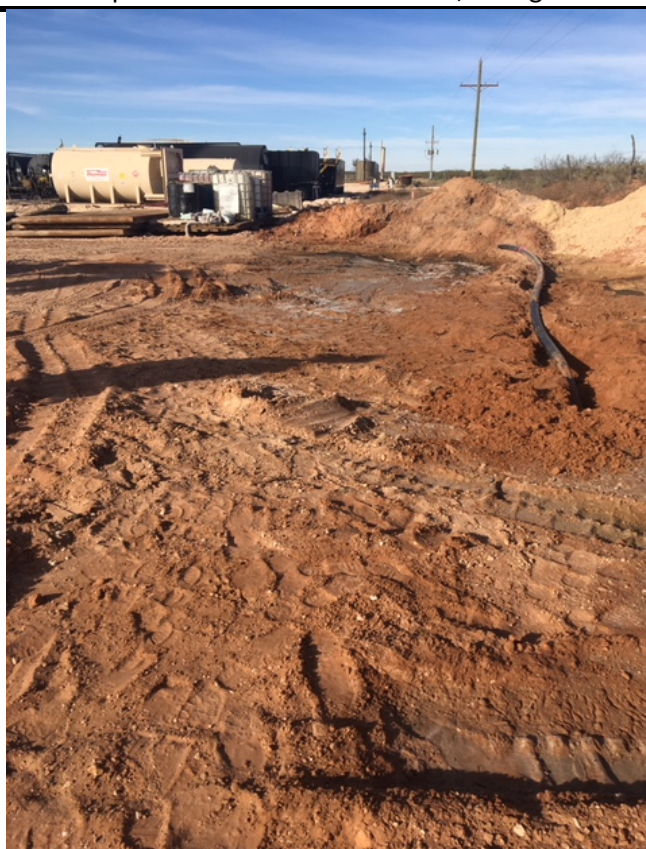
**Photo 2** - View of affected area prior to remediation activities, facing West.

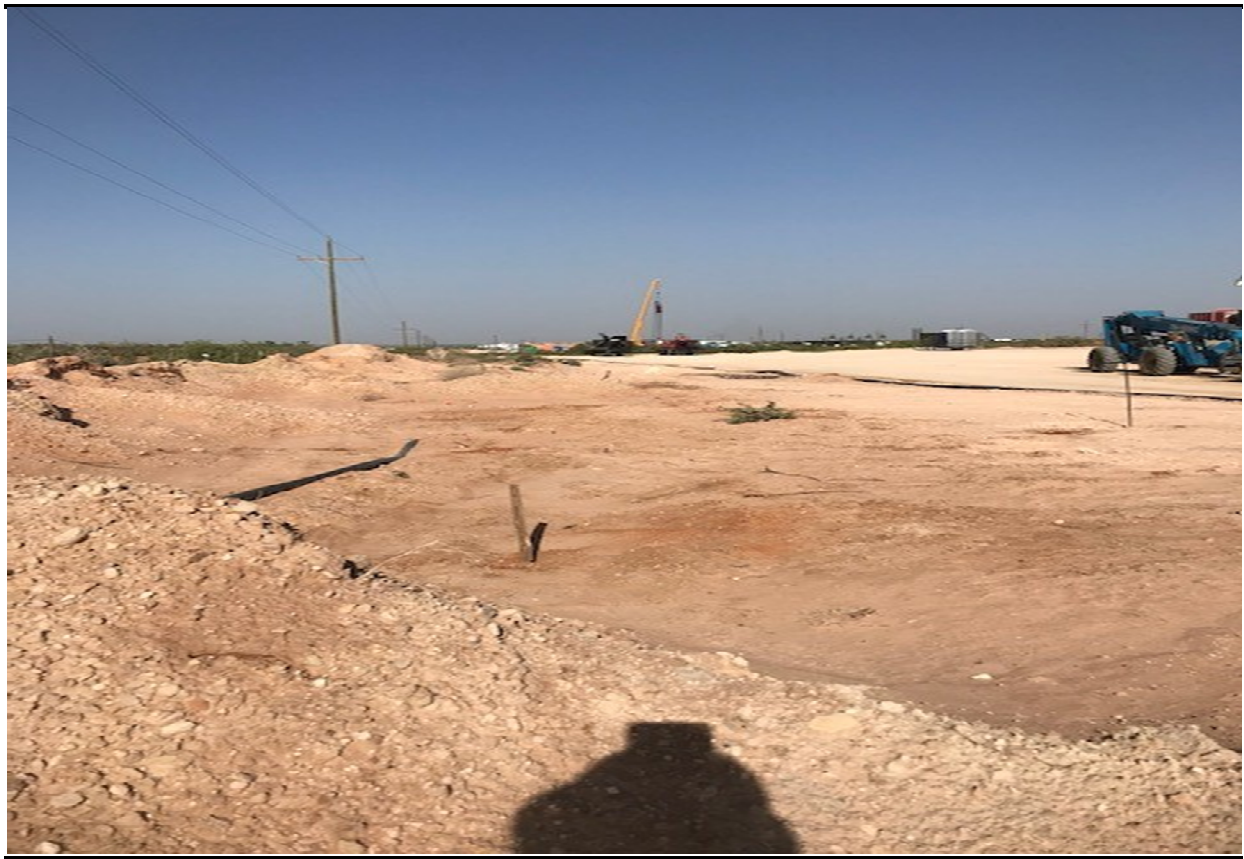
**Photo 3** - View of affected area during initial investigation, facing East.

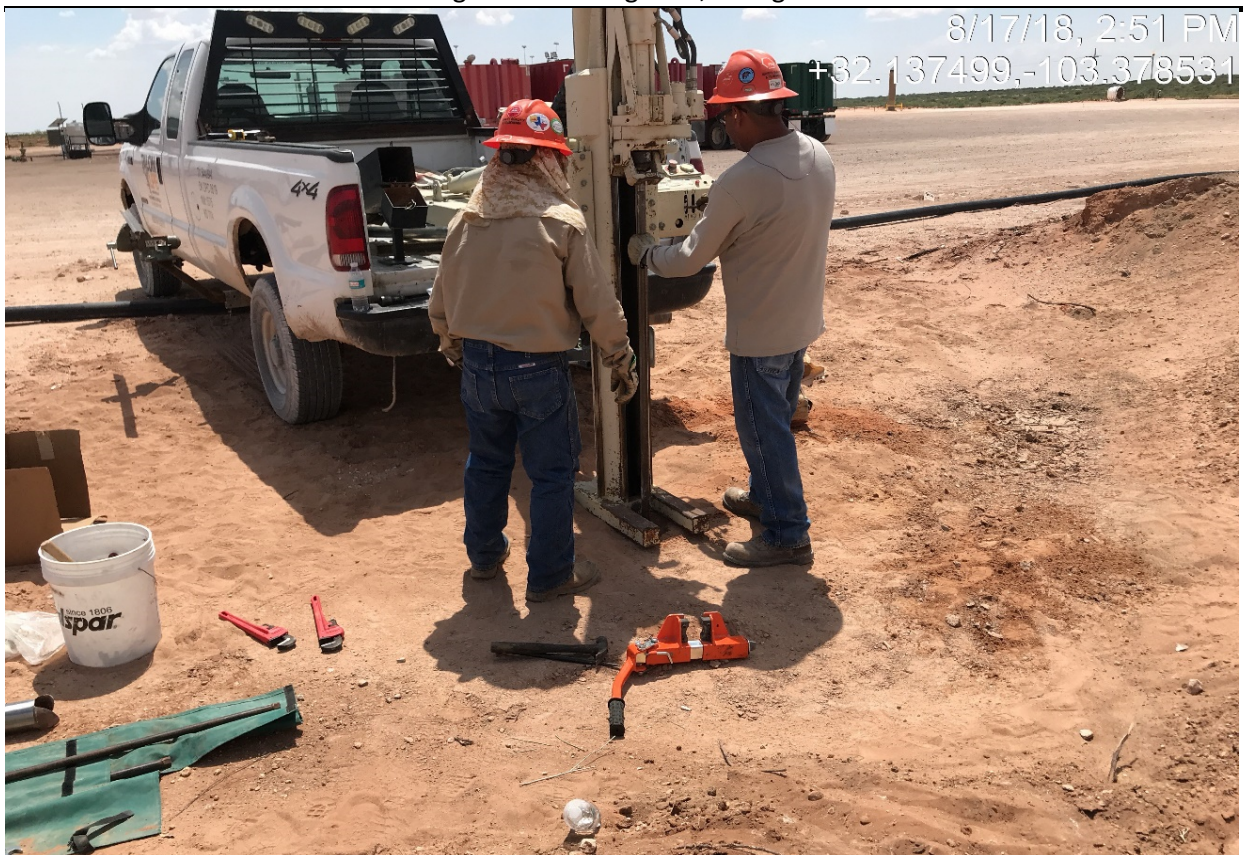
**Photo 4** - View of affected area during Geoprobings activities, facing South.

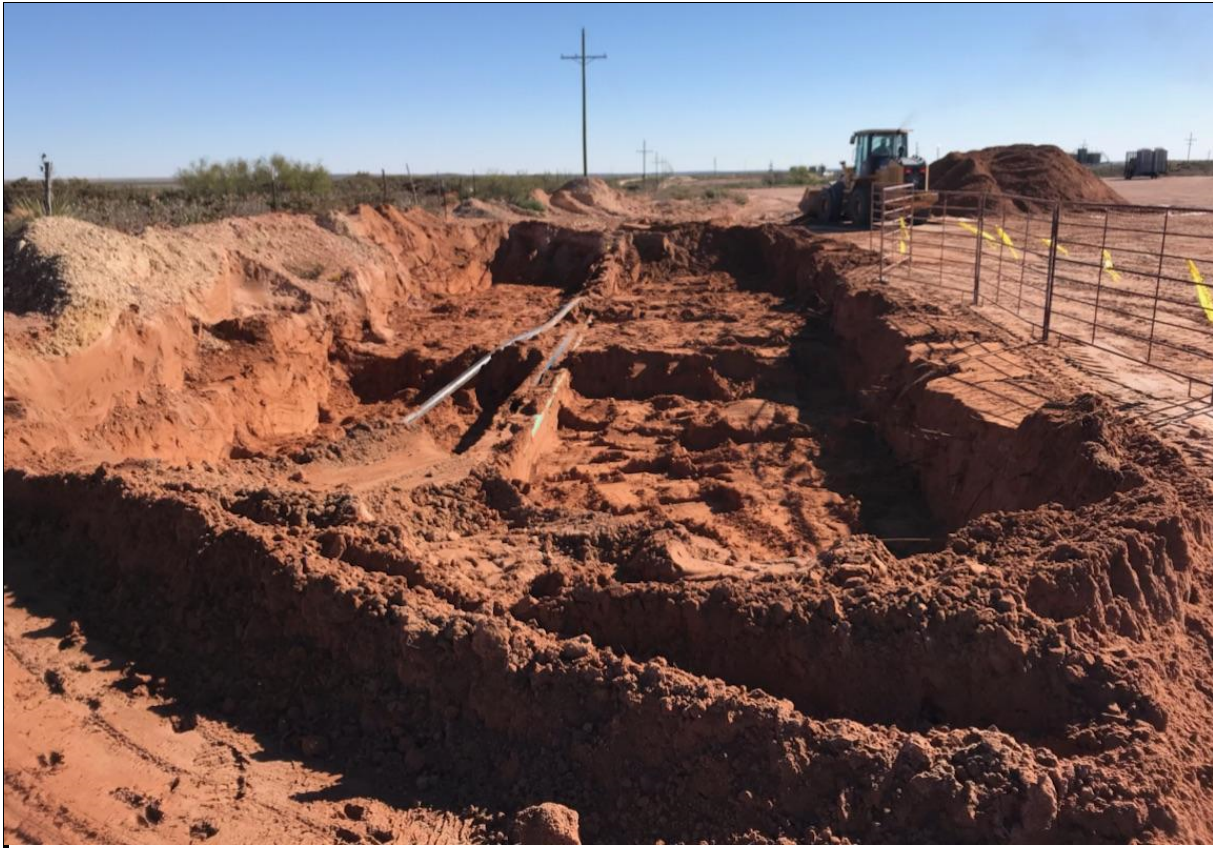
**Photo 5** - View of affected area after excavation activities, facing East.

- Utilizing mechanical equipment, excavate impacted soil within the release margins in the area characterized by sample points SP-1, SP-3 and SB-1 to a depth of approximately four (4) ft. bgs, or until laboratory analytical results from confirmation soil samples indicate concentrations of chloride are below the applicable NMOCD Closure Criteria.

- Excavate impacted soil within the release margins in the area characterized by sample point SP-2 to a depth of approximately one (1) ft. bgs, or until laboratory analytical results from confirmation soil samples indicated concentrations of chloride are below the applicable NMOCD Closure Criteria.

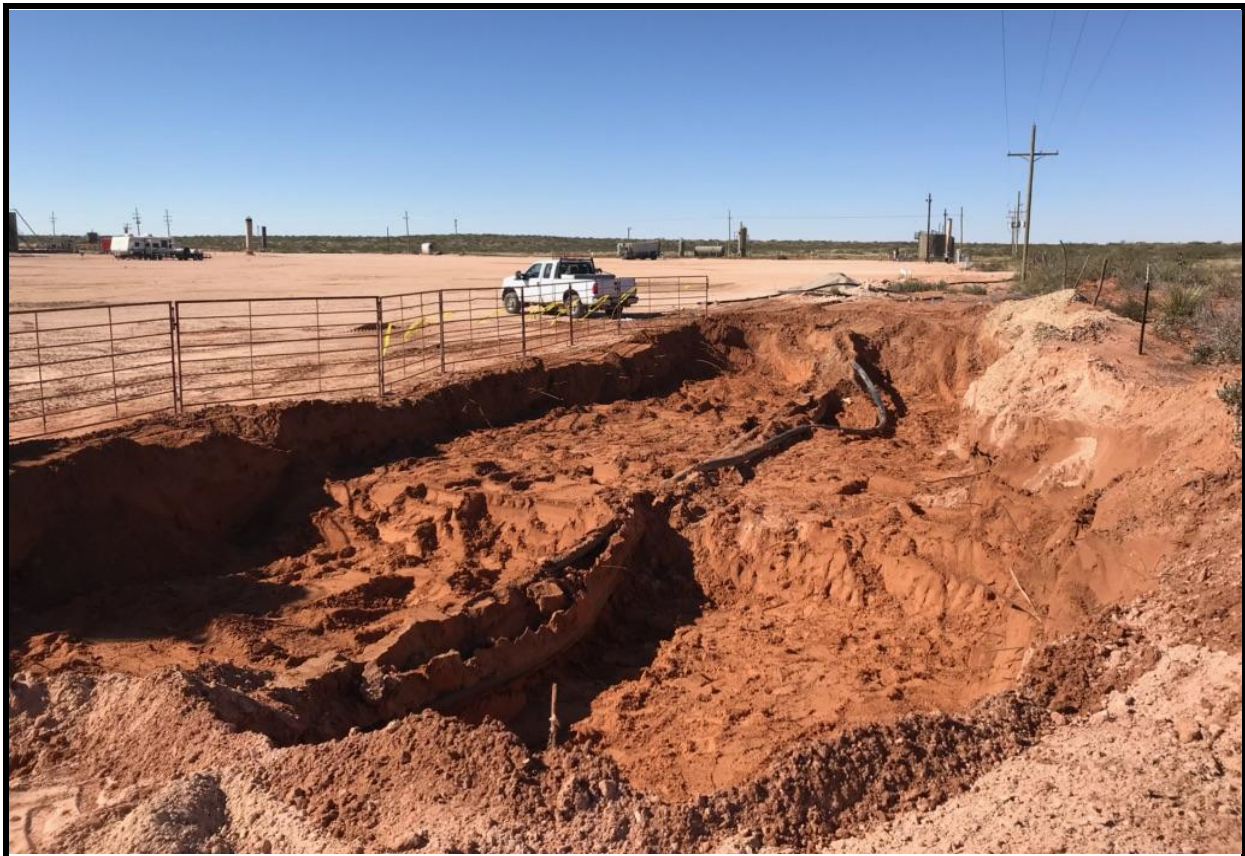
**Photo 6** - View of affected area after excavation activities, facing West.

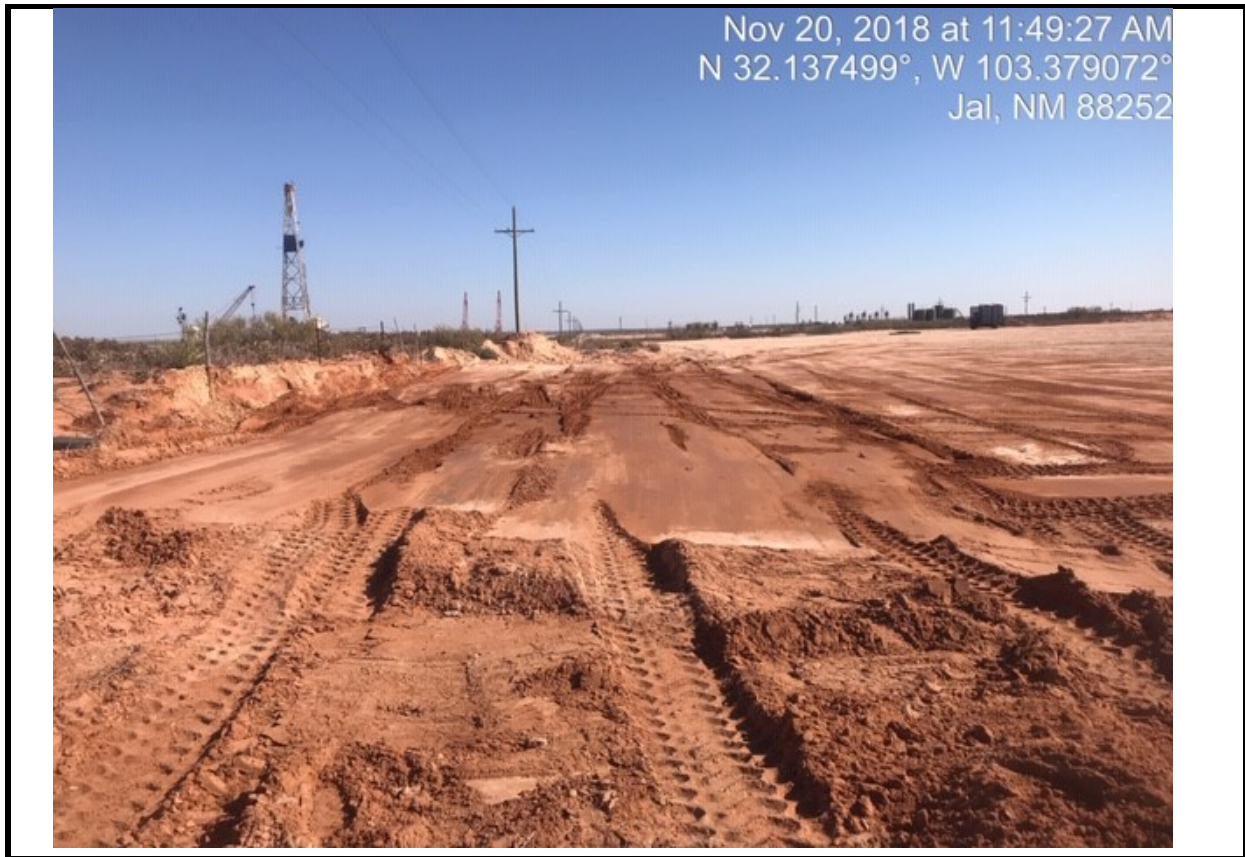
**Photo 7** - View of affected area after backfill activities, facing East.

- Upon receiving favorable laboratory analytical results from confirmation soil samples (below the NMOCD Closure Criteria) excavated areas will be backfilled with locally sourced, non-impacted "like" material, at or near original relative positions. The affected area will be contoured and/or compacted to achieve erosion control, stability and preservation of surface water flow to the extent practicable.

Areas affected by the Release and associated remediation activities will be substantially restored to the condition which existed prior to the Release to the maximum extent practicable. Excavated areas will be backfilled with locally sourced, non-impacted "like" material. The affected area will be contoured and/or compacted to achieve erosion control, stability and preservation of surface water flow to the extent practicable. Affected areas not on production pads and/or lease roads will be reseeded with "Homesteaders" seed mixture during the first favorable growing season, following closure of the site, in accordance with the applicable regulatory agency.

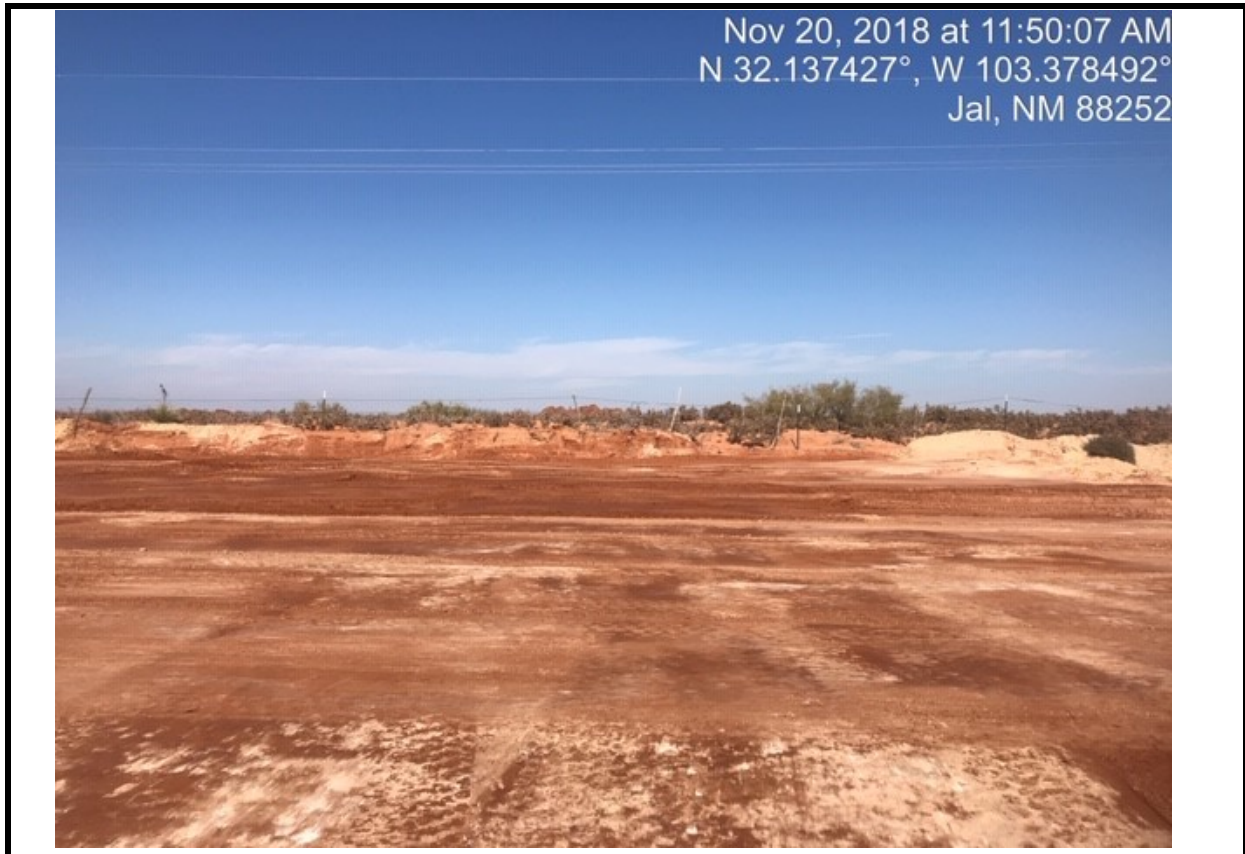
**Photo 8** - View of affected area after backfill activities, facing North.
