Closure Report

Cuadrito AZO Federal #1
Eddy County, New Mexico
API # 30-015-32172
Incident #nAPP2210346161

EOG Resources Inc.
104 S. 4th Street
Artesia, NM 88210

Talon/LPE
408 W. Texas Avenue
Artesia, New Mexico 88210

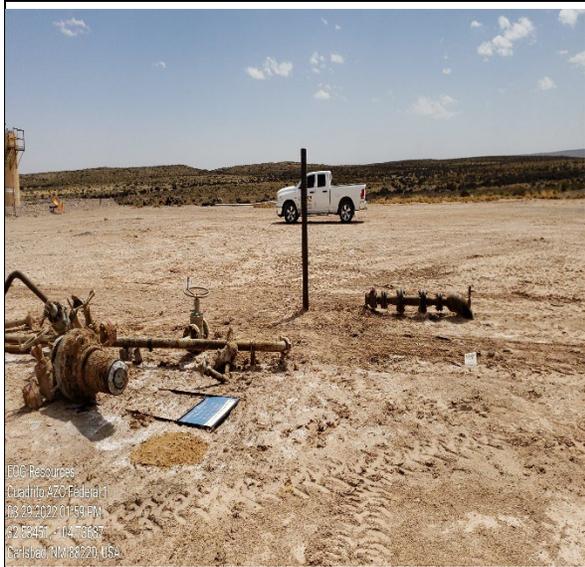
Photograph No.1 Description:
Impacted area around wellhead marker.

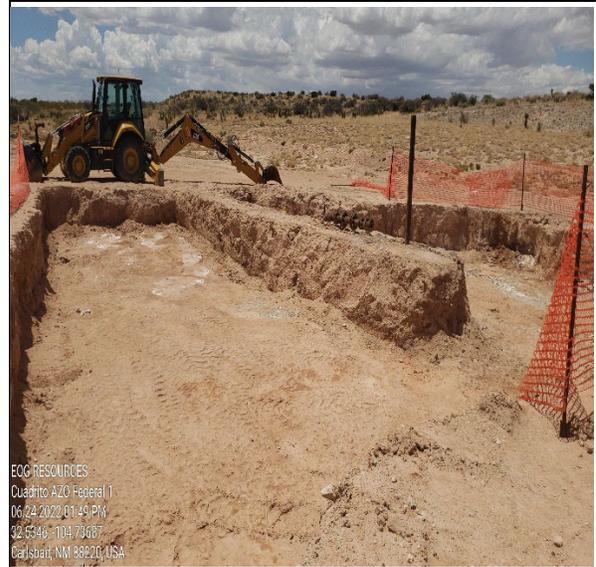
Photograph No.2 Description:
Excavation looking East.

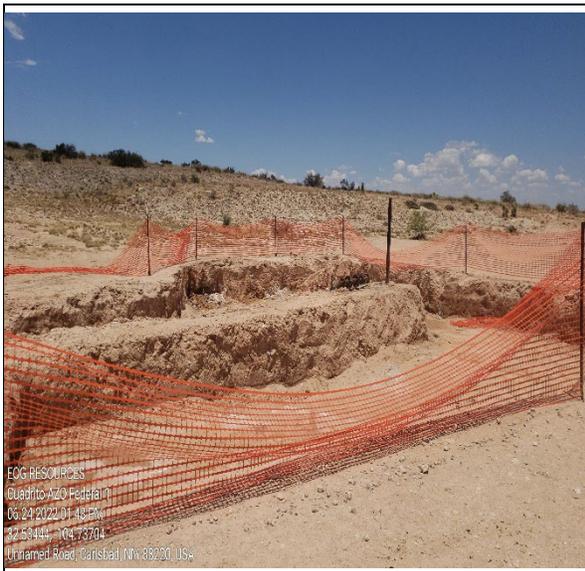
Photograph No.3 Description:
Excavation looking southwest.

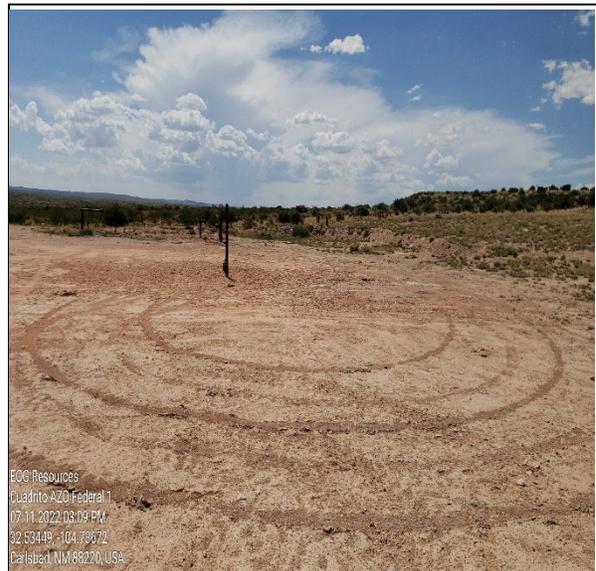
Photograph No.4 Description:
Backfilled to grade all debris removed.
