Closure Report

Shinnery Oaks SWD
Eddy, New Mexico
Incident # **nAPP2216632989**
E-02-21S-28E

Subject: **Closure Report**
Shinnery Oaks SWD
Eddy County, New Mexico
Incident # **nAPP2216632989**

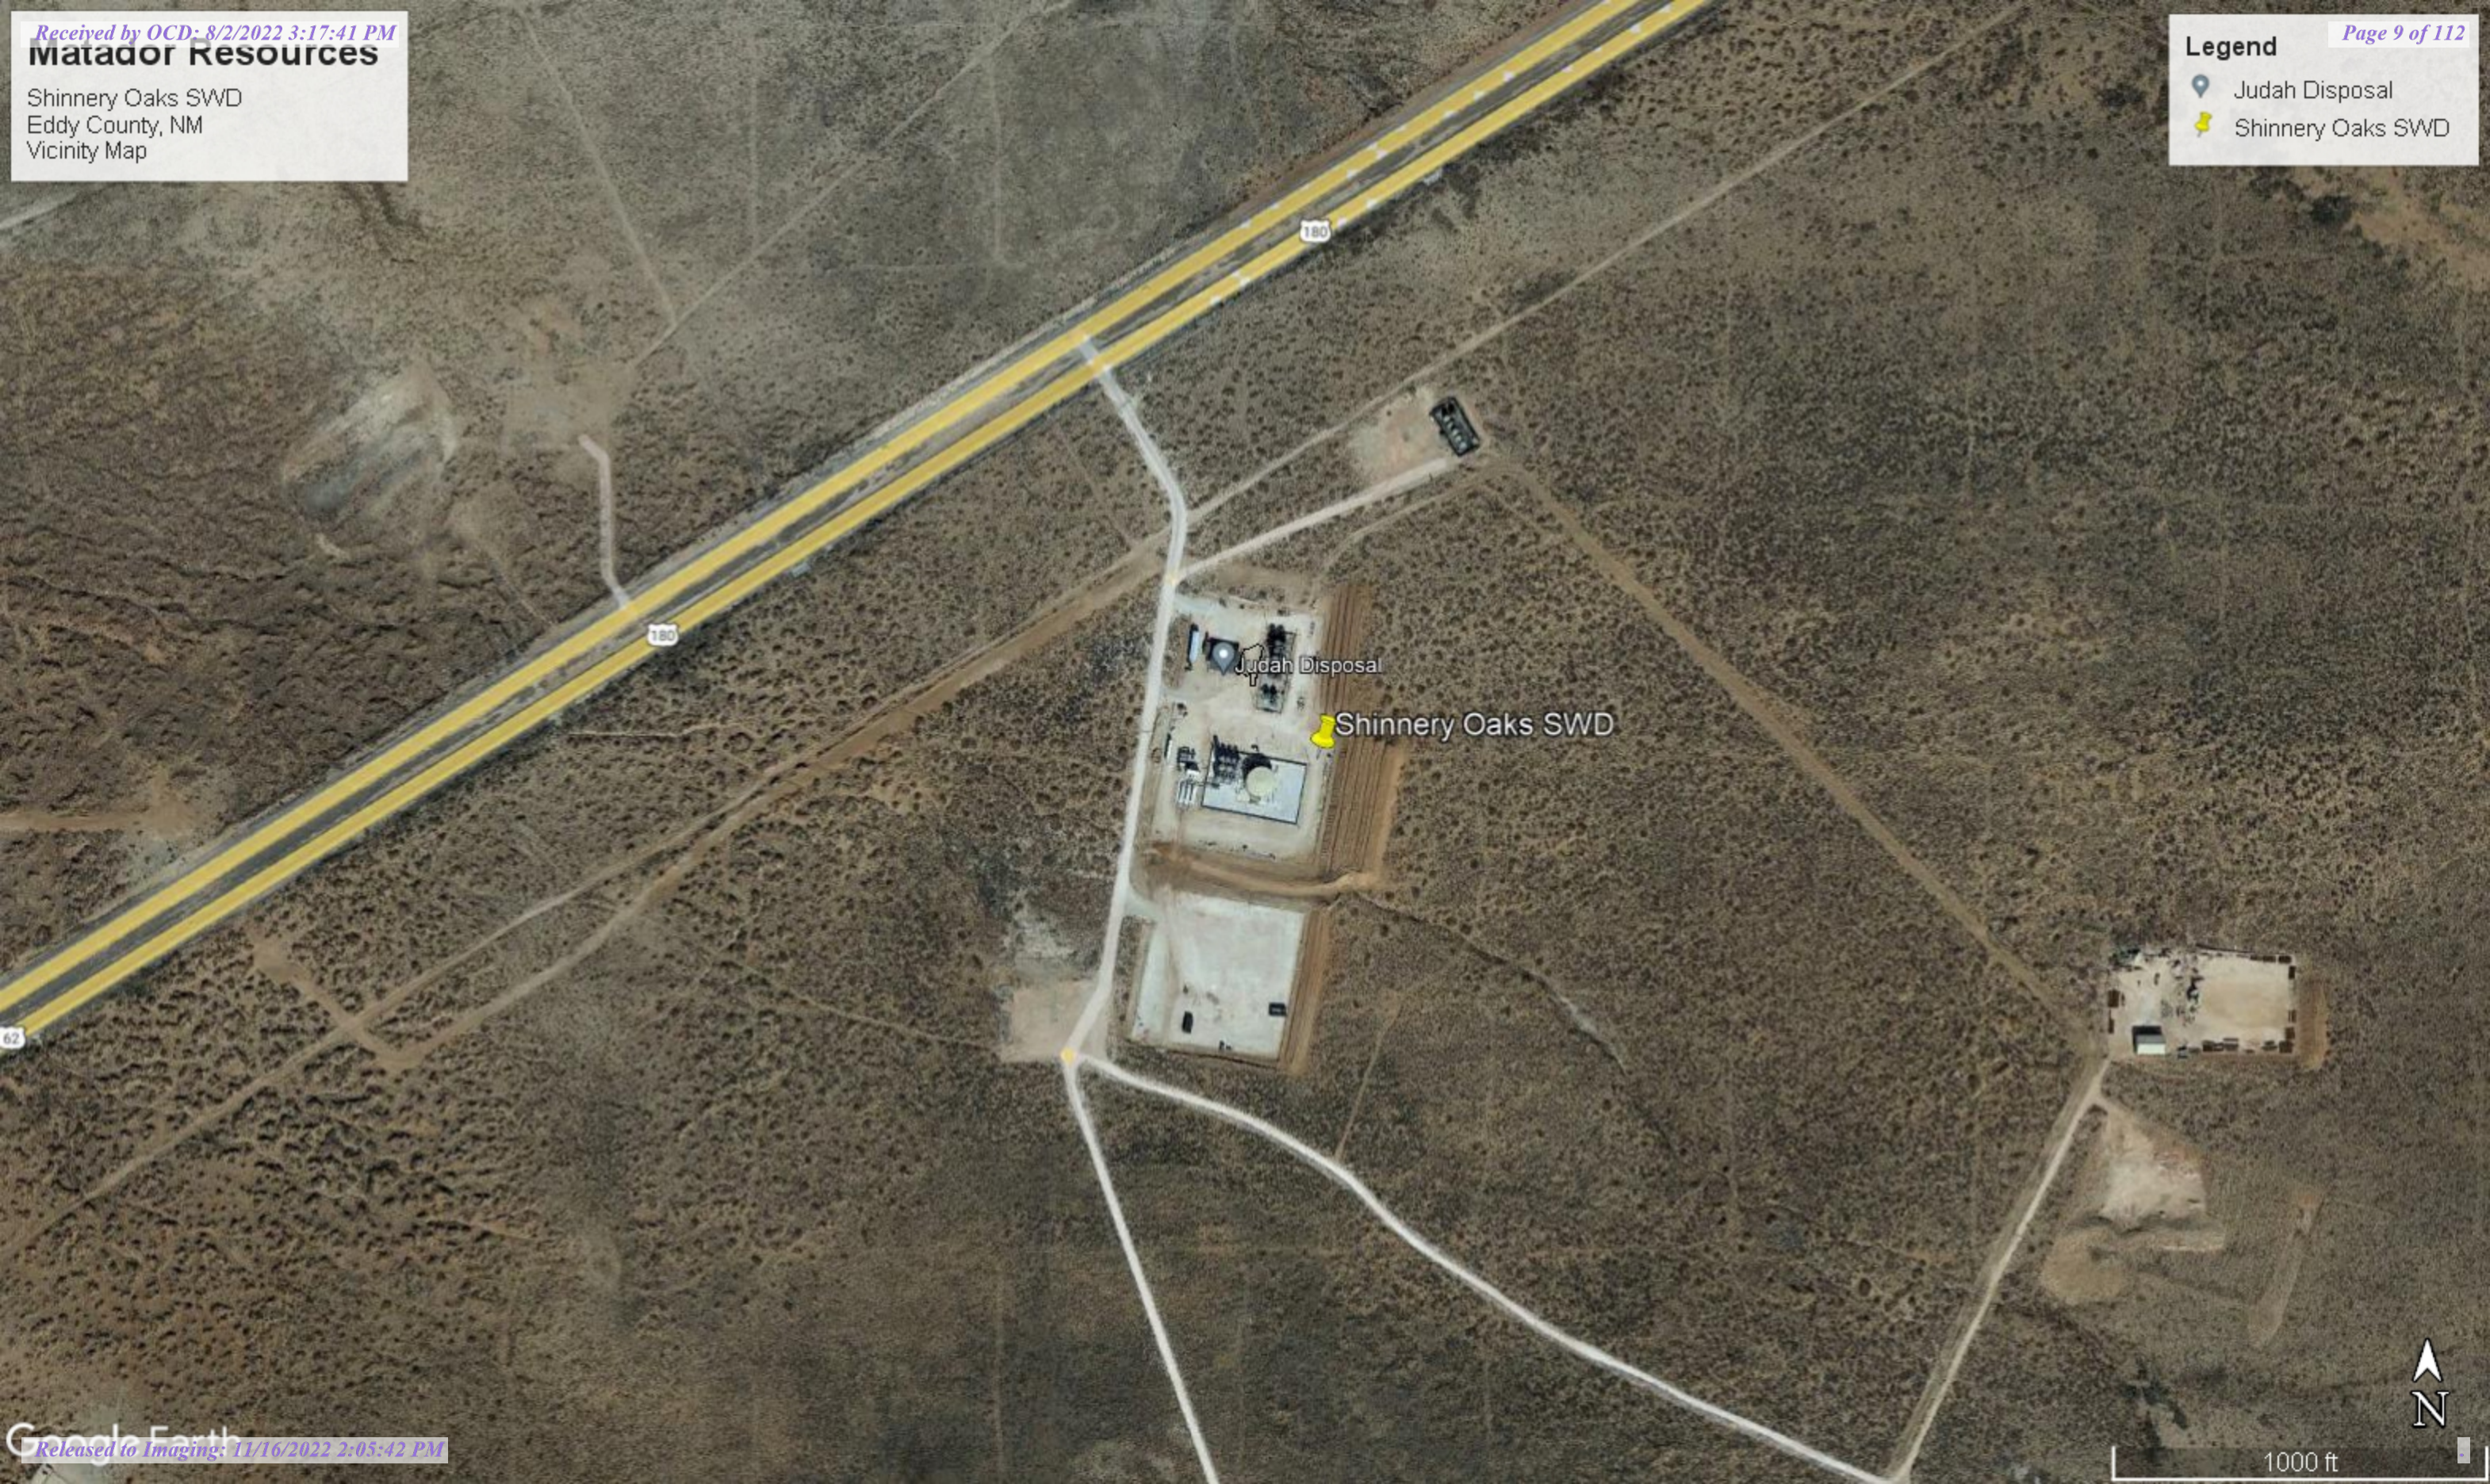
Shinnery Oak SWD
Eddy County NM
Assessment Map

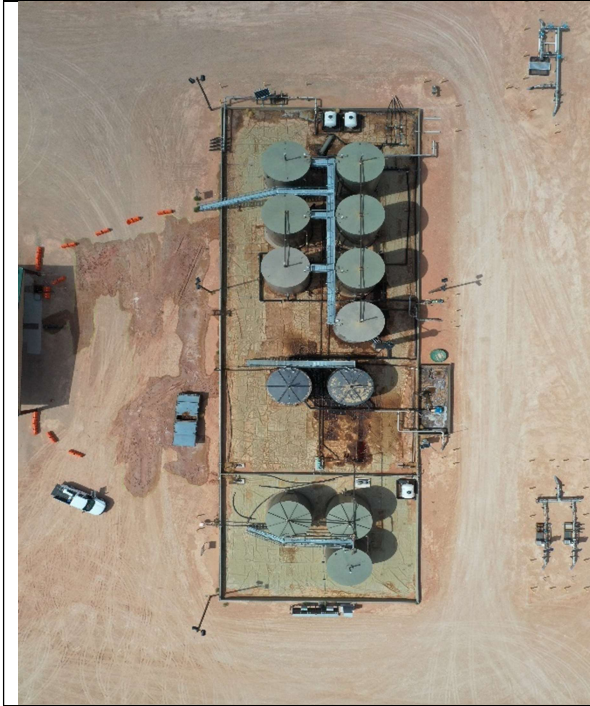
**Photograph No.1 Description:**

Aerial of spill

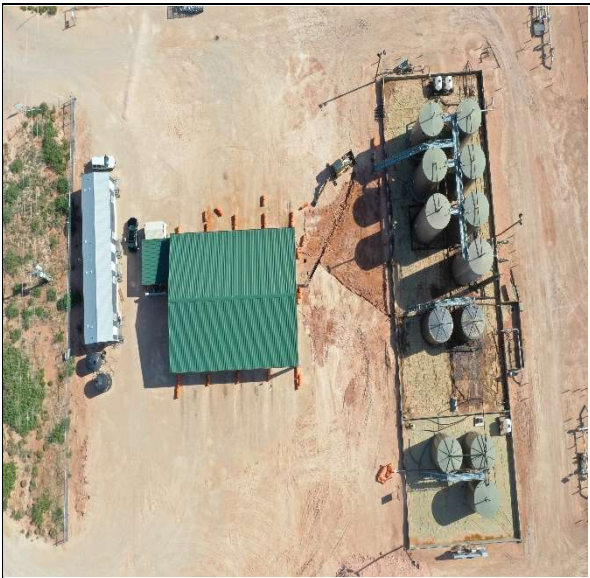
**Photograph No.3 Description:**

Aerial of excavation

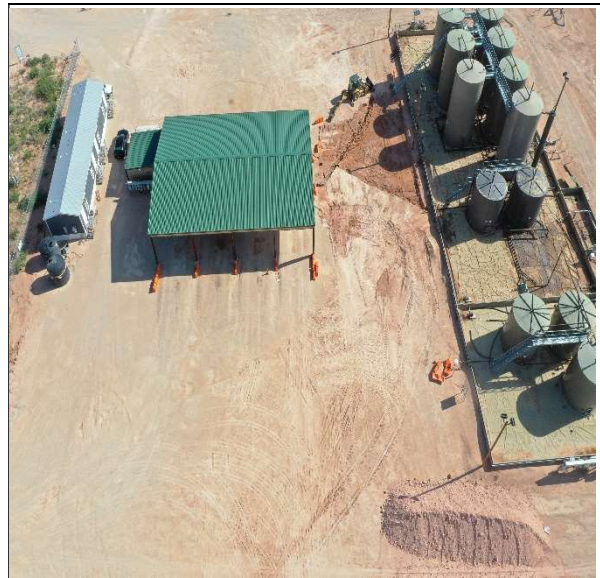
**Photograph No.4 Description:**

Excavation looking north

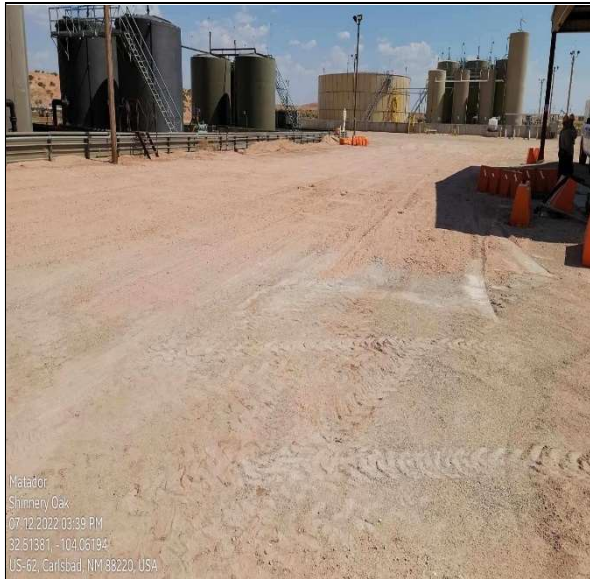
Photograph No.5 Description:

Backfill of pad area looking south

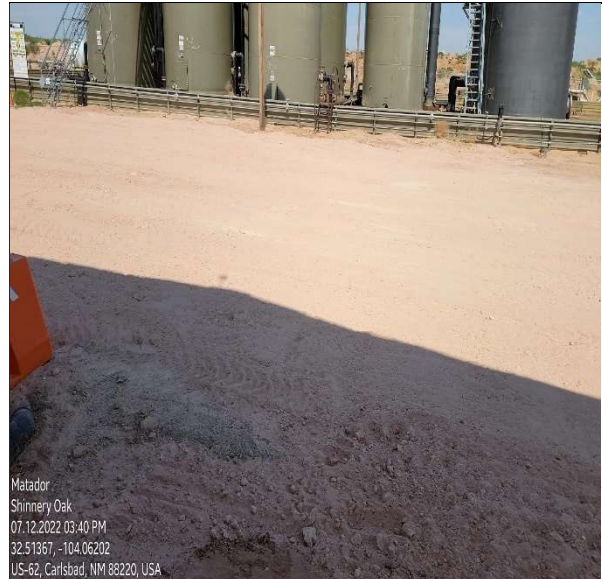
Photograph No.6 Description:

Backfill of pad area

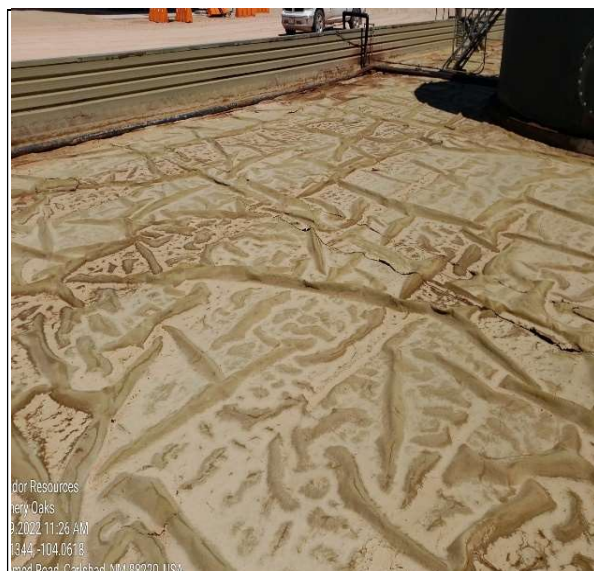
Photograph No.1 Description:

Liner on west side of release.

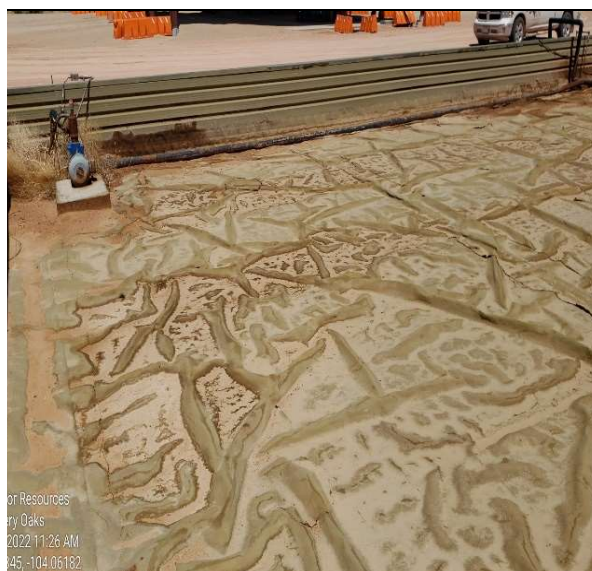
Photograph No.2 Description:

Liner on south side of release.

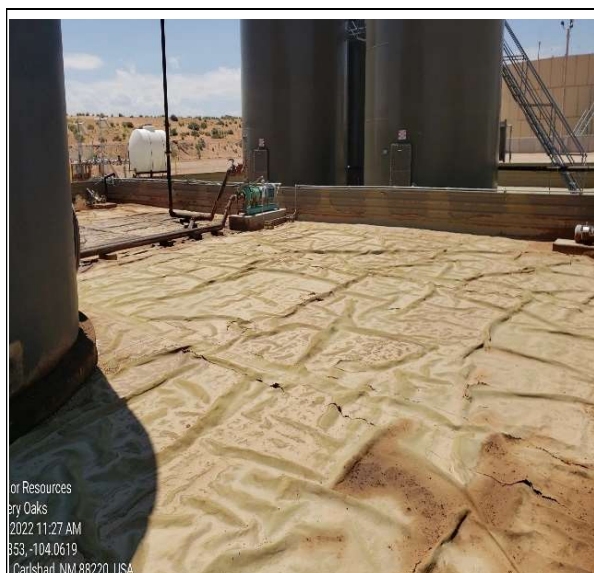
Photograph No.3 Description:

Liner on north side of release.

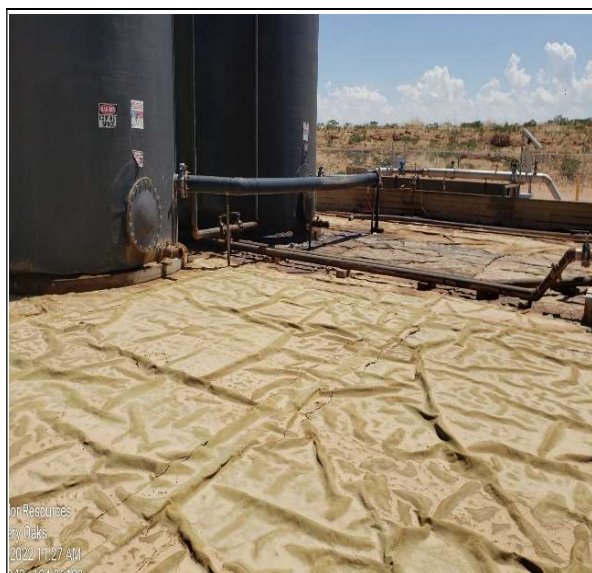
Photograph No.4 Description:

Liner at source of release.
